Issued February 2024

REPORT AVIATION 2024/03

Serious aviation incident on 24 February 2020 near the Maersk Invincible (XMKI) oil rig in the North Sea involving Sikorsky Aircraft Corporation S-92A, LN-ONT, operated by Bristow Norway AS

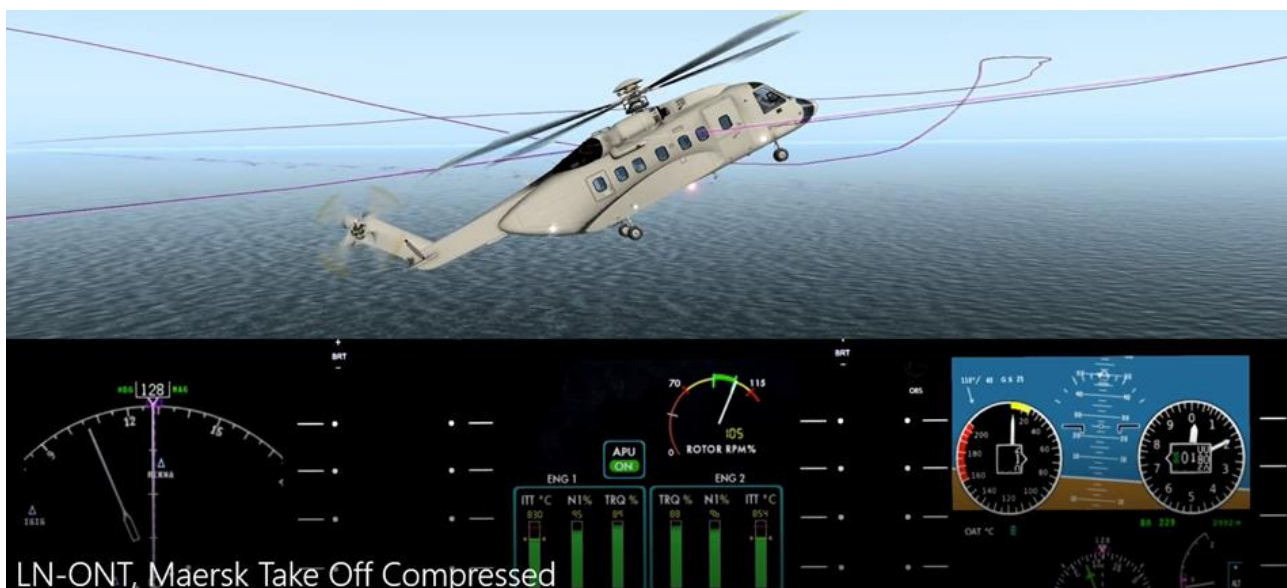
Figure 3: The highest pitch-up attitude after take-off exceeded 25° while the helicopter was accelerating rearwards and reached a ground speed of 49 kts. Animation: L3 Harris Technologies UK / NSIA. Source: LN-ONT CVFDR

The helicopter then developed a nose-up pitch in excess of 20° for approximately 15 seconds while moving sideways to the left, after which it started to accelerate rearwards and downwards. During that phase, the helicopter nose turned to the right, from 103° to 155°. With 89% engine torque, the helicopter continued to lose altitude at a vertical speed of more than 375 ft/min for 10 seconds.

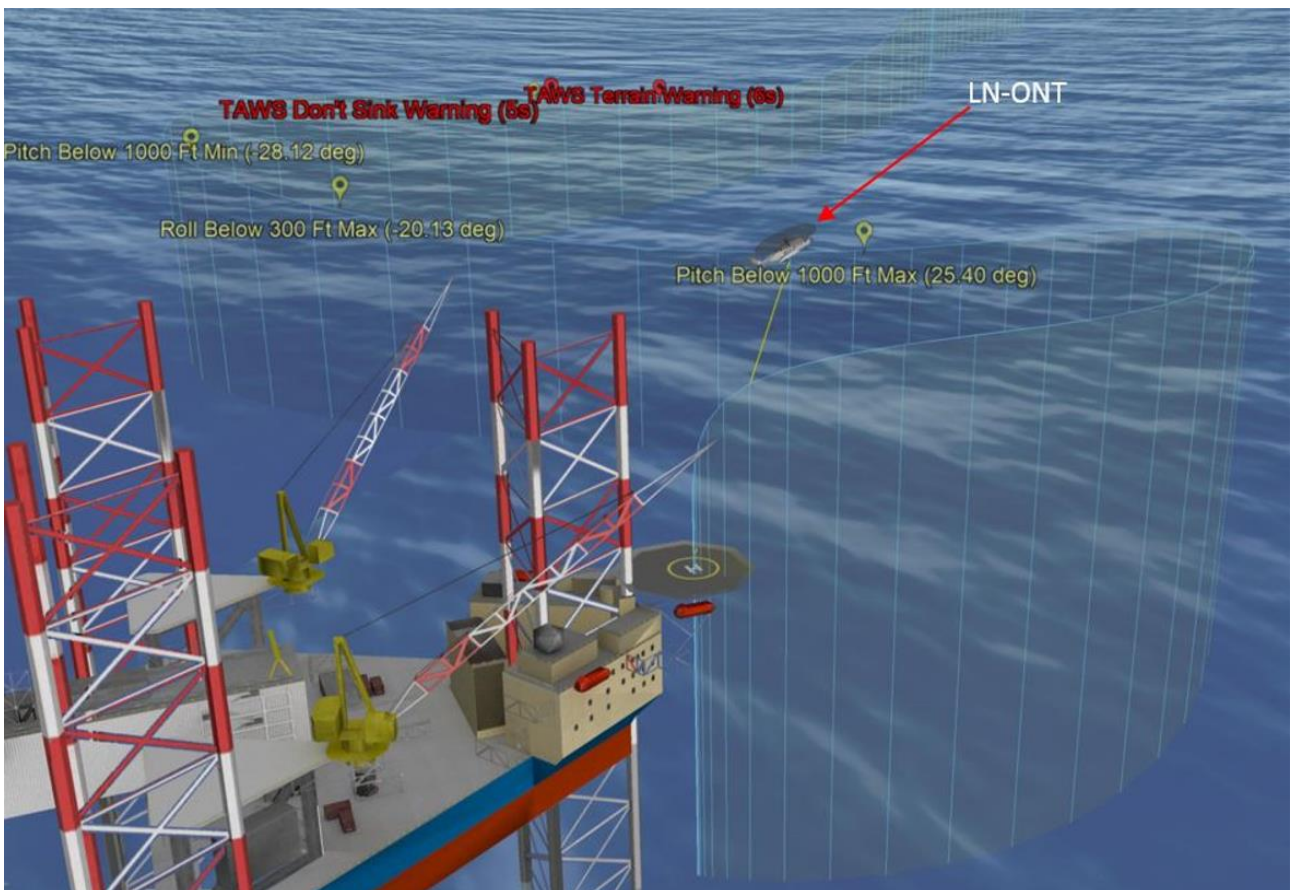
While accelerating, the helicopter had a low sink rate and the torque varied between 70 and 79%. The commander, who was pilot monitoring, has told the NSIA that he focused his attention on the vertical speed indicator. When it showed a sink rate of 100 ft/min, he called out 'We are descending' two times. Just after that, the voice alert 'Altitude, altitude – altitude, altitude' indicated that the helicopter was about to drop below the minimum altitude selected on the radar altimeter. The radar altimeter was set to 260 ft after the radar approach to Maersk Invincible. The commander has explained that, after the voice alert, he got the feeling that the instrument readings did not match with what he expected, and he felt that he became disoriented, see Figure 4.

Figure 4: The helicopter's departure profile during the seconds following its take-off from Maersk Invincible. Warnings from the enhanced ground proximity warning system (EGPWS) are highlighted in red. Illustration: L3 Harris Technologies UK / NSIA. Source: LN-ONT CVFDR

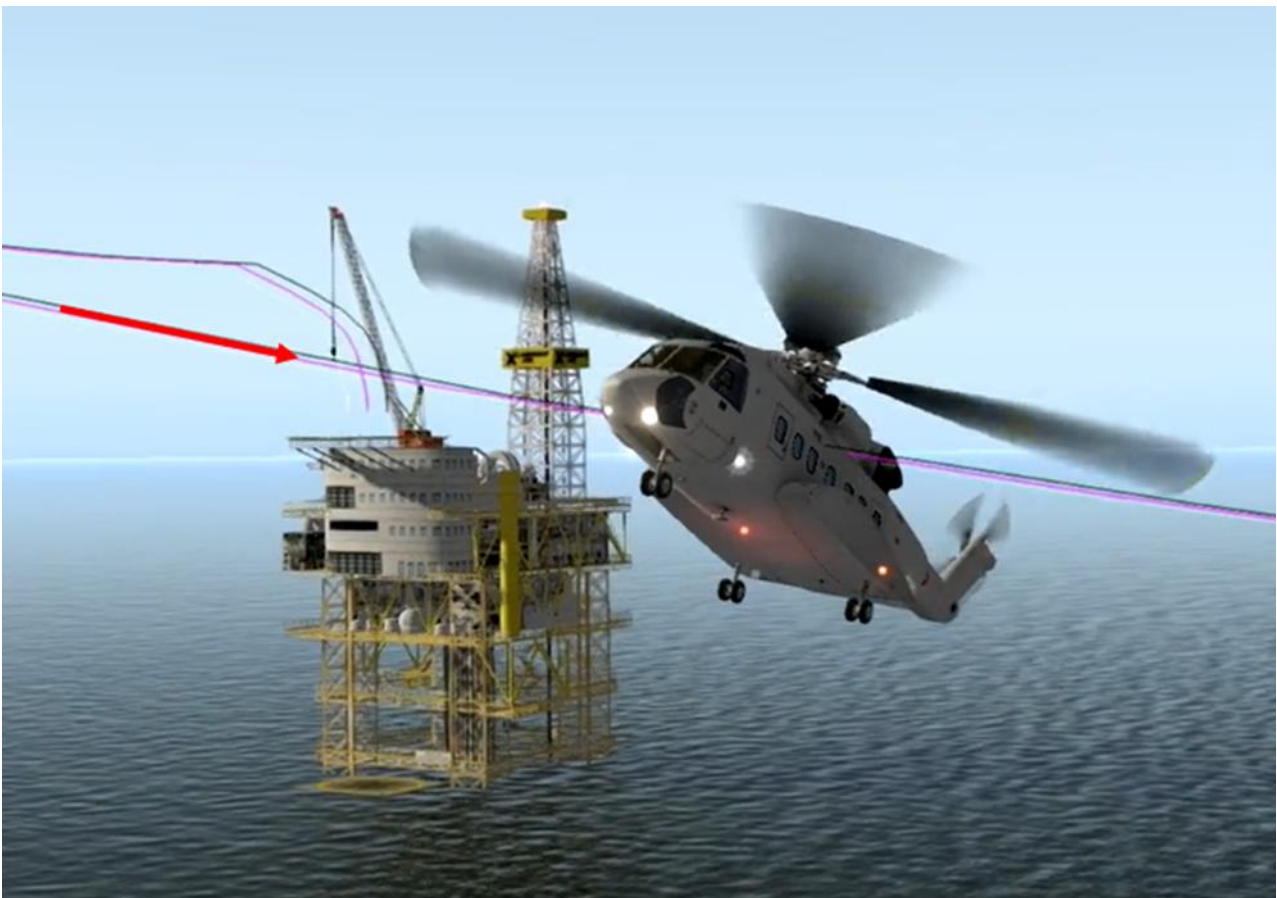
Figure 6: Animation of LN-ONT passing the oil installation while the helicopter flies backwards. (The oil installation is an illustration and not identical to Maersk Invincible). Animation: L3 Harris Technologies UK / NSIA. Source: LN-ONT CVFDR

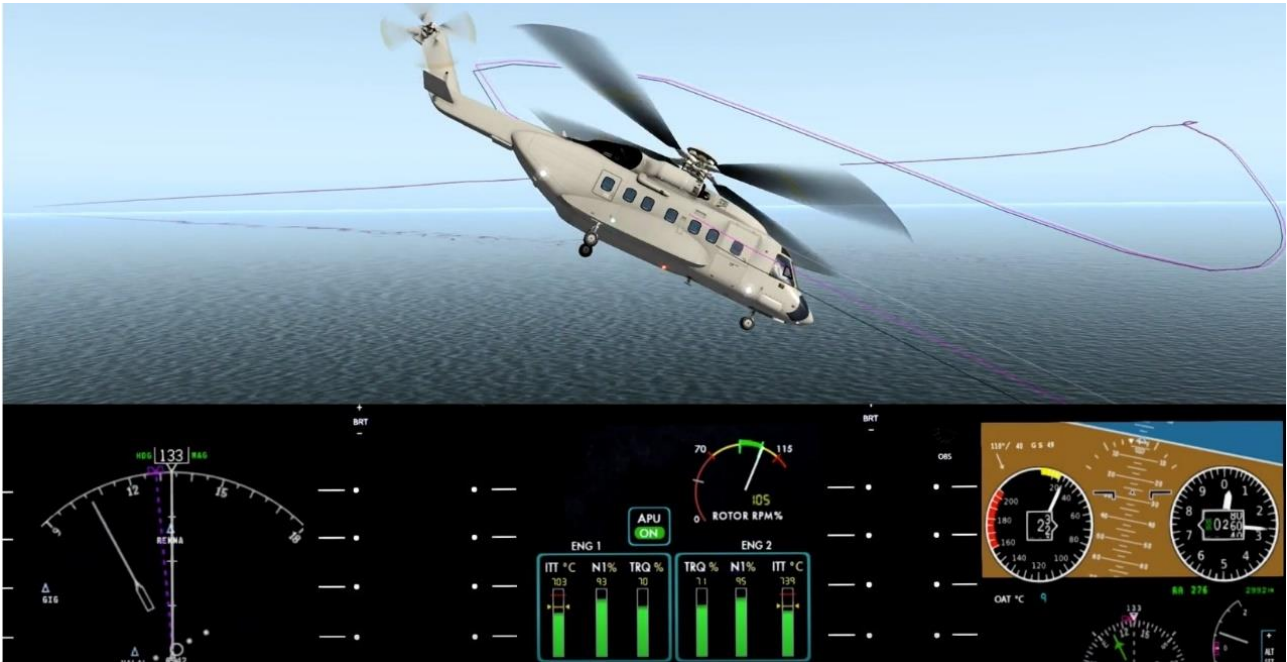
Before the subsequent acceleration, while the commander sought to regain control, the helicopter reached a maximum nose-down pitch of 28.12°; see Figure 8. The engine torque briefly dropped to 64% before it was corrected to 88% as the horizontal speed gradually increased to 90 kts.

Figure 8: While attempting to regain control of the helicopter, it developed a nose-down pitch of 28.12°. Animation: L3 Harris Technologies UK / NSIA. Source: LN-ONT CVFDR

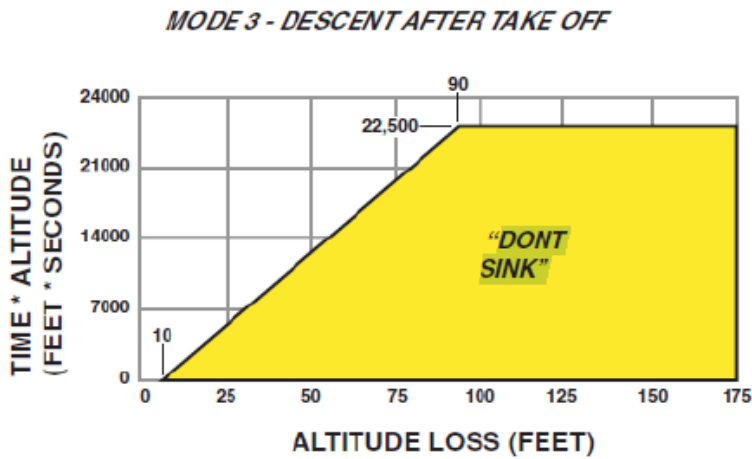
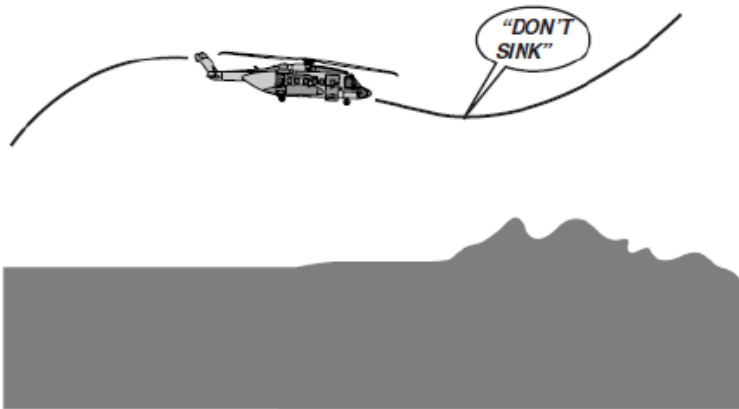
Mode 3 warns of loss of altitude after take-off. In the present incident, EGPWS Mode 3 registered a too high sink rate at too low an altitude when the helicopter's indicated airspeed passed 50 kts, and issued the warning: 'Don't sink, don't sink – CAUTION' for five seconds; see Figure 12. Immediately afterwards, Mode 2B issued the warning 'Terrain, terrain – CAUTION' for one second, followed by 'WARNING terrain, WARNING terrain, WARNING terrain' for six seconds. This indicated that the flight profile would result in the helicopter crashing into the sea unless corrections were made.

Figure 12: EGPWS mode 3 as activated in the present incident. Illustration: Bristow/NSIA

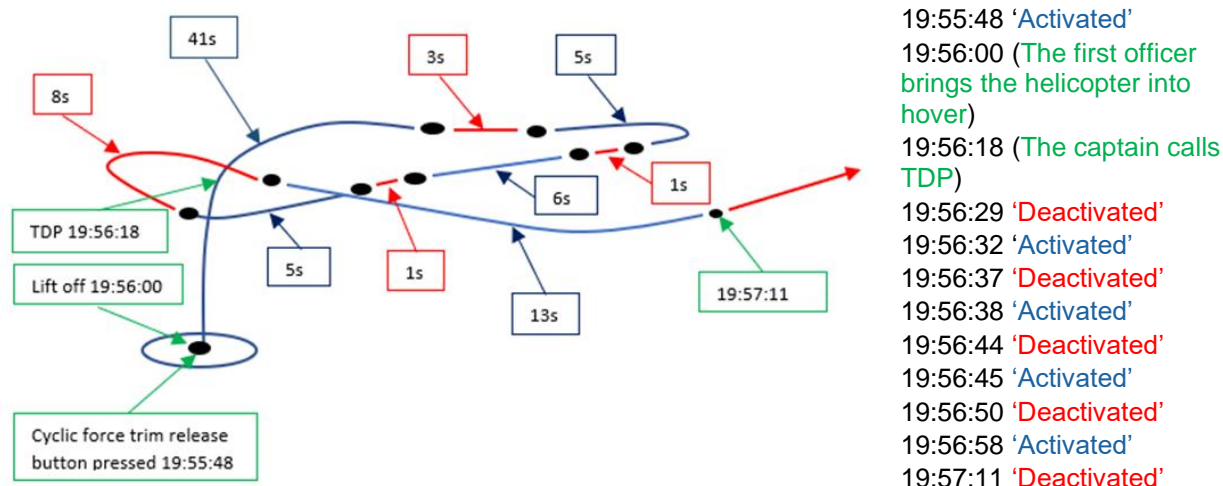
The crew has informed the NSIA that the cyclic force trim release button was last activated when the commander took over the flight controls. The button was depressed for 13 seconds and deactivated at 19:57:11; TDP + 53 seconds, after a steady climb and airspeed had been established, see Figure 16. Note that all times in this section is UTC times (local time -1 hour).

Figure 16: The departure profile and timeline for the five times the cyclic force trim release button was activated (in blue) and deactivated (in red). The illustration is not to scale. Source: LN-ONT CVFDR/NSIA.

The NSIA believes that using the cyclic force trim release button to set four new reference datums for the helicopter's attitude may have caused some overcontrolling and thus made the situation worse. The way the cyclic force trim release button was used may also have extended the period during which the helicopter was out of control.
