AVIATION 2024/04

***Aviation incident in Bergen on
26 August 2022 involving a DJI Mavic 3
drone, LN-02023CM, operated by TV 2
Luftfoto***

Report on aviation incident

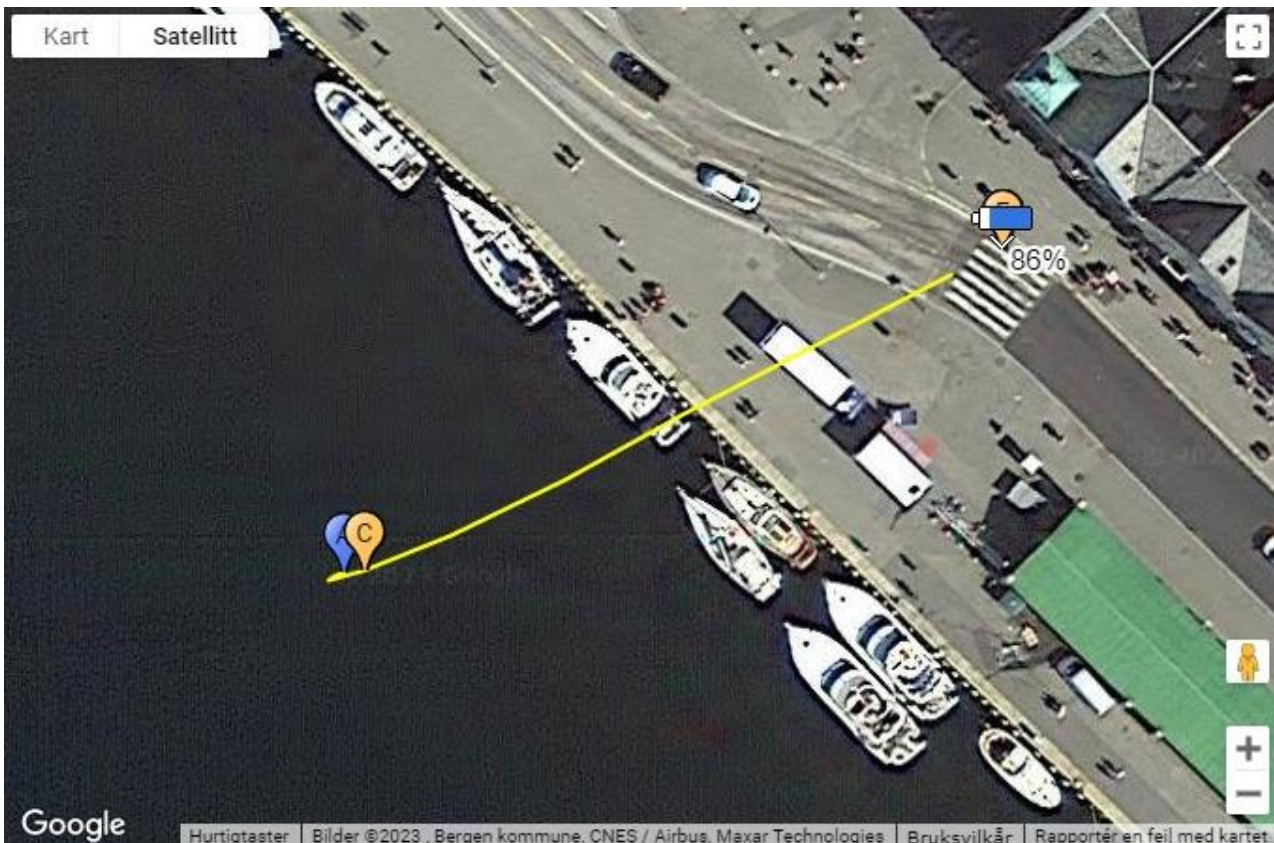
Figure 6 shows the flight path for the incident as registered in Airdata. Note that a flight path is illustrated by a line, in this case yellow, only in cases where the drone had access to a sufficient number of satellites to be able to calculate its GPS position.

Figure 6: Flight path for the flight in question. Source: TV 2 / NSIA

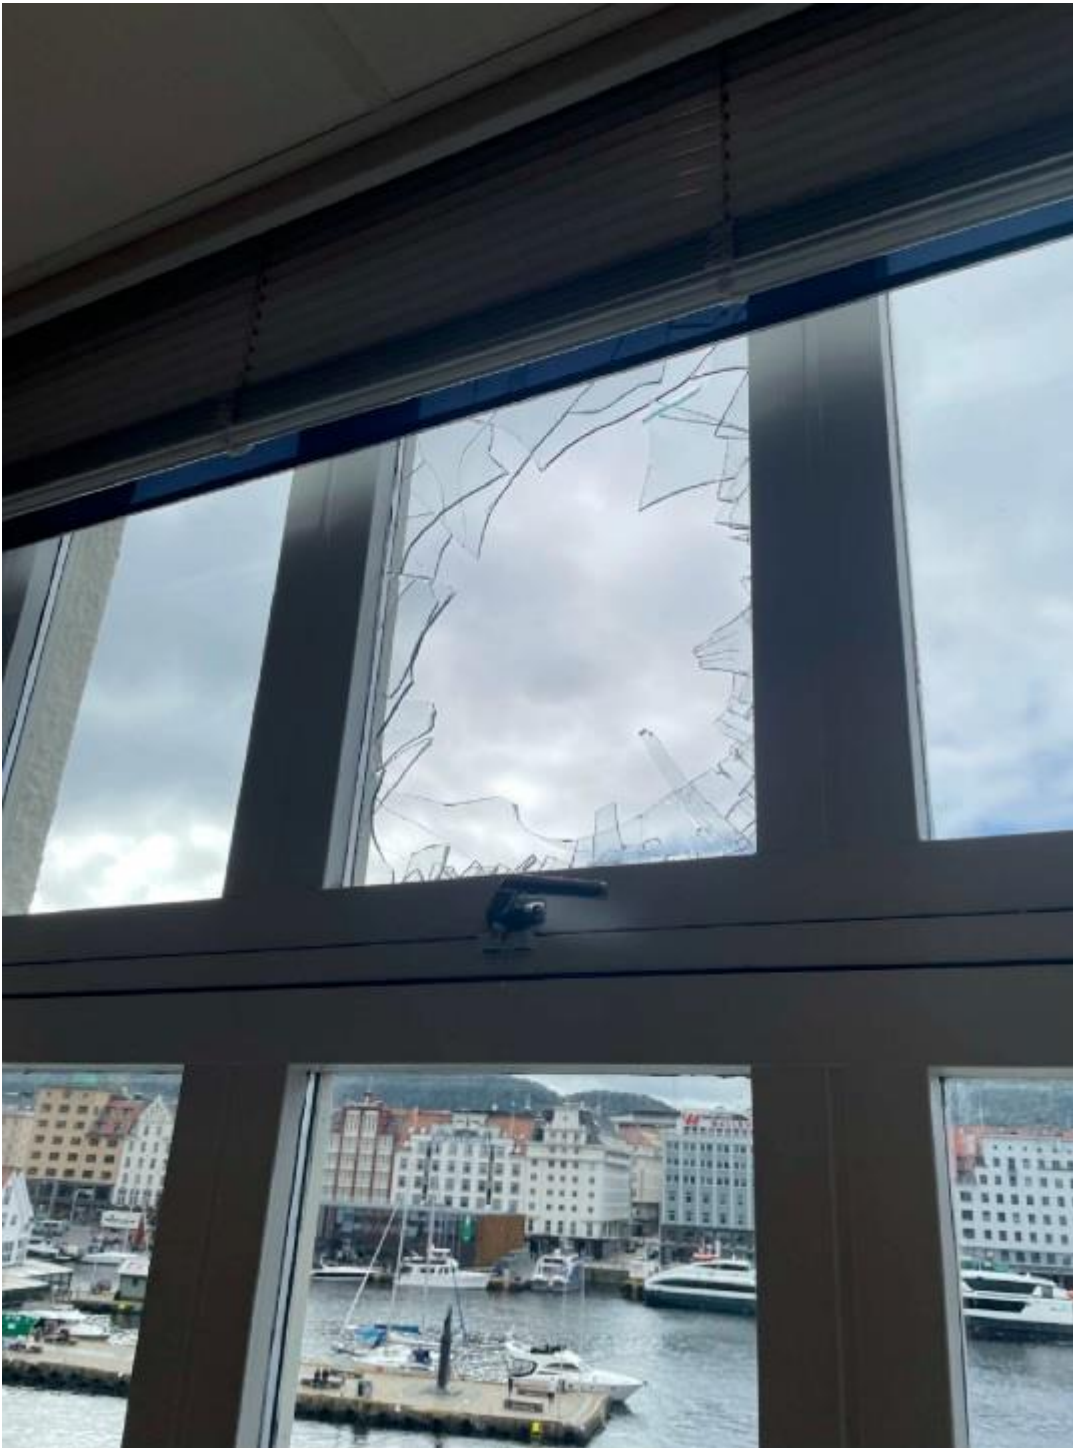
The drone flew through a triple-glazed window on the third floor of a building at Bryggen in Bergen. The drone was found lying on its back about one metre into the room. One of the persons having lunch inside the room suffered minor cuts to the head. Figure 9 is a photo taken from inside the room where the drone crashed through the window.

Figure 9: Damage to the window the drone crashed through. Source: Police / NSIA

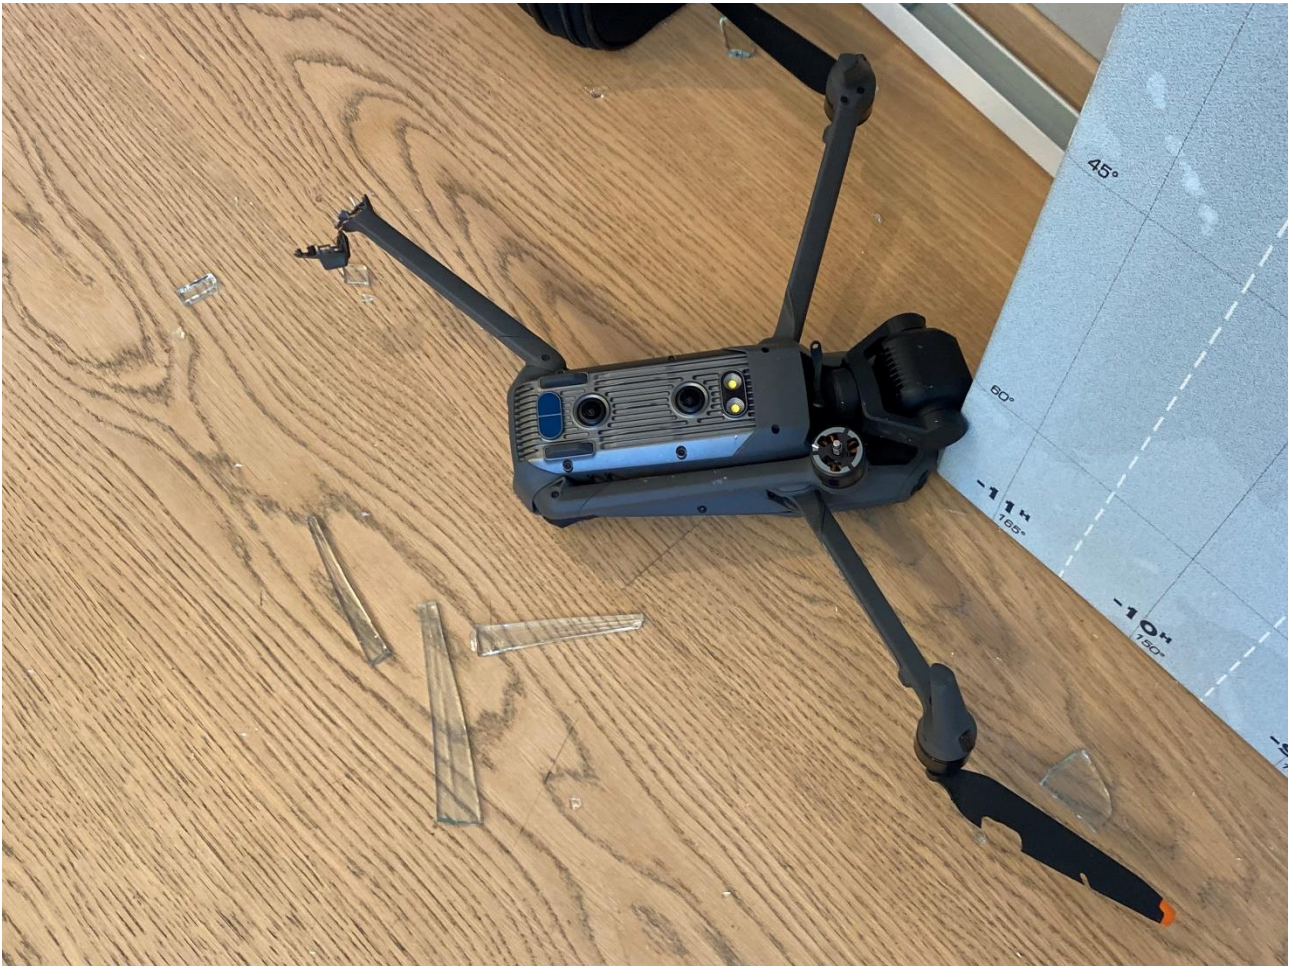
The drone sustained damage to four propellers and a motor arm. The drone's gimbal came off its fastenings.

Figure 10: Damage to the drone. Source: The police / NSIA

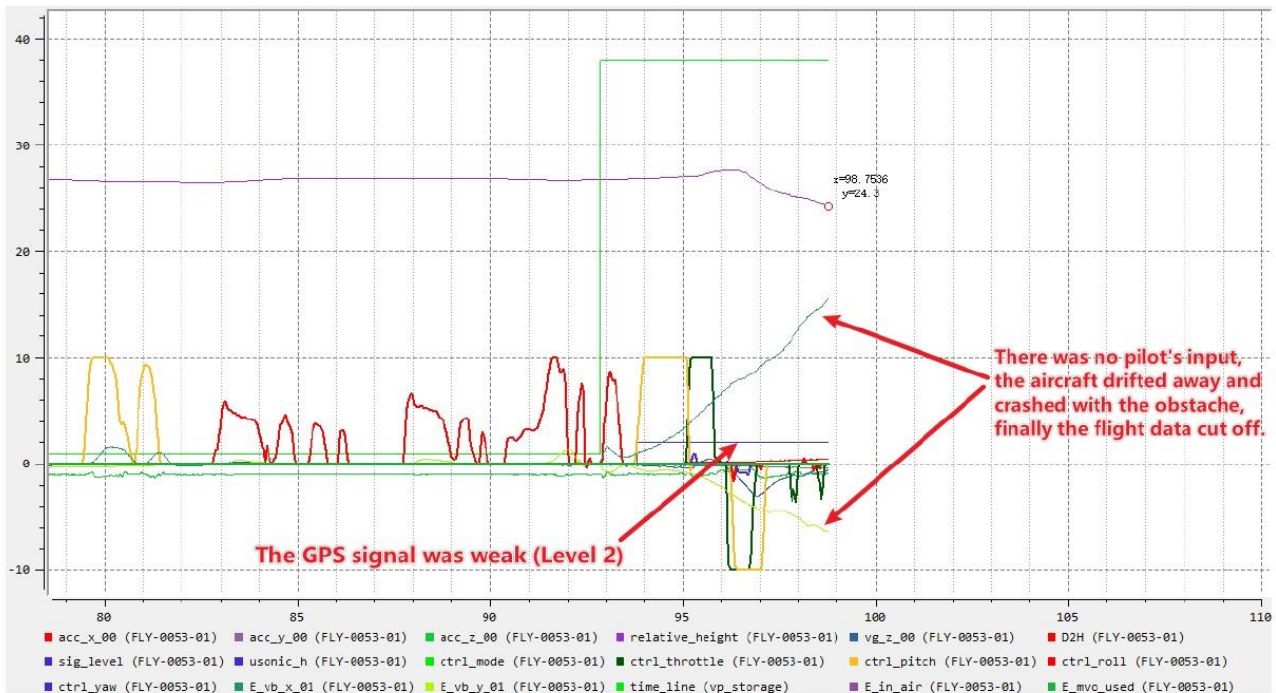
The aircraft crashed with the obstacle, then the data cut off.

Figure 12: Graphic illustration of the analysis. Source: DJI / NSIA

function was active in this case. In their analysis, DJI concluded that the drone switched from *ATTI mode* to *Tripod mode* with inadequate GPS level to be able to maintain its position and as a result drifted into the building. In their opinion this was due to pilot error.

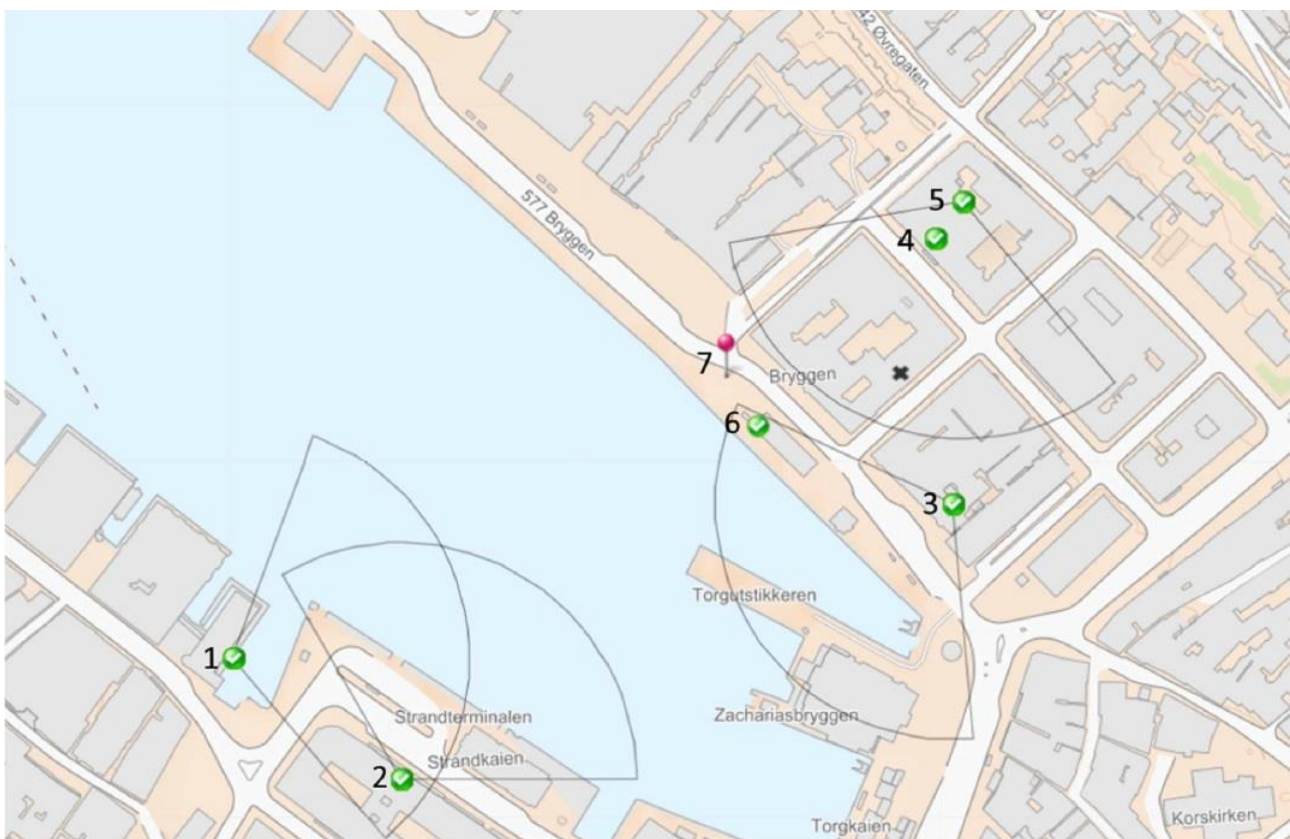
The NSIA has contacted the Norwegian Communications Authority (Nkom) to ask whether there are transmitters near Bryggen in Bergen, where the accident occurred. Figure 13 shows mobile phone base stations. They operate on frequencies around 700 MHz, 800 MHz, 1,800 MHz and 2,100 MHz. The transmitter indicated by the number 6 uses a frequency of around 440 MHz. The pin marked with the number 7 shows the drone's approximate location at the time of take-off. The relevant sectors for the mobile phone base stations are illustrated with a beamwidth of 120° and a distance of 100 metres from the transmitter.

Figure 13: Overview of mobile phone base stations. The pin marked with the number 7 shows the drone's approximate take-off location. Source: NKOM / NSIA

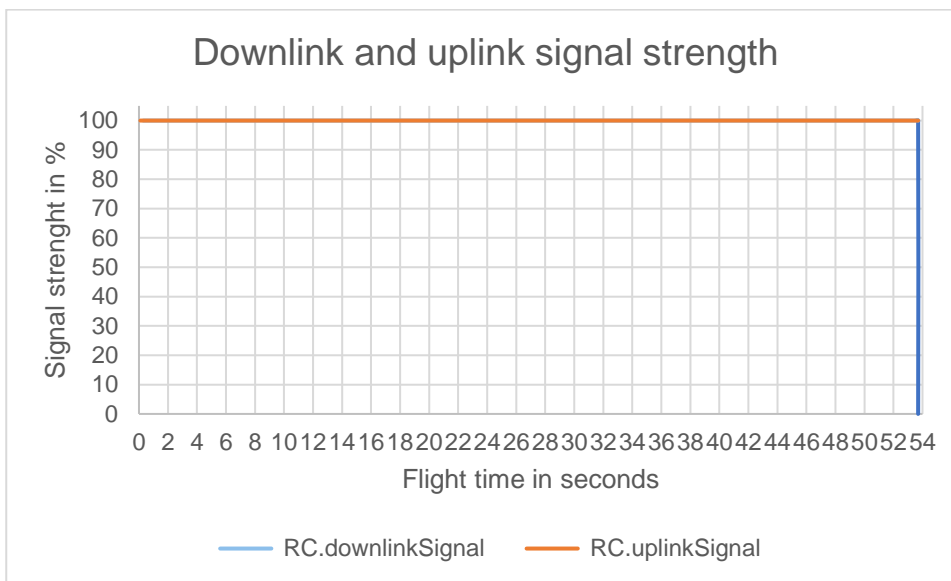
The flight record contained values for *RC uplink* and *RC downlink*. These values tell us whether the drone could receive data from the remote controller (uplink) and whether it could transmit data to the remote controller (downlink). A graph of the downlink and uplink signal strength as a function of the timeline is shown in Figure 14. The graph shows that the value for *RC uplink* is 100 from the first datapoint 0.1 seconds into the flight up until the final datapoint after 53.7 seconds. *RC downlink* shows 100 at its first datapoint after 0.3 seconds continuing right up until 53.7 seconds. The final four datapoints, at 53.7, show a value of 0.

Figure 14: Downlink and uplink signal strength. The Y axis shows signal strength in per cent, while the X axis represents the timeline. Source: TV 2 / NSIA

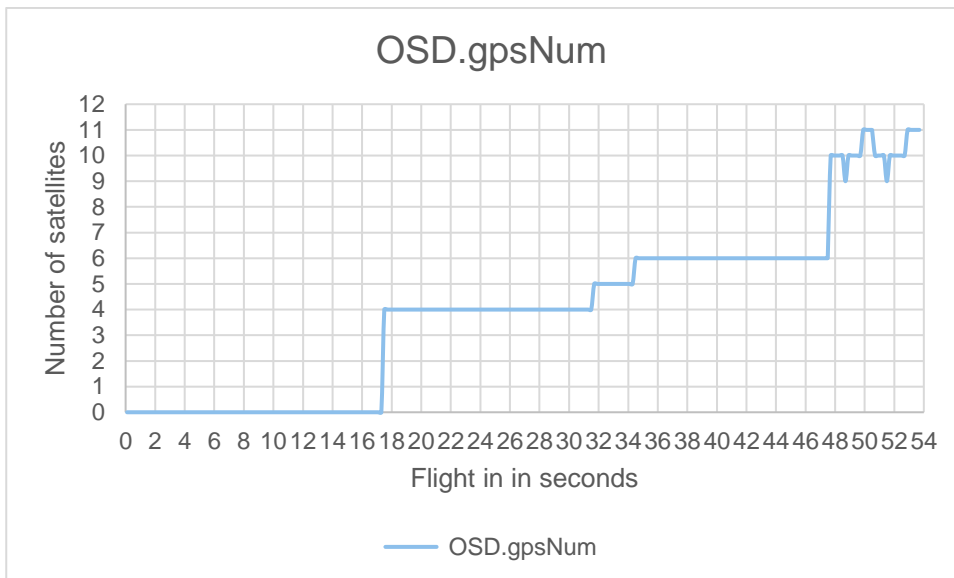
Figure 15: Number of satellites registered. The Y axis shows the number of satellites, while the X axis represents the timeline in seconds of flight. Source: TV 2 / NSIA

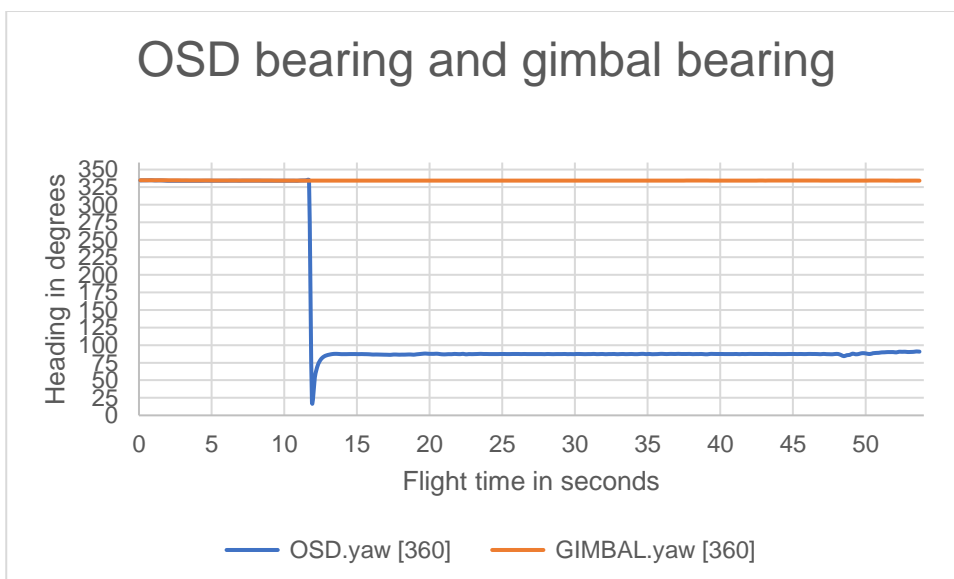
The significant discrepancy between the values for *OSD.yaw* and *GIMBAL.yaw* makes it natural to consider whether this could cause a loss of control. If the drone thought it was pointing 87° (value of *OSD.Yaw*) while it was actually pointing 334° (value of *GIMBAL.yaw*), this could result in what is known as positive feedback, where the drone's efforts to hover in place would cause it to compensate in the wrong direction with steadily increasing force that could bring the drone out of control.

The drone registered which compass bearing it was pointing in at all times. This information was recorded in the flight record as *OSD.yaw*. The drone’s camera axis also registered its compass bearing in the flight record as *GIMBAL.yaw*. A graphical representation of the values for *OSD.yaw* and *GIMBAL.yaw* is shown in Figure 16. The *GIMBAL.yaw* values remained between 334.2° and 334.8° throughout the recording.

Figure 16: Values for *OSD.yaw* and *GIMBAL.yaw*. The Y axis shows heading in degrees, while the X axis represents the timeline in seconds. Source: TV 2 / NSIA

During the period from 0.1 to 11.7 seconds, the *OSD.yaw* values were between 334° and 334.8°. After 11.9 seconds, the value changed to 20.1°, and the value increased in the following datapoints until it reached a value of between 86.2° and 88° after 13 seconds. The values remained between 84.3° and 91° throughout the period from 13 to 53.7 seconds.

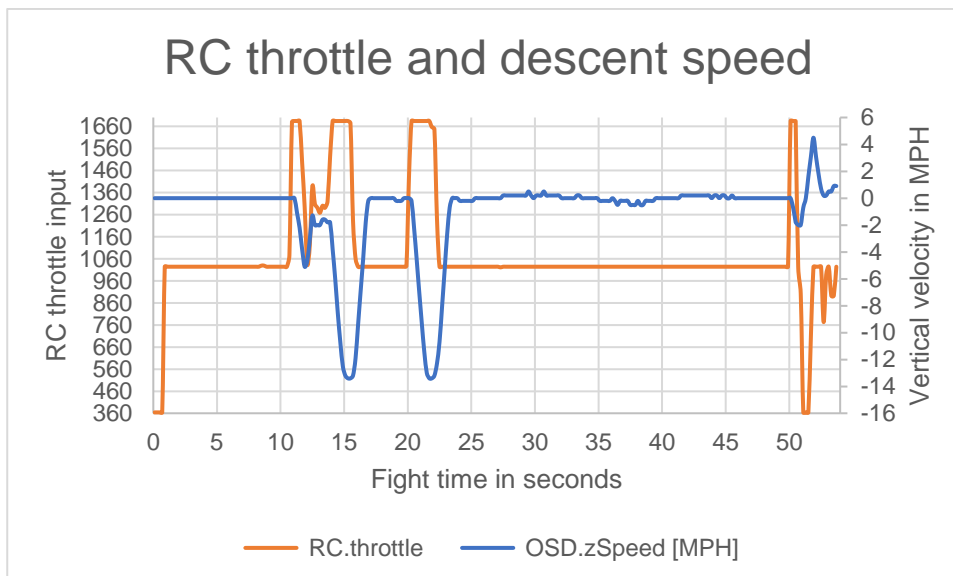
Figure 18: Altitude command input and the drone's speed on the Z axis. Source: TV 2 / NSIA

Figure 18 also shows the control stick input on the left-hand side of the graph. Value 1024 indicates a control stick in the middle position, values between 364 and 1023 indicates stick movement backwards (drone descending) and values between 1025 and 1684 indicates control stick movement forwards (drone climbing). The drone's vertical speed is indicated by the scale on the right-hand side of the graph (negative values indicate climb and positive values indicate descend). Note that the speed is shown as retrieved from the flight record, in miles per hour (MPH).

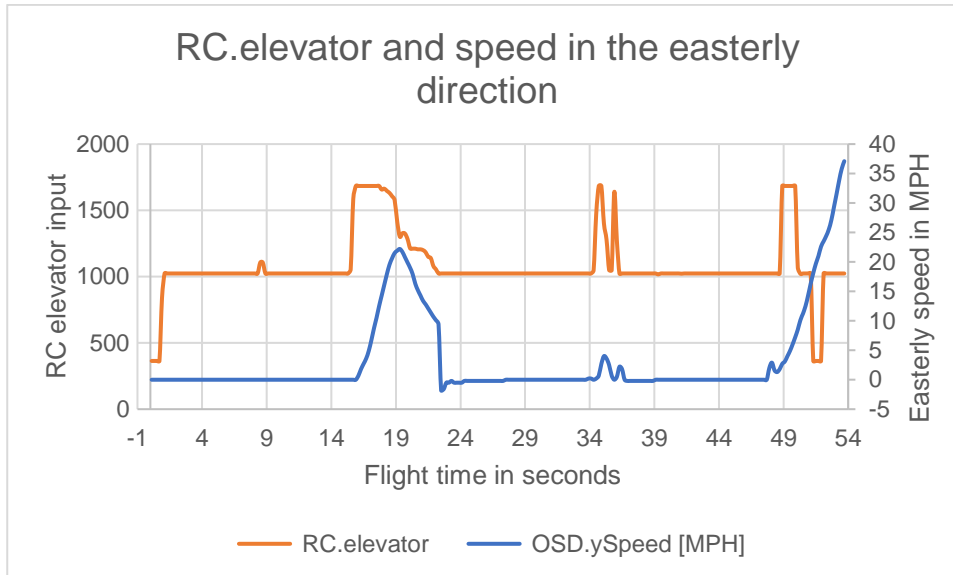
Figure 19: Stick command input and the drone's speed in the easterly direction. Source: TV 2 / NSIA

Figure 19 shows the control stick values on the left-hand side of the graph. The drone's speed in the easterly direction is indicated by the scale on the right-hand side of the graph. Note that the speed is shown as retrieved from the flight record, in miles per hour (MPH).

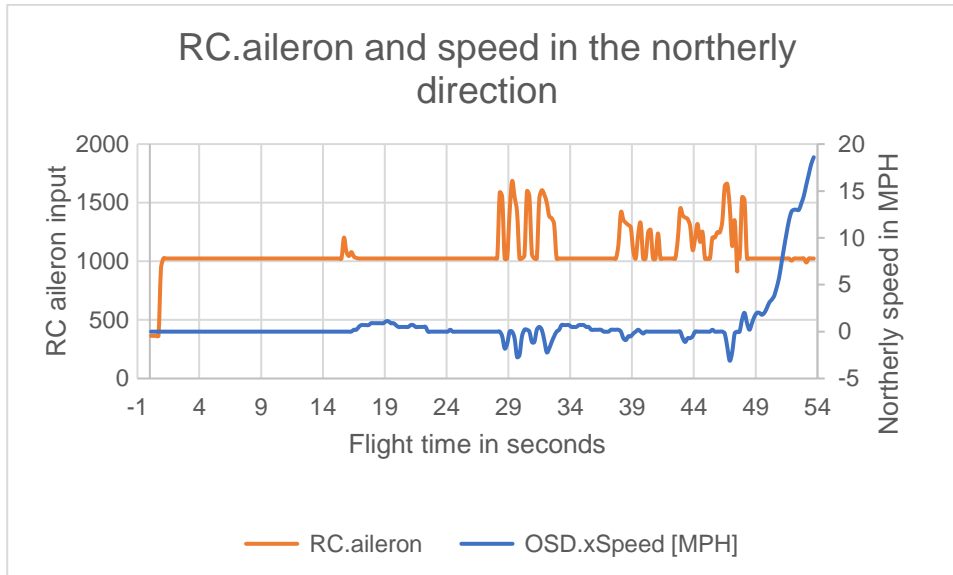
Figure 20: Command input and the drone's speed in the longitudinal axis. Source: TV 2 / NSIA

The stick movement values are shown in figure 20 on the left side while the drone's speed-component in the northerly direction is indicated by the scale on the right-hand side of the graph (left and right seen from the drone). Note that the speed is shown as retrieved from the flight record, in miles per hour (MPH).
