REPORT

AVIATION 2024/06

Aviation accident on 28 April 2023 at Rønneld airfield for model aircraft near Skjeberg, Norway, involving a 1:2 scale remotely piloted ASG-29 glider

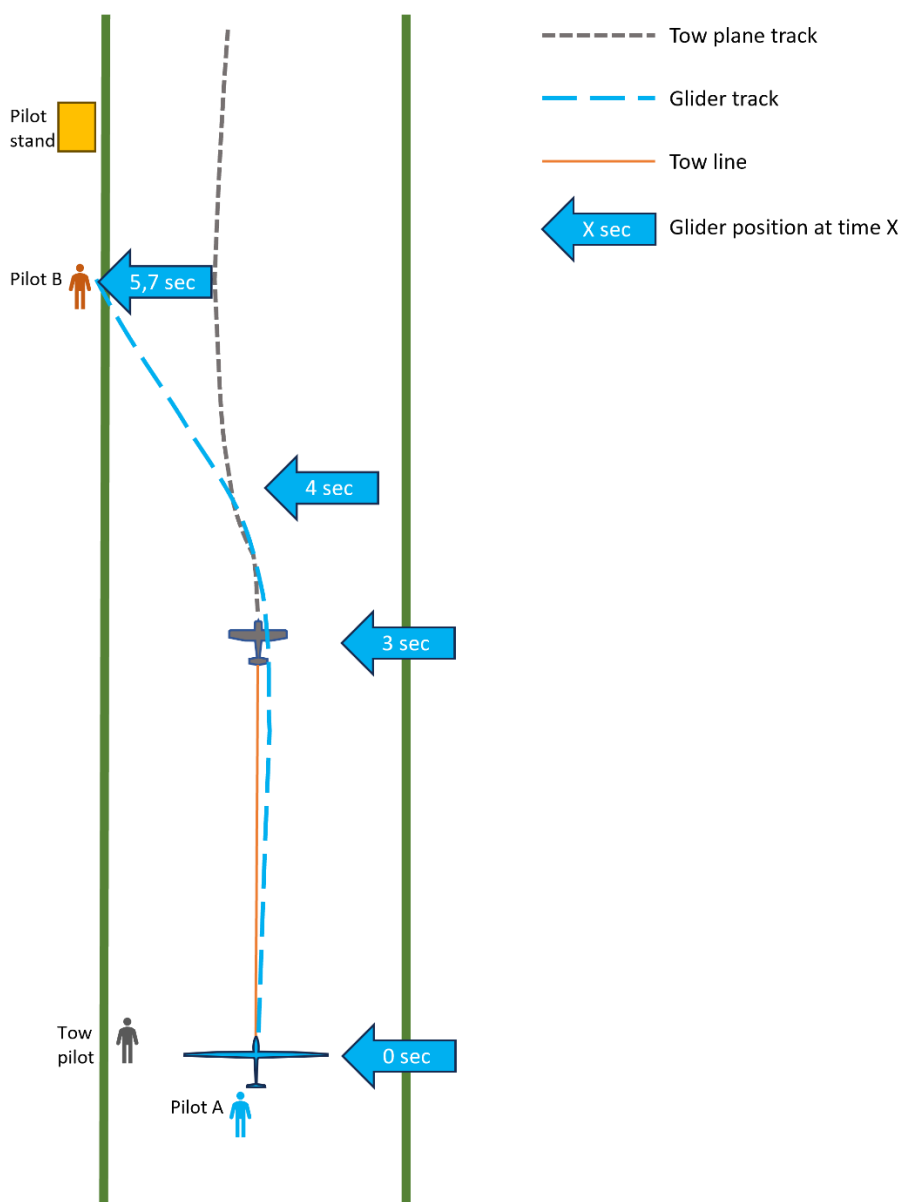
Figure 1: Illustration of the glider and tow plane tracks during takeoff. Illustration: NSIA

The tracks of the tow plane and glider during takeoff are illustrated in Figure 1, based on a video filmed with a mobile phone. At the start of the tow, the glider was lined up behind the tow plane. The tow plane had an initial vector to the left at the start of the takeoff run before correcting with a slight angle back towards the centre of the runway. The glider started the takeoff with the right wing resting on the ground, neutral ailerons and left rudder. As the aircraft began gliding forward, the pilot applied aileron to lift the right wing. It is not possible to determine from the video when this input was neutralised or reversed. As the right wing was lifted off the ground, the glider continued a smooth roll until the left wing touched the ground. At this point, the tow plane was about 2–3 metres left of the glider. With the left wing on the ground, the glider turned sharply to the left at the same time as the tow line was released and the fuselage lifted from the runway. Pilot A has explained to the NSIA that it was not until this point that he noticed Pilot B standing on the left edge of the runway, and that he attempted to lift the glider over him. A review of the video of the incident shows that, during the final seconds before the glider hit Pilot B, the glider's left wing was lifted towards wings level while the aircraft climbed slowly.

The glider swerved to the left during takeoff as a result of the left wing dragging along the ground and the aircraft pivoting around the wing. Several circumstances may have given rise to or exacerbated the situation. The most important factor was that Pilot A, after applying aileron input to lift the right wing off the ground, failed to stop the roll motion to the left in a wings level position. Due to their large wingspan, gliders are less manoeuvrable in roll than aircraft with a smaller wingspan. A large moment of inertia means that it takes longer to build up a roll rate and longer to stop a motion that has started. In practice, this means that, the larger the wingspan, the slower the aircraft responds to aileron input. When the model glider in this case was configured with the longest wings, it was less manoeuvrable than it had been earlier in the day when the shorter wings were used. The fact that it was the first day in over six months that the pilot had flown the model in question may have contributed to him being less observant of the issue. Supporting the wing, for example with one's foot, during the first part of the takeoff run would have facilitated the takeoff by requiring smaller aileron inputs during the initial phase.

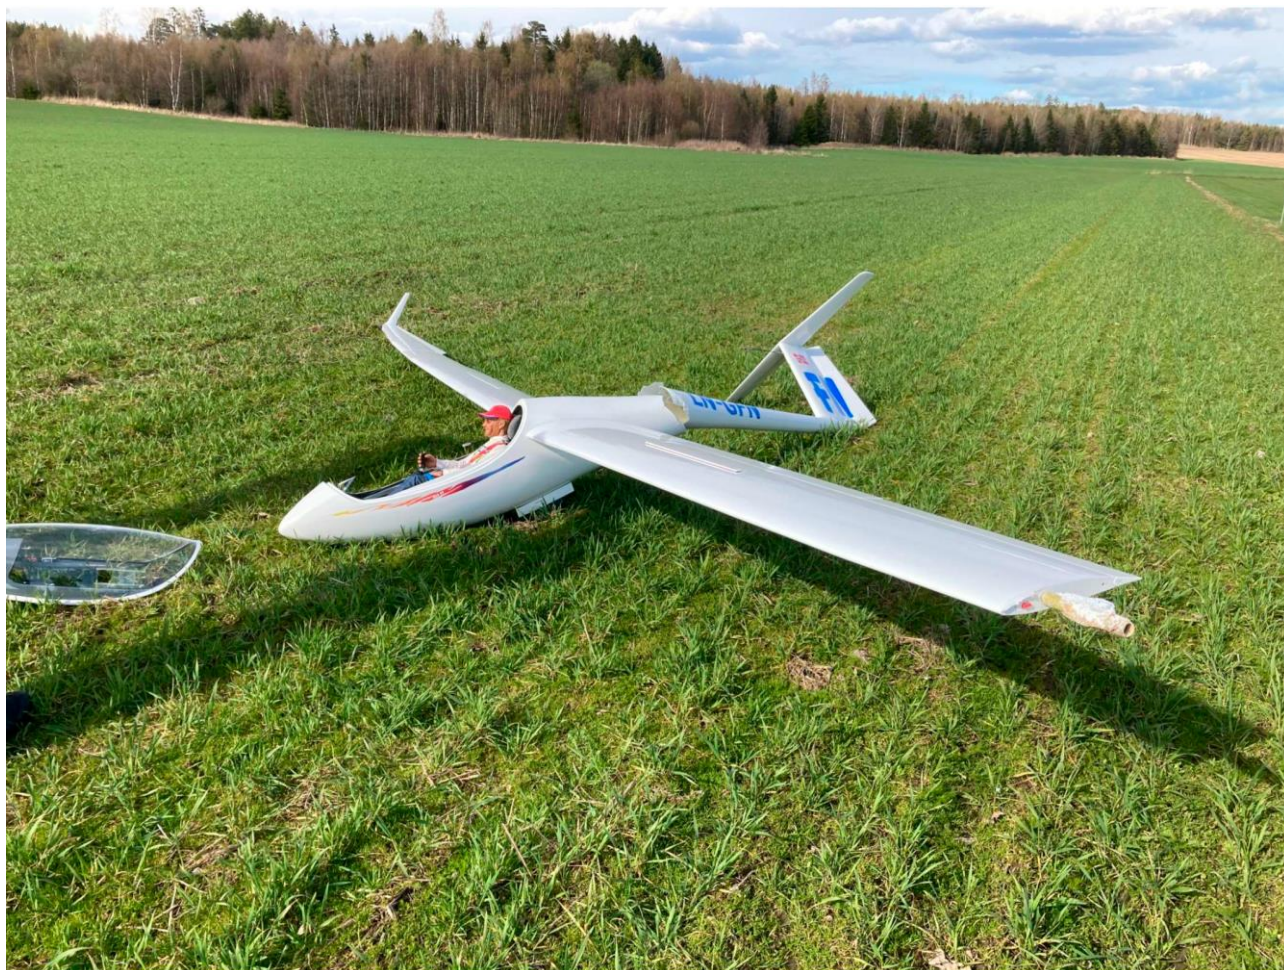
A review of the video of the accident shows that the left wing broke off as it struck Pilot B. The rest of the damage to the glider most likely occurred when the aircraft hit the ground, and includes a broken tail section and a canopy that detached (see Figure 3).

Figure 3: Damaged model glider. Photo: The police / NSIA
