REPORT AVIATION 2024/07

***Air incident during approach to Bergen
Airport Flesland, Norway 11 June 2022
with Airbus A320-232, HA-LWZ, operated
by Wizz Air Hungary Kft***

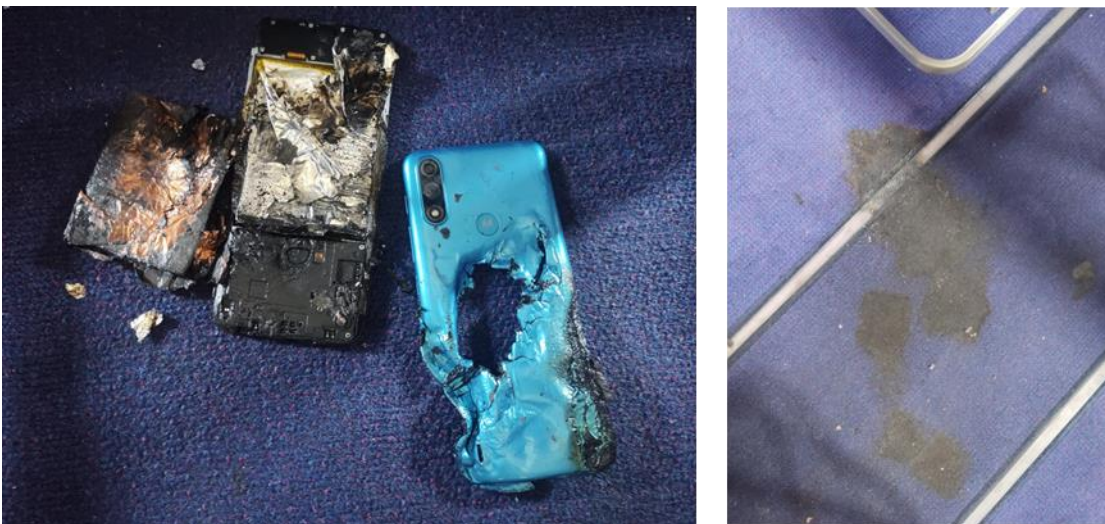
There were no further incidents for the rest of the flight. The cell phone was completely destroyed, and the cabin carpet was damaged, see Figure 2. The passenger that suffered minor injuries did not want any medical assistance.

Figure 2: The cell phone and the carpet after the fire. Photo: Wizz Air/NSIA

The cell phone battery on board HA-LWZ had a TR and released gases, and it is plausible that there was an electrolyte fire. It is unlikely, however, that metals or other solids ignited.

The cell phone was first cooled by water, which caused the fire and smoke to stop. Next, the phone was secured in a metal container and placed in one of the aft lavatories. The container was filled with water and monitored for the remainder of the flight.

Protective gloves are important in order to handle hot or burning batteries. Thus, the NSIA recommends that all operators involved in passenger transport equip both the cabin and the cockpit with easily accessible fire protective gloves to enable crew members to handle a battery with TR without delay, in addition to relevant TR and LIB fire equipment kits. It is also important that crew regularly perform TR handling procedure training.
