AVIATION 2024/08

***Air accident at Trollnes in Arendal
municipality on 25 June 2023, involving a
Robinson R44, LN-OSS***

Air accident report

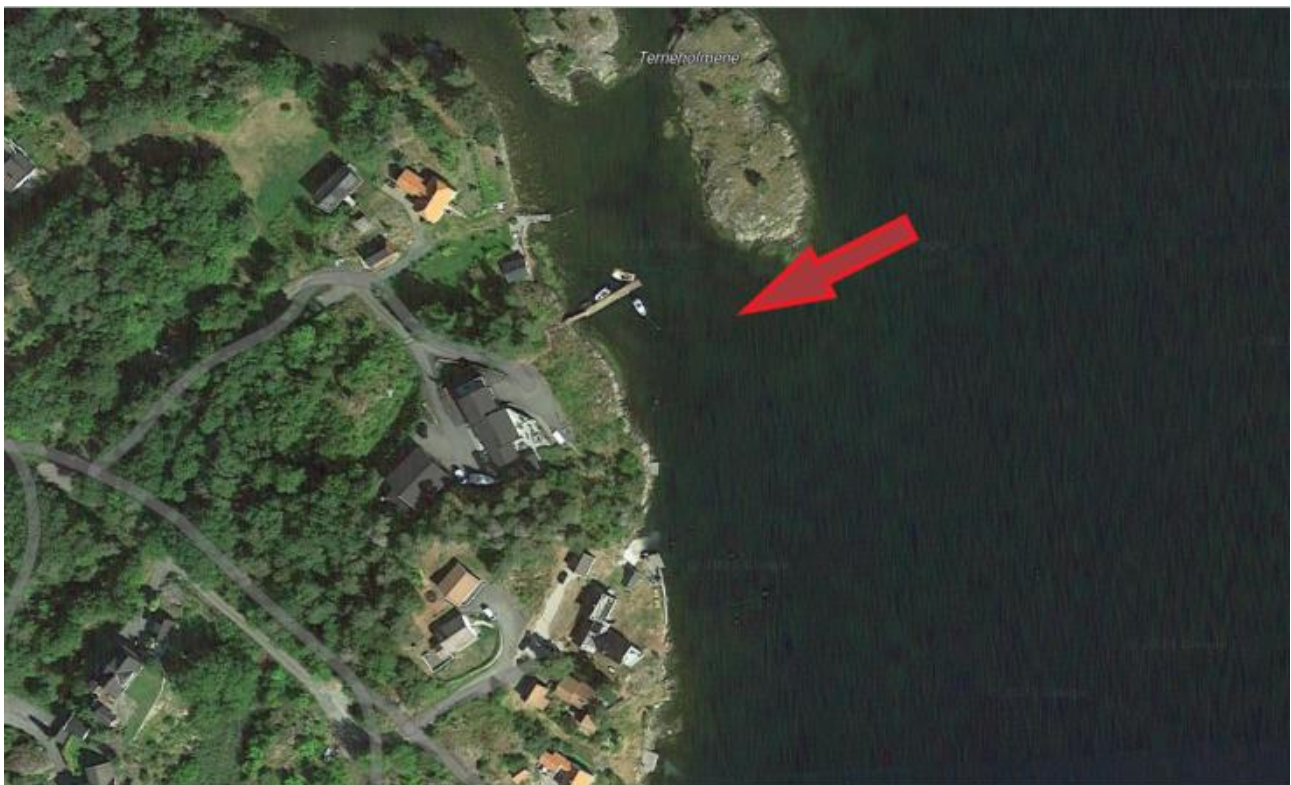
Figure 1: The tarmacked area in the middle of the photo shows the landing site at Trollnes. The arrow marks the direction of approach. Source: Google Maps / annotation by NSIA

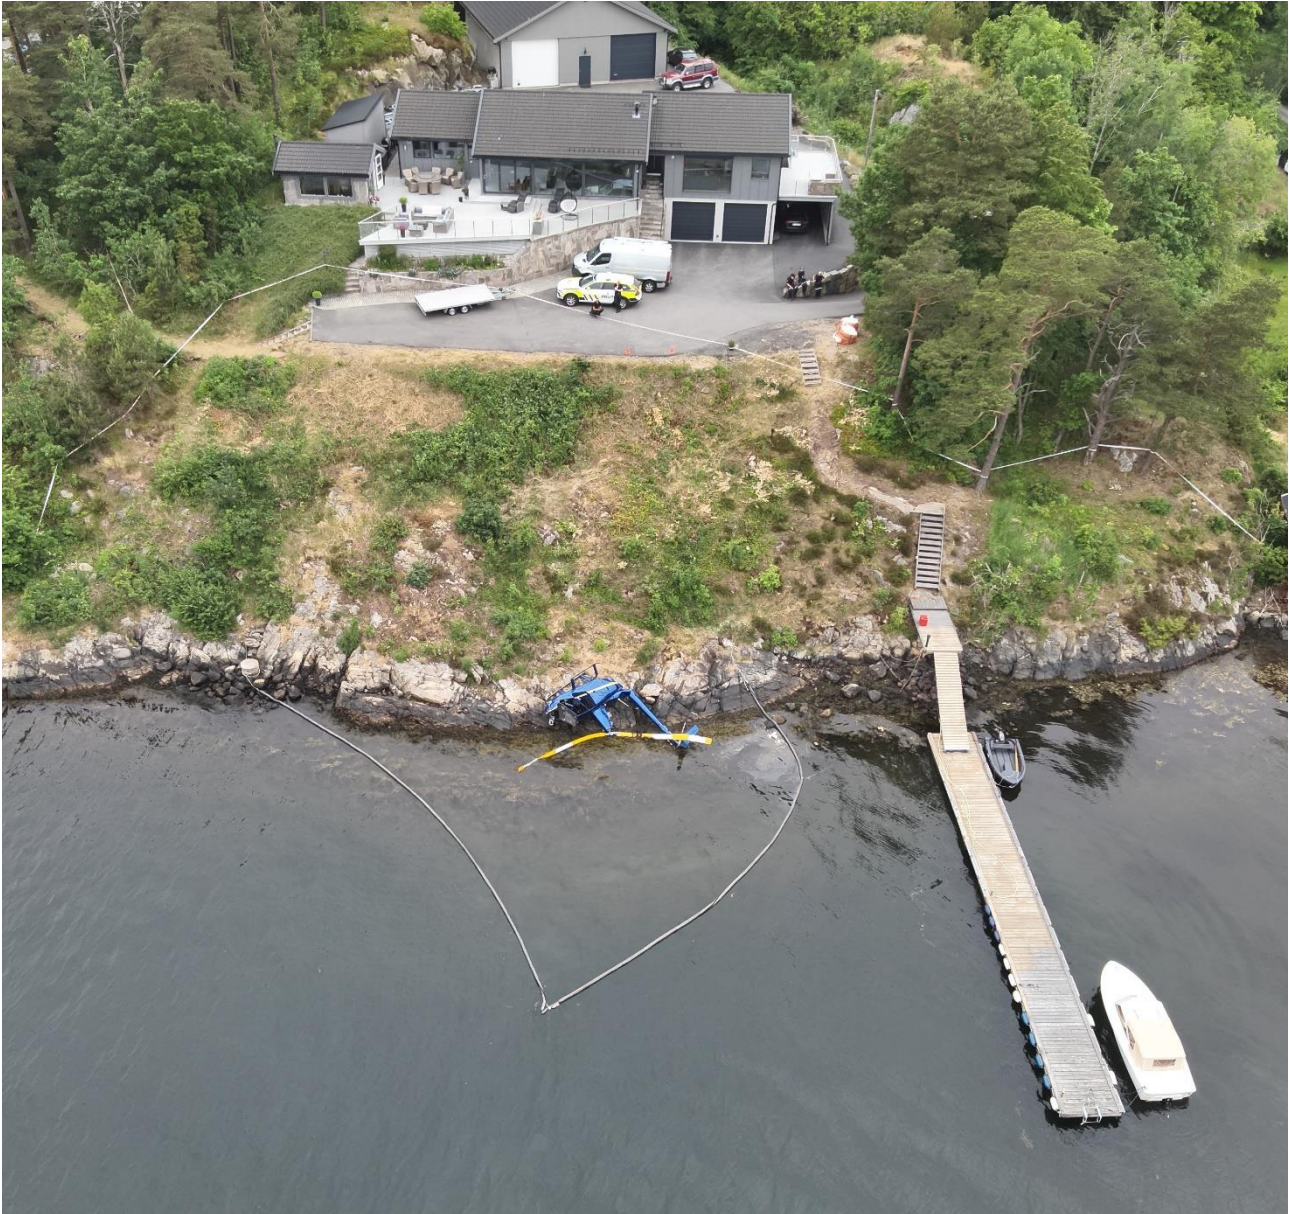
Figure 2: The photo was taken approximately one hour before the full ebb-tide. The two orange cones at the edge of the tarmacked area represent points where the mid-section of the helicopter's skids was in contact with the ground. The two vehicles were not at the site at the time of landing. The witness who filmed the crash was standing on the veranda seen at the top of the photo. Photo: The police / NSIA

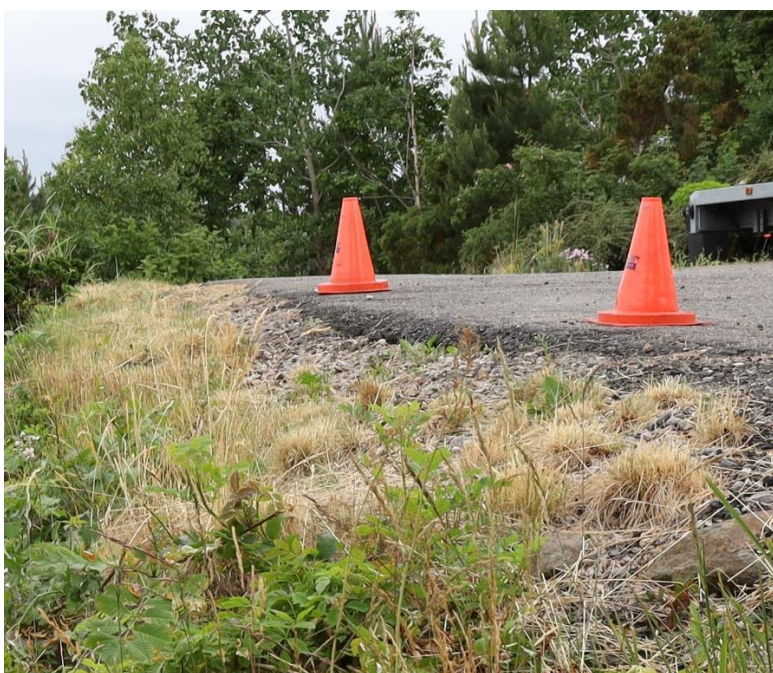
The accident occurred in a tarmacked parking area next to a private residence at Trollnes, about 4 km northeast of Arendal. The distance from the parking area to the sea was approximately 21 metres, see Figure 4. It was surrounded by trees to the right and left and a house with a veranda in front towards the parking area. There were no obstacles along the chosen direction of approach. The minimum distance to the veranda from the edge of the tarmacked area where the helicopter landed was about 10 metres. There was a 4.6-metre clearance between the main rotor and the veranda from where the helicopter touched down. The parking area was about 8.5 metres above sea level.

Figure 3: The edge of the tarmacked area where the helicopter landed. See Figure 2 for the location of the cones. Photo: NSIA

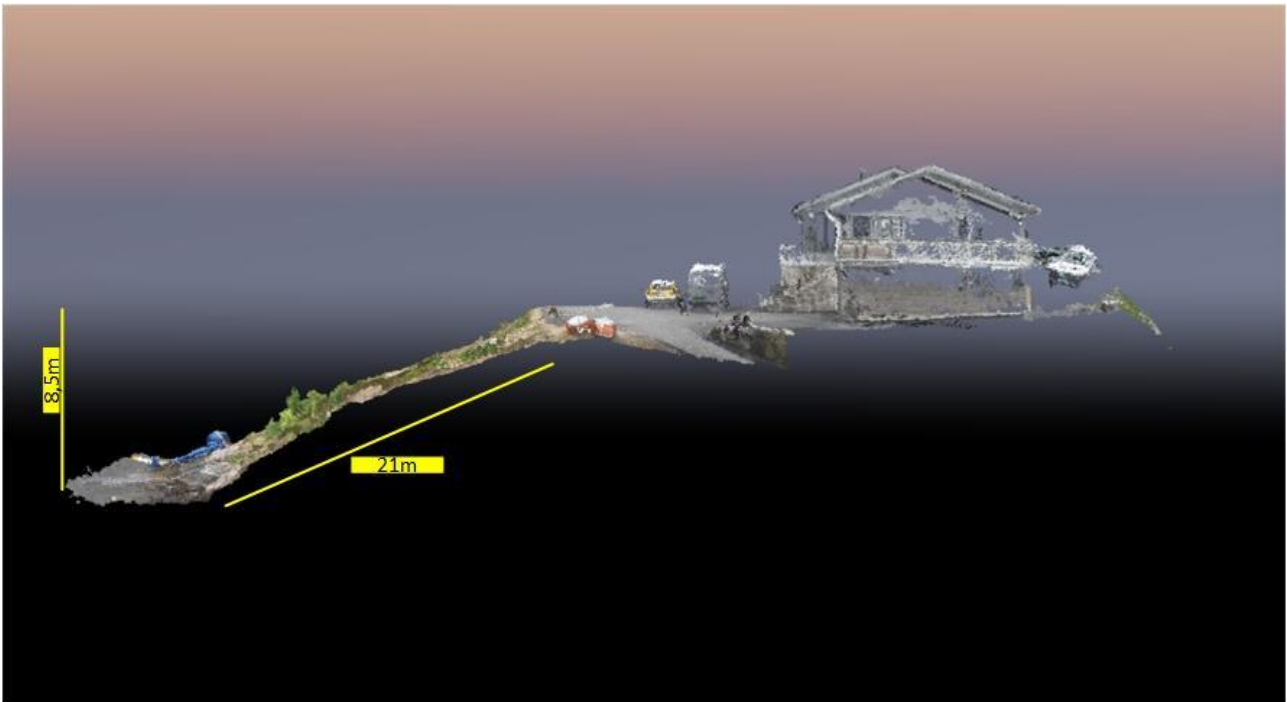
Figure 4: The illustration shows details of the slope where the accident took place. Illustration: NSIA

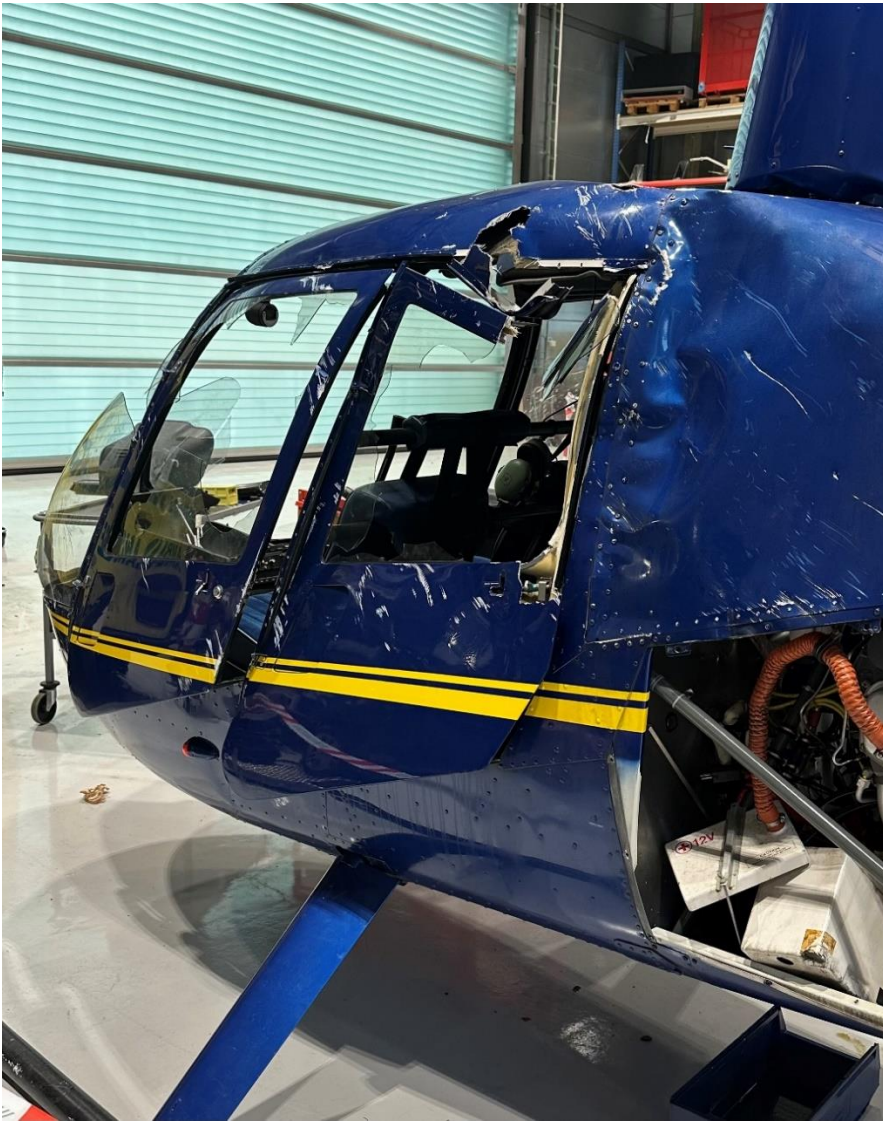
The helicopter remained in one piece on the rocks with its tail broken. The cabin suffered moderate damage and came to rest with its left side down. The tail boom was partly broken off with part of it lying in the sea with the tail rotor under water. The main rotor was still attached to the helicopter, but the blades were bent with some marks from the impact. The engine and drive train between the engine and the main rotor appeared undamaged. The battery mounted on the left side of the engine compartment came loose, see Figure 5. The right skid on the landing gear was broken off, and the aft cross tube had detached from the fuselage.

Figure 5: The illustration shows the left side of the cabin that was under water. The battery is the white box in the lower right-hand corner of the photo. Photo: NSIA

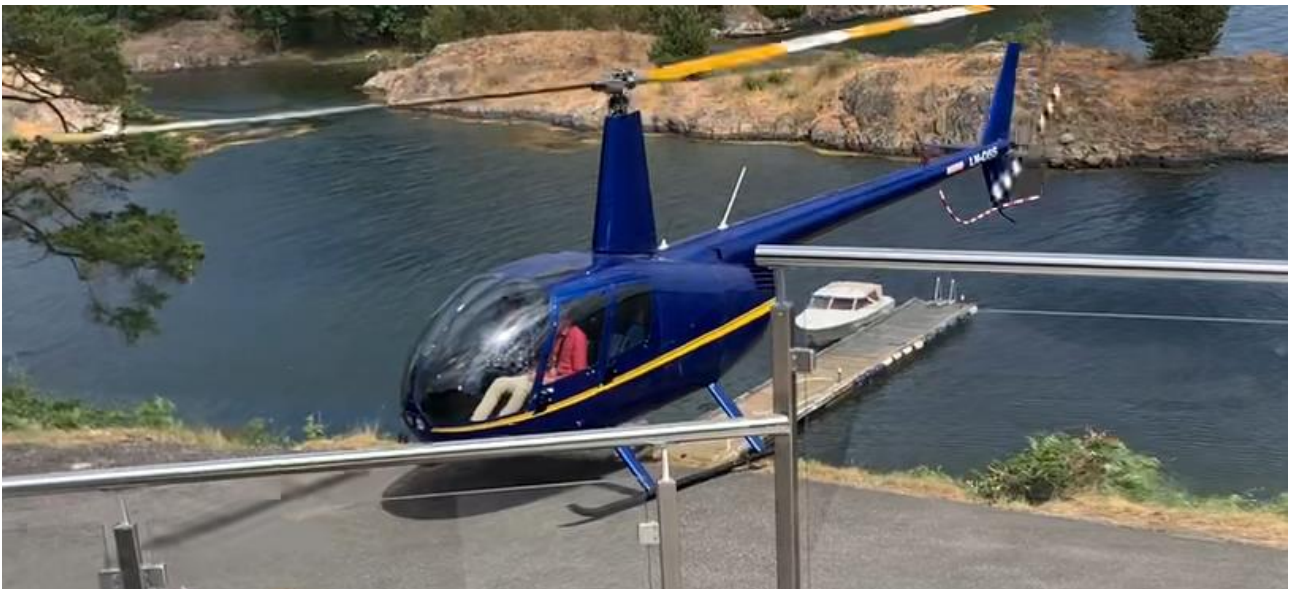
Figure 6: Stills from the video footage showing that when the helicopter landed, a large section of the skids was outside the edge of the tarmacked area. Photo: Private video / NSIA

The pilot miscalculated the landing, which caused the helicopter's centre of gravity to fall outside the edge of the tarmacked area at the landing site and the helicopter to tip backwards and fall down a slope.

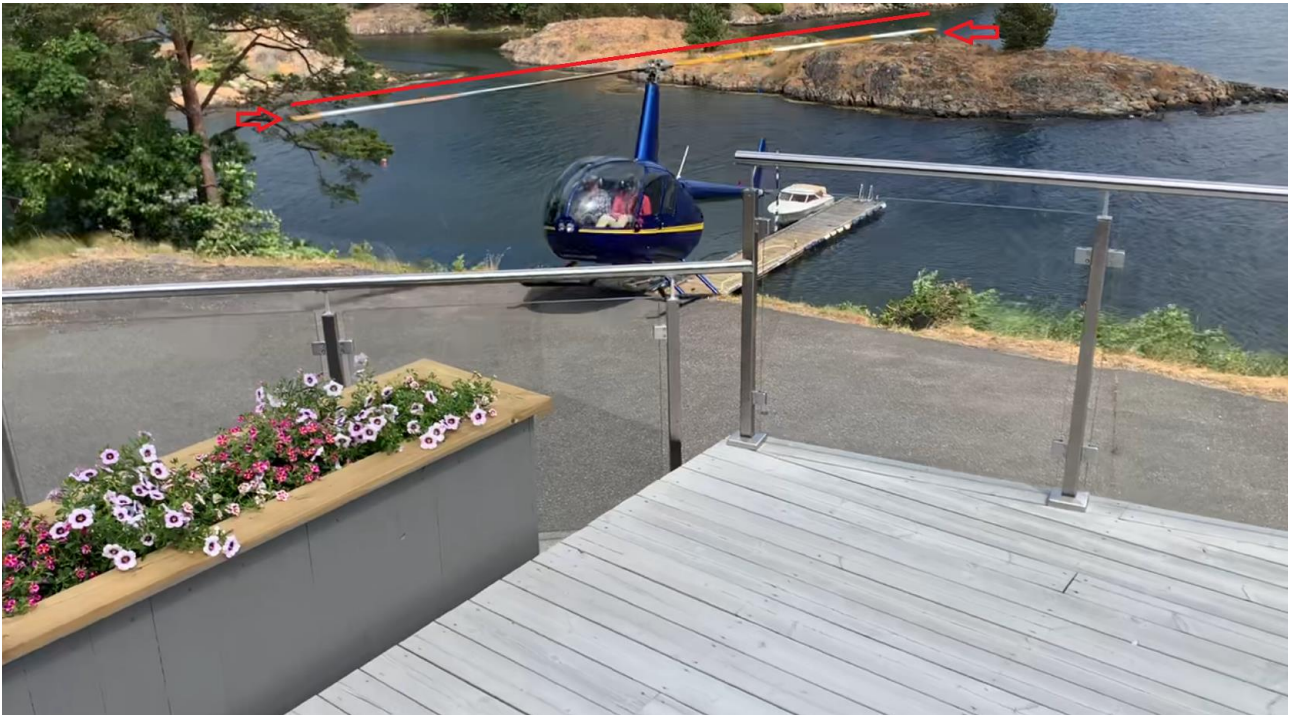
The NSIA's analysis of the sequence of events confirms the pilot's explanation that the approach was normal with an appropriate sink rate and speed. The video clearly shows that the helicopter landed with its centre of gravity too far aft and outside the tarmacked area. When the collective was lowered and the lift from the main rotor was reduced, the helicopter tipped backwards (see 6 and 7). The pilot attempted to remedy the situation by raising the collective, but this failed. The helicopter therefore hit the slope, tumbled downwards and ended up on the rocks on the shoreline.

Figure 7: Stills from the video footage showing the helicopter about to tip down onto the slope. The red arrows indicate that the helicopter had an almost flat pitch (minimal lift from the rotor blades). The line shows virtually no coning of the main rotor. Photo: Private video, annotation by NSIA

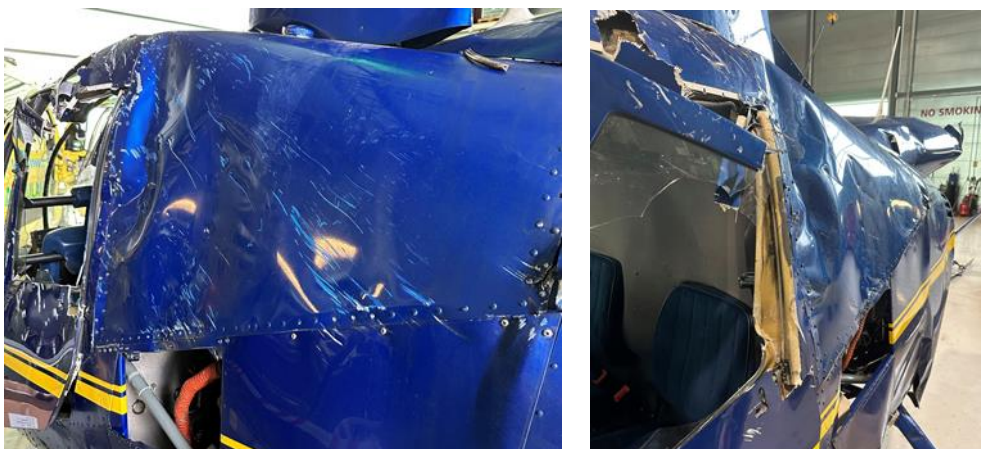
In the NSIA's opinion, the crash resistance helped prevent fuel leakage and fire hazard after the accident. Had there been a fire, the situation for those on board and their evacuation could have become critical or even fatal. It is not unlikely that the damage that occurred could have led to fuel leakage and a potential fire had the tanks not been equipped with this additional barrier, see Figure 8. In previous investigations, the NSIA has pointed out the danger of the battery becoming detached in accidents and that this can affect the risk of fire. The accident helicopter was equipped with the latest version of attachment, which should be an improved and more secure version.

Figure 8: Damage to the left fuel tank. Photo: NSIA

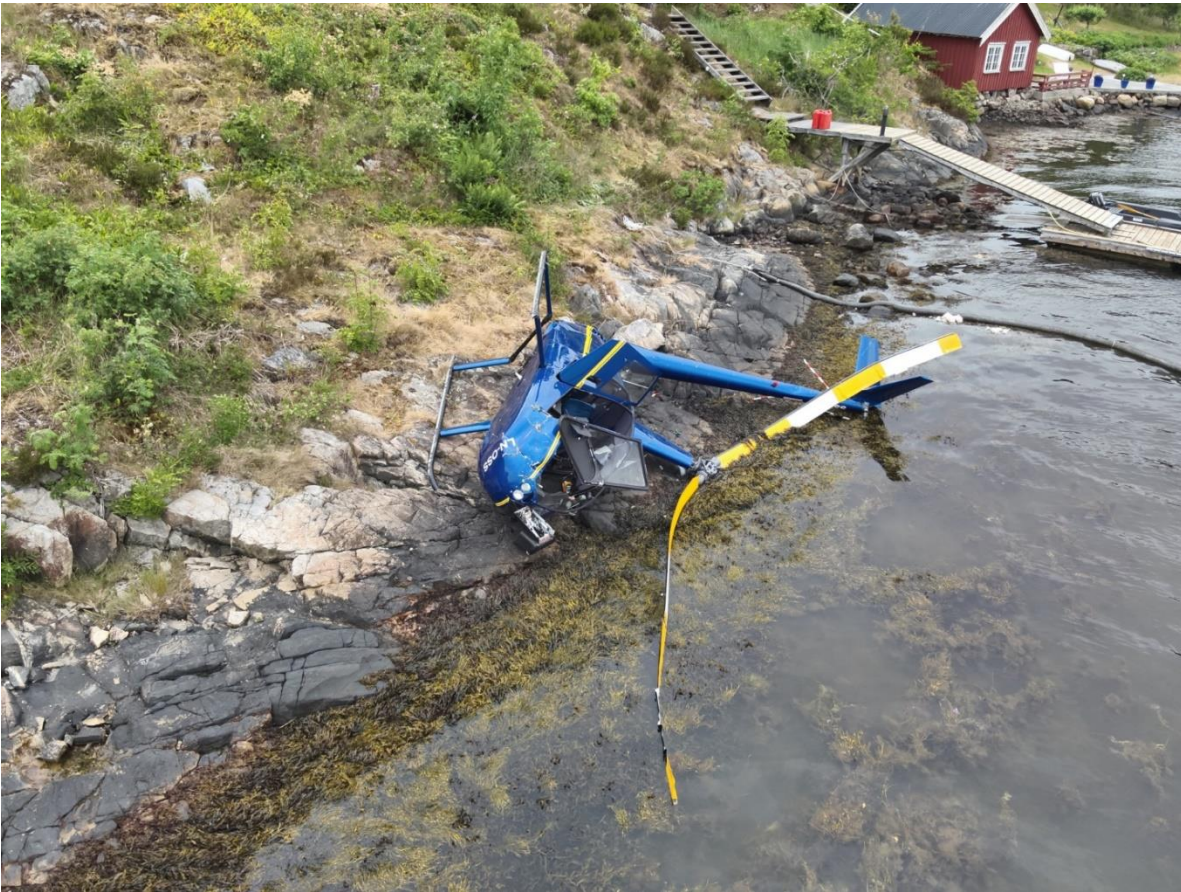
Figure 9: The helicopter in its final position on the rocks. Photo: The police/NSIA

The approach to Trollnes took place at low altitude over open water. No measures were taken to mitigate the risks associated with this. The passenger was knocked almost unconscious from the crash. The passenger was sitting in the front left-hand seat, i.e., in the part of the helicopter that ended up in the lowest lying position, see Figure 9. If the helicopter had landed further out, the risk that the passenger had been totally underwater would have been greater.
