# REPORT AVIATION 2024/09

***Serious aviation incident near the Gullesfjord in Kvæfjord municipality, Troms county, on 6 September 2021 involving Airbus Helicopters AS 350 B1, LN-ORJ, operated by Heli-Team AS***

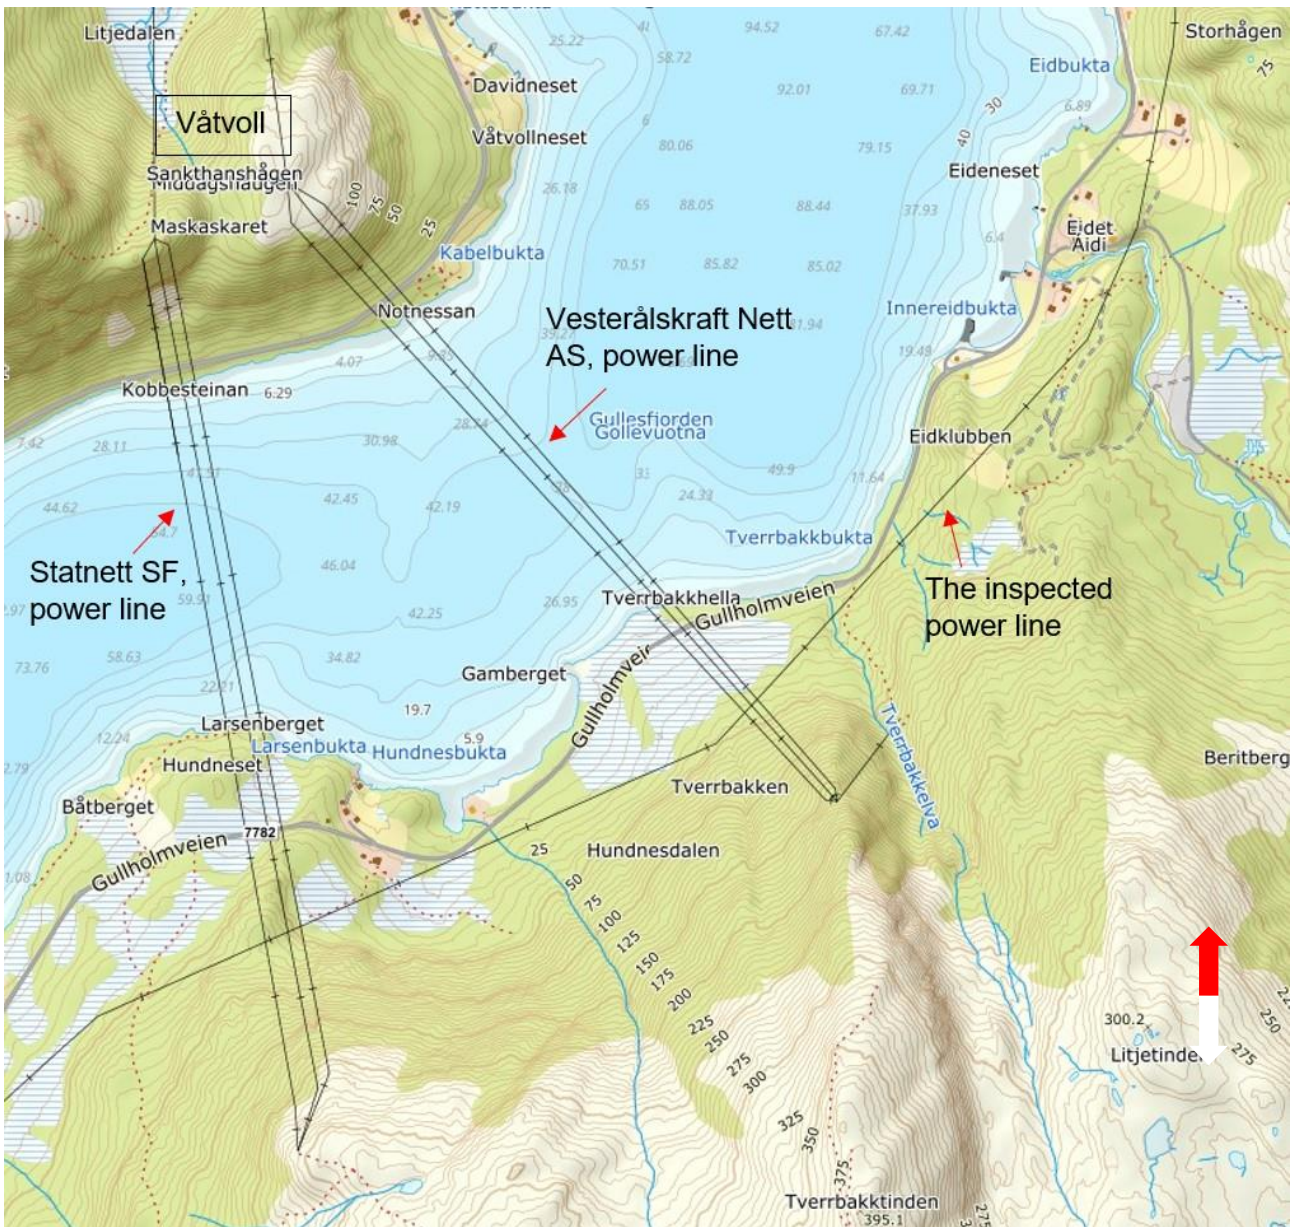
Both overhead power lines have been reported as obstacles to aviation, but only Statnett's line has been physically marked.

Figure 2: Map section showing the location of Vesterålskraft Nett AS's overhead power line in relation to Statnett's line over the Gullnesfjorden. Map: © Norwegian Mapping Authority / Heli-Team / NSIA

The Norwegian Safety Investigation Authority recommends CAA Norway to reconsider its conclusion and consider whether the overhead power line spanning the Gullsfjord should be physically marked.

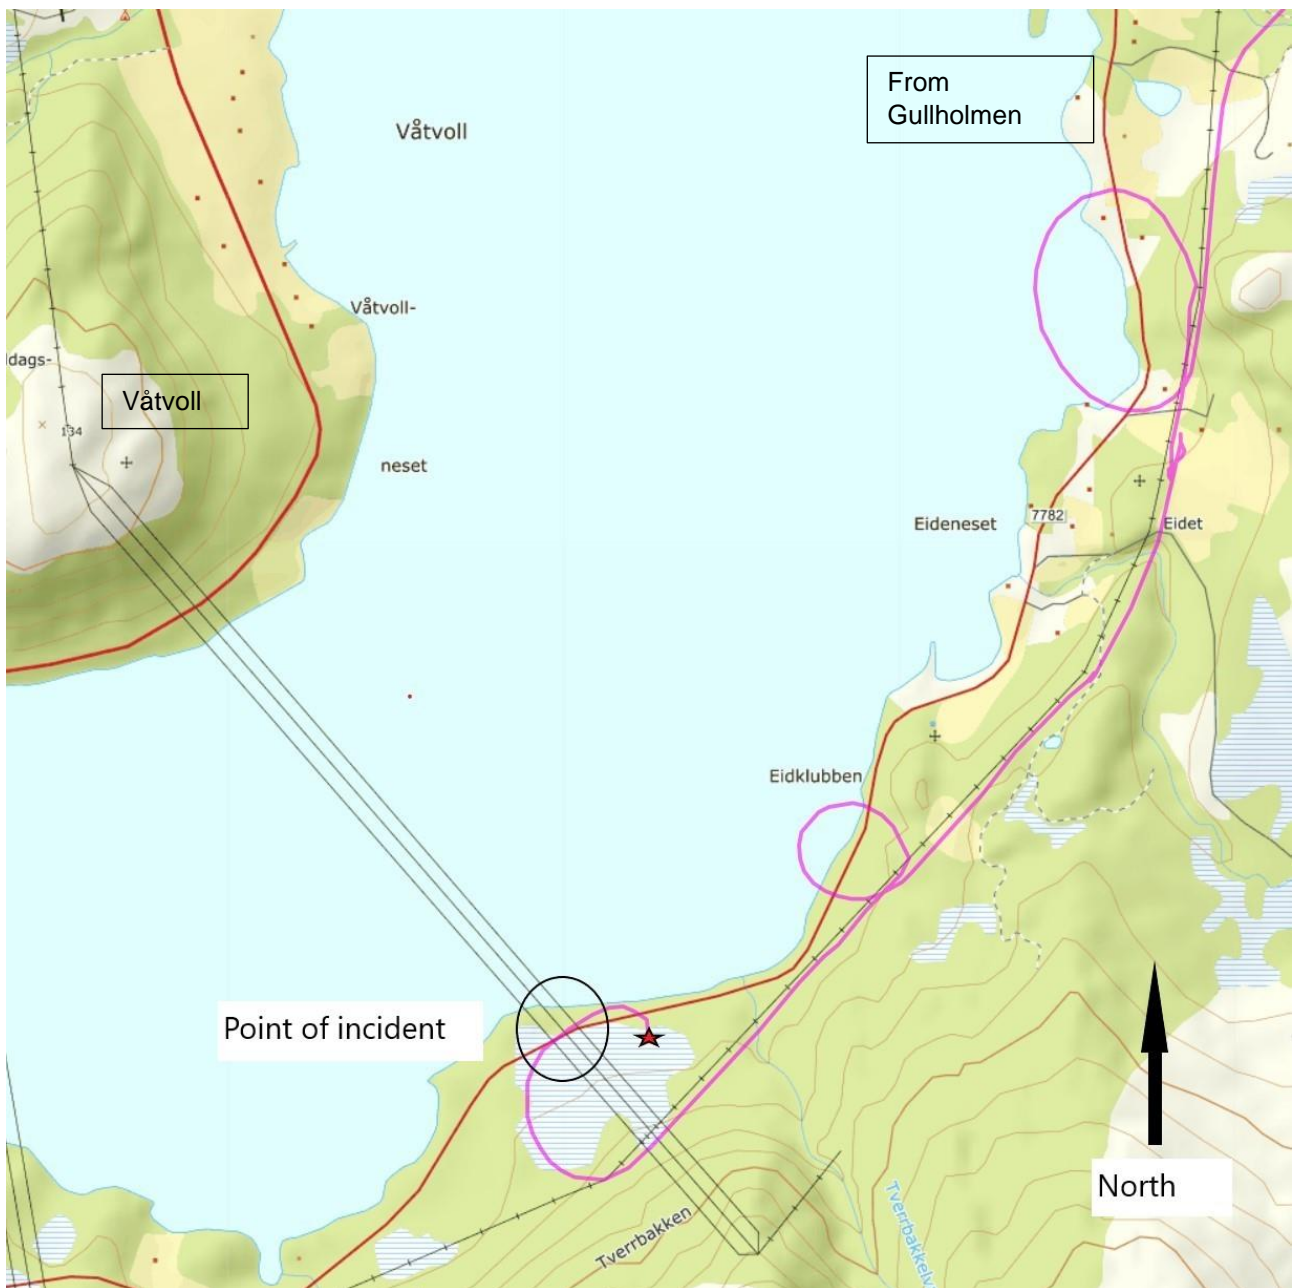
Figure 3: Map section of the incident showing the power company's overhead power line spanning the fjord and the power cable being inspected. The pink line shows the helicopter's flight path along the power line from Gullholmen, downloaded from the helicopter's iPad. The downloaded position data deviate from the explanation given by the commander and the power supply fitters. Map: © Norwegian Mapping Authority / Air Navigation Pro / NSIA

During the flight south along the Gullfjord, the commander and the power supply fitters explained that the helicopter flew on the west side of the power line. However, information downloaded from the detachable iPad shows that the helicopter flew on the east side of the power line. The NSIA is aware that position data from a detachable piece of equipment at low altitude may be inaccurate, see Figure 3.

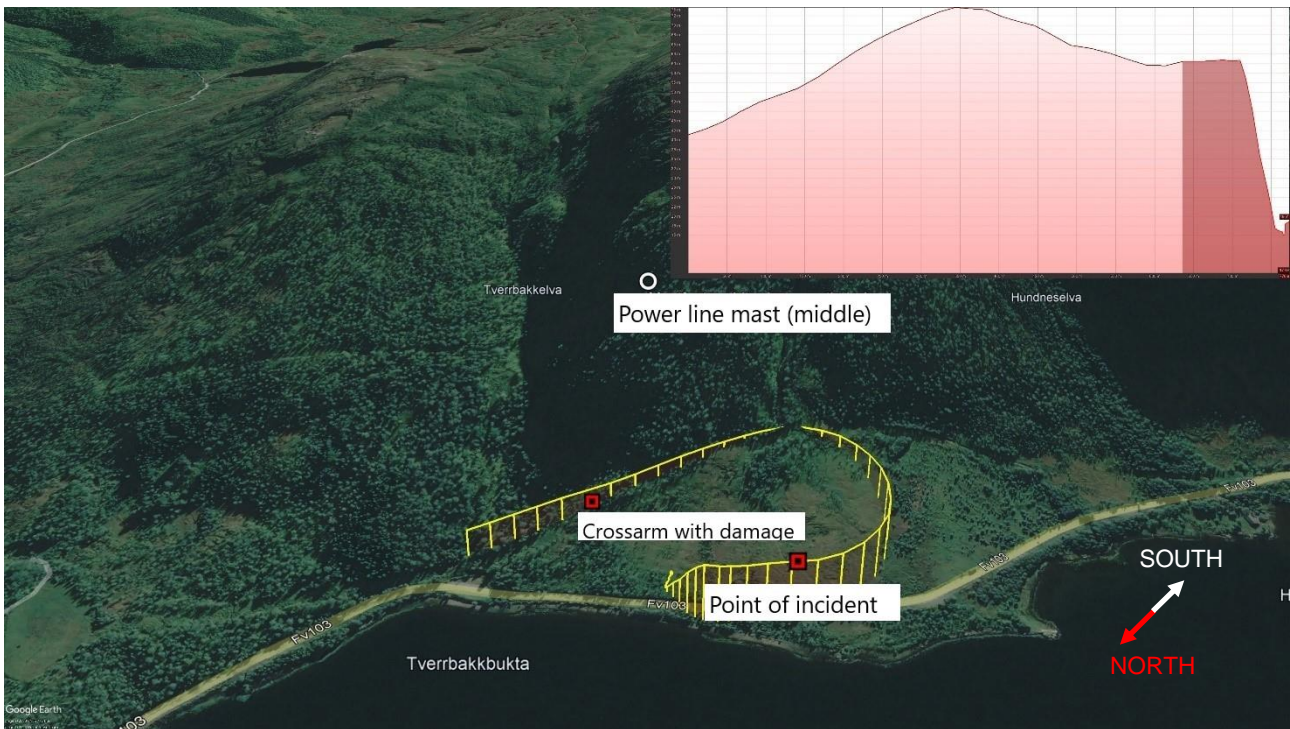
The helicopter then started to turn right at a speed of between 40 and 60 kt and passed under the power line without the commander noticing. The helicopter then commenced a slight ascent before switching to a downward turn, after about 180 degrees, see Figure 5. While making the turn, the commander suddenly noticed the overhead power line spanning the fjord and instinctively pulled up the collective pitch control to avoid a collision. Shortly after, the helicopter's right skid caught in the middle cable and lifted it over the northernmost cable. The commander and the power supply fitter sitting in the front seat heard a bang as the middle cable made contact with the northernmost one and short-circuited. The commander has stated that the helicopter was momentarily caught in the cable, causing the helicopter's nose to point downwards at an angle of about 90 degrees.

Figure 5: The last part of the helicopter's flight path (seen from the northwest). The graph shows the elevation profile of the flight path (highlighted in yellow) where the point of impact is at the start of the dark red area. Source: Air Navigation Pro. Map: Google Earth/NSIA

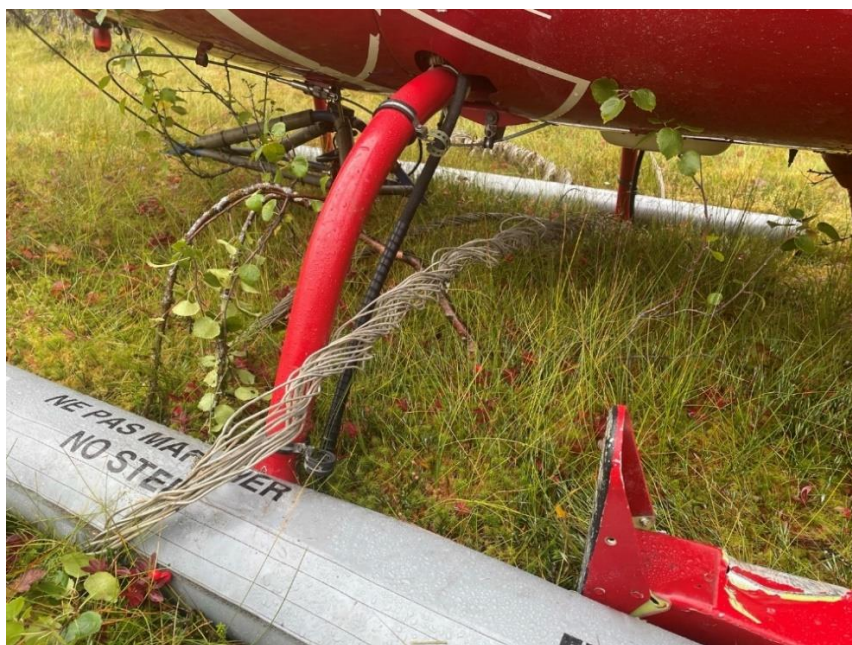
After everybody on board had evacuated the helicopter, the commander found that one of the rotor blades, the skids, floats and tail rotor cover had been damaged.

Figure 7: The aluminium wires wrapped around the helicopter's right skid with floats after the emergency landing on the marsh. Photo: Heli-Team/NSIA

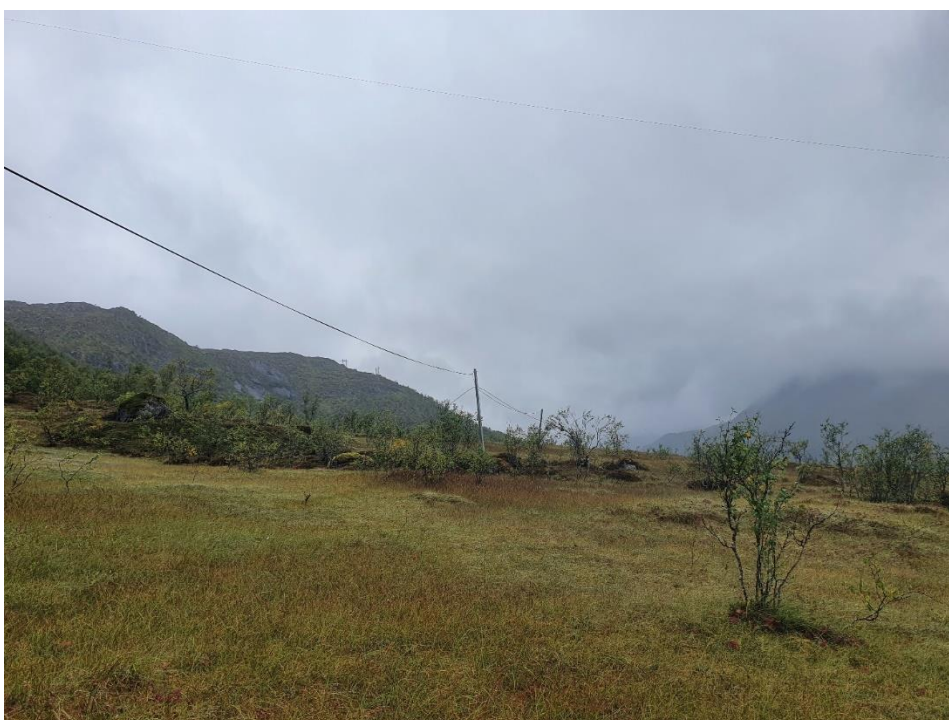
Figure 9: The photo was taken immediately after landing and shows the weather at the time. The power cable that was cut can be seen in the background lying above the southbound telephone line. Photo: Heli-Team/NSIA
