Published October 2024

REPORT AVIATION 2024/09

Serious aviation incident near the Gullesfjord in Kvæfjord municipality, Troms county, on 6 September 2021 involving Airbus Helicopters AS 350 B1, LN-ORJ, operated by Heli-Team AS

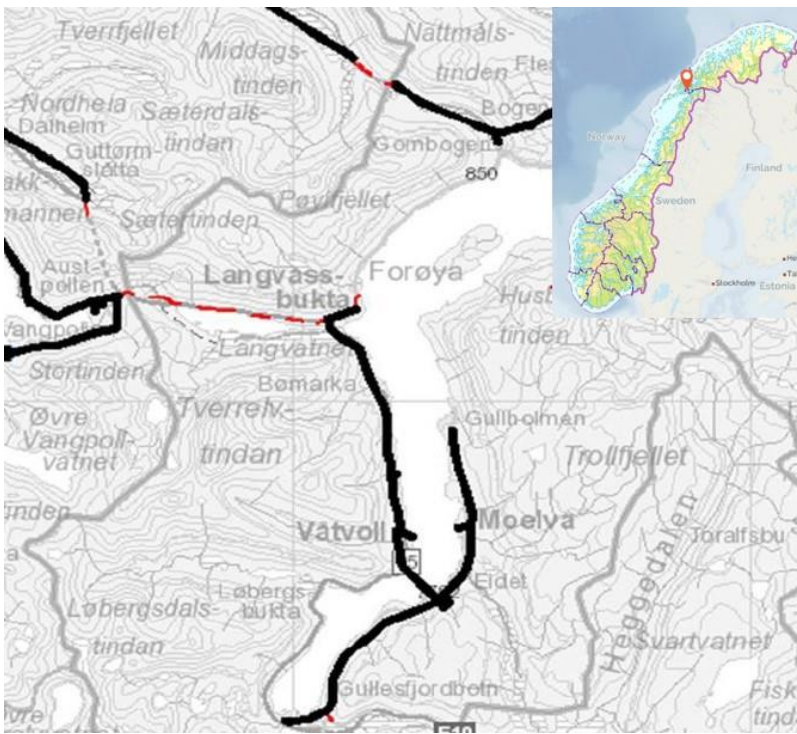
The commission from the power company included two black and white maps on which the power lines to be inspected were marked, see figure 1. It was 188.16 km of line inspection and 38.97 km of pylon/pole top inspection. The maps only showed the power company's own power lines, and other power companies' lines running through the same area were not visible on the map. The commission also specified the desired date for the inspection, and that two power supply fitters from the power company were to take part in the inspection. The week before the flight, the power company asked Heli-Team AS whether it would be possible for a third person to take part in the assignment as a passenger to take photos for the power company's social media platforms.

Figure 1: Map excerpt from the power company's commission. The map shows the section from Langvassbukta to Gullesfjordbotn marked in black in the map. Map: Vesterålskraft Nett AS/Heli-Team/NSIA

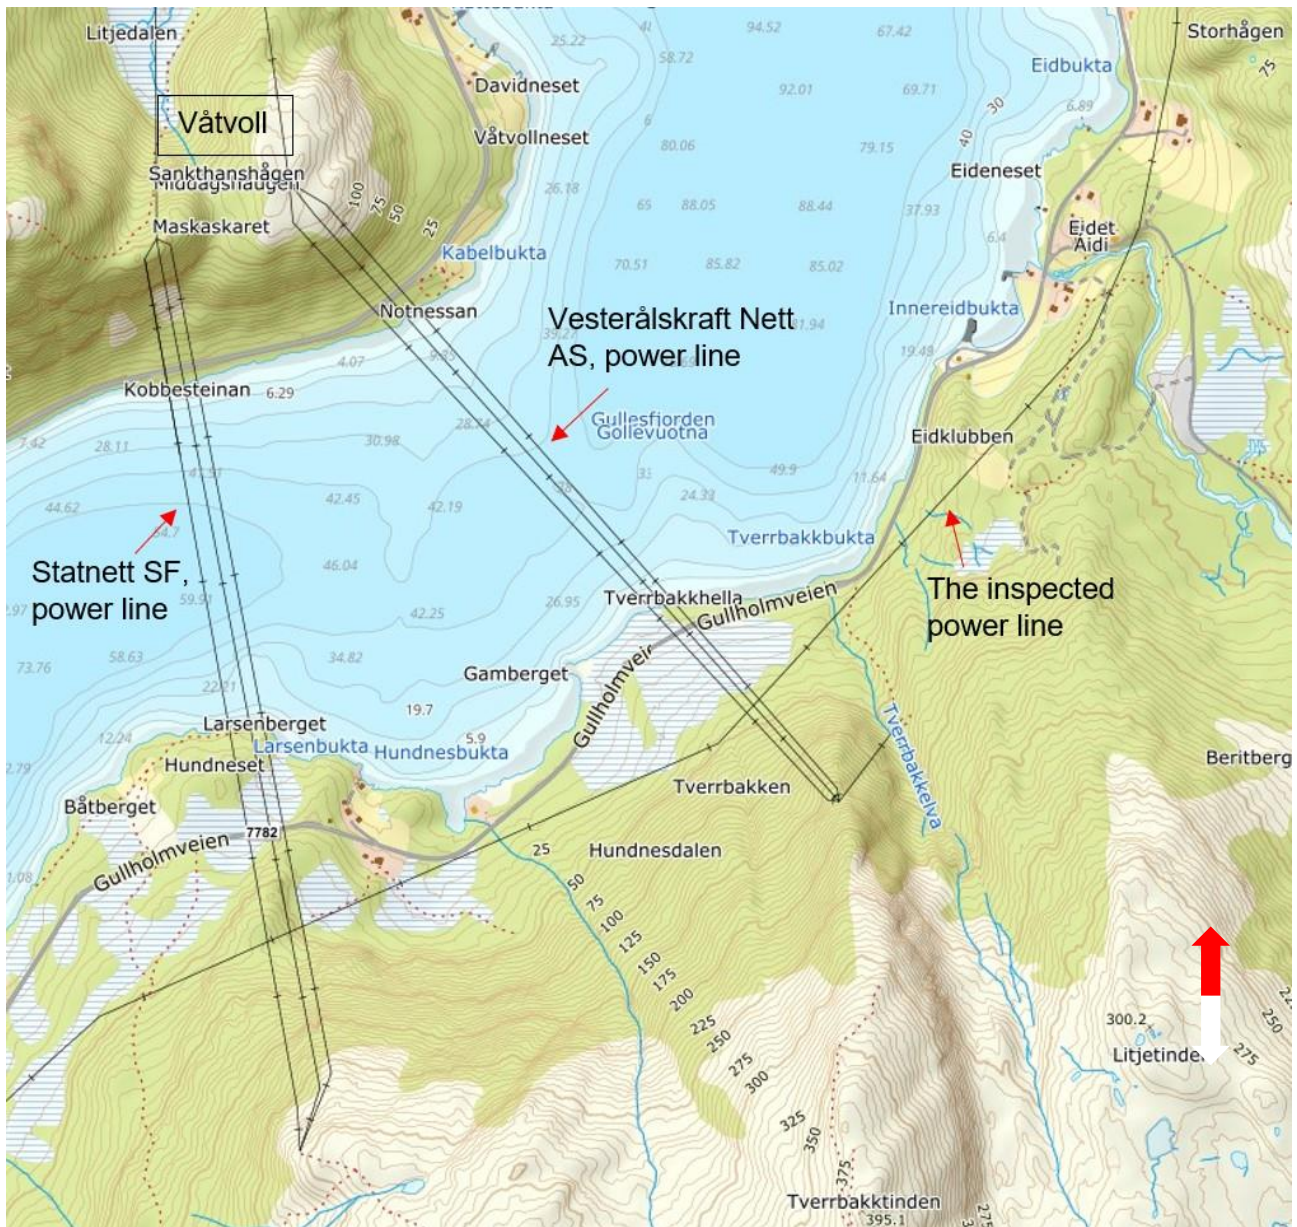
A Statnett SF overhead power line also runs close to where the incident occurred. The distance between the overhead power lines decreases to the north. In addition to these lines spanning the fjord, the inspected line runs on the eastern side of the fjord, see Figure 2.

Both overhead power lines have been reported as obstacles to aviation, but only Statnett's line has been physically marked.

Figure 2: Map section showing the location of Vesterålskraft Nett AS's overhead power line in relation to Statnett's line over the Gullfjord. Map: © Norwegian Mapping Authority / Heli-Team / NSIA

The Norwegian Safety Investigation Authority recommends CAA Norway to reconsider its conclusion and consider whether the overhead power line spanning the Gullsfjord should be physically marked.

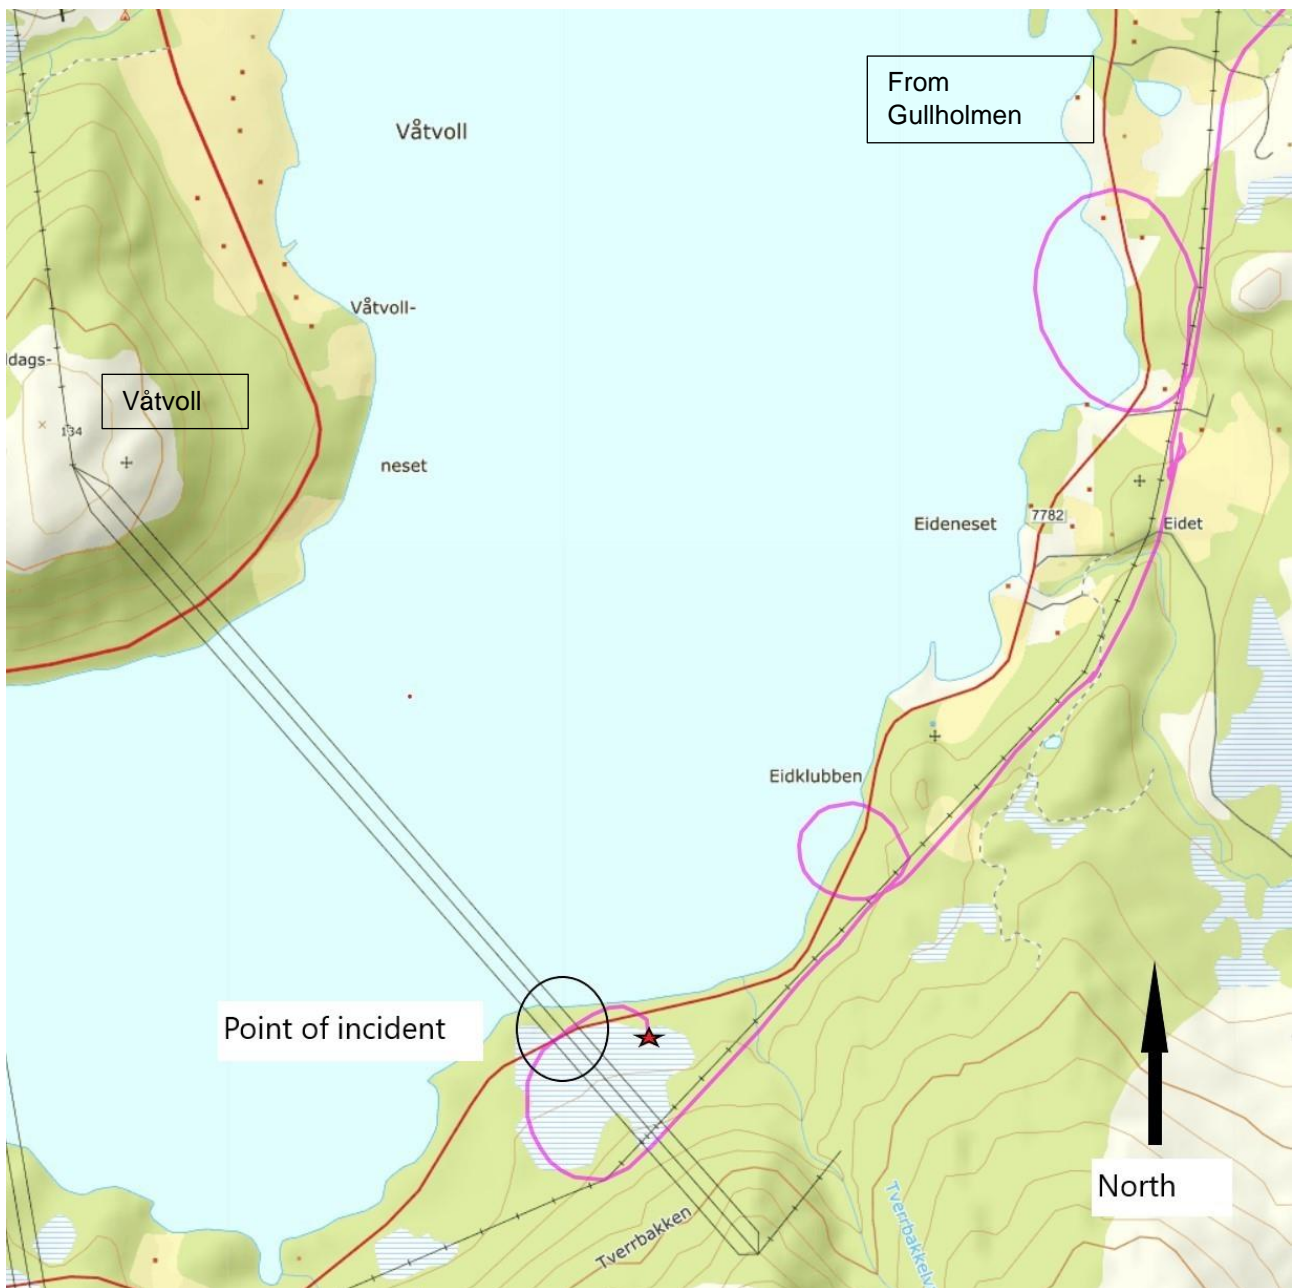
Figure 3: Map section of the incident showing the power company's overhead power line spanning the fjord and the power cable being inspected. The pink line shows the helicopter's flight path along the power line from Gullholmen, downloaded from the helicopter's iPad. The downloaded position data deviate from the explanation given by the commander and the power supply fitters. Map: © Norwegian Mapping Authority / Air Navigation Pro / NSIA

During the flight south along the Gullfjord, the commander and the power supply fitters explained that the helicopter flew on the west side of the power line. However, information downloaded from the detachable iPad shows that the helicopter flew on the east side of the power line. The NSIA is aware that position data from a detachable piece of equipment at low altitude may be inaccurate, see Figure 3.

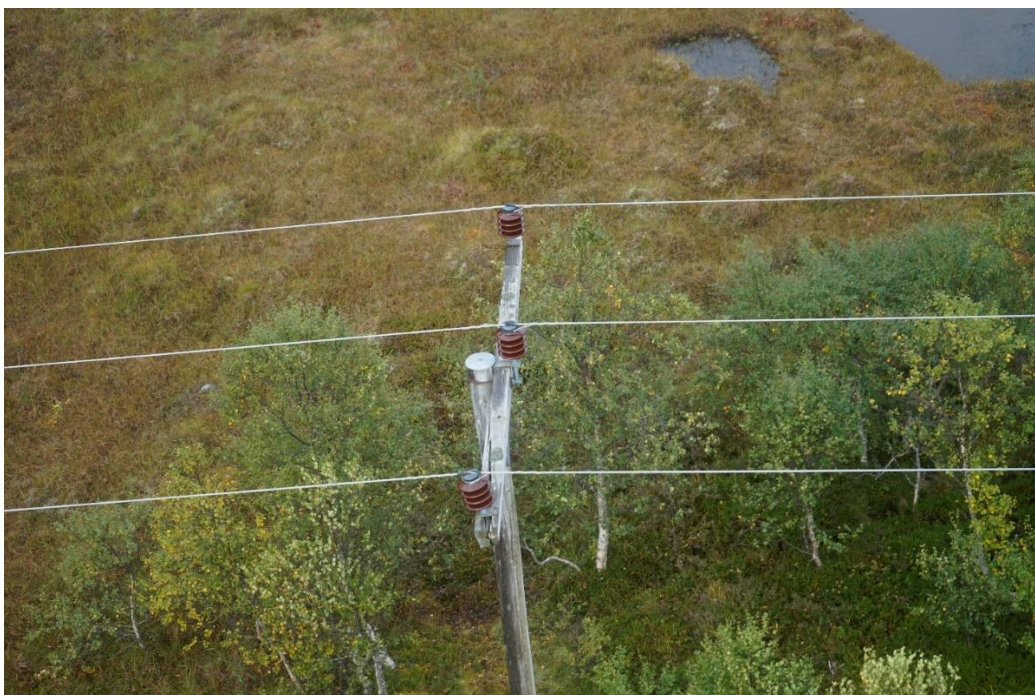
At Tverrbakken, just before the crossing overhead power line spanning the Gullsfjord, the fitters observed another fault on the crossarm of an electricity pole, see figure 4. The flight also became more demanding at this point with light rain and rising terrain to the left of the helicopter. The fitters have stated that at this point in time, they were focused on inspecting the electricity pole, while the commander was planning another 360-degree right turn to go back to the crossarm where the possible fault had been identified.

Figure 4: An example of a crossarm with damage inspected the same day as a part of the power line inspection. Photo: Vesterålskraft Nett AS / NSIA

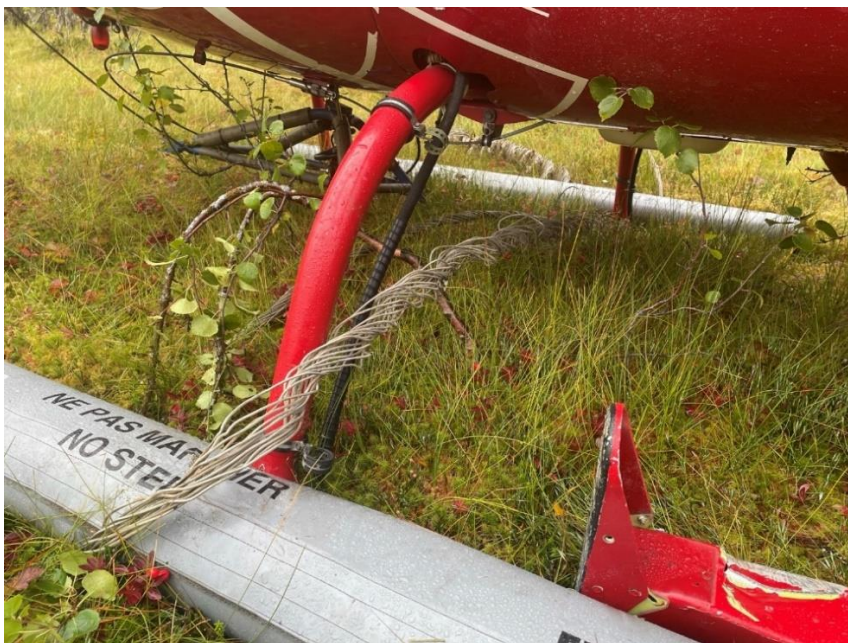
After everybody on board had evacuated the helicopter, the commander found that one of the rotor blades, the skids, floats and tail rotor cover had been damaged.

Figure 7: The aluminium wires wrapped around the helicopter's right skid with floats after the emergency landing on the marsh. Photo: Heli-Team/NSIA

The way in which the helicopter hit the power line had considerable bearing on the sequence of events that followed. The helicopter's vertical position resulted in the right-hand skid catching the power line. The point of impact with the skid meant that the helicopter heeled sharply to the right. The damage to the rotor blade is compatible with the steel core of the power cable being cut by the rotor blade. In the NSIA's opinion, small margins and coincidence are to thank for the cable first hitting the helicopter between the fuselage and the skids instead of hitting the rotor system. Had the cable hit the rotor system, the outcome would very likely have been catastrophic.

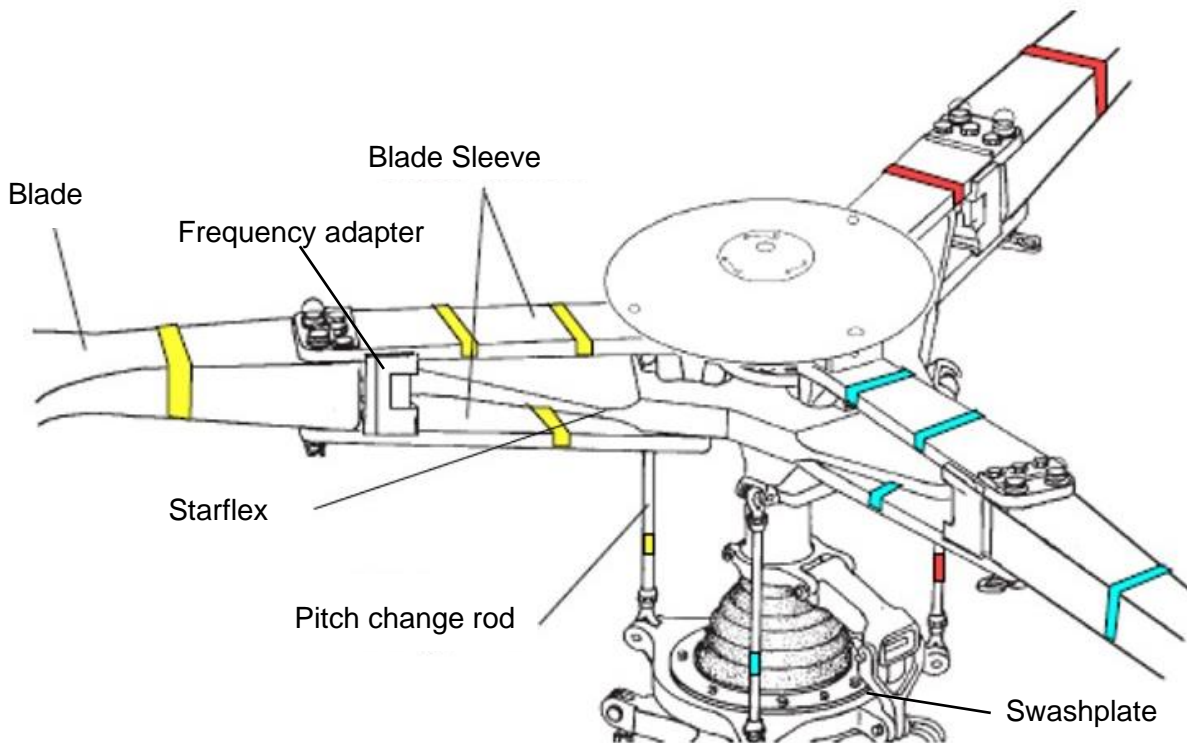
Figure 8: The Starflex Hub's position in the rotor head. Source: Airbus Helicopters / NSIA

Airbus Helicopters has named its main helicopter rotor head Starflex. The rotor head consists mainly of composite material. The rotor blades are made from laminated, flexible fibreglass, and each blade is mechanically attached to two sleeves. Starflex frequency adapters are fitted between the sleeves. The rotor blades' angle of attack is adjusted by the rotating part of the swashplate and the pitch change rods, see figure 8.

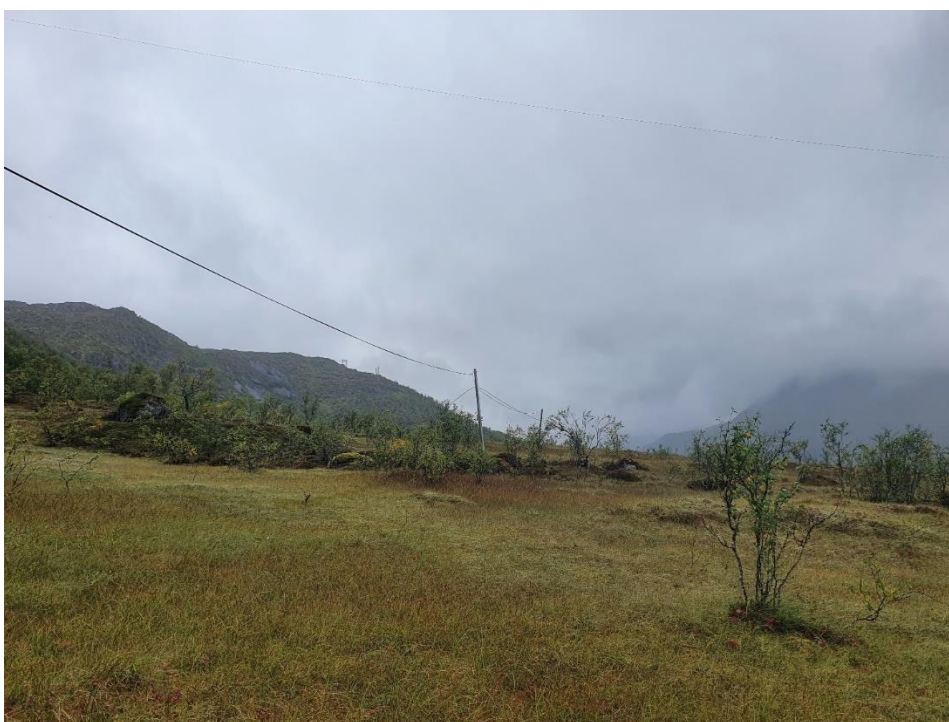
Figure 9: The photo was taken immediately after landing and shows the weather at the time. The power cable that was cut can be seen in the background lying above the southbound telephone line. Photo: Heli-Team/NSIA
