REPORT AVIATION 2024/11

Aviation accident at Villmobakken airstrip on Vannøya in Troms County on 6 August 2024 involving a Vans RV-14, SP-YBI

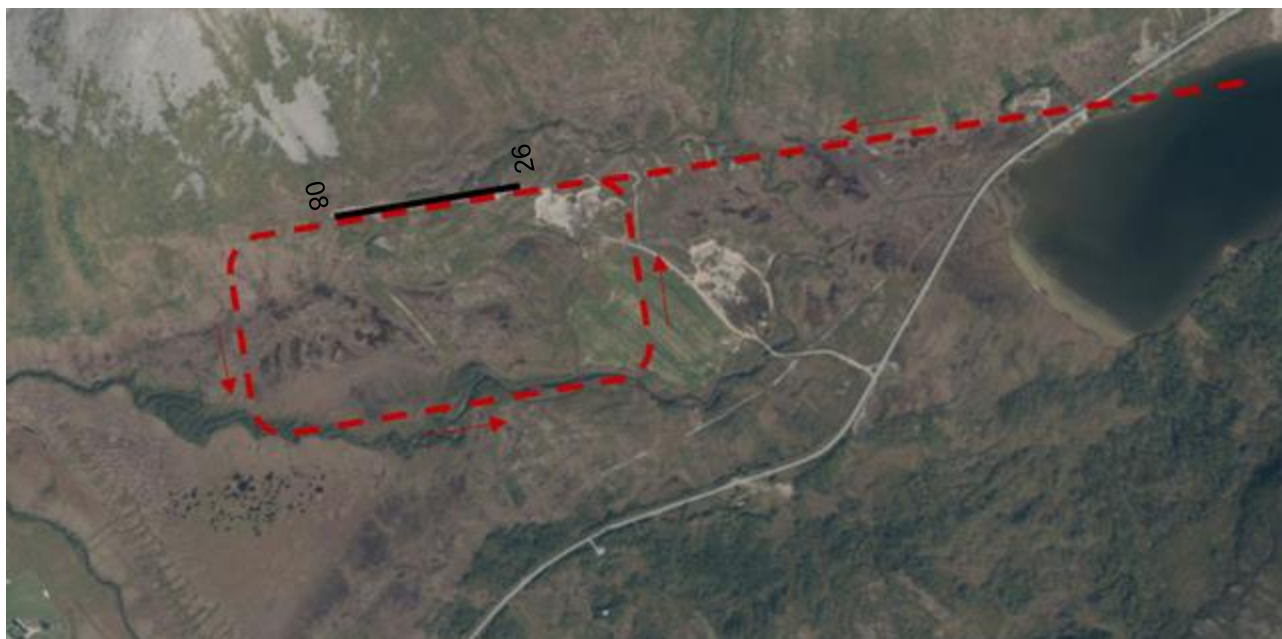
On arrival in the area from the east, the pilot established a left landing circuit for runway 26. To familiarise himself with the terrain, he performed a high and a low flyover of the airstrip (see Figure 2). As there is no windsock in the immediate vicinity of the airstrip, he used visual observations of

surrounding bodies of water and vegetation. He assessed the wind conditions as being calm. He decided to land to the southwest, on runway 26. The aircraft was set down just within the threshold at a speed of about 60 knots.

Figure 2: The pilot approached from the east, made two circuits, and landed on runway 26. The black line is the airstrip. Map: © norgeskart.no. Illustration: NSIA

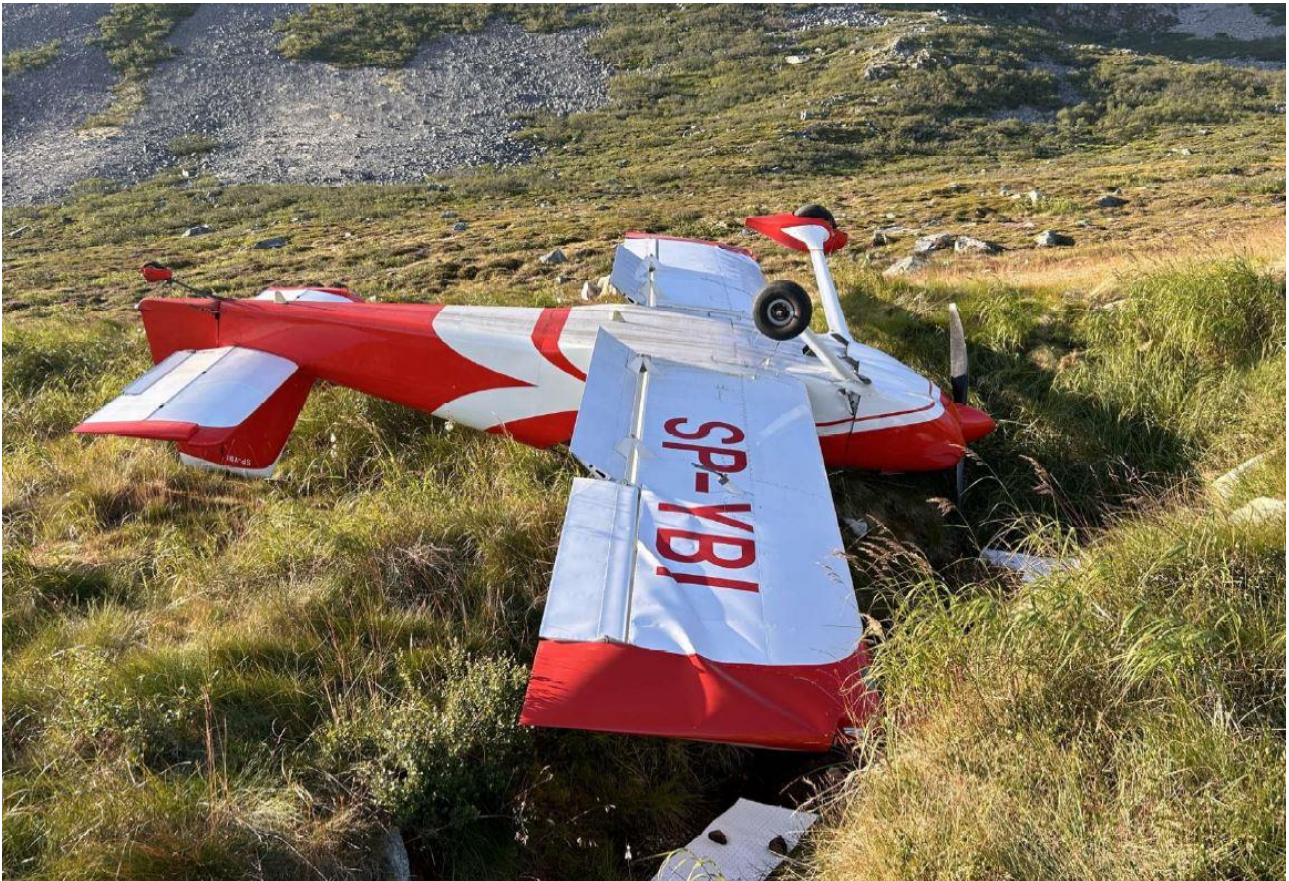
The pilot knew from experience that the aircraft could be stopped in about 200 metres. Vannøya airstrip is around 400 metres long. The pilot chose to brake carefully because of the length of the airstrip and because he was afraid that heavy braking could throw gravel up into the propeller. After around 200 metres, he passed the airstrip's highest point and continued slightly downhill. At this point, the pilot lost directional control, and the aircraft veered to the left. The aircraft quickly veered onto an uneven surface off the gravel runway and continued for a few metres, before the landing gear went into a ditch across from the edge of the airstrip. The aircraft flipped forward and ended up on its back with the front facing the direction the aircraft had come from (see Figure 3 and 4). The pilot has stated that the aircraft's speed was low when it veered off the gravel.

The pilot switched off the fuel supply and electricity, before both of those on board got out of the aircraft unaided. Both sustained minor injuries. The aircraft sustained extensive damage. The pilot has stated that the aircraft had no technical faults before departure, and that no faults arose during the flight that may have affected the landing.

Figure 3: SP-YBJ after the accident. Photo taken looking north. Photo: The police / NSIA

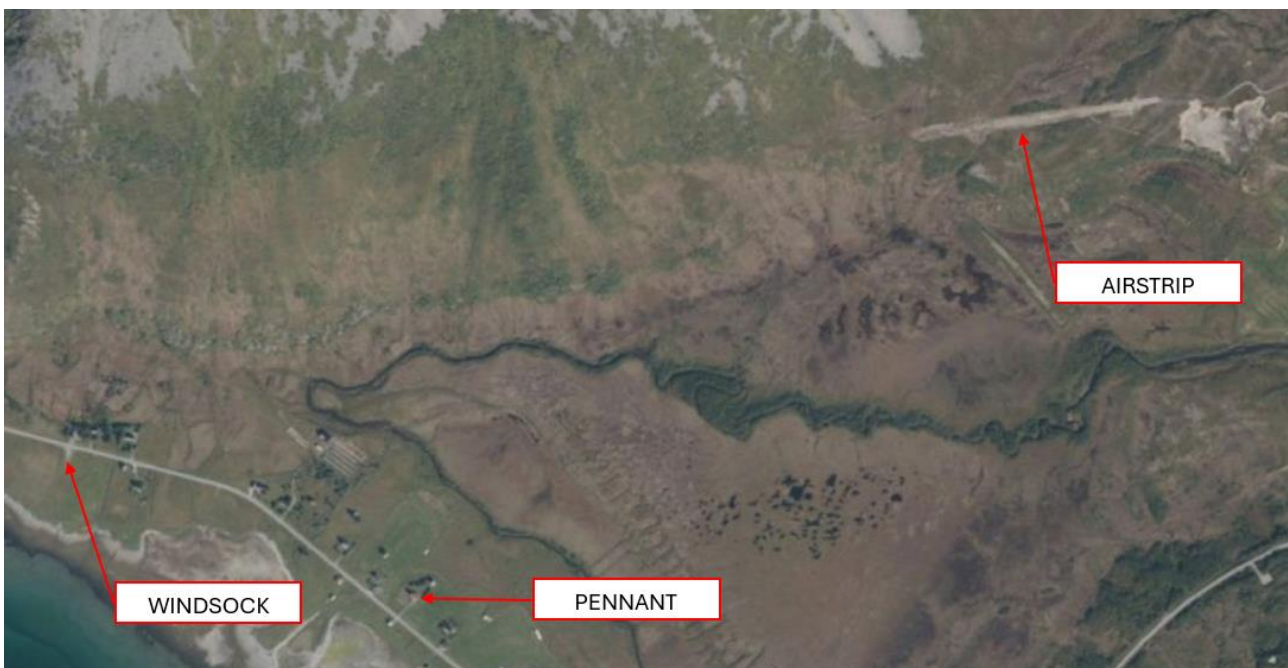
There are currently no windsocks at the airstrip. Instead, a windsock has been set up approximately 1.4 km northwest of the airstrip (see Figure 6) which, according to the operator, is new and easy to see from the air. A pennant flag beside a residential building is also used to assess local wind conditions before landing.

Figure 6: Location of windsock and pennant in relation to the airstrip. Map: © norgeskart.no Illustration: NSIA

The NSIA believes it is a weakness that there are no windsocks in the immediate vicinity of the airstrip. Although the wind conditions had no impact on this incident, this is nonetheless a factor that means extensive knowledge of local conditions is required at Villmobakken airstrip. This makes take-offs and landings on the airstrip particularly demanding.

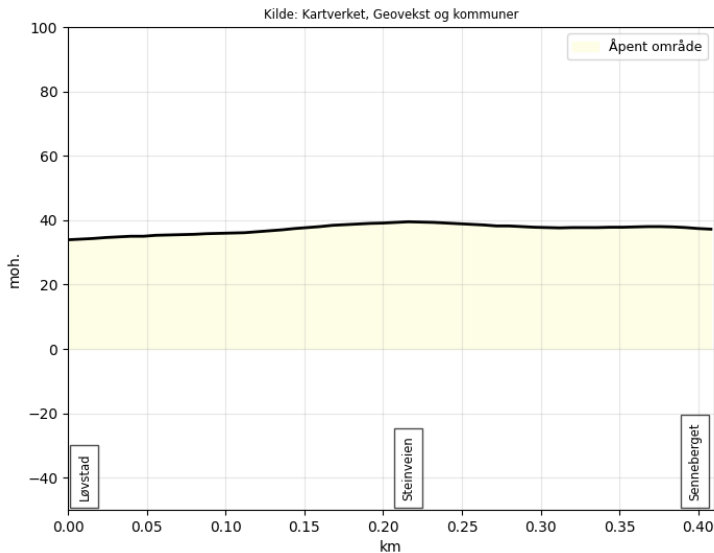
The profile of the airstrip is such that the middle section is slightly elevated compared to either end of the runway. The airstrip is around 40 metres above sea level. To the north, the terrain rises steeply to about 750 metres above sea level. The runway surface is gravel with stone and grass along the edges. There is a 15-metre-high power line approximately 340 metres from the threshold to runway 26.

Figure 7: Elevation profile of the airstrip. Runway 26 from left to right. Source: © norgeskart.no

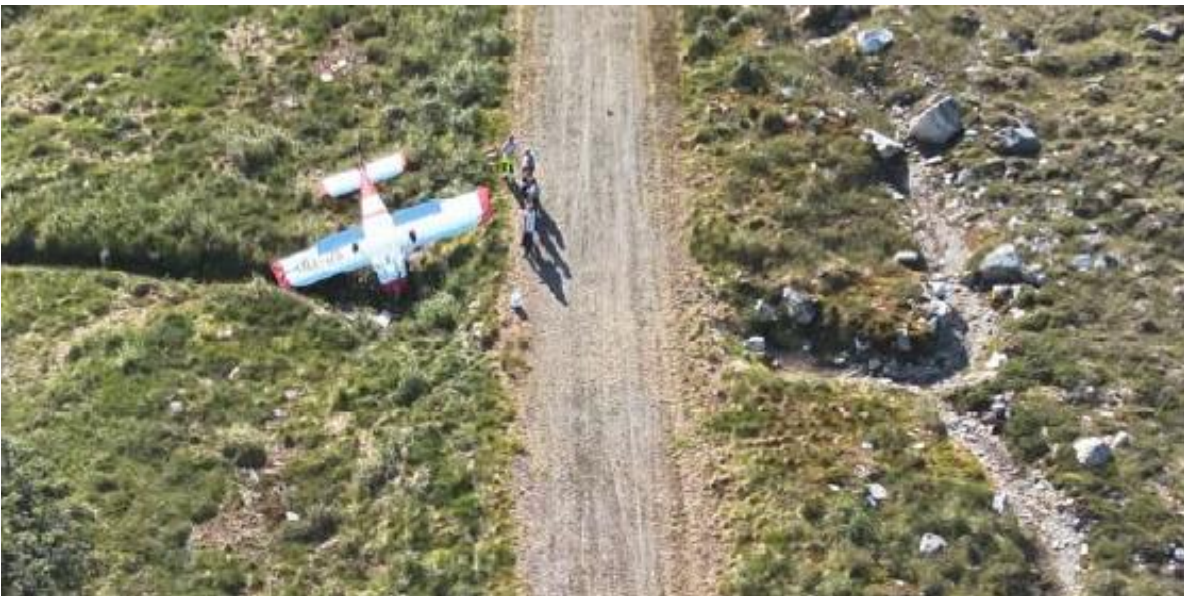
The ditch that SP-YBI ended up in is intended to drain water from the upper side of the airstrip and runs almost to its edge. There are two open ditches on the upper side of the airstrip that lead water to a pipe under the airstrip. The open trench continues on the lower side of the airstrip.

Figure 8: The ditch SP-YBI ended up in. Photo: The police / NSIA

When the left main wheel veered off the gravel, the uneven surface, combined with the small wheels, made it difficult to correct the aircraft and regain directional control. As this occurred just before the point where drainage ditches had been dug, the main wheels ended up going into one of the ditches and the aircraft flipped over.

The drainage ditches constitute an obstacle. This applies to both sides of the airstrip. The room for manoeuvre is no more than the width of the airstrip itself. The ditch is such that the aircraft would probably have tipped over even at a very low speed. There are multiple examples of both serious injury and loss of life resulting from aircraft tipping over in this way.

The sides and ends of approved airstrips have safety zones. The NSIA's assessment is that an open ditch across the airstrip is very unfortunate and does not provide a safety zone along the sides of the airstrip. Simple measures could have removed this safety risk. The aircraft's speed was low, and it would probably not have tipped over if the ditch had not been there. The operator should ensure that everyone operating at Villmobakken airstrip is aware of the drainage ditches.
