AVIATION 2025/01

Aviation accident at Songesand, Sandnes municipality, Rogaland on 16 November 2020 involving Airbus Helicopters AS 350 B3, LN-OAX, operated by Heli-Team AS

Air accident report

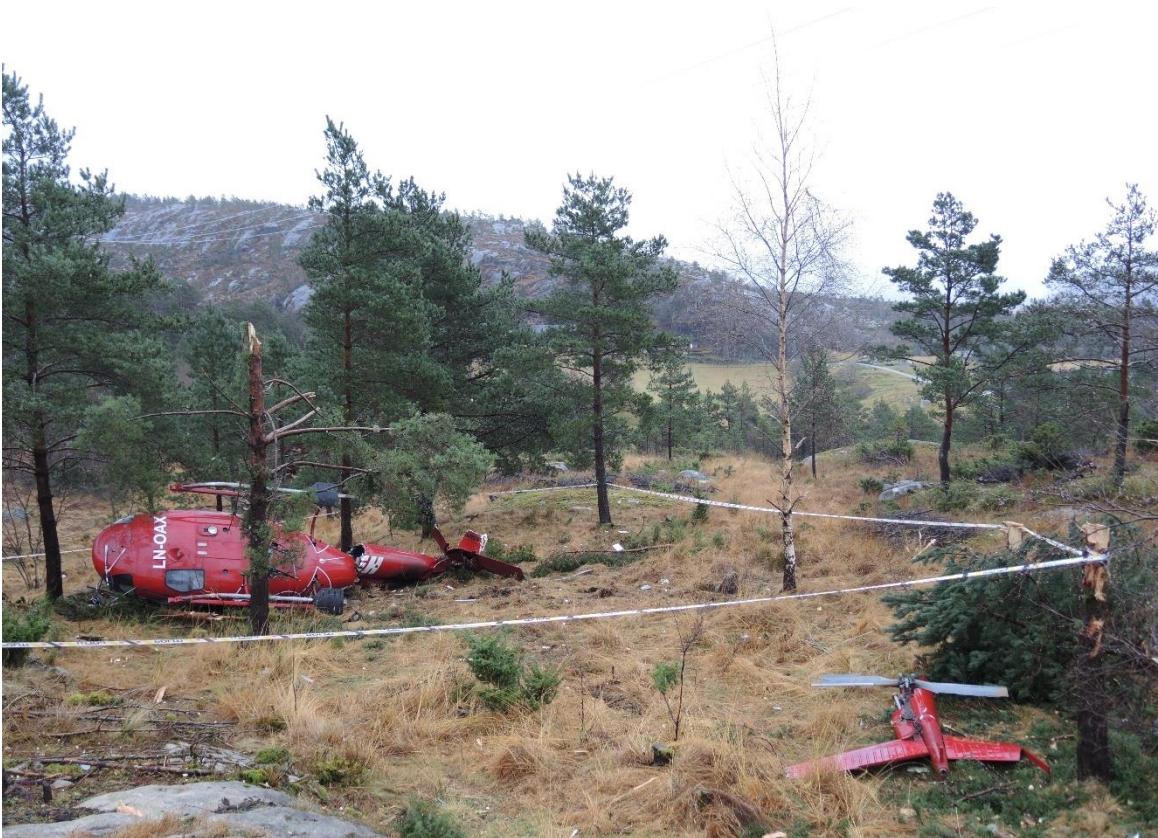
The helicopter's main rotor cut through some trees before the helicopter hit the ground and was left lying on its right side about 50 meters from pylon foundation 49. The direction of rotation of the main rotor caused the helicopter at the end get a twist to the left; see Figure 3.

Figure 3: The helicopter's final position about 50 metres east of pylon foundation 49. The tail rotor with the vertical stabiliser on the right. Photo looking east, with pylon foundation 49 behind the photographer. Photo: NSIA

The wreckage remained lying on its right side, with the individual pieces fairly close together. The cabin was still intact, while the tail section had broken into three parts. The two foremost portions of the tail boom remained tied to the helicopter by a hydraulic hose and panels of the tail boom structure. The rear of the tail, including the vertical fin and tail rotor gearbox with tail rotor, was found approximately 13 metres southwest of the main wreckage; see Figure 3.

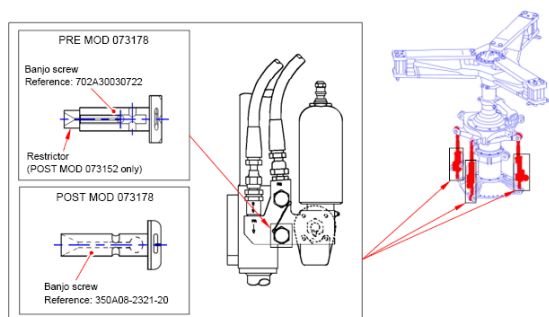
In 2018, Airbus published SB AS350-67.00.69, Main Servo Controls. Installation and verification of banjo screws with built-in restrictor. The reason for the service bulletin was that the wrong type of banjo screws could be installed, which could be at the expense of the pilot's ease of use. The modification was recommended by Airbus Helicopters, but not mandatory. Owners and operators were advised to check that the servo configuration was correct. At the same time, Airbus recommended that the operator upgrade the servo installation in accordance with Mod 073221 (SB AS350-67.00.41) or Mod 073178 (Banjo screws with reduced cross-section); see Figure 6.

Figure 6: Image from SB AS350-67-30-0001 showing the change in the configuration of banjo screws, where the inside diameter has been reduced to reduce sensitivity to RPC. Illustration: Airbus Helicopters / NSIA

In October 2023, Airbus Helicopters published a new service bulletin, AS350-67-30-0001, describes a modification in which the banjo screws on the main servos are replaced by screws with a smaller internal diameter. The SB which contains partly the same requirement as SB AS350-67.00.69 reduces the helicopter's sensitivity to pilot induced oscillation (PIO) or pilot assisted oscillation (PAO) during external sling load operations. Airbus Helicopters states that this can be done as a first measure, and then to subsequently, in connection with the main overhaul, upgrade the servos to the latest generation in accordance with SB AS350-67-00.41.

SBAS350-67-30-0001 was published on 26 October 2023 during this investigation. It describes replacement of the banjo screws installed in the helicopter's main servos to a new screw with a smaller cross-section to reduce the sensitivity of the helicopter's control system.

The NSIA share Airbus Helicopters recommendation to incorporate this modification.

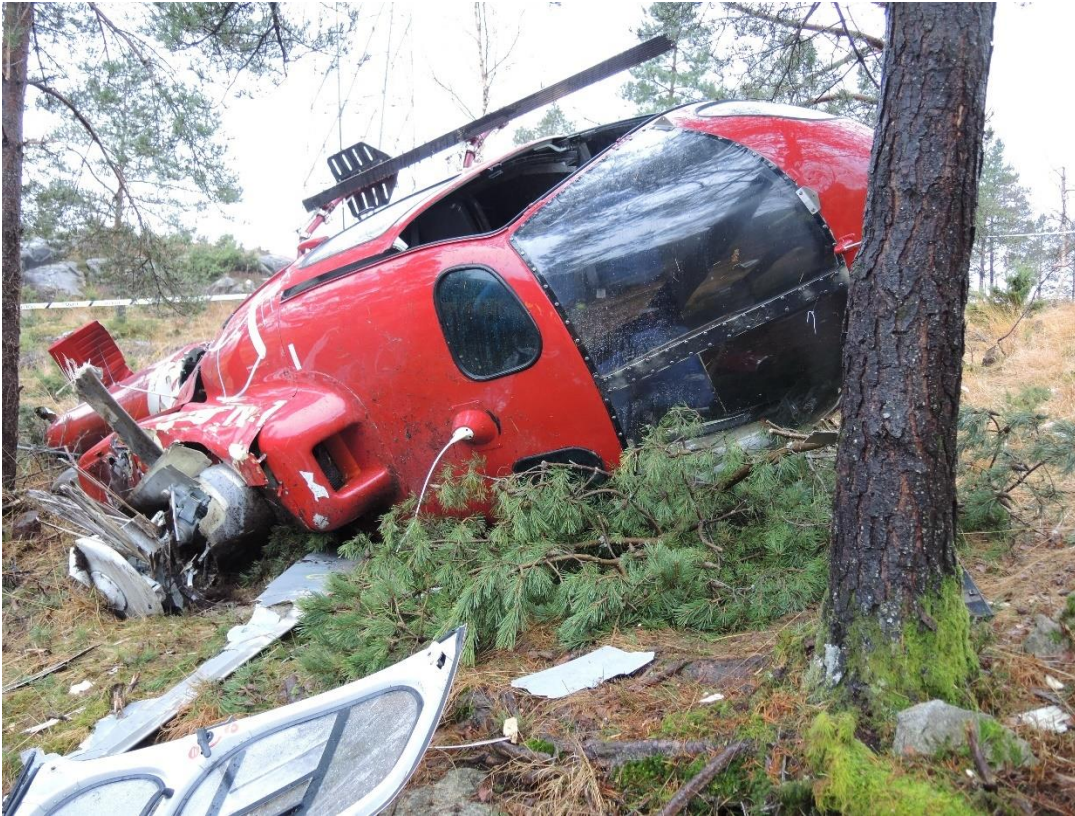
The main rotor with three rotor blades, hydraulic servos and a rotor head was destroyed after the impact with the trees and the ground. One of the rotor blades ended up coiled around the main rotor shaft; see Figure 12. The remaining rotor blades were found severely damaged near the wreckage. The helicopter's tail rotor blades were still attached to the tail rotor gearbox and had sustained various degrees of damage.

Figure 12: The helicopter wreck looking southwest. One of the rotor blades has been coiled around the rotor mast. Photo: NSIA

An inspection was carried out of the helicopter's rotor system, servos and rotor head. The Starflex rotor hub was broken at a 45-degree angle. This is a typical fracture pattern seen in situations where the rotor blade rpm is reduced abruptly, for example when hitting the ground or another hard object. The rotor head frequency adapter and liners were inspected without any faults or defects being detected. The remains of the rotor blades were inspected, but they were so severely damaged that it was not possible to identify any possible faults or defects in them. The NSIA has concluded that the rotor system was in operation and controllable at the time of the accident. In addition, the NSIA has concluded that the engine was in operation and was operating the helicopter's rotor blades when it hit the ground.
