Published February 2025

# REPORT

AVIATION 2025/01

***Aviation accident at Songesand, Sandnes municipality, Rogaland on 16 November 2020 involving Airbus Helicopters AS 350 B3, LN-OAX, operated by Heli-Team AS***

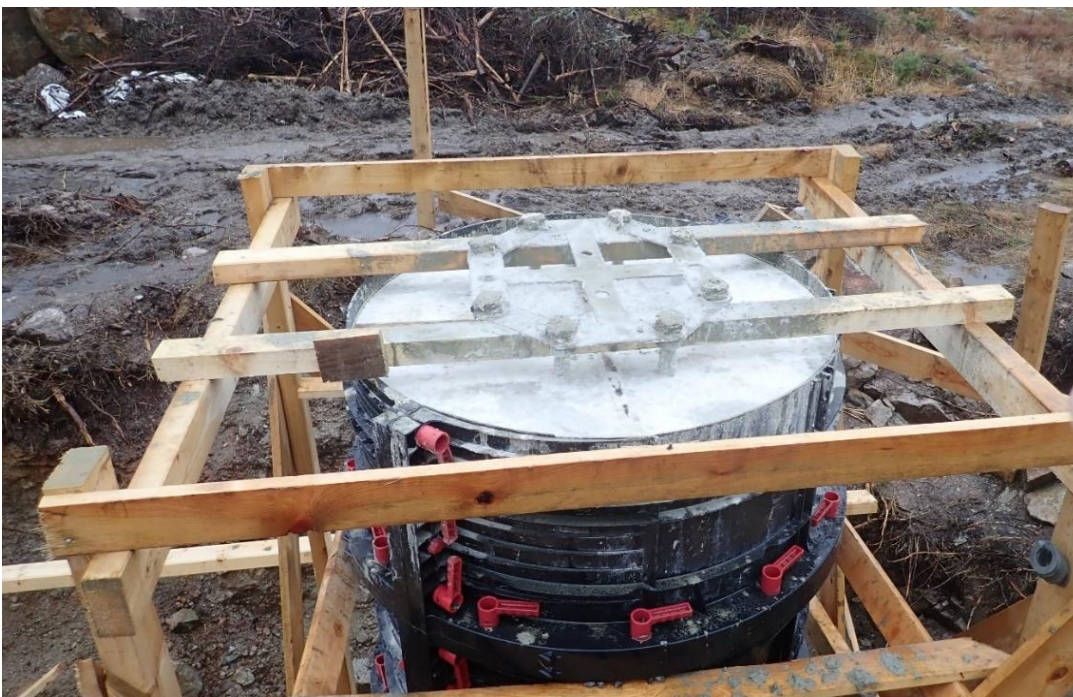
Figure 2: Pylon foundation 49, the day after the accident. Casting of the foundation had then been completed. Photo: NSIA

The phenomenon may have arisen when the pilot had to correct the helicopter's altitude in connection with unloading the concrete. The correction may have been due to a gust of wind from behind in addition to contact between the bucket and the formwork of the foundation.

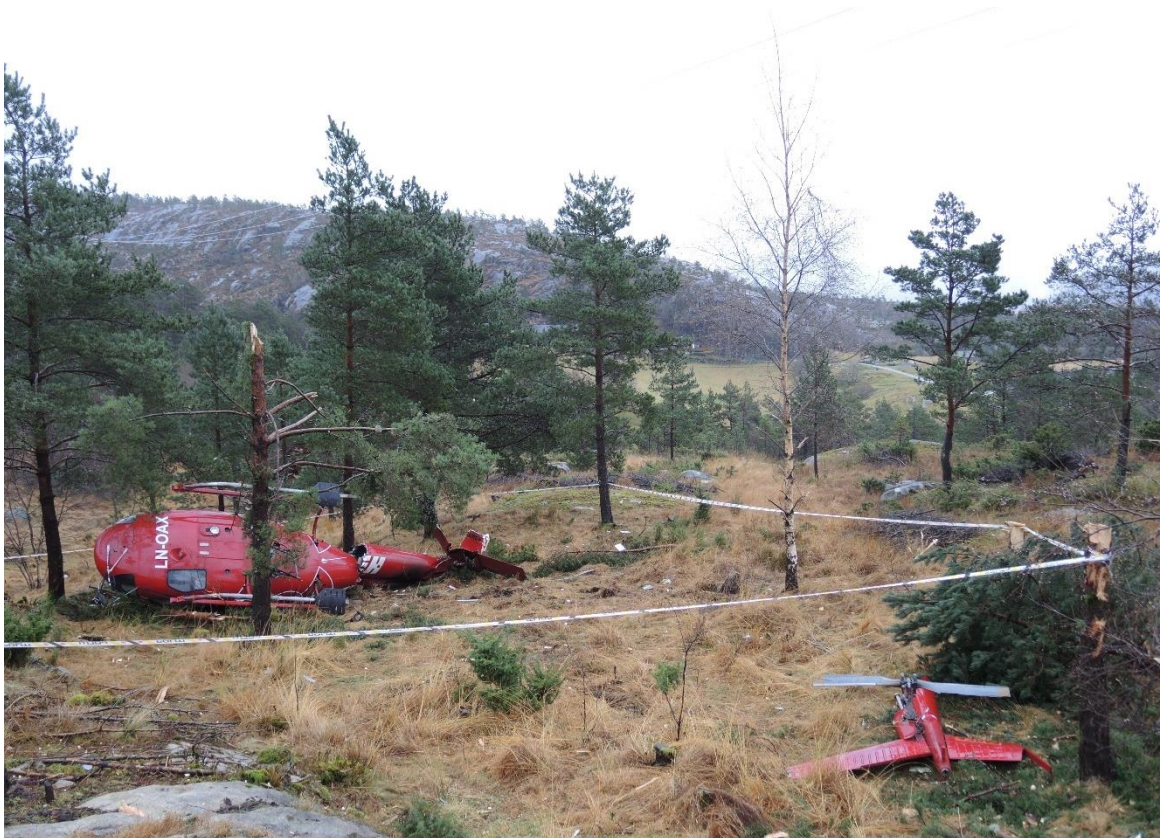
*Figure 3: The helicopter's final position about 50 metres east of pylon foundation 49. The tail rotor with the vertical stabiliser on the right. Photo looking east, with pylon foundation 49 behind the photographer. Photo: NSIA*

The wreckage remained lying on its right side, with the individual pieces fairly close together. The cabin was still intact, while the tail section had broken into three parts. The two foremost portions of the tail boom remained tied to the helicopter by a hydraulic hose and panels of the tail boom structure. The rear of the tail, including the vertical fin and tail rotor gearbox with tail rotor, was found approximately 13 metres southwest of the main wreckage; see Figure 3.

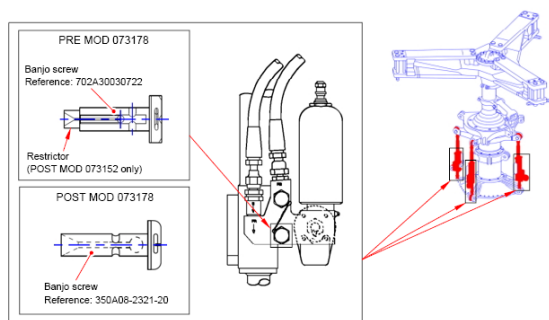
In 2018, Airbus published SB AS350-67.00.69, Main Servo Controls. Installation and verification of banjo screws with built-in restrictor. The reason for the service bulletin was that the wrong type of banjo screws could be installed, which could be at the expense of the pilot's ease of use. The modification was recommended by Airbus Helicopters, but not mandatory. Owners and operators were advised to check that the servo configuration was correct. At the same time, Airbus recommended that the operator upgrade the servo installation in accordance with Mod 073221 (SB AS350-67.00.41) or Mod 073178 (Banjo screws with reduced cross-section); see Figure 6.

Figure 6: Image from SB AS350-67-30-0001 showing the change in the configuration of banjo screws, where the inside diameter has been reduced to reduce sensitivity to RPC. Illustration: Airbus Helicopters / NSIA

In October 2023, Airbus Helicopters published a new service bulletin, AS350-67-30-0001, describes a modification in which the banjo screws on the main servos are replaced by screws with a smaller internal diameter. The SB which contains partly the same requirement as SB AS350-67.00.69 reduces the helicopter's sensitivity to pilot induced oscillation (PIO) or pilot assisted oscillation (PAO) during external sling load operations. Airbus Helicopters states that this can be done as a first measure, and then to subsequently, in connection with the main overhaul, upgrade the servos to the latest generation in accordance with SB AS350-67-00.41.

SBAS350-67-30-0001 was published on 26 October 2023 during this investigation. It describes replacement of the banjo screws installed in the helicopter's main servos to a new screw with a smaller cross-section to reduce the sensitivity of the helicopter's control system.

The NSIA share Airbus Helicopters recommendation to incorporate this modification.

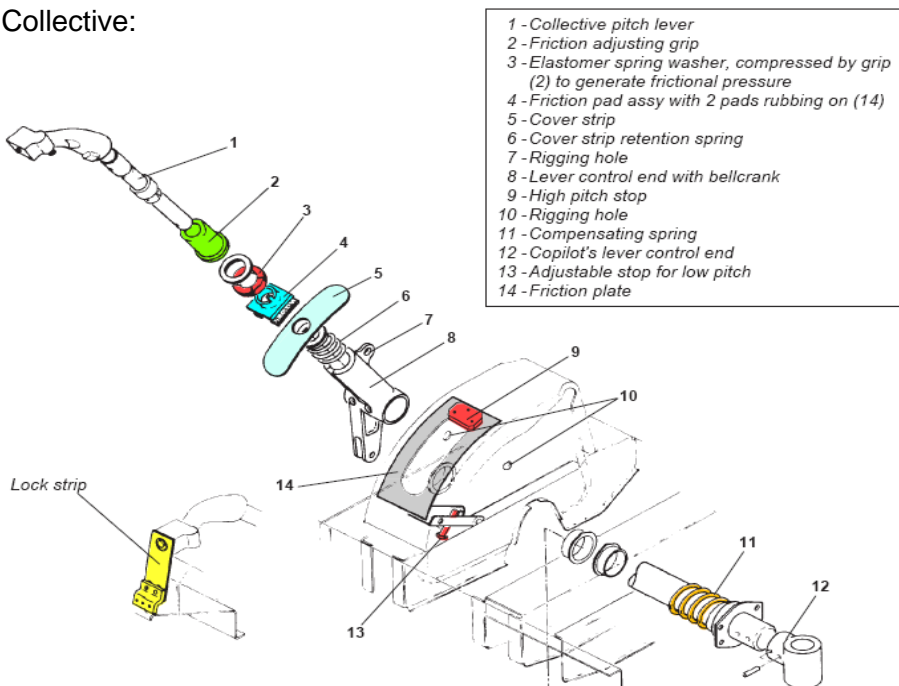
Figure 7: Overview of the collective's friction mechanism. By turning the grip (2), the pilot can adjust the friction between the collective's sliding plate (4) and the fixed sliding plate (14) in the console (cockpit). Illustration: Airbus Helicopters/NSIA

The NSIA has examined and measured the friction system. The actual value at the time of the accident was used in the measurement of friction on the collective. The friction was measured at 150 g. By turning the friction wheel a quarter of a turn, the value increased to 700 g. It was not possible to get the friction below 150 g. The friction was set to its lowest level, and no faults or defects have been detected in the system.

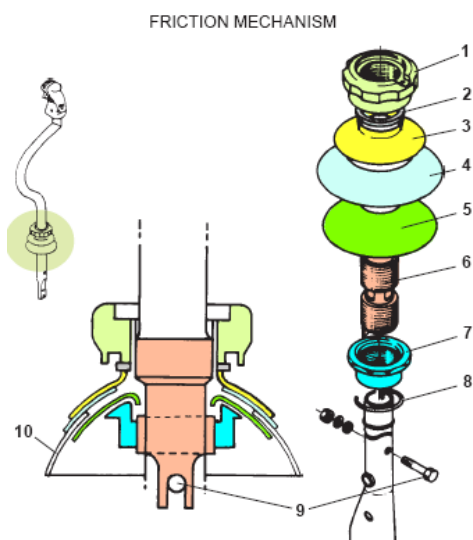
Figure 8: Overview of the cyclic's friction mechanism. The pilot can adjust the cyclic friction with the help of the light green (1) tensioning wheel mounted on the control. By turning the wheel clockwise, friction will increase steplessly between the friction cap, (3), the moving cup (5), the lower cup (4) and the stationary friction cup (10). Illustration: Airbus Helicopters/NSIA

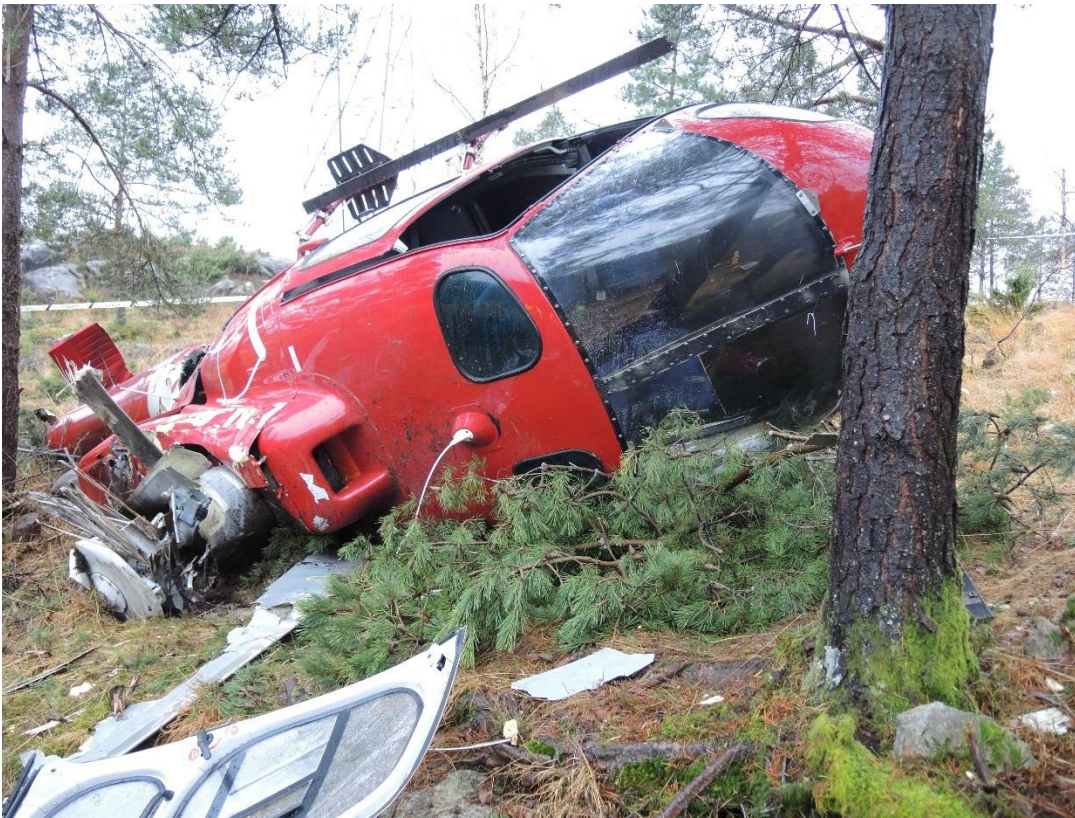
The main rotor with three rotor blades, hydraulic servos and a rotor head was destroyed after the impact with the trees and the ground. One of the rotor blades ended up coiled around the main rotor shaft; see Figure 12. The remaining rotor blades were found severely damaged near the wreckage. The helicopter's tail rotor blades were still attached to the tail rotor gearbox and had sustained various degrees of damage.

Figure 12: The helicopter wreck looking southwest. One of the rotor blades has been coiled around the rotor mast. Photo: NSIA

An inspection was carried out of the helicopter's rotor system, servos and rotor head. The Starflex rotor hub was broken at a 45-degree angle. This is a typical fracture pattern seen in situations where the rotor blade rpm is reduced abruptly, for example when hitting the ground or another hard object. The rotor head frequency adapter and liners were inspected without any faults or defects being detected. The remains of the rotor blades were inspected, but they were so severely damaged that it was not possible to identify any possible faults or defects in them. The NSIA has concluded that the rotor system was in operation and controllable at the time of the accident. In addition, the NSIA has concluded that the engine was in operation and was operating the helicopter's rotor blades when it hit the ground.

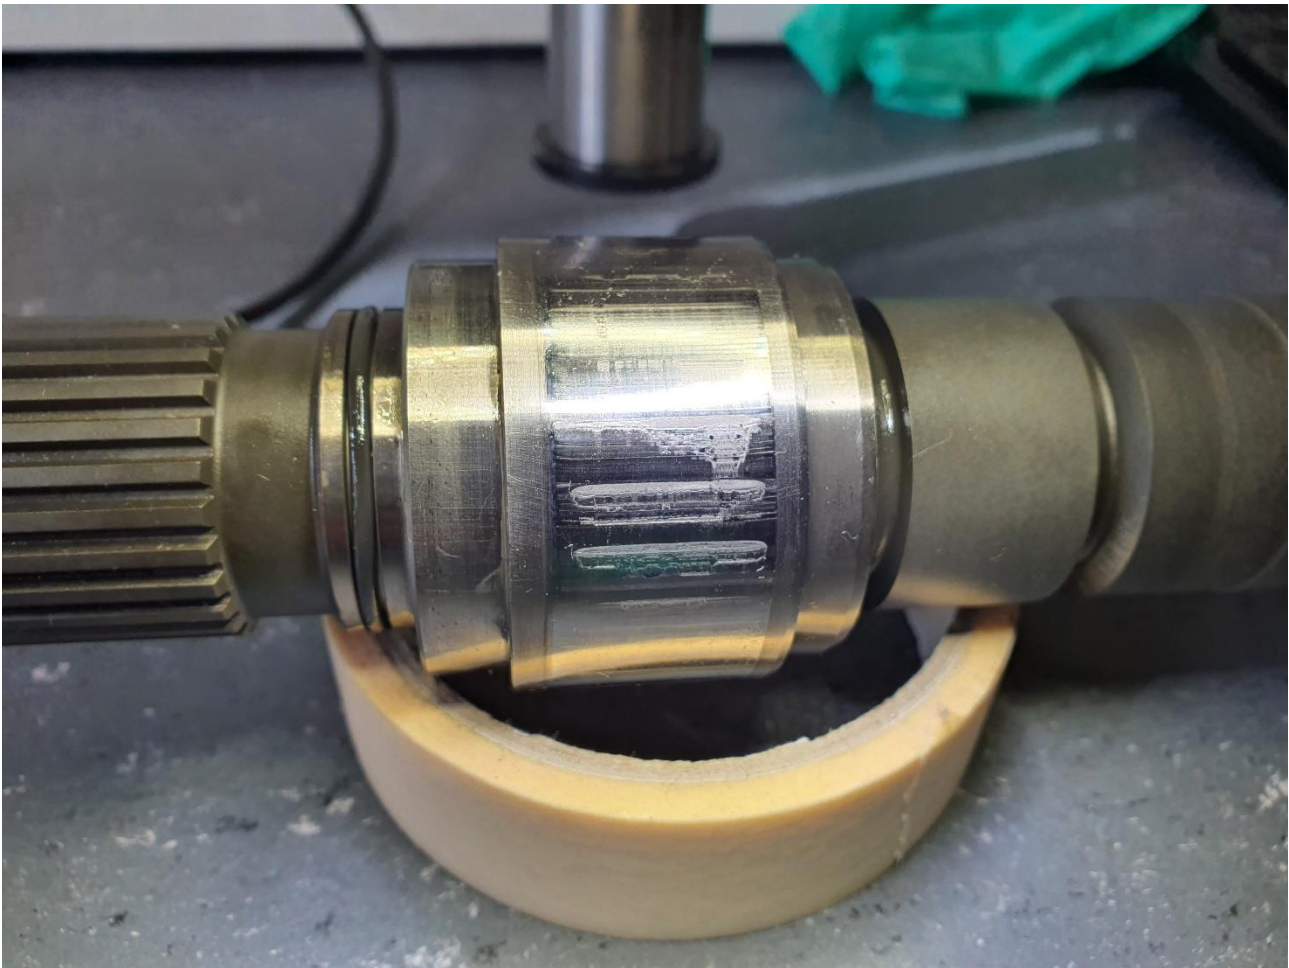
The engine control unit (DECU) and the free wheel shaft; see Figure 14, were disassembled and sent to the engine manufacturer (Safran Helicopter Engines) for inspection together with the NSIA and BEA. Data from the DECU and markson the free wheel shaft show that the engine supplied power to the main gearbox when the rotor system was slowed down as a result of the accident.

*Figure 14: Marks on the helicopter's free wheel shaft. The marks are typical of a situation where the rotor rpm is reduced at the same time as the engine supplies power to the drive shaft. Photo: NSIA*

The engine's free wheel shaft underwent inspection by the engine manufacturer Safran Helicopter Engines together with the engine's DECU. The purpose of the inspection was to determine whether an engine failure could have caused or contributed to the accident. The inspection of the free wheel shaft found clear marks indicating that the engine was running normally when the accident occurred. The analysis of information downloaded from the DECU indicated the same. The NSIA has thus concluded that the engine functioned normally at the time of the accident.

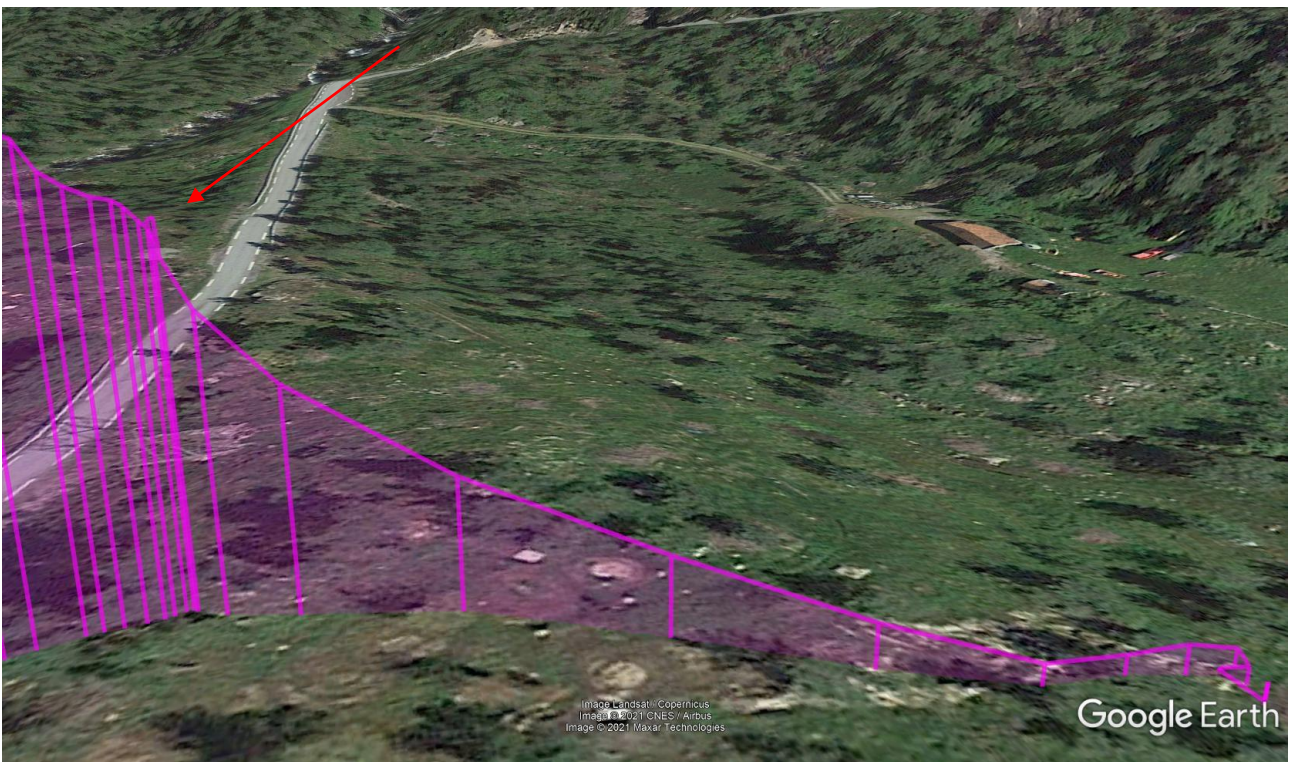
Figure 16: The illustration shows the last movements and crash site of the helicopter. The red arrow indicates a vertical movement just above pylon foundation 49. Each vertical reference line represents one second. The last four seconds of recording is judged as not reliable. Source: Air Navigation Pro / Google Earth / NSIA

The approach above the pylon foundation appears normal, and electronic data from the helicopter's EFB, combined with statements from the pilot and ground personnel, indicate that an altitude correction was made above the pylon foundation. In this correction, the ground personnel observed that the bucket came into contact with the formwork. Shortly after the correction was made, the helicopter started developing strong vertical movements. The pilot's statement, in which he described how the helicopter started 'jumping', corresponds well with the occurrence of oscillations and RPC.
