REPORT AVIATION 2025/03

Serious aviation incident at Skjetten in Akershus County, Norway on 20 January 2024 involving an Aquila AT01, LN-NRC

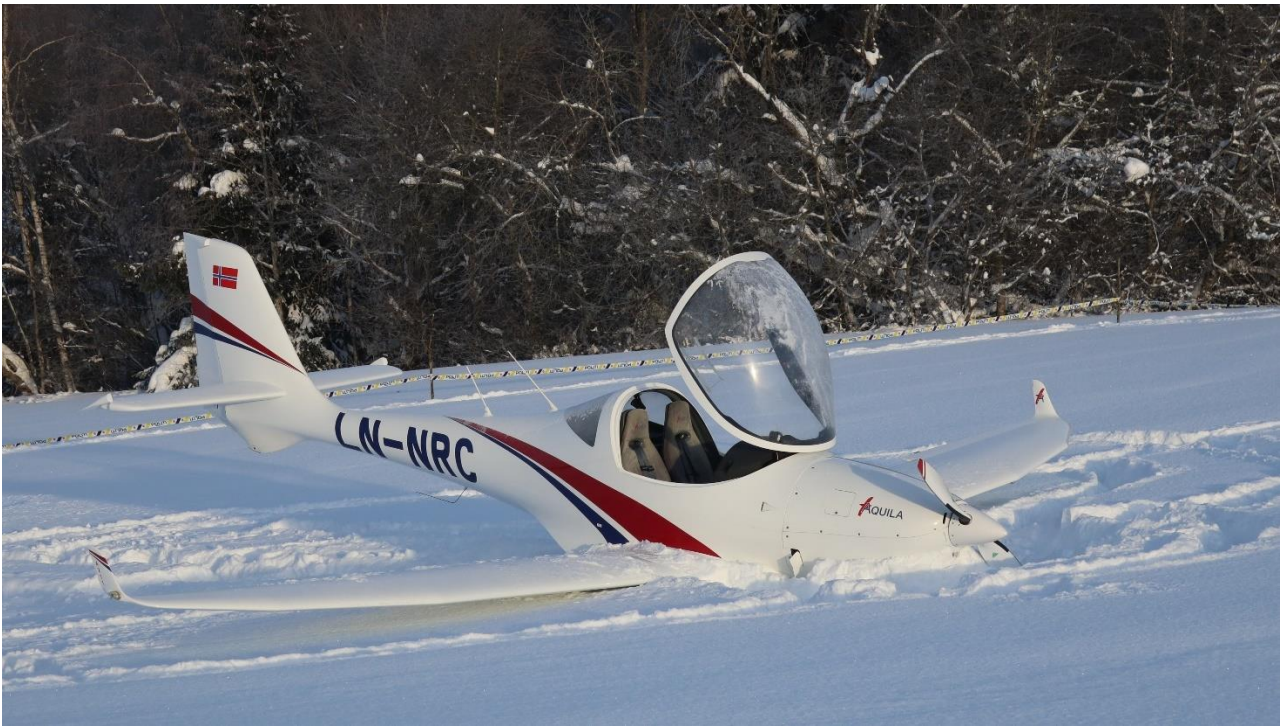
Figure 2: LN-NRC after the emergency landing in the field. Photo: NSIA

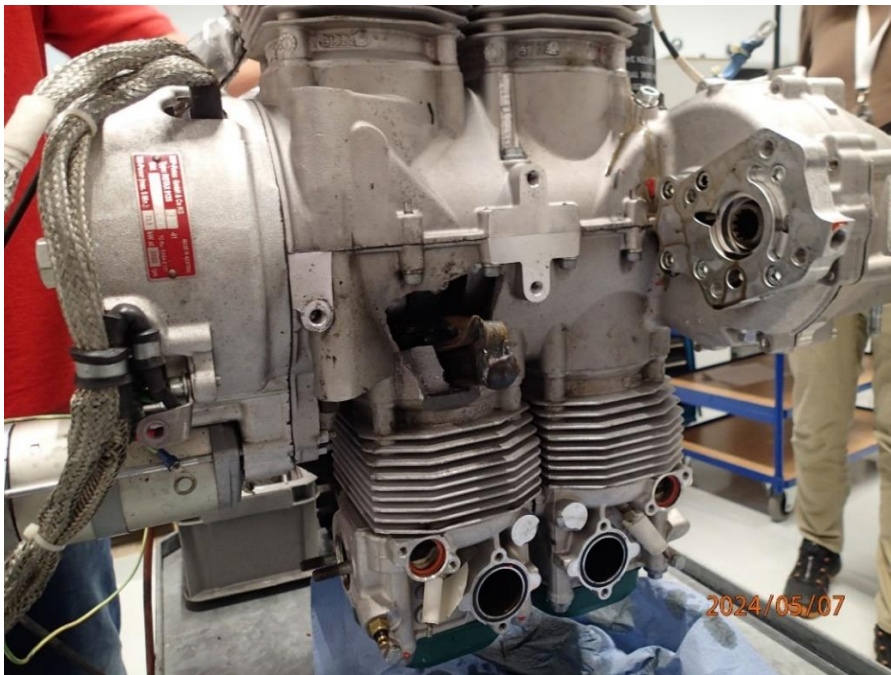
connecting rod #3 had punched its way through the crankcase, see Figure 3. Further disassembly showed that both big end bearings of connecting rod #2 and #3 had failed with clear indications of heat damage, see Figure 4 and Figure 5.

Figure 3: The connecting rod of cylinder number three which has punched through the crankcase. Photo: Rotax/NSIA

The engine inspection quickly established that two connecting rod big end bearings had sustained considerable damage. Both bearings had split due to the damage and connecting rod number three had punched through the crankcase. This meant the engine suddenly seized. The NSIA and the engine manufacturer Rotax agree that the damage was caused by a lack of oil lubrication.

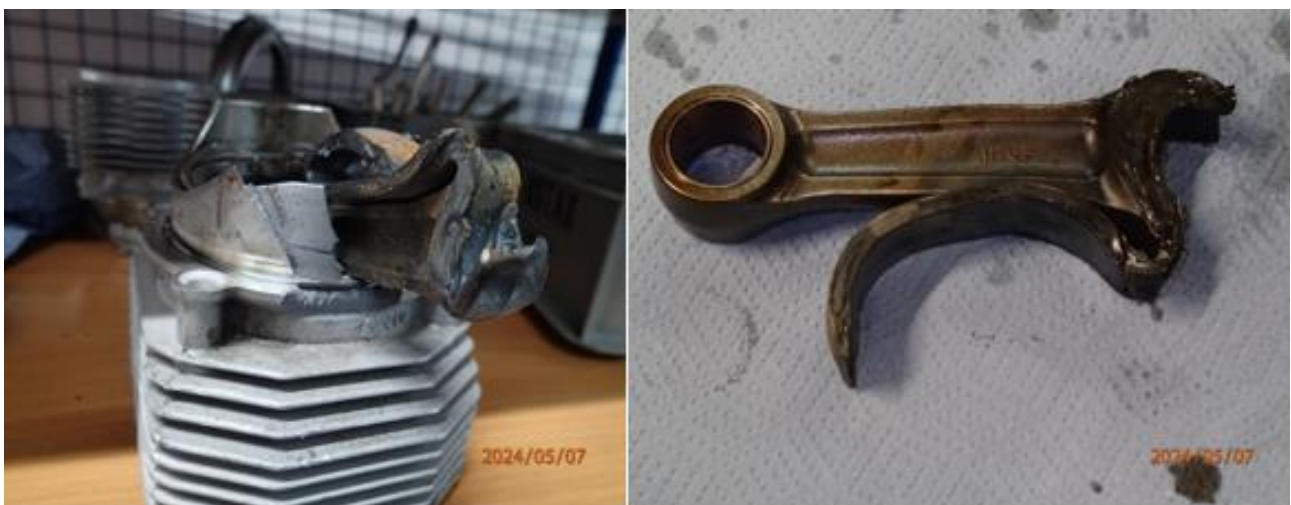
Figure 4: Connecting rod number three and two which had failed. Photo: Rotax/NSIA

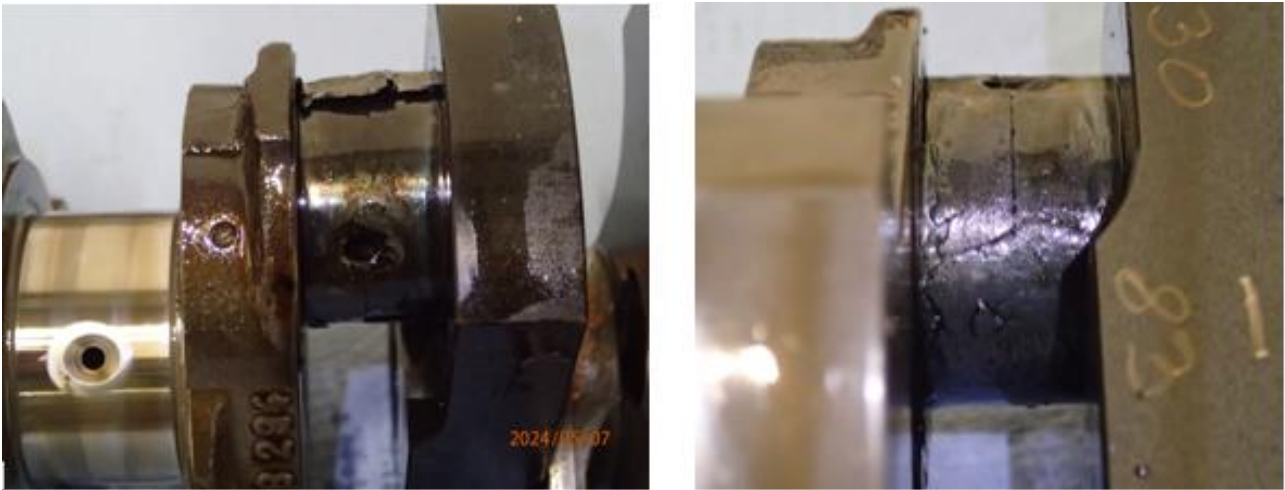
Figure 5: Close-up of connecting rod big end bearing three and two with clear signs of heat damage. Photo: Rotax/NSIA

The NSIA believes this was caused by the oil cooler being filled with very cold oil. After engine start and running at idle, warmer oil would start to circulate as shown in Figure 13. Heated oil would circulate through the oil lines, the upper part of the oil cooler and the oil pump housing, where the oil temperature and oil pressure sensor is found. The oil pressure could then be within expected values and the oil temperature above minimum for take-off. Since the oil pump is driven directly by the camshaft, the rotation speed would increase significantly when the engine power increases during take-off. The oil pump then needs to suck a substantially larger volume of oil from the oil tank and through the cold oil cooler. The NSIA considers it likely that this caused low enough pressure to cause cavitation and air bubbles in the oil pump. This would significantly decrease the oil pump's ability to deliver the correct oil pressure. The lubrication requirements are great during maximum power output from the engine, and the initial reduction in RPM that the pilot noticed was most likely caused by a developing bearing failure.

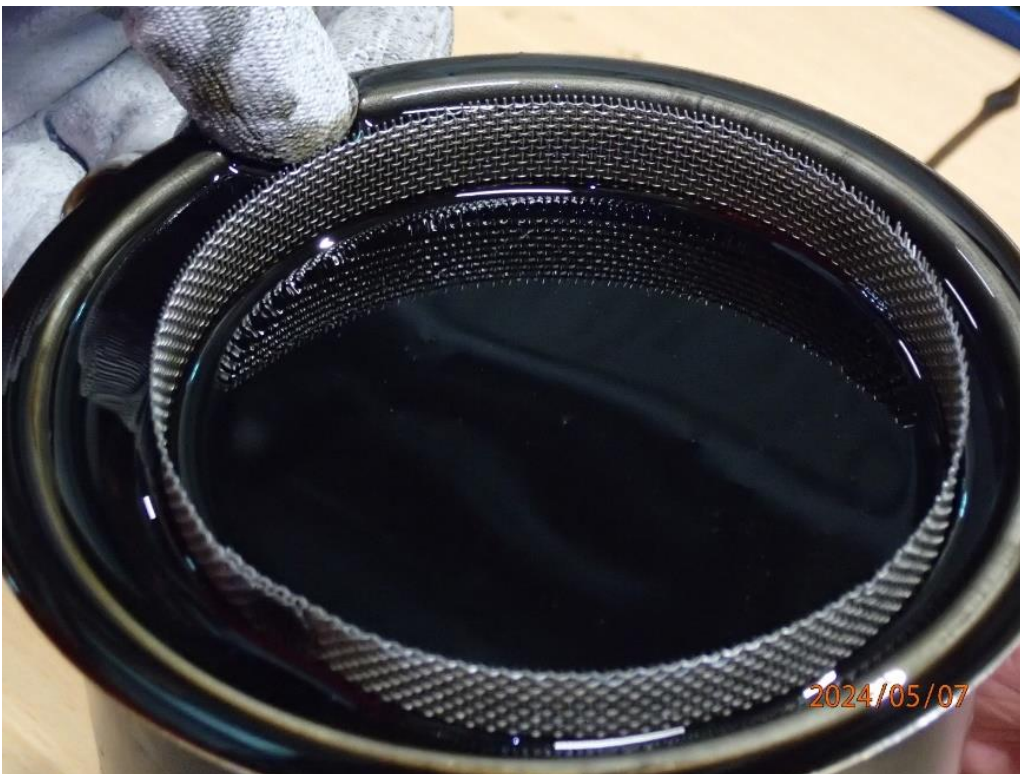
The engine oil pump and oil filter were inspected. There were no particles in the oil filter and the oil pump did not show any signs of failure or damage. There was less oil in the crankcase than expected, but no clear signs of oil leakage. Inspection of the oil tank showed that it was completely full, holding around 3 litres of oil, see Figure 6. The engine should have held between 2.55 and 3 litres of oil. No internal blockages were found in the oil line between the oil tank and the oil cooler or the line from the oil cooler to the oil pump. Nor were any internal blockages found in the oil cooler.

Figure 6: The oil tank was found to be completely full. Photo: Rotax/NSIA

No faults were found with the lubrication system during the inspection. The amount of oil found in the oil tank equals the maximum normal capacity. The fact that the oil tank was full indicates that the oil has not circulated as expected and that the issue lies between the oil tank and the oil pump, ref. Figure 7. The NSIA considers it likely that a combination of the oil system design and the engine pre-heating system gave rise to a situation where the engine received enough oil on idle and during run-up, but not enough oil when the engine was running at a high RPM for the maximum power setting during take-off.

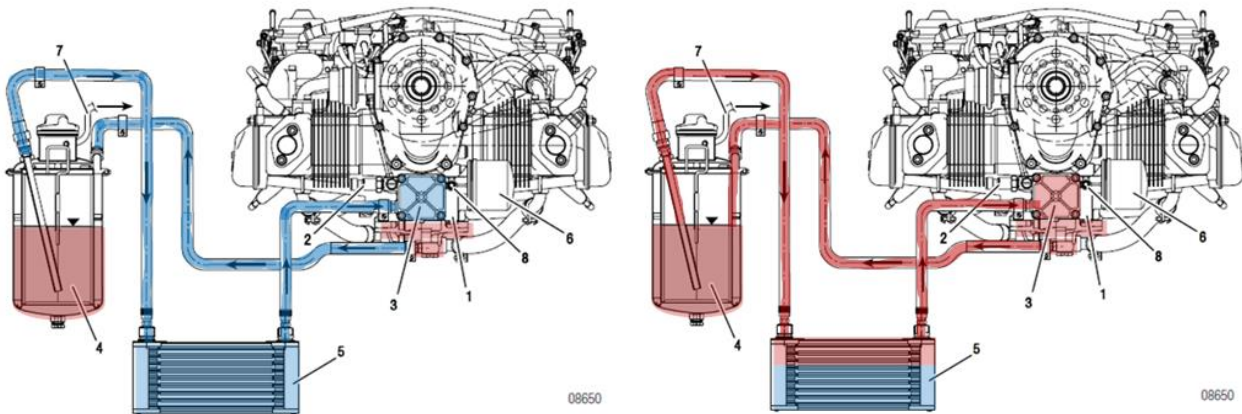
Figure 12: Situation before engine start. Blue is cold oil; red is warm oil. Illustration: Rotax/NSIA

Figure 13: Possible situation after engine start. Blue is cold oil; red is warm oil. Illustration: Rotax/NSIA
