# REPORT AVIATION 2025/05

***Aviation incident 120 NM southwest of Stavanger Airport Sola, Norway, on 20 October 2020 involving Sikorsky S-92A, LN-OMI, operated by Bristow Norway AS***

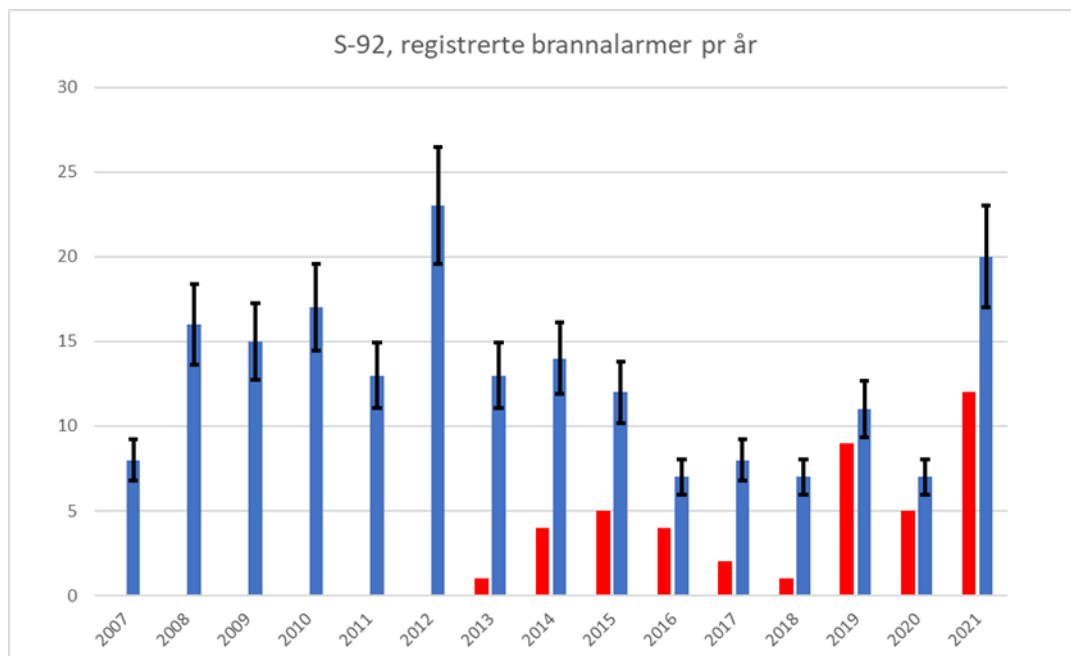
The system installed in the S-92 has led to several false warnings. The NSIA has been sent an overview of the number of fire warnings for the helicopter type registered in CAA-N's national

database, and the number of warnings that have been registered by Bristow; see Figure 4. CAA-N's figures include both operators of S-92s in Norway in the period 2007 to 2021. The database was searched for reports concerning a S-92 containing at least one of the following words: *fire*, *brann*, *false* or *alarm* ('brann' is the Norwegian word for fire). CAA-N states that there could be up to 15 per cent uncertainty associated with the figures, since the search has not been reviewed in detail.

Figure 4: False fire warnings on S-92 helicopters registered by CAA-N (blue bars) and Bristow (red bars), respectively. CAA-N's figures are also marked with up to 15 per cent uncertainty (black bars). Source: CAA-N and Bristow and the NSIA

The LN-OMI modification status was according to these ASBs. Despite this, the operator still recorded several incidents of false warnings. The incident covered in this report is the first that Bristow has registered where the warning remained continuously on.

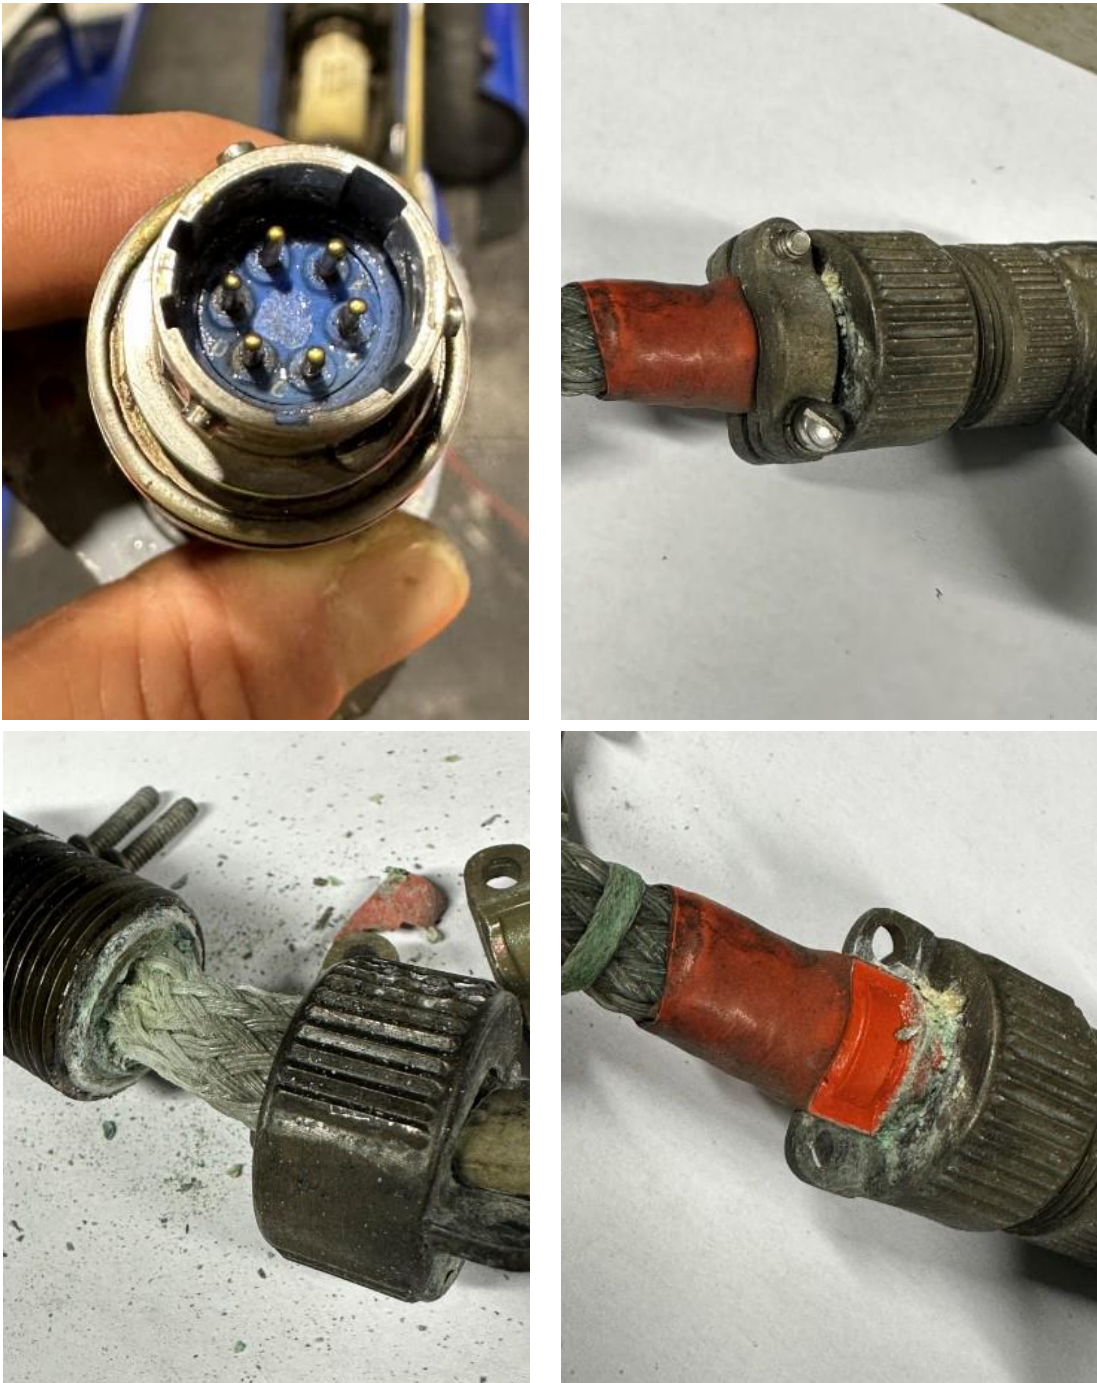
After the incident, Bristow Norway has examined electrical connectors in the fire warning system in the company's helicopter fleet and identified some corrosion. The operator believes that the number of false warnings has decreased on helicopters where the parts affected by corrosion have been replaced. Examples of corroded parts are shown below in figure 5.

Figure 5: Examples of corrosion found on connectors in the S-92's fire warning system at Bristow's facilities. Photo: Bristow Norway/NSIA

Based on the finding of corrosion by the operator on their other S-92 helicopters, it is possible that the false warning during this accident flight was caused by corrosion or other damage to the fire detectors and its wiring. However, this could not be confirmed as the fire detectors in question were never examined and tested. Generally, corrosion can be an issue on aircraft flying in the vicinity of salt water.
