Defence 2021/02

*REPORT ON SERIOUS AVIATION  
INCIDENT ON 11 MARCH 2020  
INVOLVING A C-130J SUPER HERCULES  
MILITARY TRANSPORT AIRCRAFT  
AT MOSKEN, A ROCKY ISLAND IN  
VÆRØY MUNICIPALITY IN NORDLAND  
COUNTY*

**REPORT ON SERIOUS AVIATION INCIDENT**

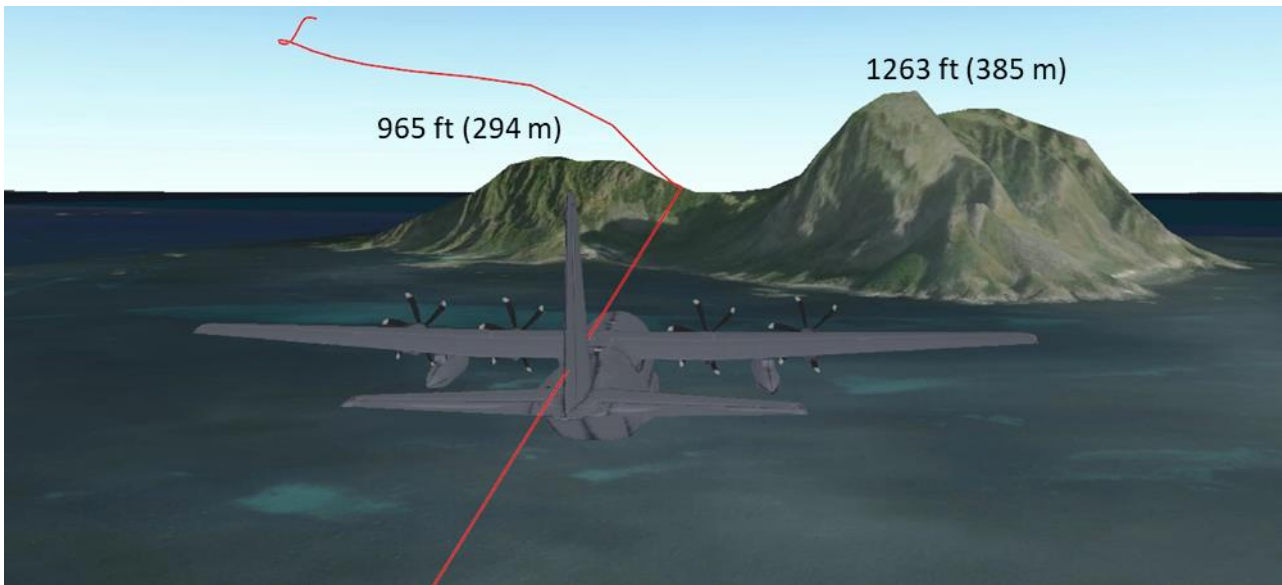
Figure 2: The aircraft cleared the terrain by 144 ft (44 metres). Source: RNoAF

At 20:26:19, 14 seconds after the obstacle was detected, MG31 passed the northern part of Mosken with a clearance of 144 ft (44 m). It then continued to climb to the altitude of 5,000 ft for which clearance had been granted. Figure 8 shows MG 31 shortly before the near collision with Mosken and the aircraft's subsequent manoeuvres.

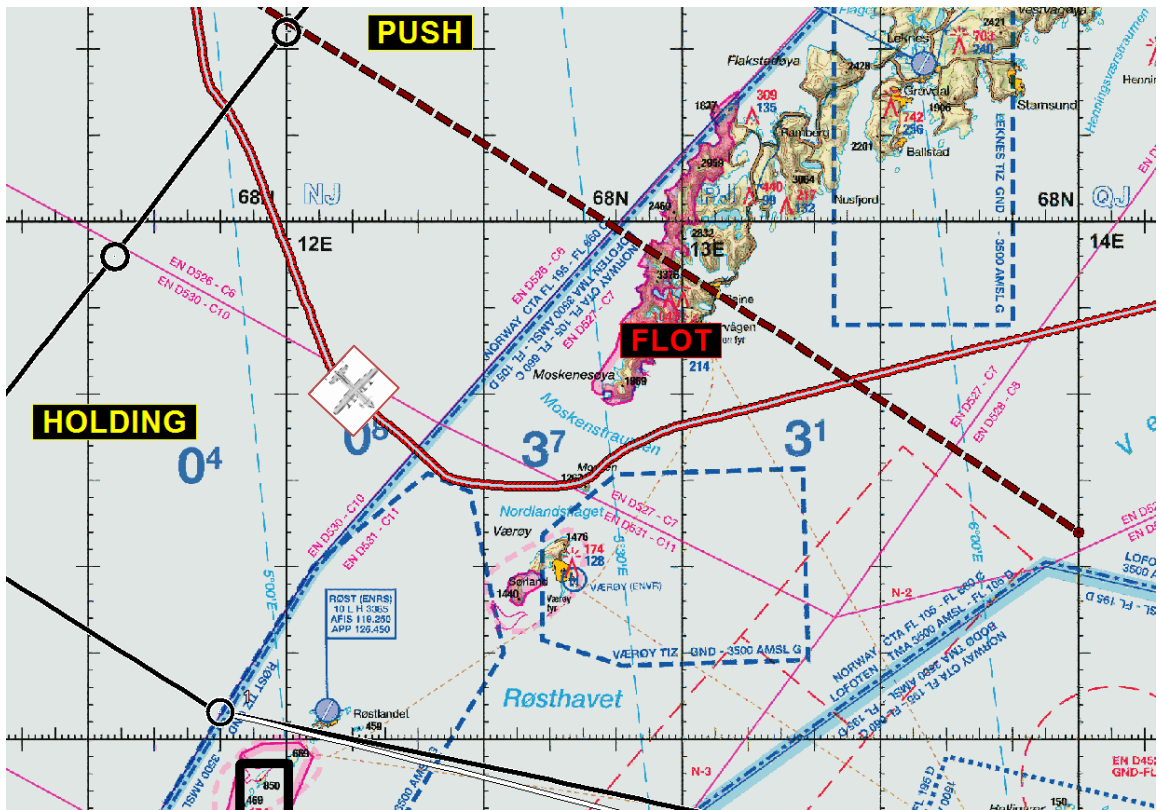
At 20:21 the formation received clearance to leave the exercise area and fly VFR at 500 ft back to Bodø. The formation continued its flight in accordance with the clearance. PF MG31 has stated that they navigated to stay clear of the Røst Traffic Information Zone (TIZ) and eventually ended up on a more easterly course towards Mosken. Figure 7 shows the route taken by the formation when leaving the exercise area and MG31’s exact position at 20:21.

Figure 7: The formation’s route when leaving the exercise area (illustrated by a red double line). The black line shows the route followed when entering the exercise area. The aircraft symbol marks MG31’s exact position at 20:21. Source: RNoAF

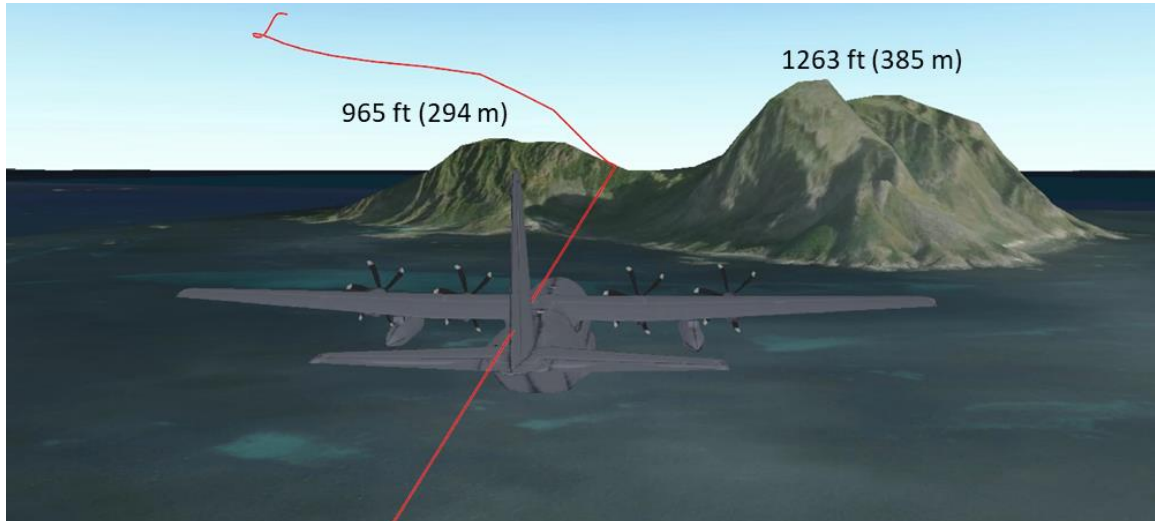
The aircraft flew about 500 ft above ground level (AGL) at a speed of 200 knots. At 20:26:02, PF MG31 banked the aircraft to the left; three seconds later he visually observed the terrain ahead through the NVG and immediately initiated an evasive manoeuvre to avoid impact with the terrain.

Figure 8: MG31 shortly before the near collision with Mosken. Source: RNoAF

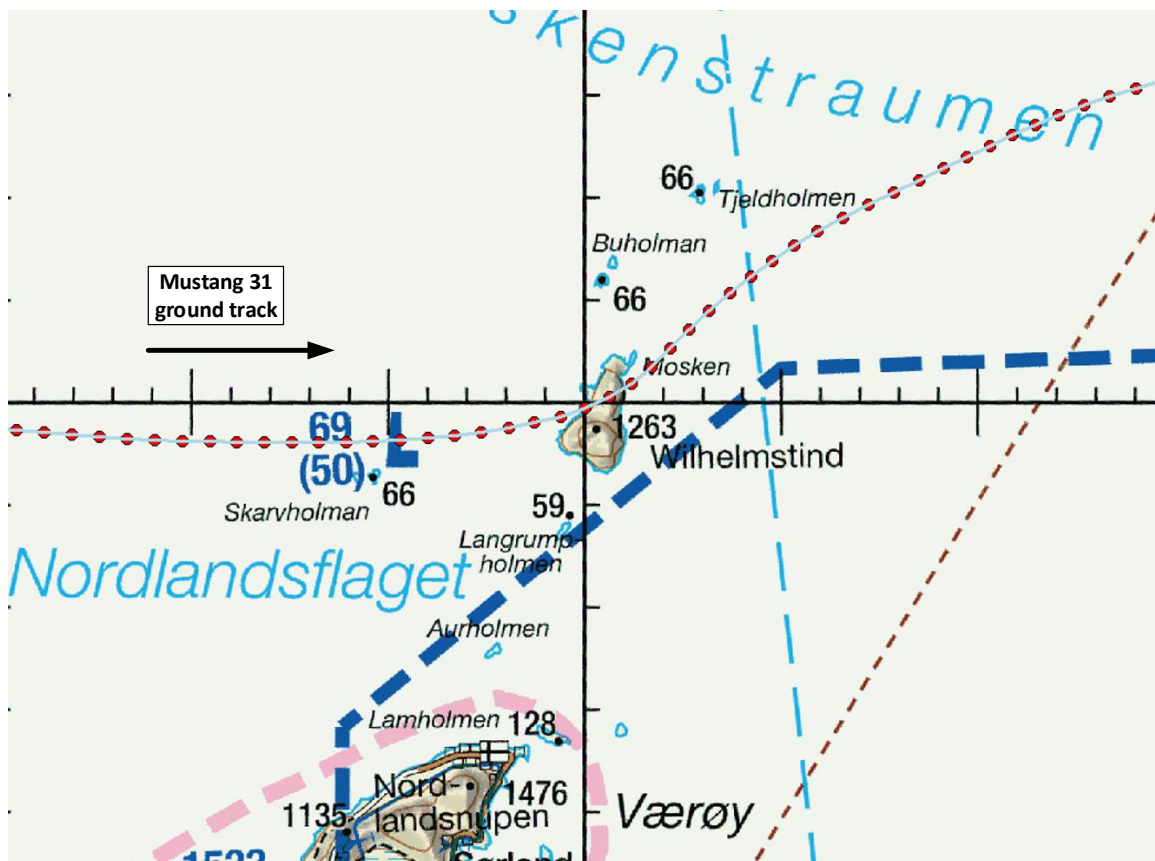
PF MG31 has stated that he observed several small islands and skerries before spotting the terrain that was in fact Mosken directly ahead of the aircraft. According to PF MG31, the aircraft entered the cloud cover (IMC) immediately after it started to climb. PF MG31 was the only person who visually saw Mosken. Figure 9 shows MG31's ground track on passing Mosken.

Figure 9: MG31's ground track on passing Mosken. Source: RNoAF

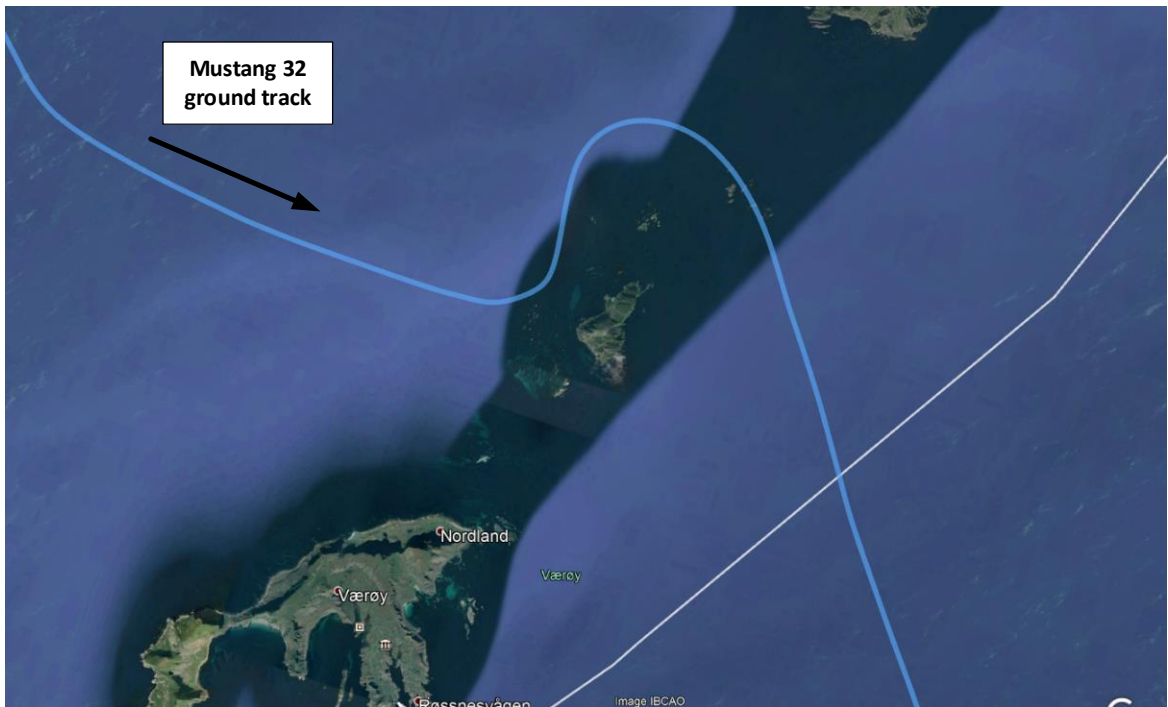
MG32's closest proximity to Mosken in connection with the avoidance manoeuvre was approximately 1,500 m. After maintaining a northerly course for about 10 seconds, the aircraft was turned to the right and set course for Bodø. In connection with this latter turn, the lowest height was only 374 ft AGL. Figure 10 shows MG32's ground track around Mosken. Figure 11 is a photo of Mosken looking north from the island of Værøy.

Figure 10: MG32's ground track around Mosken. Source: FDR/RNoAF

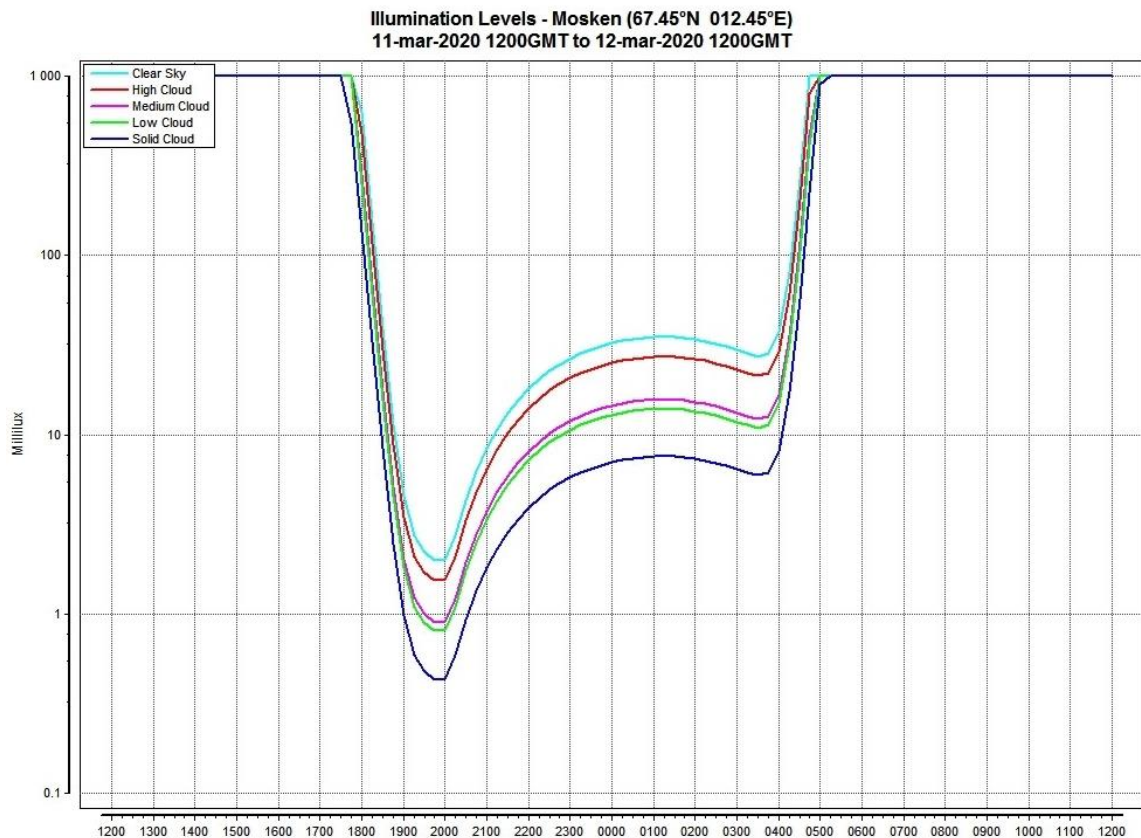
The table in Figure 5 shows that the expected illumination levels during the flight period, in light of the weather forecast (medium/low cloud at 19–20 GMT), was below the minimum regulatory requirement of 2.2 millilux (see Section 1.18.4.2). Throughout the planning and authorisation of the mission, the attitude prevailed that the expected luminous intensity values were not absolute. The mission was therefore authorised based on a 'wait and see' approach. This entailed that the aircrews were to assess en route whether the light conditions permitted them to complete the mission, even if the minimum requirements for luminous intensity were not met as a result of low cloud cover.

Figure 18: Illumination levels at Mosken during the relevant period. The incident occurred at 19:26 GMT. Source: The Norwegian Meteorological Institute
