# REPORT

Sjø 2010/04

THE JOINT ACCIDENT INVESTIGATION BOARD NORWAY &  
BAHAMAS MARITIME AUTHORITY MARINE ACCIDENT REPORT

CRETE CEMENT - IMO NO. 9037161, GROUNDING  
AT ASPOND ISLAND IN THE OSLO FJORD,  
NORWAY, ON 19 NOVEMBER 2008

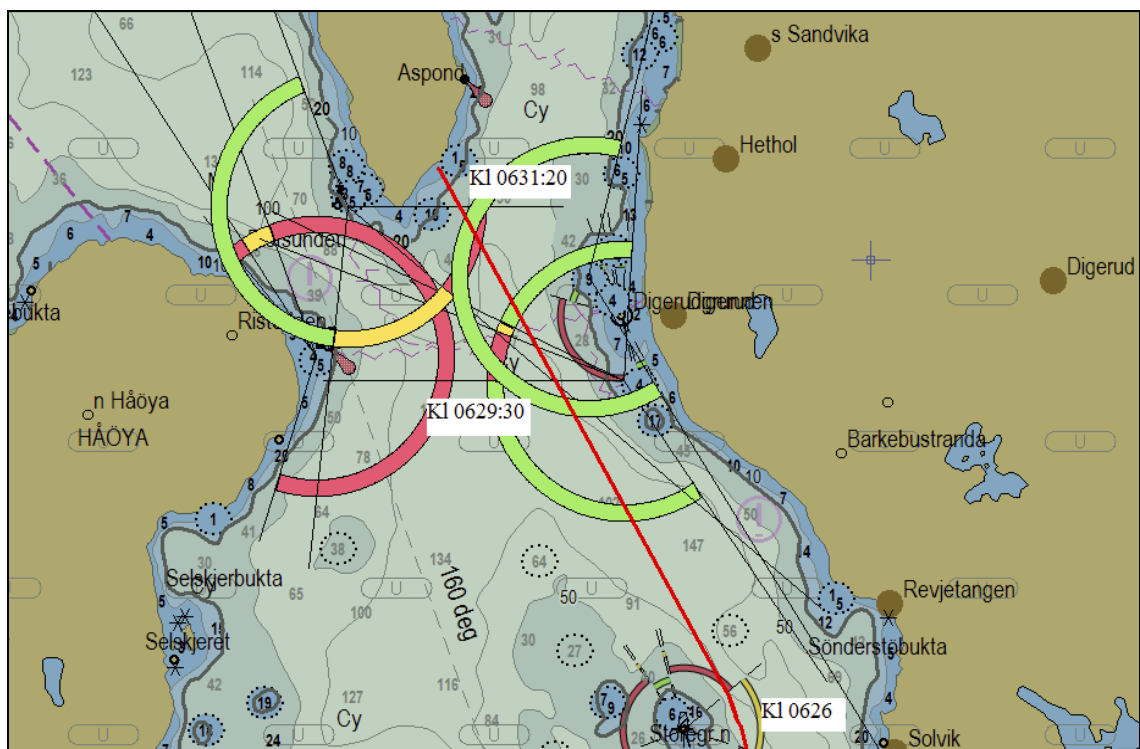
Figure 1: Crete Cement's voyage during the last few minutes before it ran aground.

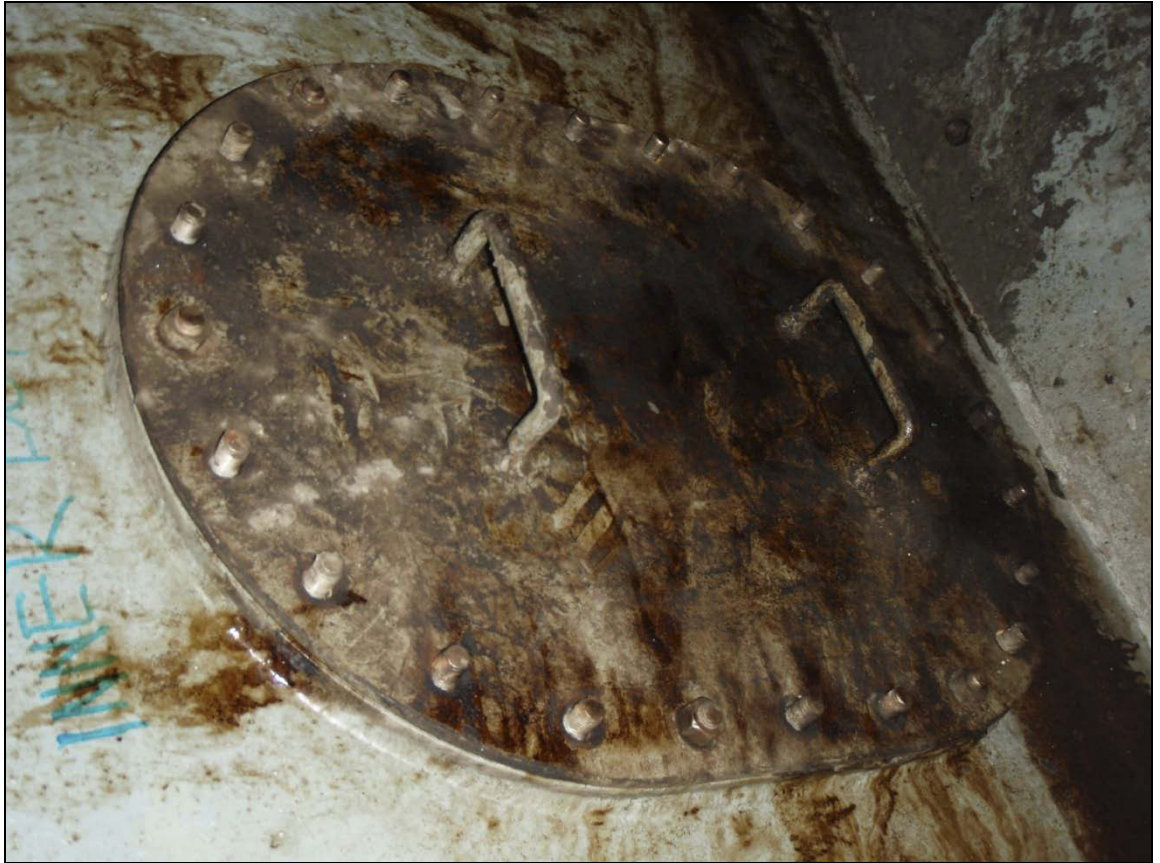
- 1.6.3 The design of the *Crete Cement* incorporates a pipe trunk alongships from the bow-thruster room to the engine room. The middle part of this pipe trunk is located under the blow tank tunnel. Inside the pipe trunk, which is approximately one

*Figure 4: Manhole cover from the blow-tank tunnel towards the void below the cargo hold.*

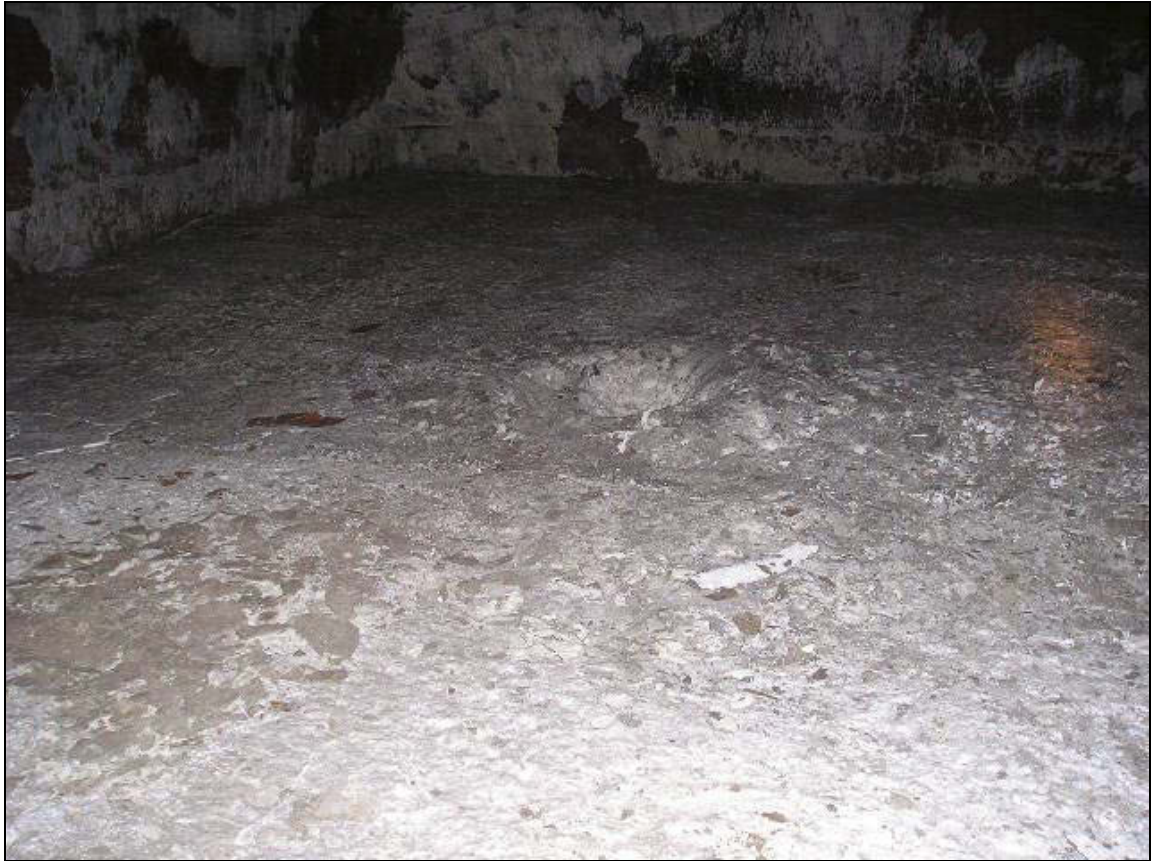
- 1.6.6 Water flowed into cargo holds 2 and 3, both starboard and port. The water probably flowed in through access hatches from the trunk deck (over the main deck) and the main deck after these decks were submerged. Water may also have entered through the discharging pipes, but this is less likely. In that case, water would most likely also enter cargo hold 1.

Figure 5: From cargo hold 3 after the water was pumped out and the cement had set. (Photo: DNV)

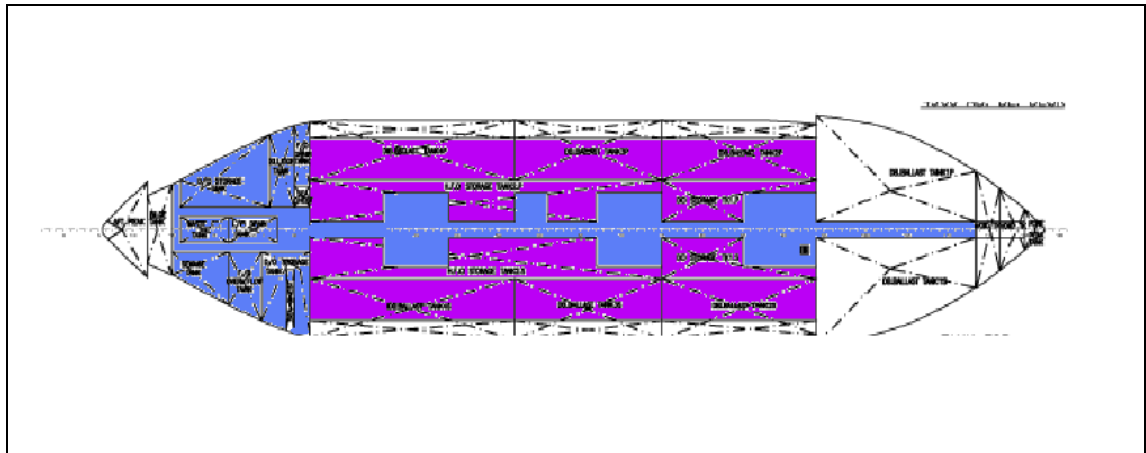
Figure 7: Flooding of vessel after running aground (scenario 2a).

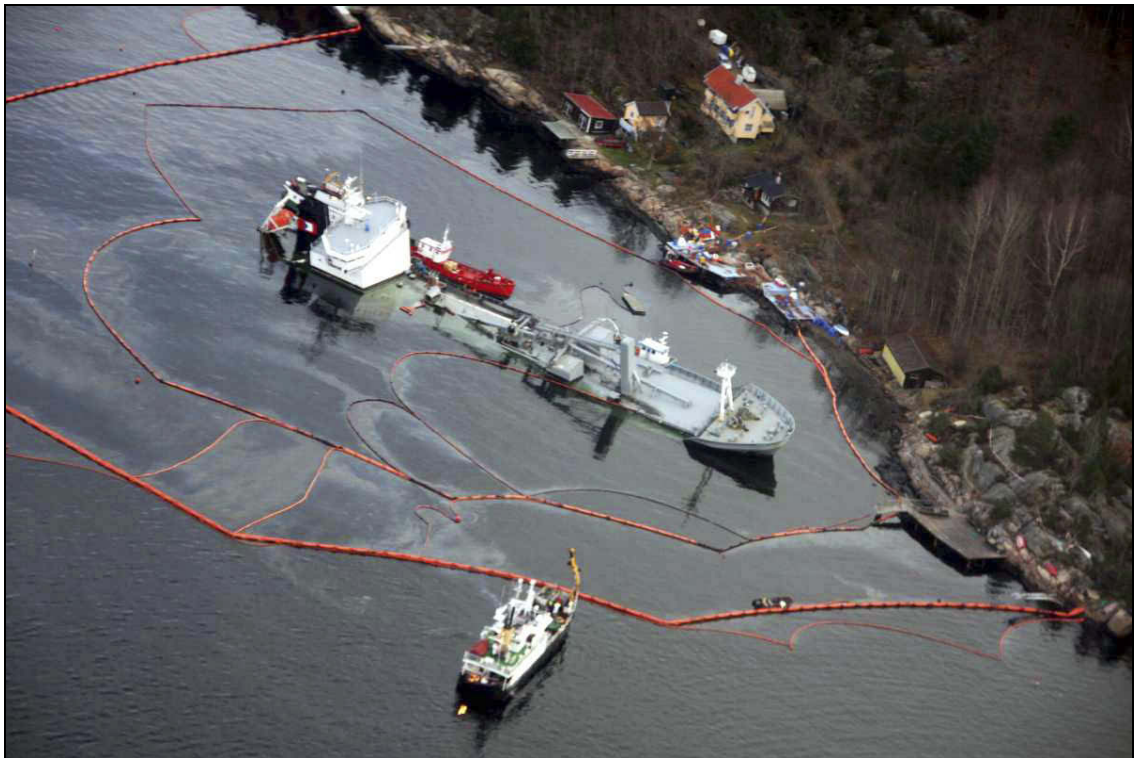
Figure 8: The *Crete Cement* during the oil-spill response action. (Photo: the Norwegian Coastal Administration).

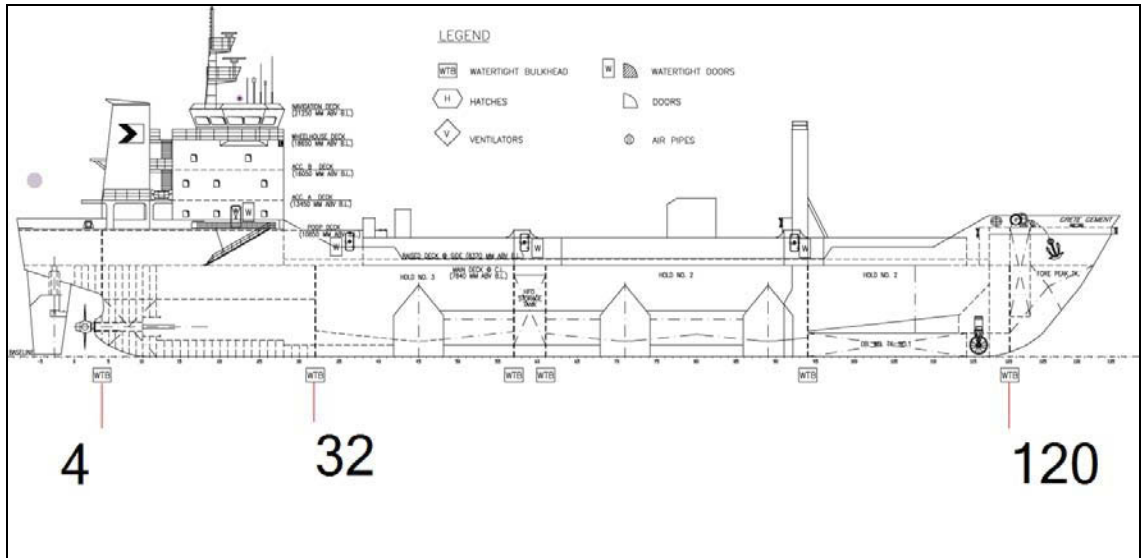
Figure 9: Watertight compartments by virtue of the positioning of the mandatory watertight bulkheads.

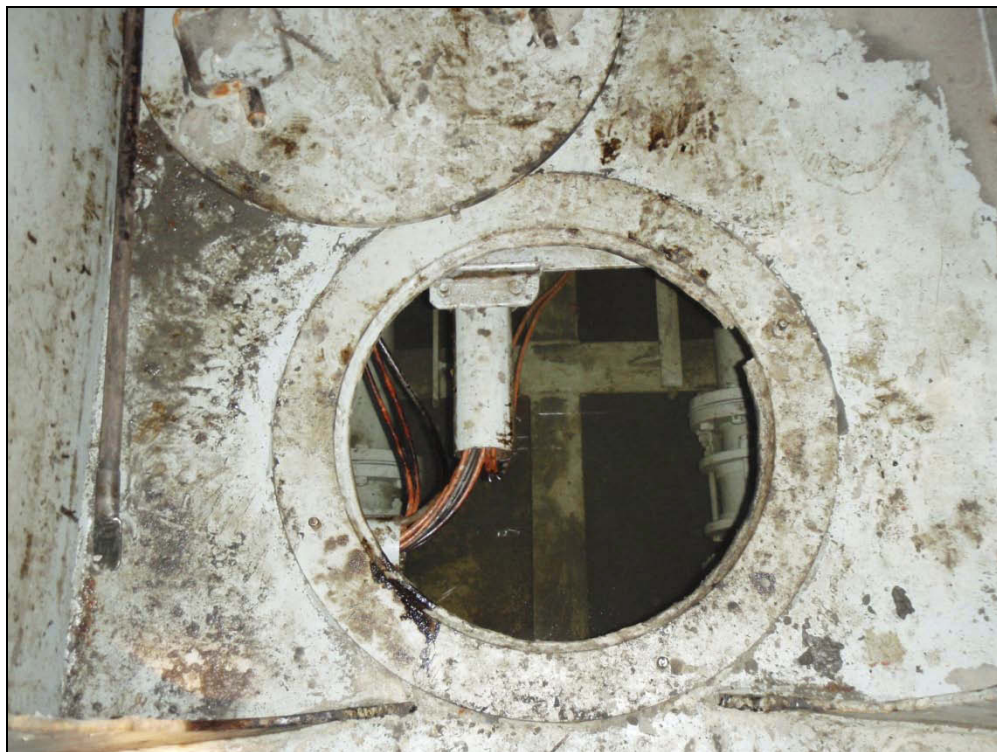
1.10.2.3 When the *Crete Cement* was converted to a cement carrier, a blow-tank tunnel was constructed that contains three blow tanks. There is no watertight barrier between the blow-tank tunnel and the pipe trunk that runs from the bow-thruster room to the engine room.

Figure 10: Connection between the blow-tank tunnel and the pipe trunk.

1.10.2.5 Because it is not possible to close the hatches shown in figure 10 so that they are watertight, any water ingress into the bow-thruster room will lead to flooding of the spaces shown in figures 12 and 13, provided that all watertight sections are intact.

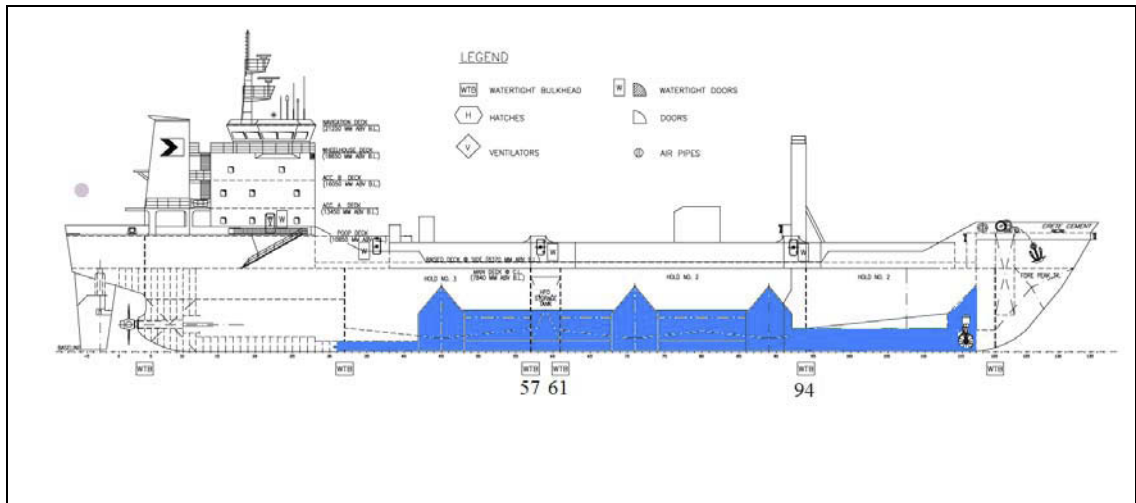
Figure 12: Flooded spaces following water ingress into the bow-thruster room, provided that all watertight sections are intact.

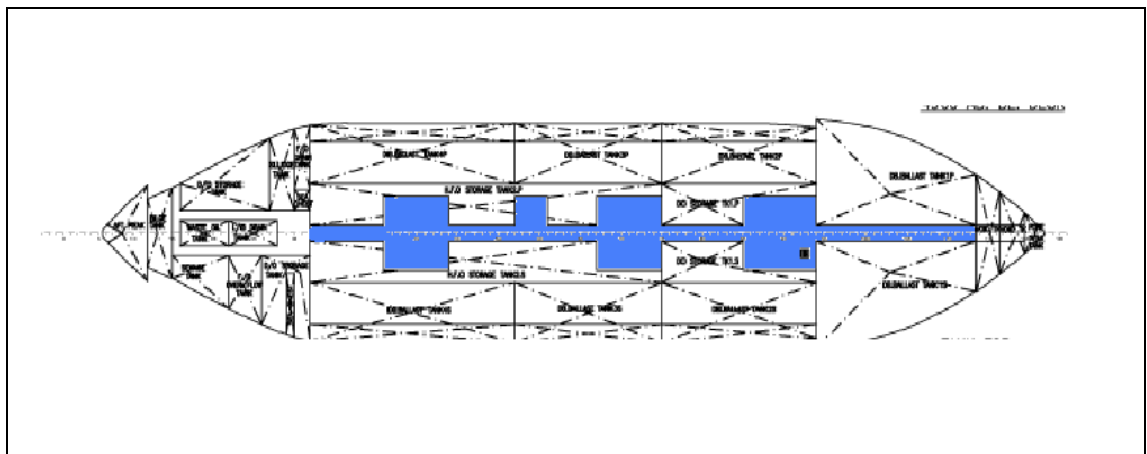
Figure 13: Flooded spaces following water ingress into the bow-thruster room, provided that all watertight sections are intact. Viewed from above, the aft is to the left.

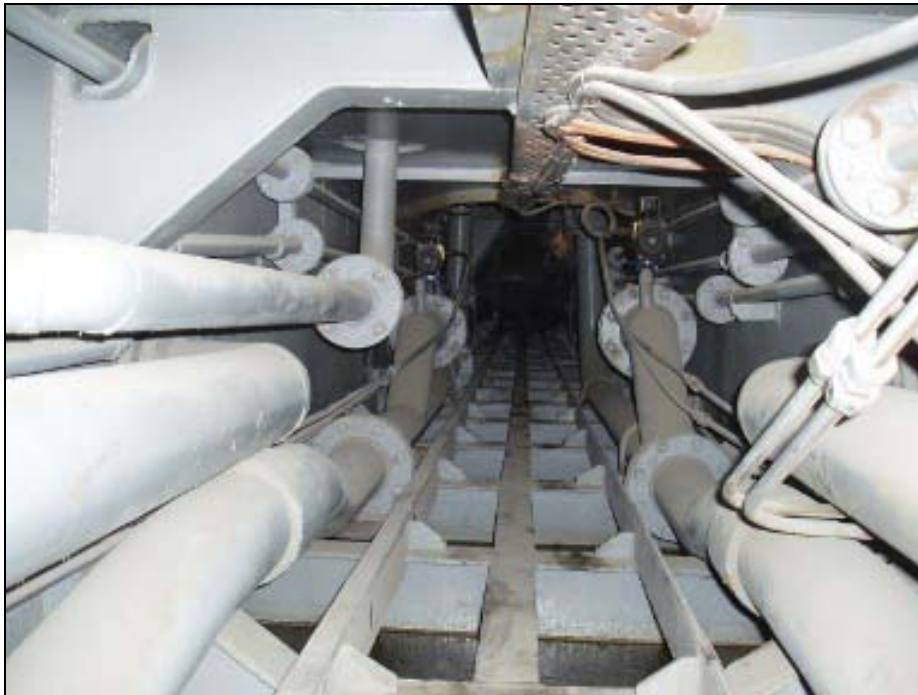
Figure 14: Photo of the pipe trunk.

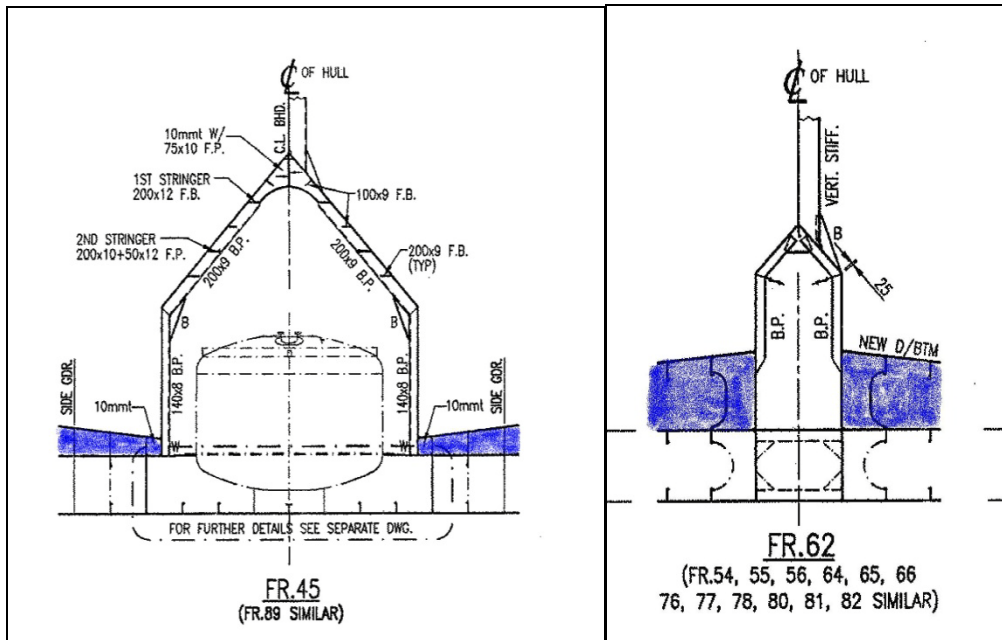
Figure 15: Cross section of blow-tank tunnel by the blow tank (frame 45) and between the blow tanks (frame 62). Voids are marked in blue.

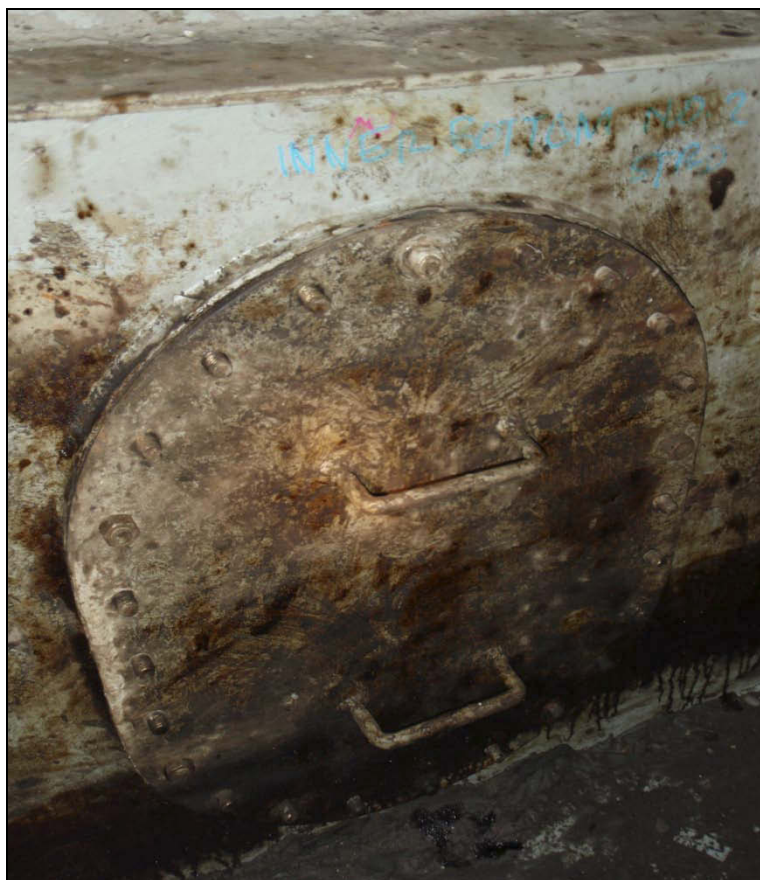
1.10.2.9 From the blow-tank tunnel, the voids below the cargo holds can be accessed via manholes. The manhole covers have 24 fixing bolts. The manhole covers are watertight if correctly installed. Figure 16 shows one of these manhole covers.

Figure 16: Manhole cover for access to void.

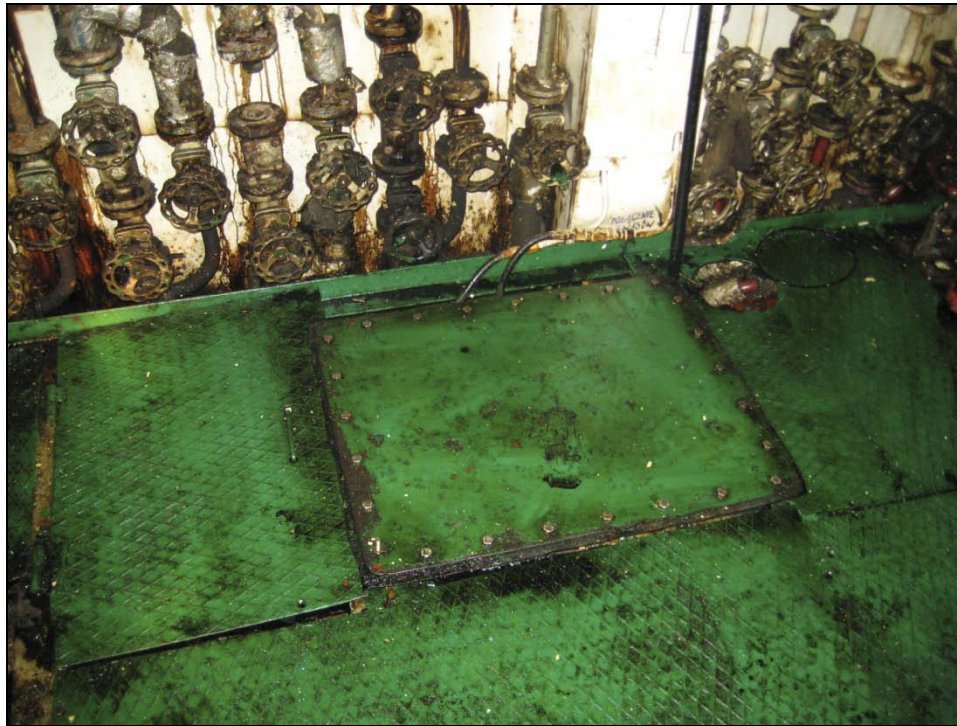
- 1.10.2.10 The pipe trunk has also been extended through the engine room bulkhead and ends in an almost square manhole cover inside the engine room.

Figure 17: Manhole cover in engine room for access to the pipe trunk.

This manhole cover arrangement also has 24 fixing bolts, and it is used for access to the aft part of the pipe trunk. This is required in connection with maintenance and controls of the bilge and ballast equipment. According to the crew, they may want to get into the tunnel an average of three or four times a week, often at short intervals. This is why the cover was not fastened with all the bolts; it was often fitted loosely with just two or three bolts.

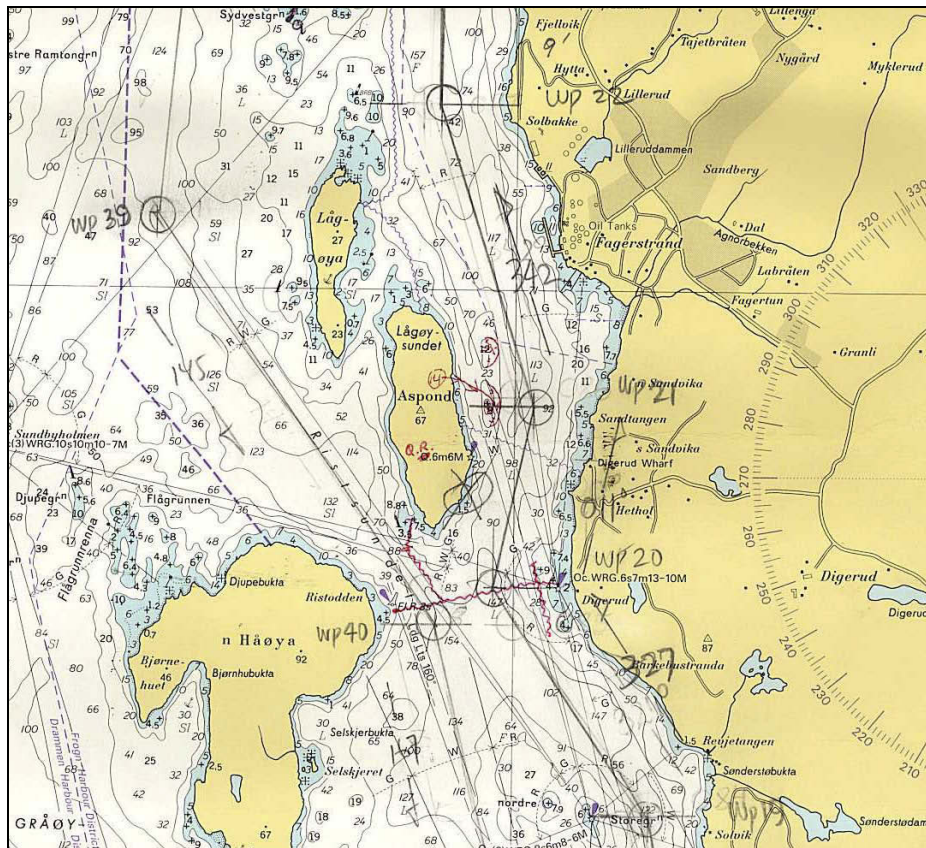
- 1.12.1.1 The *Crete Cement* used nautical charts from the British Admiralty (BA) as official navigation charts. The vessel's official BA chart over the relevant area had been updated with the most recent corrections. Corrections to BA charts do not include temporary ('T') or provisional ('P') corrections in Norwegian waters. The lighthouse modifications at Digerud were therefore not reflected on the vessel's official charts.

Figure 18: Detail from the Crete Cement's chart BA 3563. (not to scale.)

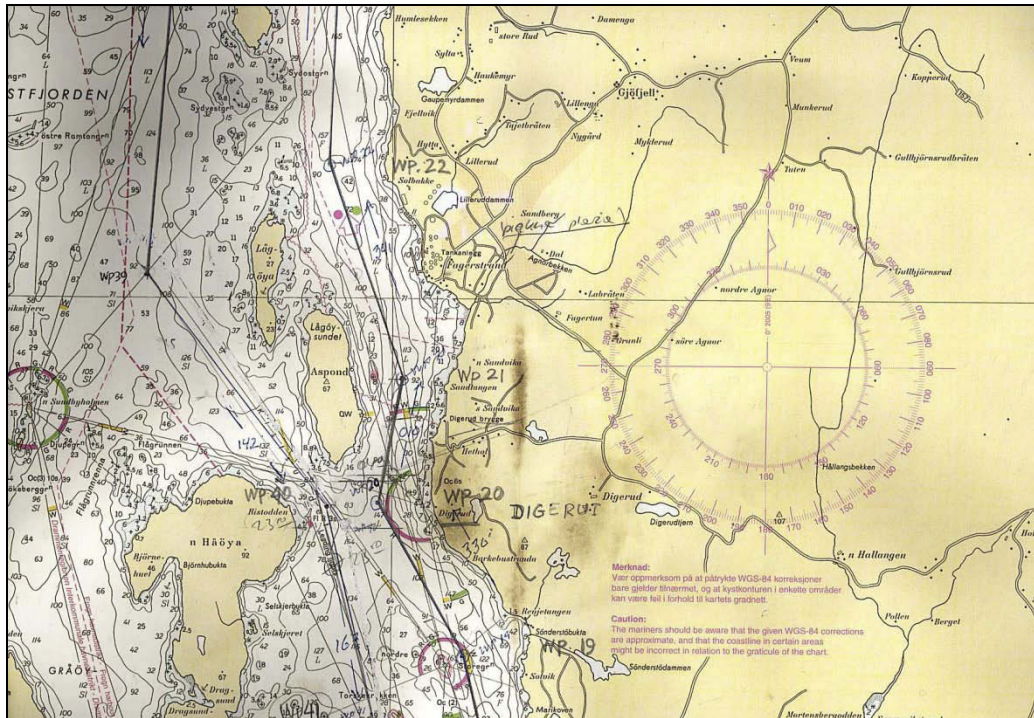
1.12.1.2 There were also some Norwegian charts on board. They included nautical chart no. 402 (Spro – Filtvet), which covered the relevant area. This is a detailed chart, scaled on 1:25,000, printed in August 2006. When printed, the chart had been updated with corrections up to and including *Etterretninger for Sjøfarende (EfS)* (Norwegian Notices to Mariners) no. 16/2006. Norwegian EfS notices had been subscribed to since July 2007, so it was not possible for the crew on the *Crete Cement* to update the chart with all corrections made after the printing date. Some of the EfS notices on board contained information about construction work in the Oslofjord, but chart no. 402 had not been updated with this information (ref. section 1.18).

Figure 19: Detail from the Crete Cement's chart BA 402. (not to scale.)

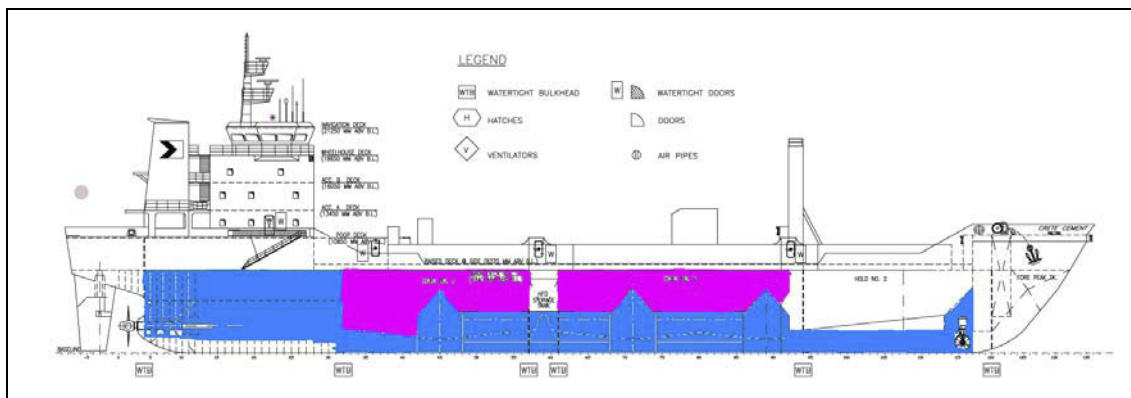
- 1.14.1.3 Figures 20 and 21 show the spaces that were flooded after the *Crete Cement* ran aground. The spaces highlighted in blue were flooded after a short period of time, estimated to between 30 and 45 minutes; while the spaces highlighted in pink show the spaces that were gradually flooded with water in the course of a few hours.

Figure 20: Flooded spaces.

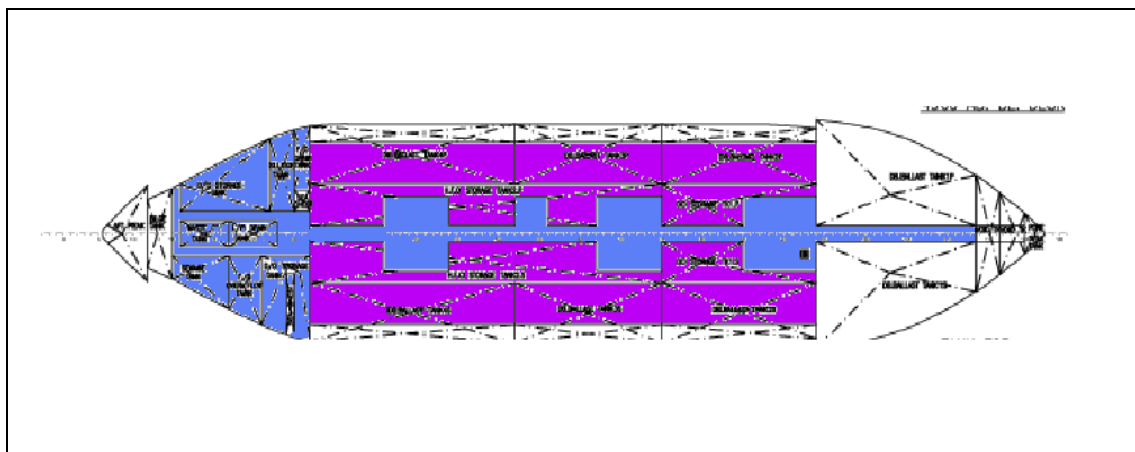
Figure 21: Flooded spaces.

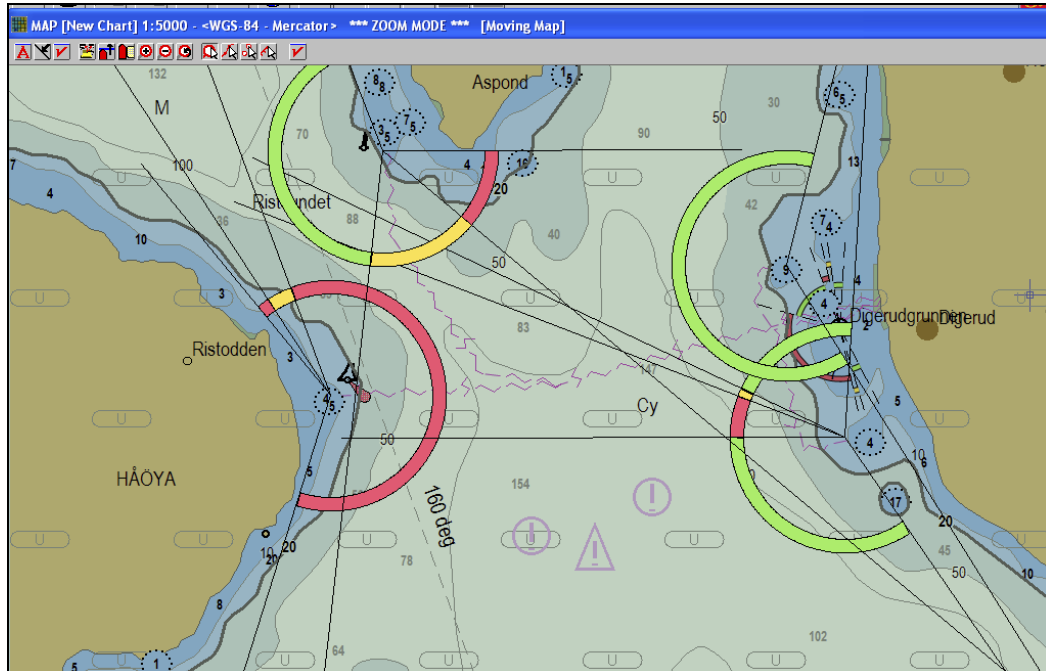
1.18.2 The chart in figure 23 below, shows navigational aids in the area roughly as they were in the morning of 19 November 2008. You can see the two newly constructed lighthouses at Digerud and new lighthouses southwest of Aspond Island and off Ristodden. The old lighthouse at Digerud is still marked on the chart, between the two new ones, but it had been demolished when the vessel ran aground. Hence there was no light emanating from this position.

Figure 23: Overview of new navigational aids in the area. Source: The Norwegian Coastal Administration).

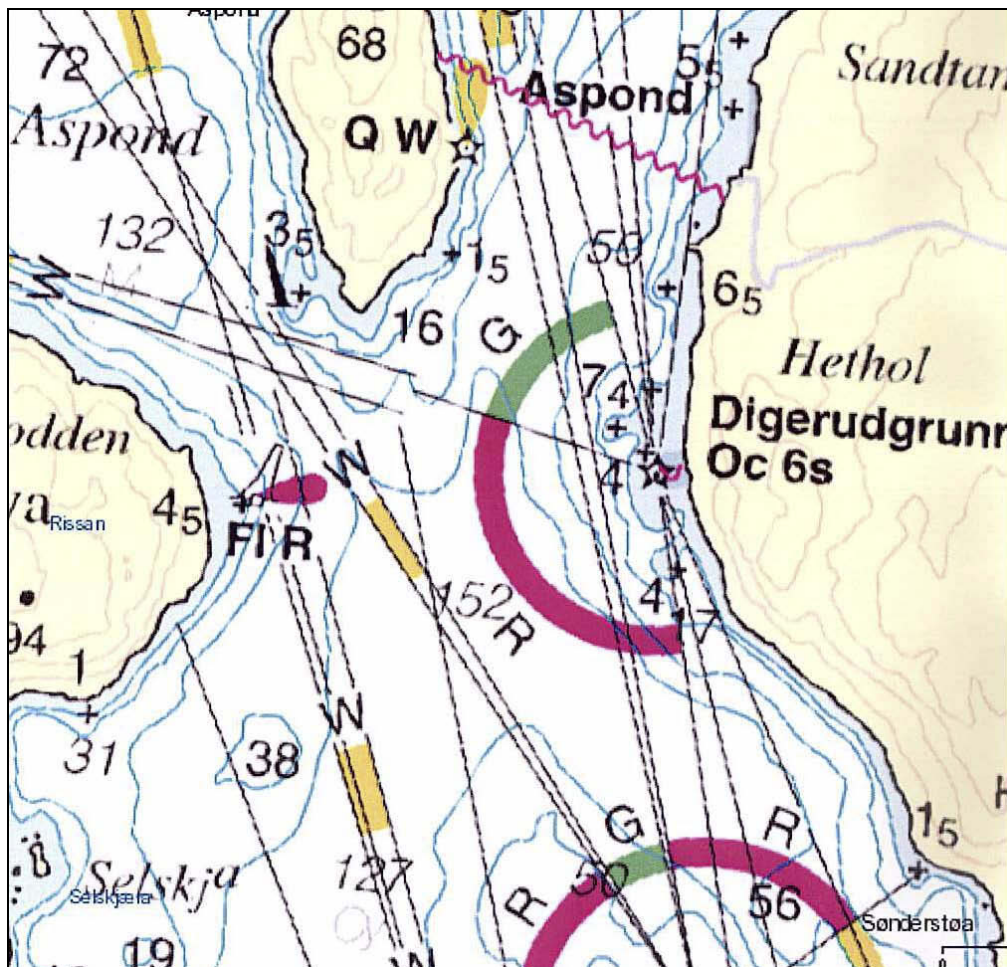
Figure 24: Chart of the same waters before the construction work started.
