Accident
Investigation Board
Norway

REPORT

Mar 2010/09

REPORT ON INVESTIGATION OF MARINE ACCIDENT REGARDING FALL OVERBOARD FROM CARGO SHIP NYSAND LJIE ON DEPARTURE FROM PORT AT FORUS 24 OCTOBER 2008

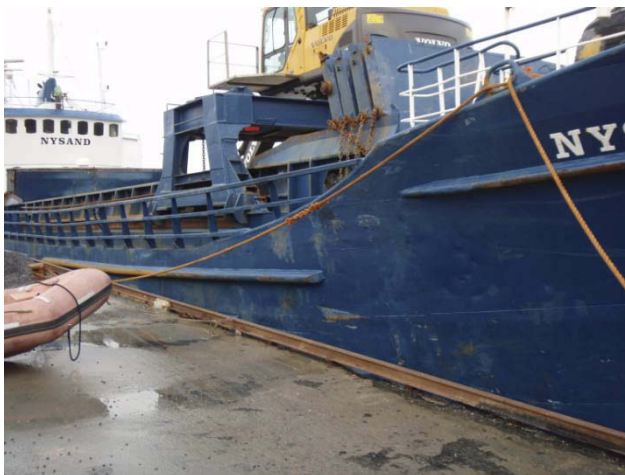
Figure 1: Nysand moored at the quay facility at Forusstranda on the day after the accident.

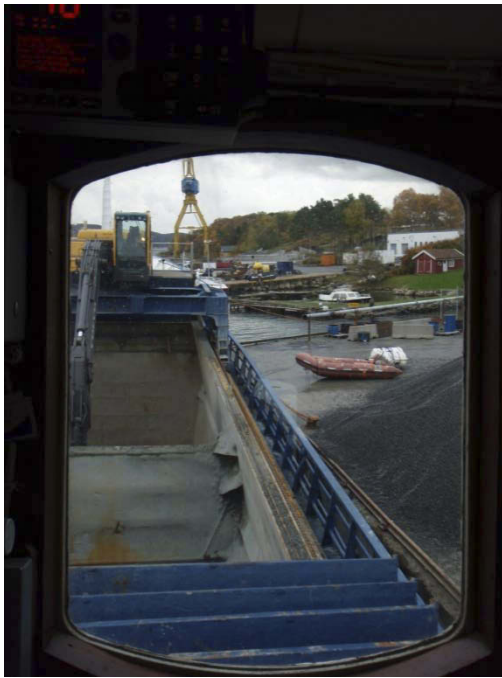
Figure 2: View from the wheel house and down towards the quay in daylight.

The master did not receive any confirmation that the ordinary seaman was on board, and could no longer see the ordinary seaman at this time, but he assumed she was on board as the spring had been pulled on board. The master engaged the bow thruster to take the bow away from the quay. After having achieved the desired position from the vessel, the master started moving the vessel forward. According to the master, it was difficult to see the place where the ordinary seaman would come on board due to the dark, and because the view from the wheel house towards the side of the ship was partially blocked by the excavator.

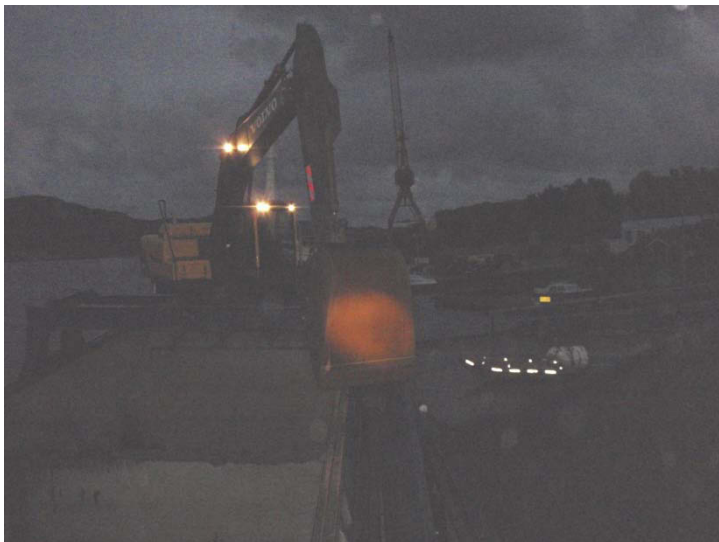
Figure 3: The view from the wheel house down towards the quay at night with the ship's floodlights on.

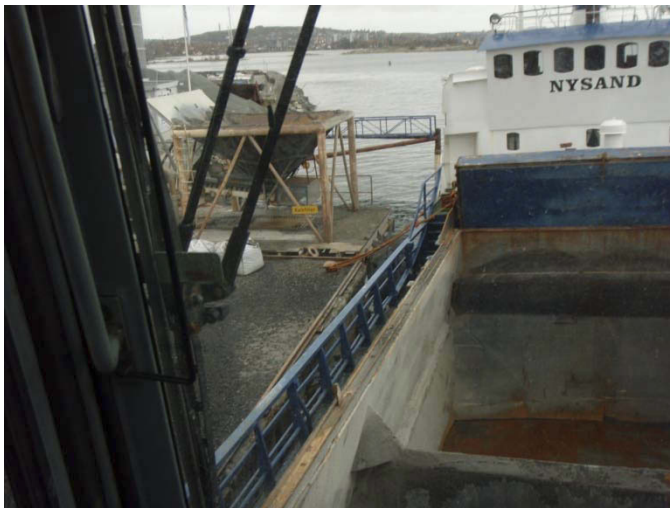
Figure 4: View from the excavator.

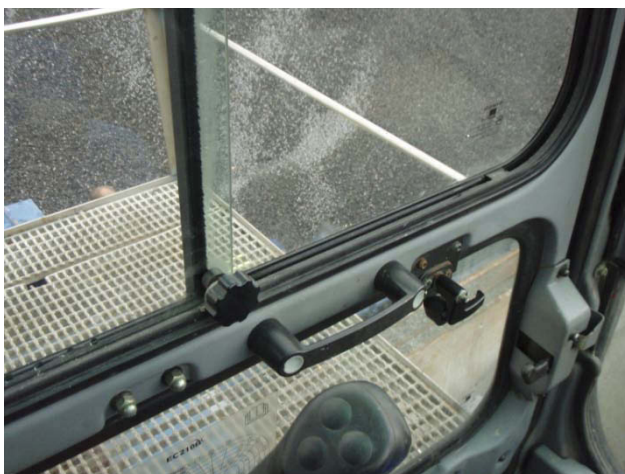
Figure 5: View from the excavator and down towards the quay.

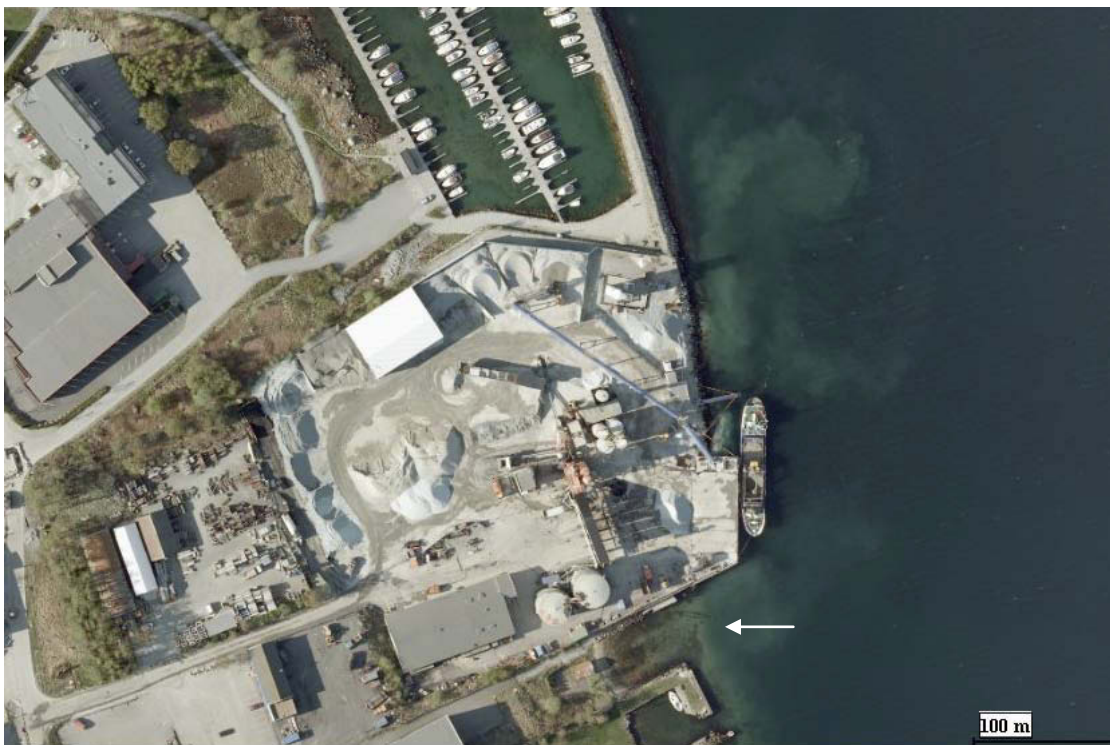
Figure 6: The quay facility at Forus with ship at the quay. The white arrow indicates the area where the deceased was found. Source: Norwegian Coastal Administration

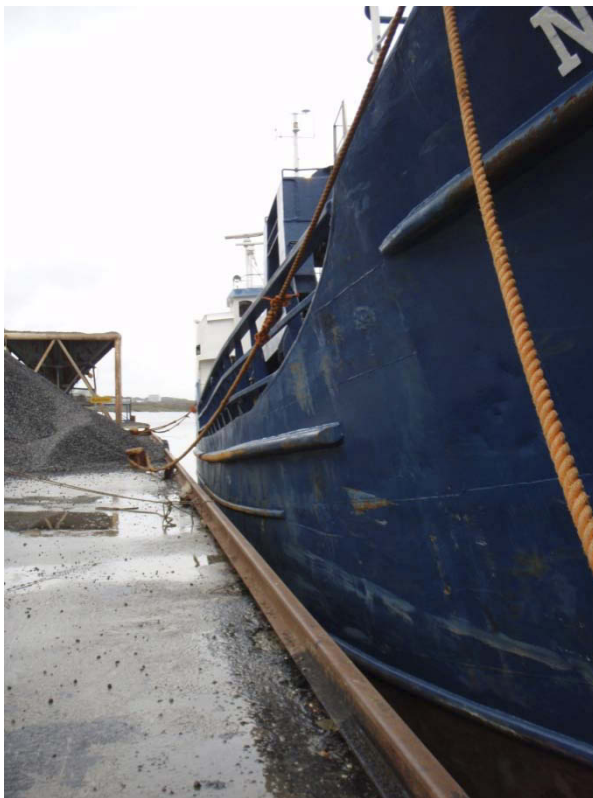
There was no gangway on board in spite of the requirement in Section 9 of the Regulations relating to Safety Measures, and repeated orders from the Norwegian Maritime Directorate to acquire this. There was also no gate or similar in the railing where a gangway could be placed. It was stated that they did not use a gangway due to large rolling movements in the vessel when using the vessel's own excavator during unloading.

Figure 7: There was no gate in the railing and no gangway was used.

- The vessel had no gate or other opening in the railing, making it more difficult to get on board.
- There was a lot of gravel on the quay, and only a small passage between the heap of gravel and the edge of the quay. This made it more difficult for the ordinary seaman to walk along the edge of the quay, and had a negative impact on the working conditions.

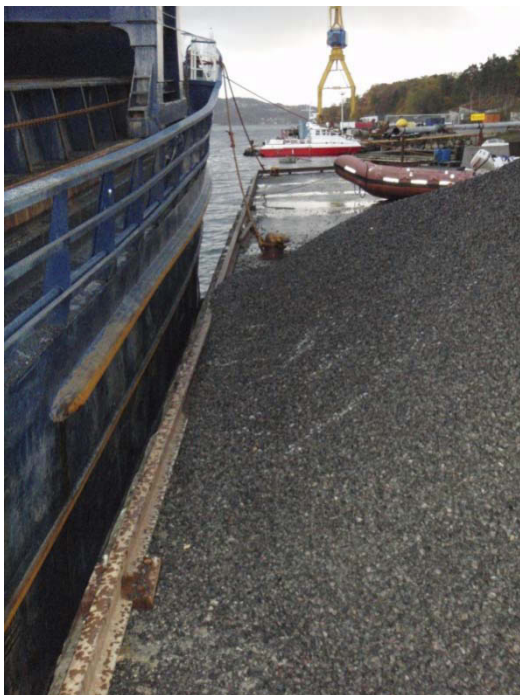
There was a large pile of gravel on the quay. This had been left by a vessel which had unloaded directly onto the quay. The passage between the gravel pile and the edge of the quay was very narrow in places. In one area, the gravel was right up against the railway rail. Section 19 of the Regulations relating to Port Work, states that the passage along the edge of the quay shall be sufficiently wide and orderly and free of loads and other obstacles.

Figure 8: There was a lot of gravel on the quay, and only a very narrow passage along the edge of the quay.

After the accident, NorStone and Lemminkainen held a meeting reviewing factors relating to the accident. One of the results of the meeting was a decision to prepare guidelines for mooring assistance. After the accident, the quay owner has installed a ladder on the quay facility.
