REPORT

Mar 2010/11

REPORT ON INVESTIGATION OF MARINE ACCIDENT STAR ISMENE - LANT5, NANTONG CHINA 16 DECEMBER 2008

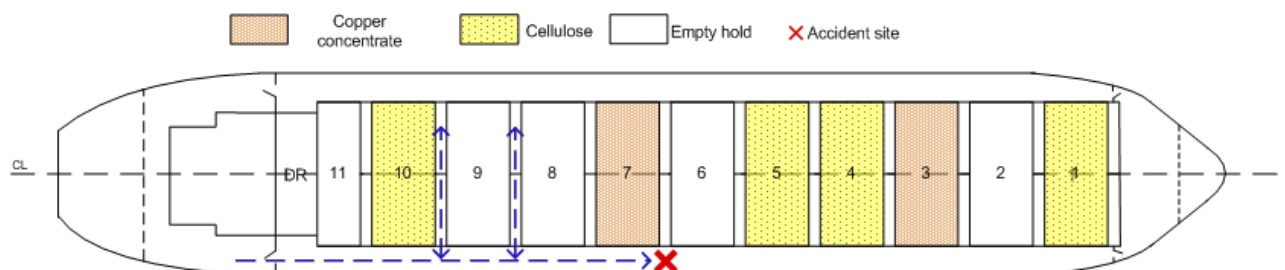
Shortly after 13.00 the work of sounding the ballast tanks started. The deck repairman and the Chinese cargo inspector started by sounding ballast tanks 6, entering from the starboard passageway below deck between cargo holds 9 and 10, and went on to sound tanks 5, between cargo holds 9 and 8. Cargo holds 2, 6, 8 and 9 had previously been fully unloaded and aired; see figure 4. The agent also took part in this work.

Figure 4: Cross-section of the deck with the passageways, seen from above. The sketch shows the distribution of cargo at the time of the accident. The route taken to sound the tanks on the day of the accident is marked in blue. Cargo holds 3 and 7 had been closed for 29 days.

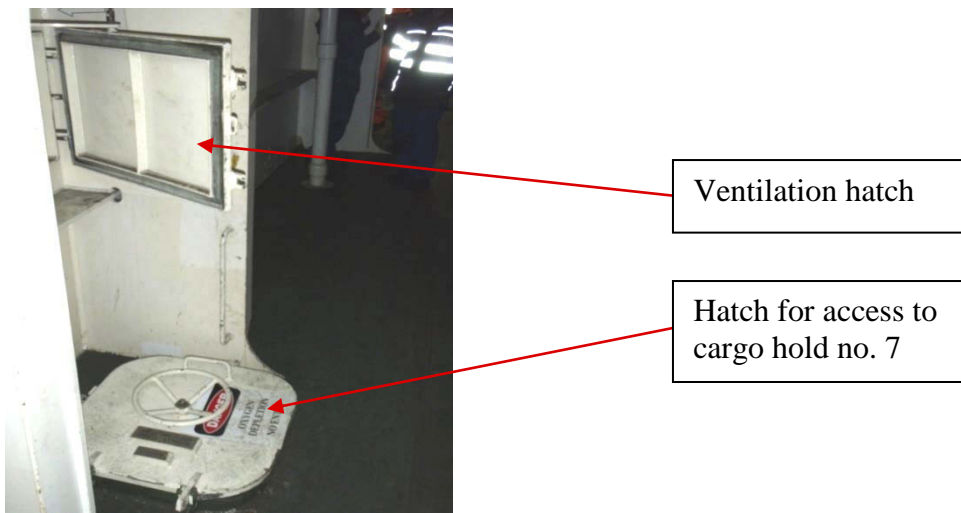
When the deck repairman and the shipping agent³ arrived in the area between cargo holds 6 and 7, the hatch providing access to the cargo hold was closed, and the cover was secured with cable ties and marked with 'DANGER OXYGEN DEPLETION NO ENTRY', see figure 5.

Figure 5: The hatch for access to cargo hold 7 and the ventilation hatch between holds 6 and 7.

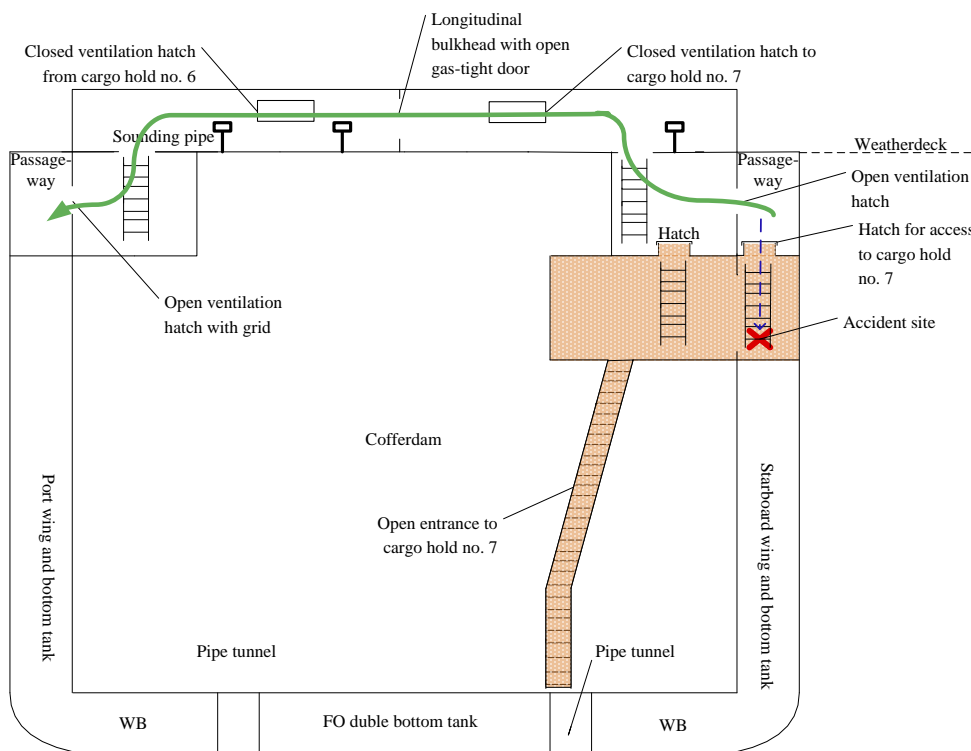
Figure 6: Sketch of cross-section of the ship between cargo hatches 6 and 7. The sketch shows which ventilation hatches, doors and access hatches are assumed to have been open and closed on the day of the accident. The area highlighted in brown shows that the atmosphere in the area where the accident occurred was the same as in cargo hold 7. Cargo hold 7 is closed off from the other spaces.

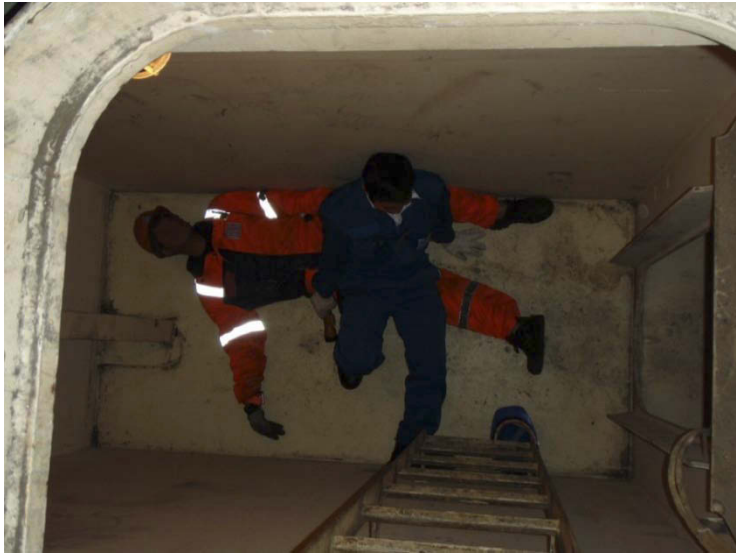
The deck hand arrived at the accident site and was instructed by the boatswain to climb down to the landing to attach a strap to the deck repairman. The boatswain had just witnessed the second mate climb down and come back up, and did not, therefore, suspect that there might be risks involved in climbing down. The deck hand climbed down to examine the deck repairman and to attach a lifting strap. He felt that there was something wrong and tried to climb back up again, but passed out, fell and ended up lying halfway across the deck repairman (see photo, figure 7). The boatswain now realised the danger of climbing down onto the landing and notified of the situation over the VHF radio.

Figure 7: Photo taken from the passageway on the starboard side looking down onto the landing through the access hatch for the cargo hold. Reconstruction of how the deck hand was found lying unconscious partially on top of the unconscious deck repairman.

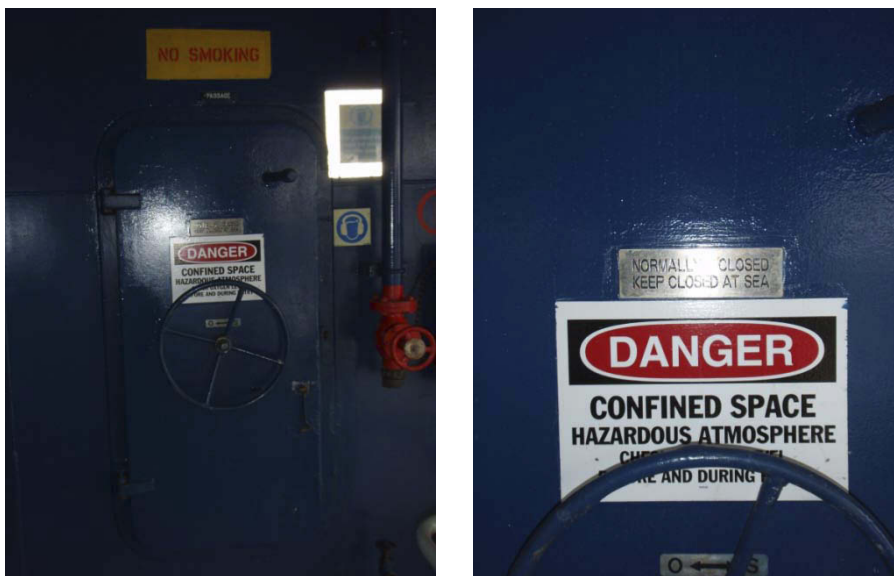
The ship is designed with enclosed passageways on the starboard and port sides below the weather deck. The passageways run from the forecabin to the accommodation area aft. There are watertight doors in both the forward and aft ends of the passageways. The doors are marked 'DANGER CONFINED SPACE, HAZARDOUS ATMOSPHERE', cf. figure 8.

Figure 8: Photo of the door at the aft end of the passageway on the starboard side.

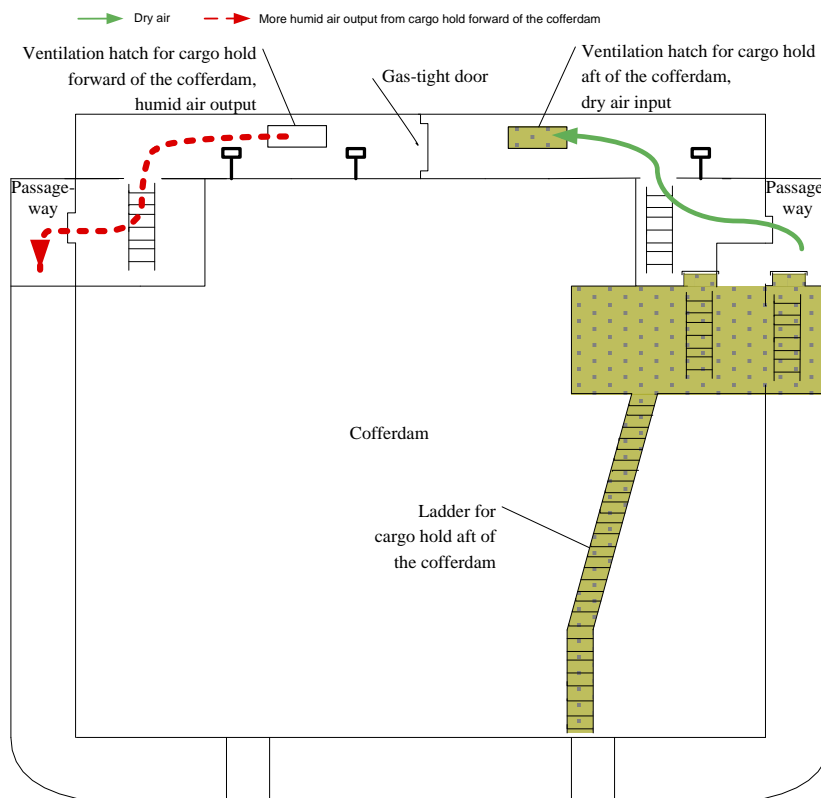
Figure 12: Simplified and schematic cross-section between two cargo holds showing the arrangement for dehumidifying the cargo hold. The dry air is pushed down from the space at the forward end of the cargo hold. The humid air moves back up at the aft end of the cargo hold.

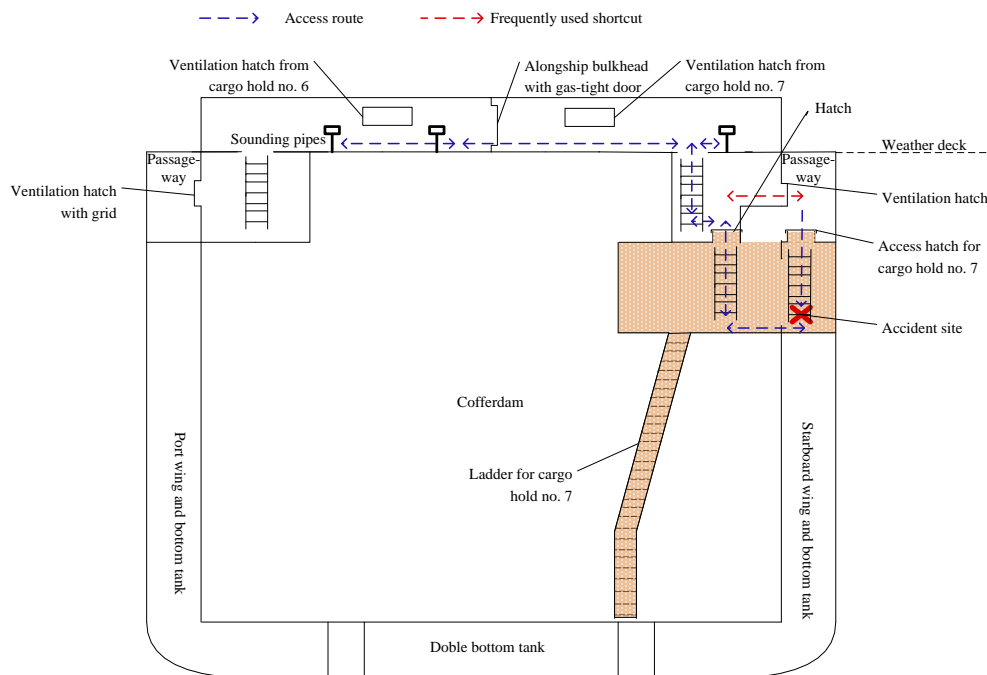
Figure 14: Cross section of the rooms between the cargo holds showing how the sounding pipes and ventilation hatches could be accessed.

A ladder near the ship's centreline leads back up to the room on the inside of and on the same level as the passageway. From here, a second ladder leads up to the space between the cargo holds, where the sounding pipes are located; see figure 14. The two crew members who lost consciousness were found on the floor in the room below the passageway on the starboard side, marked with a red X.

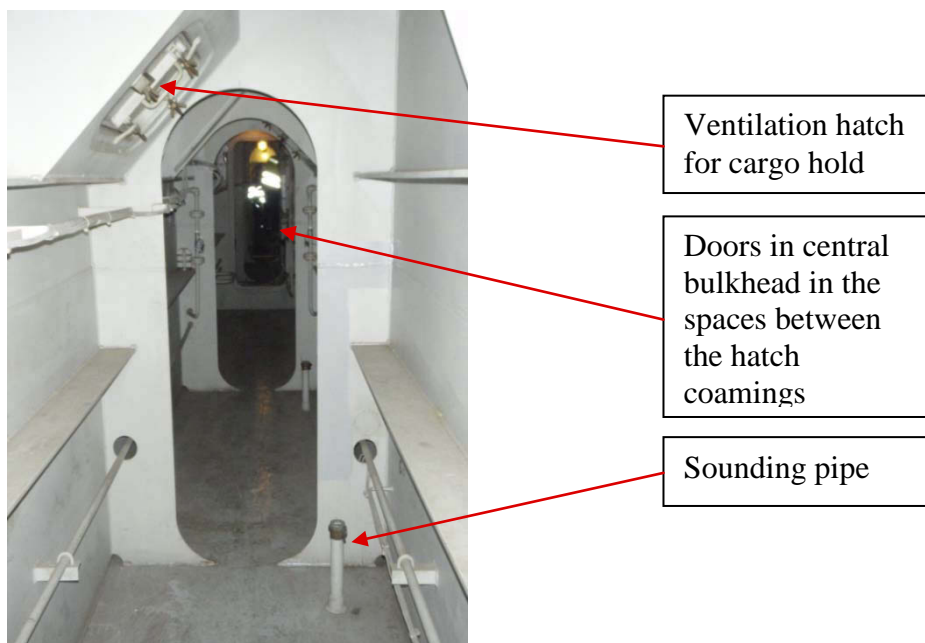
Figure 15: The photo shows the space between the hatch coamings for cargo holds 6 and 7, where the sounding pipes are located. The photo is taken from the port side looking towards starboard.
