# REPORT

Sjø 2012/07

## REPORT ON INVESTIGATION OF AN OCCUPATIONAL ACCIDENT ON BOARD THE SOLSTRAUM, LDEB3, EN ROUTE TO ROTTERDAM 4 FEBRUARY 2011

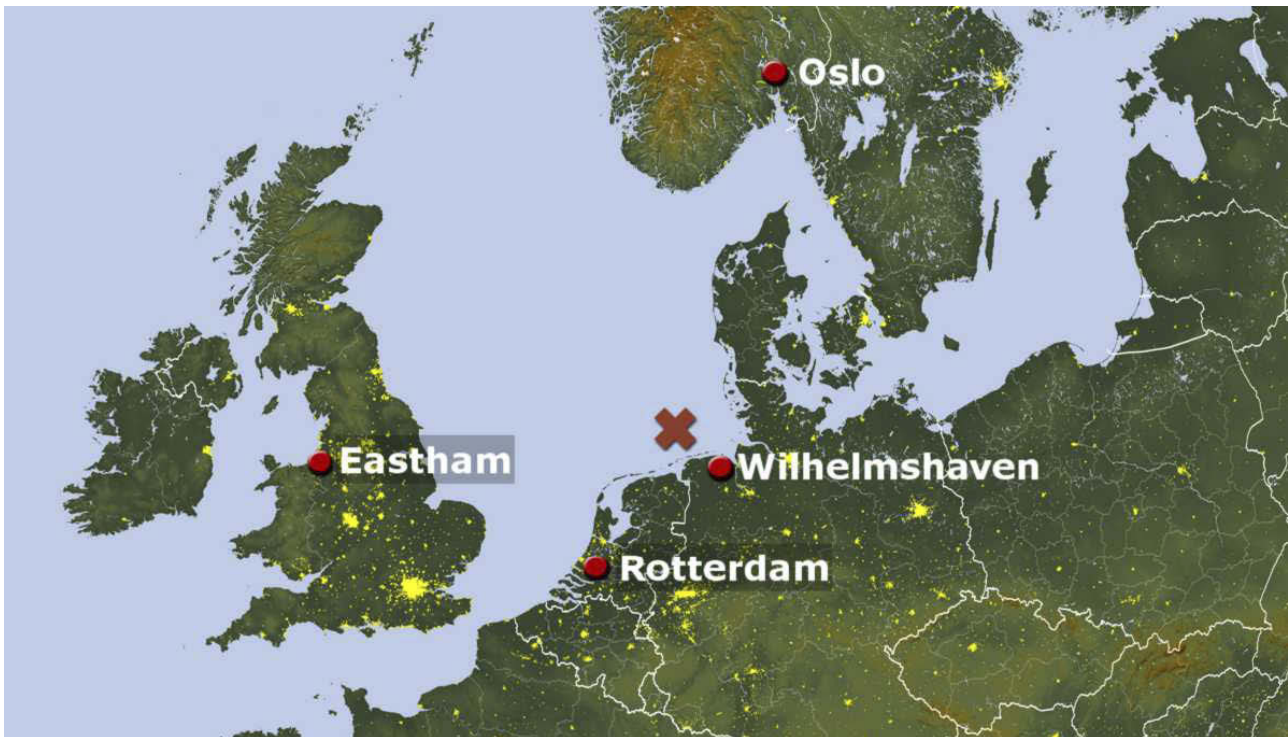
Figure 1: The occupational accident on board the *Solstraum* took place at 14:45<sup>1</sup> on 4 February 2011, while the vessel was en route from Wilhelmshaven to Rotterdam. The vessel's position when the accident occurred is marked with a red cross.

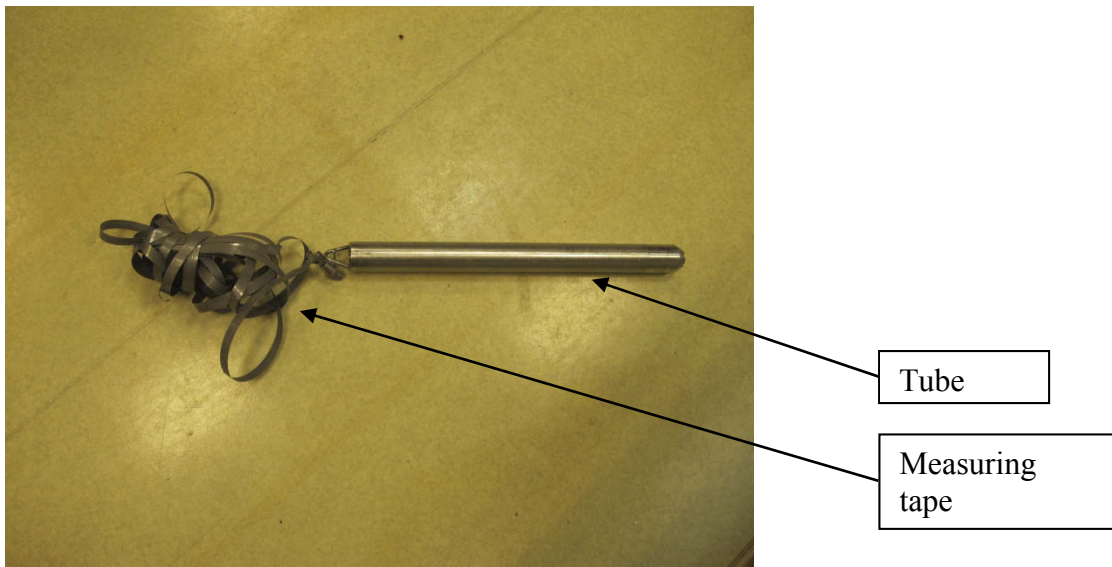
In accordance with the shipping company's procedures, cargo samples were to be collected in connection with both loading and discharging, so as to be able to document that the quality of the cargo had not deteriorated on board. This was to be done by using a device consisting of a sampling tube attached to a steel measuring tape, cf. figure 3.

Figure 3: The sampling device used to collect cargo samples.

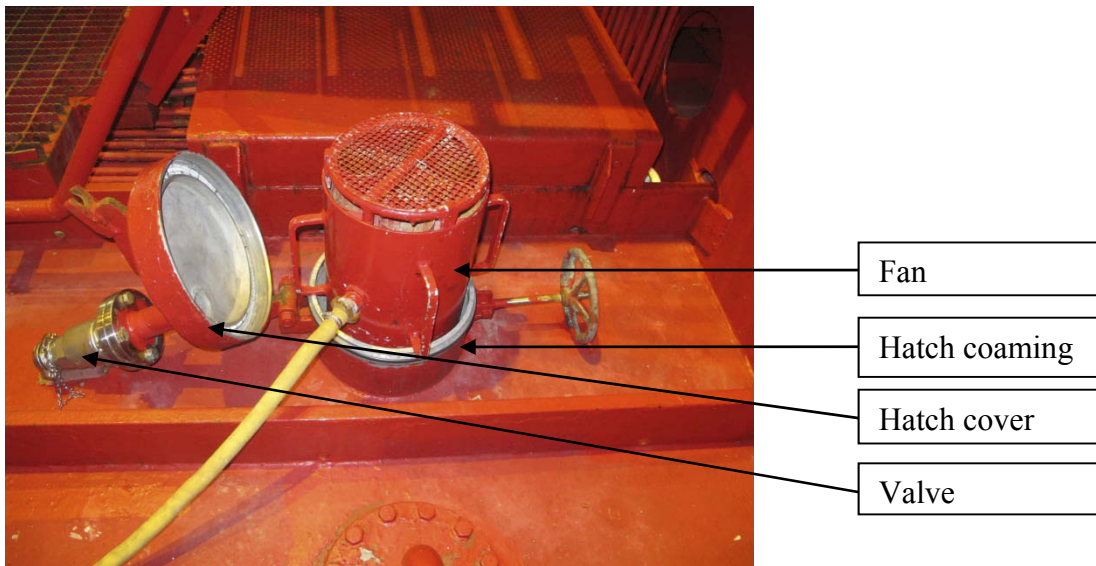
The sampling would take place by standing on deck and lowering the device into each cargo tank through a valve in the butterworth hatch at the aft end of each cargo tank. Figure 4 shows the butterworth hatch of cargo tank 7P.

Figure 4: The butterworth hatch of cargo tank 7P. In the photo, the cover has been removed and a fan mounted in its place, in order to ventilate the tank.

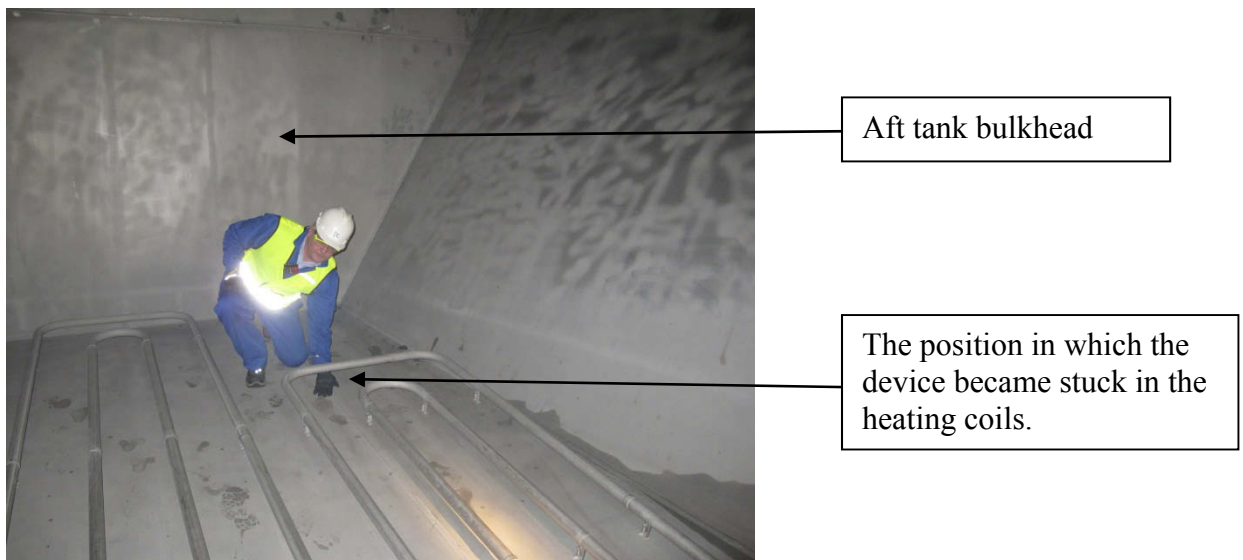
When a cargo sample was to be collected from cargo tank 7P after loading in Eastham, the tube became stuck in the heating coils at the bottom of the tank, cf. figure 5. After unsuccessful attempts to dislodge the tube and retrieve the sampling device from the tank, the measuring tape was temporarily fastened above deck to prevent the whole sampling device from disappearing into the cargo tank.

Figure 5: The heating coil where the cargo sampling device became stuck.

The device was left hanging in cargo tank 7P until it probably came loose and fell into the tank, either before the Solstrøm arrived at Wilhelmshaven, in connection with the discharging there, or during the following cleaning process. This could cause a problem, as the device could have been pulled into the pipes and pump systems. In such case, the cargo sampling device could have caused material damage, and the pumpman probably tried to prevent this from happening.

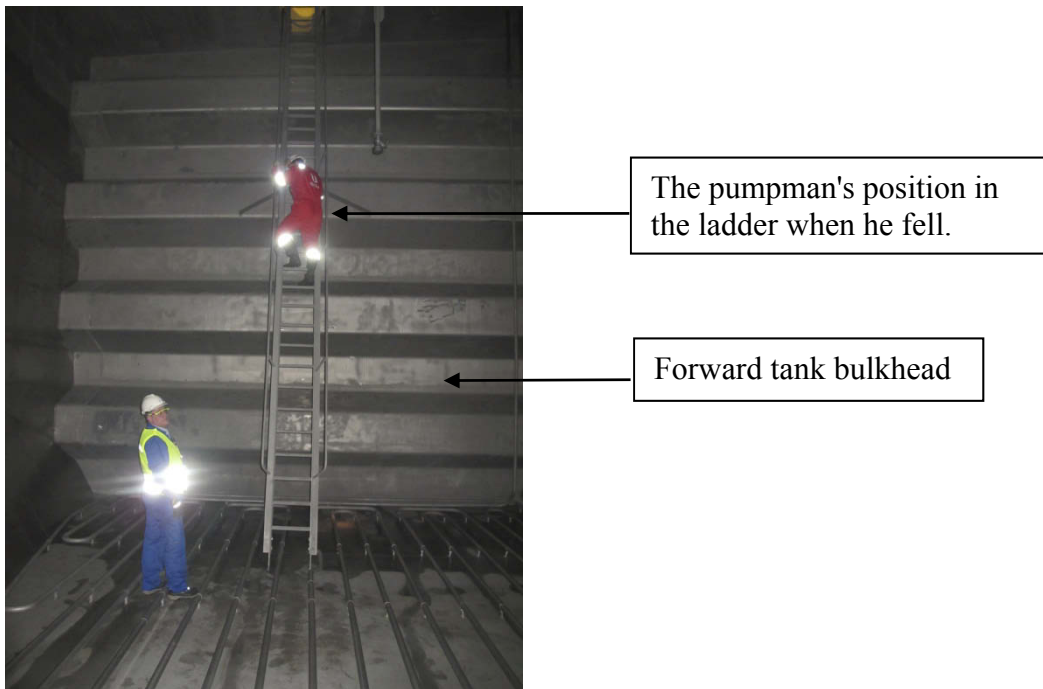
Figure 7: Reconstruction of the accident The pumpman fell 4-5 metres (from the position of the person wearing the red overalls) and lay lifeless at the bottom of cargo tank 7P.

According to the statements of the other crew members, the atmosphere in the tank was not measured before the tank was entered by the pumpman. Nor did the pumpman use a breathing apparatus. The AIBN assumes that the pumpman, based on his long experience as crew and pumpman on chemical tankers, must have known that the atmosphere in the tank made it unsafe to spend any time there. The AIBN believes that the pumpman took a calculated risk when he entered the tank. He only wanted to retrieve the cargo-sampling device and he did not think that this would take much time. He could hold his breath. On this basis, he took two deep breaths and proceeded to climb down the ladder. When he had climbed down into the tank, he probably realised that he would not be able to retrieve the cargo-sampling device. He turned when he was half way between the ladder and the device and climbed back up the ladder. Half way up the ladder he probably lost consciousness and fell backwards, back into the tank.

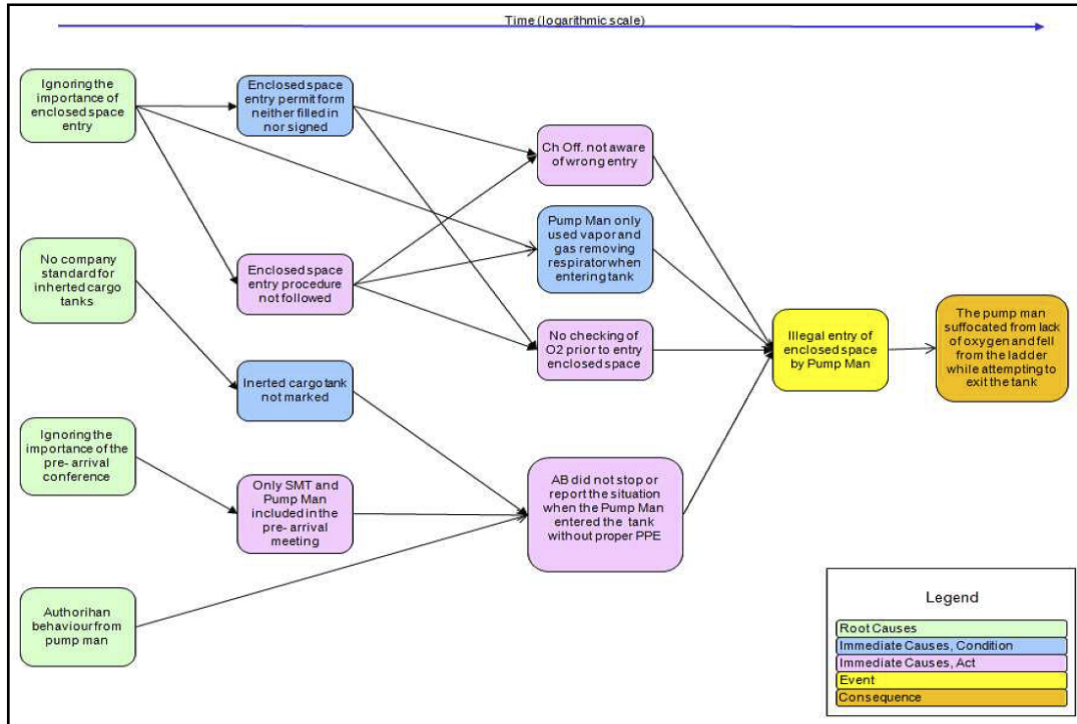
The shipping company has summarised the results of the internal investigation in a diagram to illustrate the relationship between causes and effects, see Figure 9:

Figure 9: Cause and effect model. Source: The shipping company's internal report following the accident.

On the basis of the cause and effect model, the shipping company has decided to implement several corrective and preventive actions, cf. Table 3. The shipping company has also decided to establish barriers on the basis of contributory causes, cf. Table 4.
