REPORT

Sjø 2012/08

REPORT ON INVESTIGATION OF MARINE ACCIDENT, LANGELAND LDJB3, FOUNDER IN THE KOSTERFJORD, SWEDEN 31 JULY 2009

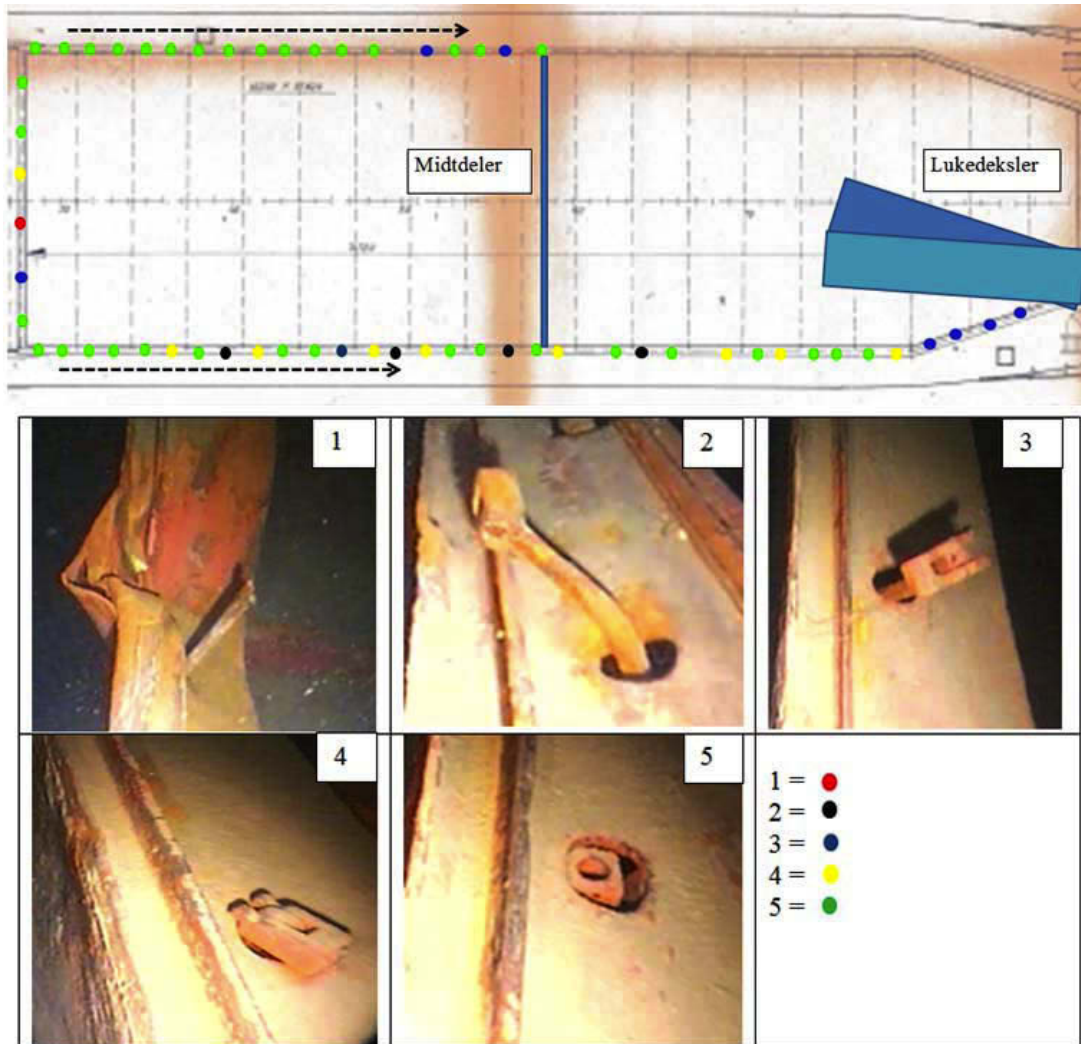
Figure 19: The sketch at the top shows the condition of the hatch cleats plotted against the background of the ROV images. Cleats shown in red are those that were broken (picture 1). Cleats shown in black are those standing over the hatch coaming (picture 2). Those shown in blue are those standing over the hatch coamings apparently undamaged (picture 3). Yellow cleats are apparently undamaged with their heads over the hatch coaming (picture 4). Green are apparently undamaged cleats lying down in the hatch coaming (picture 5). The dotted black line shows where the chain used by the excavator to move along the ship is broken.

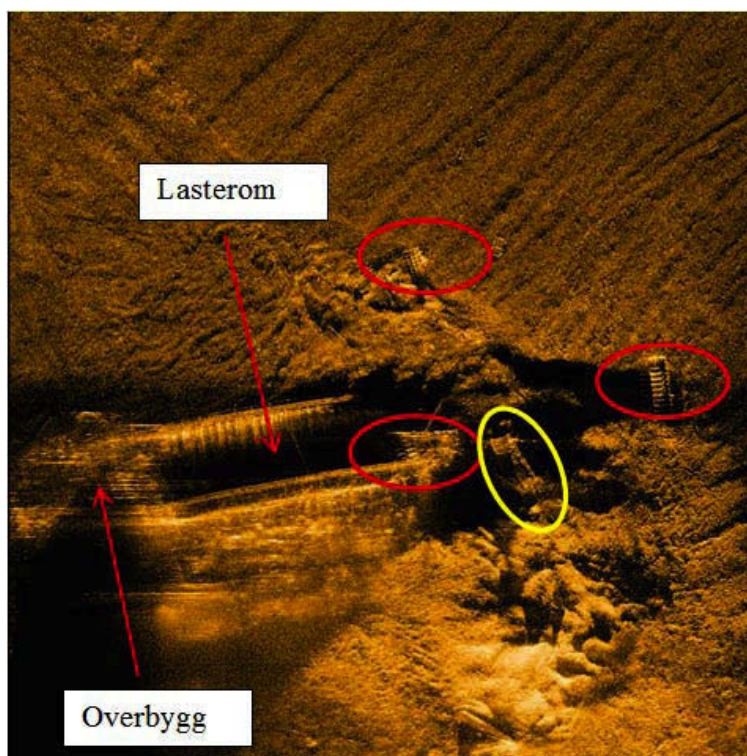
Fig. 20: Wreck on the bottom, with the bows at approx. 075°. Hatch covers marked by red rings, traverse by yellow ring. (Photo: FF)

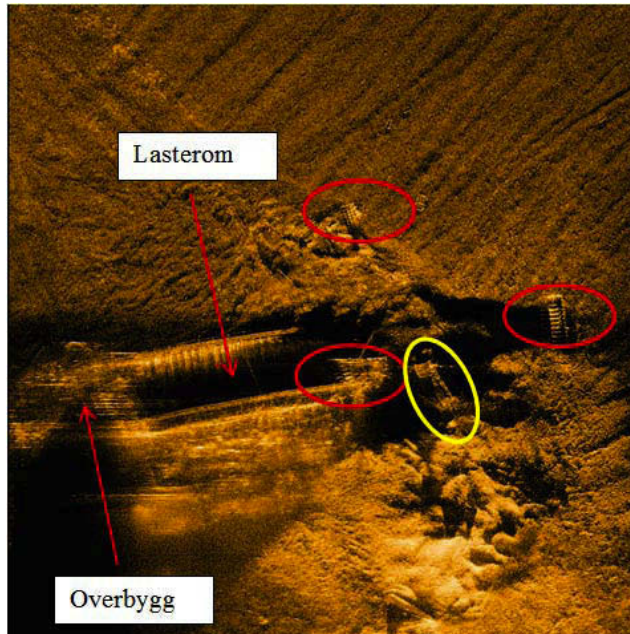
The cargo hatch covers are no longer in position on the vessel, but two hatch covers are inside the cargo hold, and two were found in front of the vessel. There are also some smaller objects close to the ship which may be parts of cargo hatch covers or cargo hatch covers buried partly in the mud. It is very probably the traverse for the excavator, which is over to starboard of the bows (Fig. 21). The excavator is not visible in the pictures, but the Accident Investigation Board thinks it likely it may be under the traverse.

Figure 21: Wreck on bottom with bows at approx. 075. Hatch covers ringed in red, traverse ringed in yellow. (Photo: FFI)

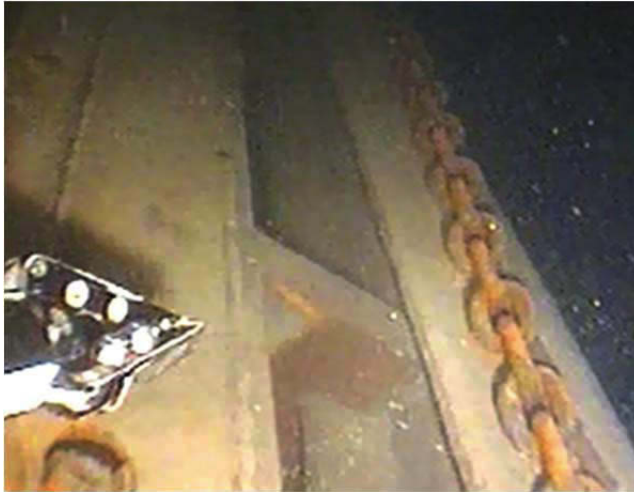
This theory is supported by the ROV investigations of the wreck, where the chains which pulled the excavator along the longitude of ship are mainly found lying in channel sections on the hatch coamings. If the vessel had been heeling badly when it was lost, the chains would most likely have slid out of these sections, and the traverse for the excavator and hatch covers would probably not have been in front of the wreck. Had the ship capsized, these and the excavator would be more likely to have gone overboard abeam and so be lying aft of the wreck on the bottom.

Figure 22: Traverse chains for excavator. Picture from port side. (Photo: KBV)

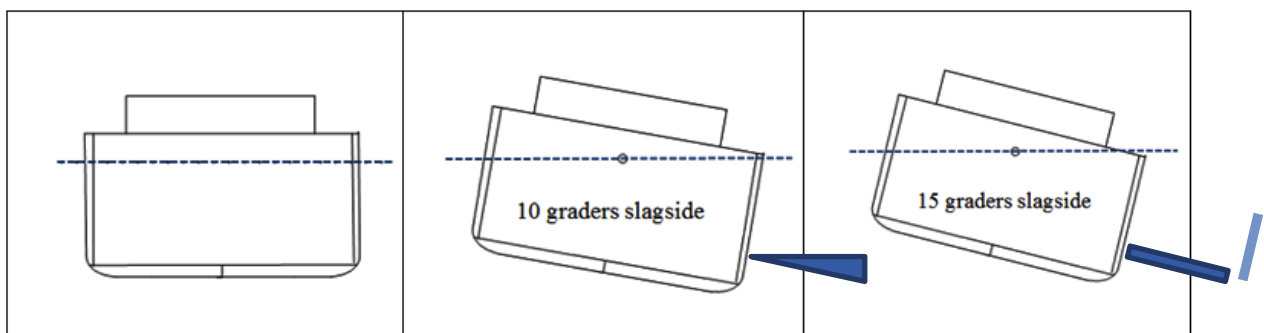
The captain of the vessel contacted the shipping company at around 04.19, saying they were listing 10-15° to port and that he intended to sail into the Kosterfjord to seek shelter. The shipowner also think he remember the captain said they were pumping water from the cargo hold. Fig. 20 shows the Langeland listing as stated.

Figure 23: Section through the Langeland as it was loaded, at 0, 10 and 15° list respectively

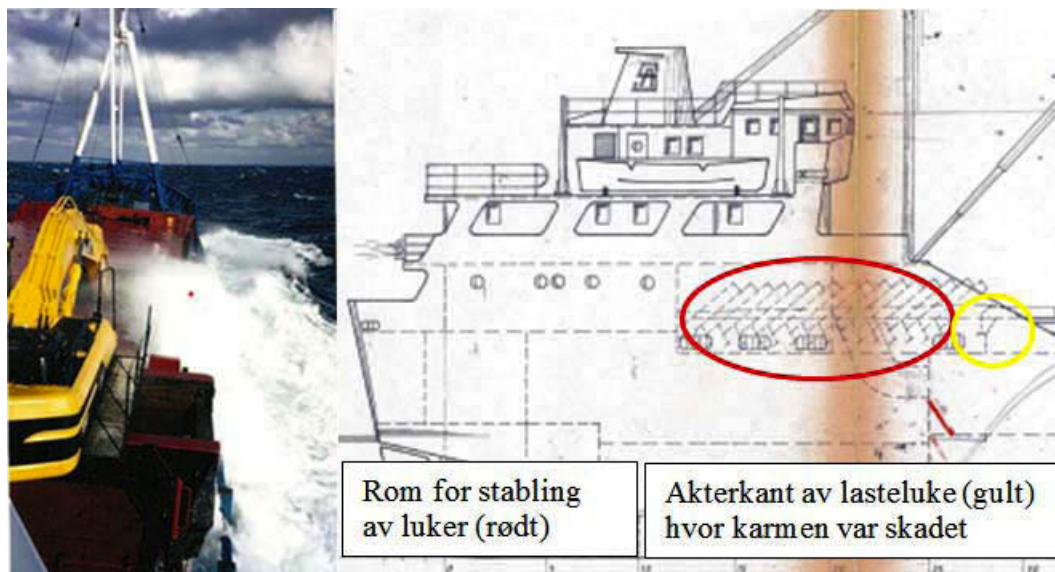
Space for stowing hatches (red)

As the vessel had little freeboard, we may assume that the vessel was exposed to excessive seas on deck. Information from discussions with the shipping company confirms that the vessel would have been exposed to water on deck more or less continuously in its loaded condition and under the sea conditions prevailing at the time. The image below shows the Langeland sailing earlier with cargo on board. The space in which the hatches were stacked during loading and unloading may be assumed to have been partly filled with sea water.

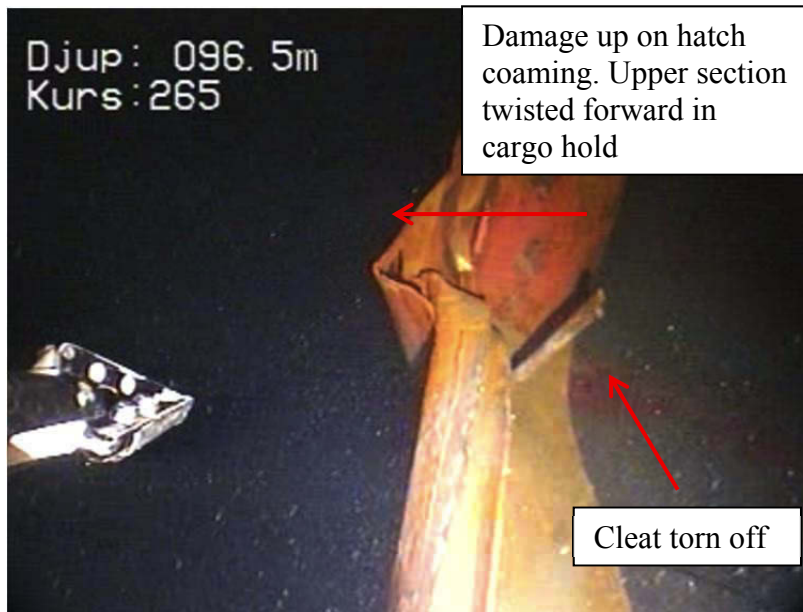
The ROV investigations conducted on 8 August showed that the hatch coaming was damaged aft. The ROV image shows that the upper section of the hatch coaming has been pushed down and buckled in towards the cargo hold (forward). The image also shows a cleat that was torn off. The shipping company held an inspection on board the vessel in Gudvangen on 15 July 2009, and confirmed the hatch coaming was not damaged at that time.

Figure 27: Damage around centre of hatch coaming aft.

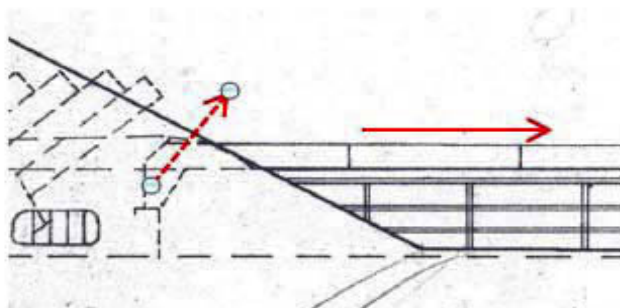
The images from the ROV investigations show the hatch covers are gone, and it is only natural to wonder if the damage may have occurred when they disappeared. The AUV investigation findings indicate that the hatch covers slid forwards. At the back of the cargo hold, the hatch coaming is considerably lower than the hatch coamings on either side.

Figure 28: Sketch showing aft section of the Langeland's hatch coamings, the aft-most hatch covers and front of the space in which the covers were stowed during loading and unloading.

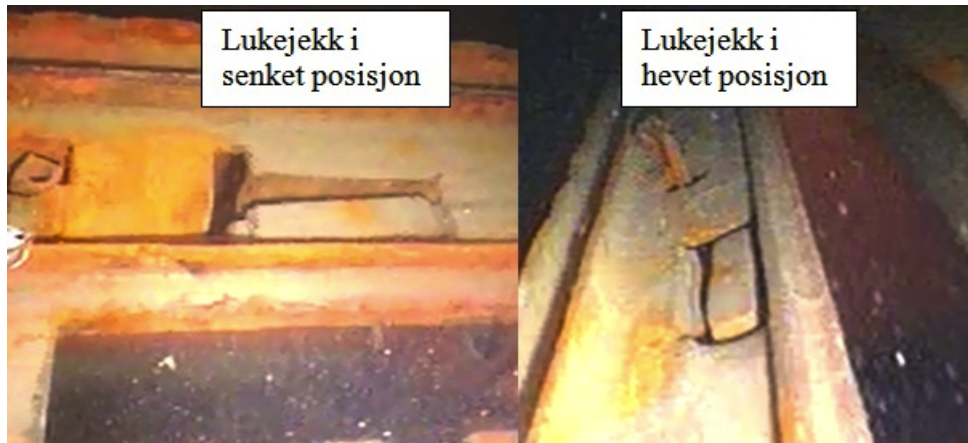
Figure 29: (Left) One of the hatch jacks on the port side. (Right) One of the hatch jacks on the starboard side. (Photo: KBV)

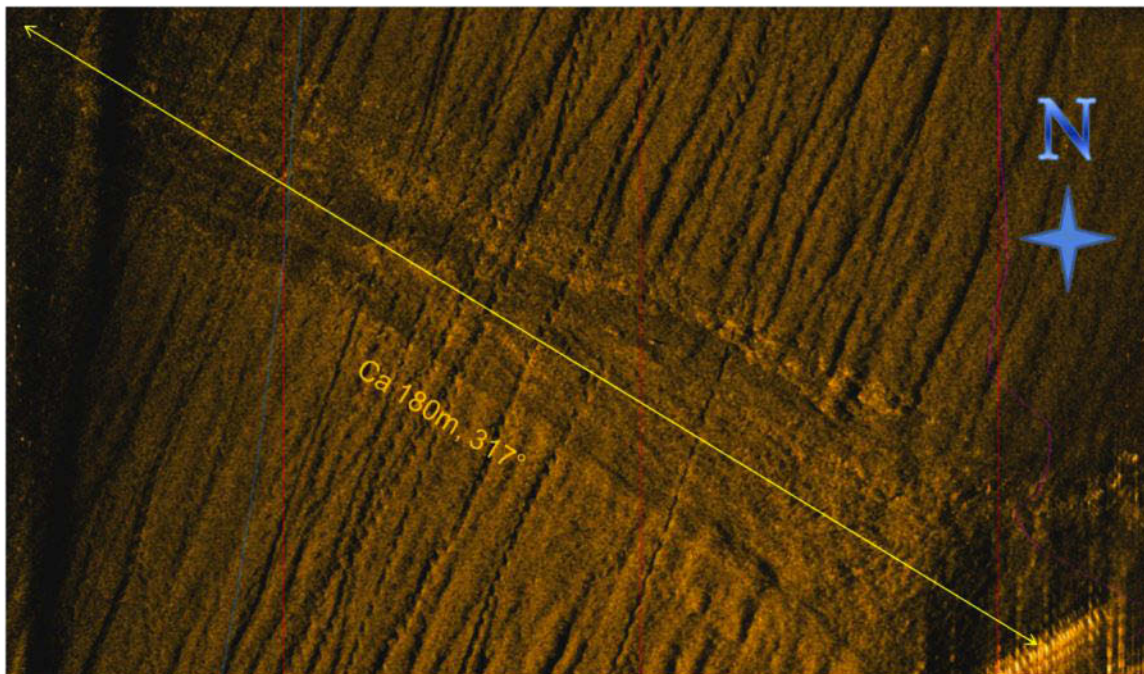
I retning 317° (ned skråningen vraket ligger i) fra vraket strekker det seg et omtrent 180m langt skred som er vist i Figur 3.5.

Figur 3.5: Skred ved vraket, ca 180m langt.

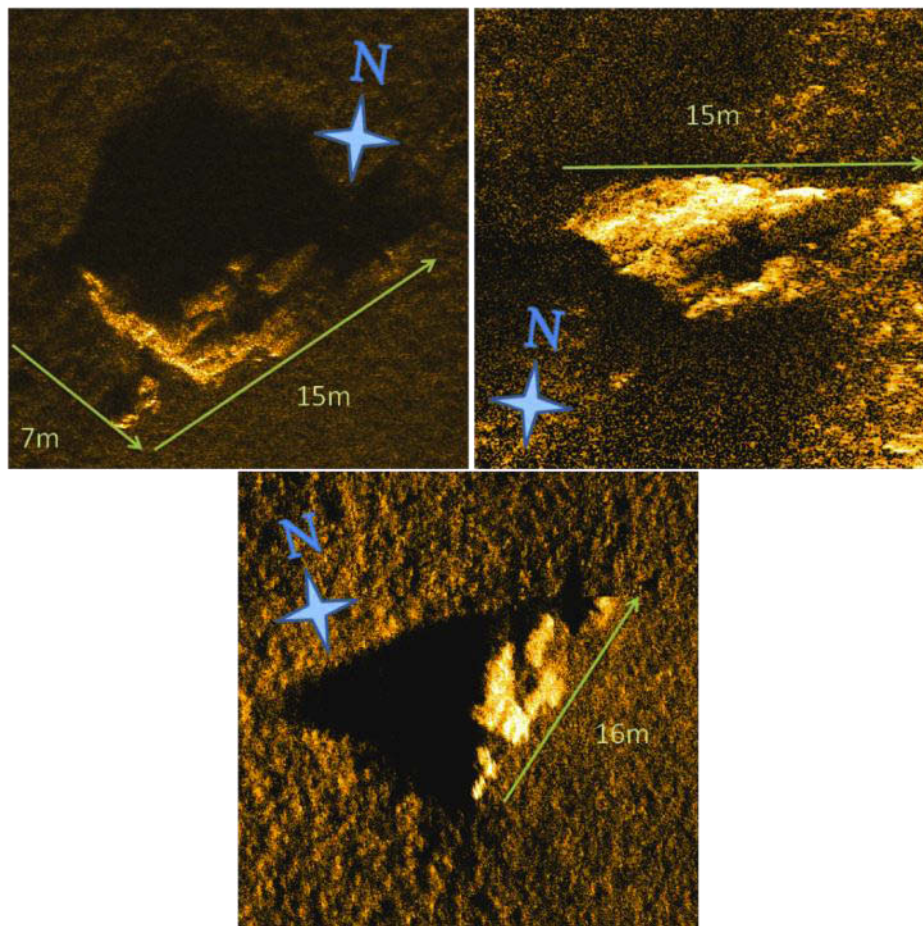
Det ble observert et objekt som kunne være gravemaskinen med EM710 om bord i Simrad Echo. Dette objektet er navngitt O1 og ble passert flere ganger, vist i Figur 3.14.

Figur 3.14: Objekt O1. Fra øverst til venstre og med klokka er bildene tatt fra sør, nord og øst i forhold til objektet.
