# REPORT

Sjø 2013/01

## MARINE INCIDENT REPORT M/S TIDEROSE LEGL/9510242 PASSENGER OVERBOARD NEAR VESTNES ON 16 SEPTEMBER 2012

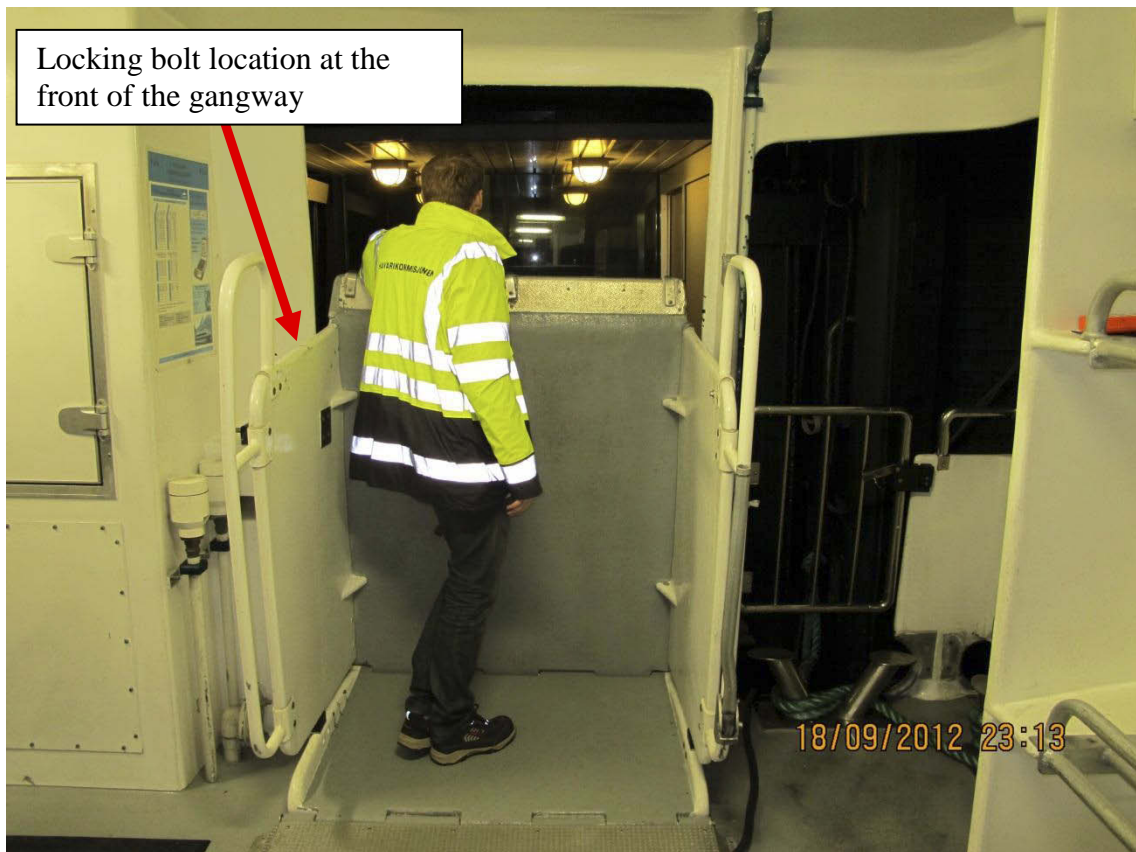
The passenger and her son then moved from the port to the starboard side of the aft deck because they wanted to photograph Feøy island. She was standing close to the gangway. The gangway was in the vertical position and functioned as a gate in the side of the vessel, see Figure 3.

*Figure 3: Illustration photo. Starboard gangway on the aft deck. In this position, the gangway serves as a gate in the side of the vessel. Photo: AIBN.*

The sudden change of course may have caused the passenger to lose her balance and try to steady herself against the gangway. The gangway fell down, and the passenger fell overboard. The incident happened just before 16:36.

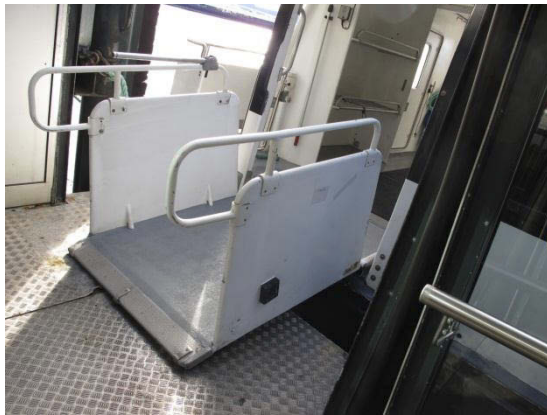
Figure 4: Gangway on the starboard side of the aft deck, seen from the quay. The gangway rests on the quay's surface. The black block on the side of the gangway is there to secure the gangway when in the vertical position. Photo: AIBN.

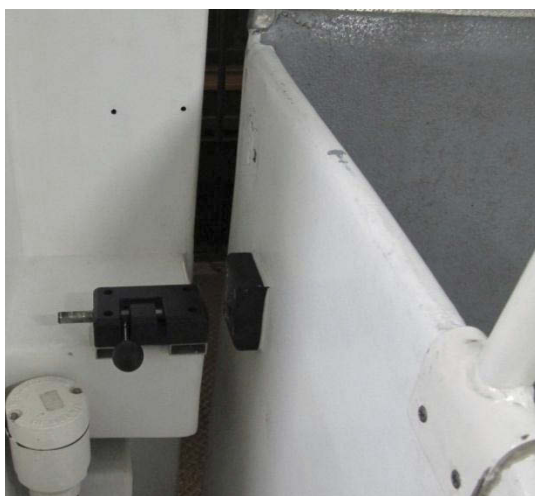
During crossings, the gangways function as gates in the side of the vessel, see Figure 3. A bolt at the front of the gangway is used to secure the gangway in the vertical position, see Figure 6 and Figure 7. The ordinary seaman must stand in front of the gangway when securing it. From this position, it will also be possible to see whether or not the gangway has been secured. It is not possible to see whether the gangway has been secured from other positions.

Figure 6: The locking bolt for the starboard gangway on the aft deck is not secured. Photo: AIBN.

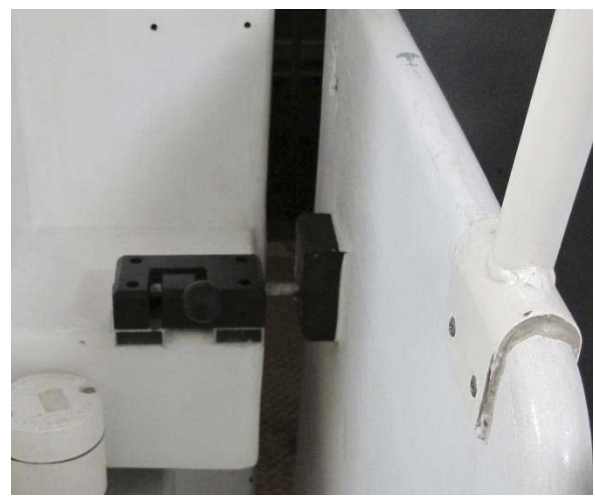
Figure 7: The locking bolt for the starboard gangway on the aft deck is secured. Photo: AIBN.

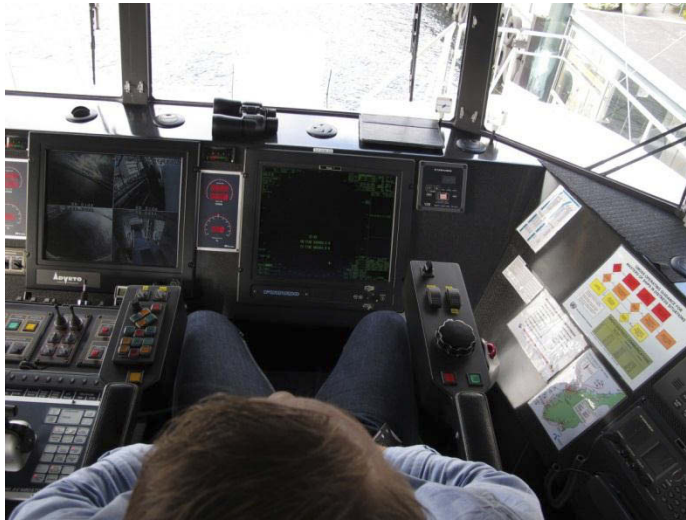
The vessel was equipped with a steering system consisting of an autopilot located in the middle of the central console, a manual steering wheel on the armrests of the starboard and port seats, and an emergency system in front of the central console, see Figure 8. The starboard seat was defined as the captain's position. This seat's manual steering wheel did not have a spring arrangement that would return it to the middle position after it was turned. Since there was virtually no resistance in the manual steering wheel's axle, it was easy to turn it to the side.

Figure 8: Illustration photo. Overview of the starboard navigator's seat. The armrest is fitted with a manual steering wheel and buttons for the takeover of control of manoeuvring. Photo: AIBN

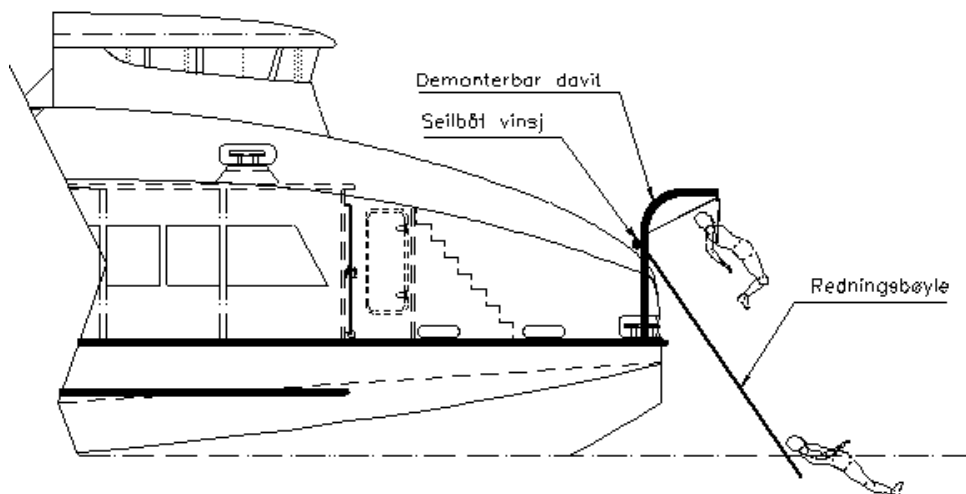
The manufacturer has set an upper limit of 4 metres freeboard for use of the rescue frame. It is a condition for use of the rescue frame that the person is floating and remains still when the frame is placed around him/her. If a person does not remain still, it could be necessary for one of the rescue personnel to jump into the water to help to put the sling under the person's arms, but the manufacturer does not recommend this, since it will endanger the rescuer's life.

Figure 9: The drawing shows rescue equipment used to hoist a person from the sea. Translation from the figure: Redningsbøyle = Rescue frame system, Demonterbar davit: dismountable davit, Seilbåt vinsj = sailing boat (manual) winch. Source: Norled AS

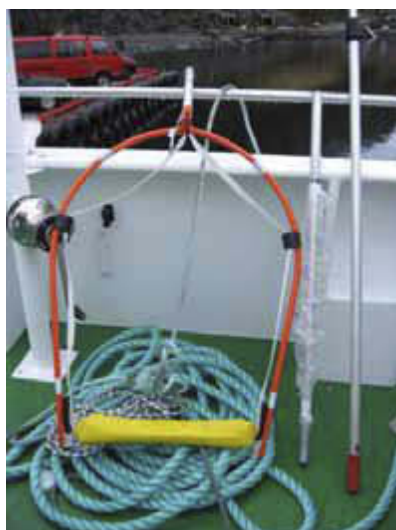
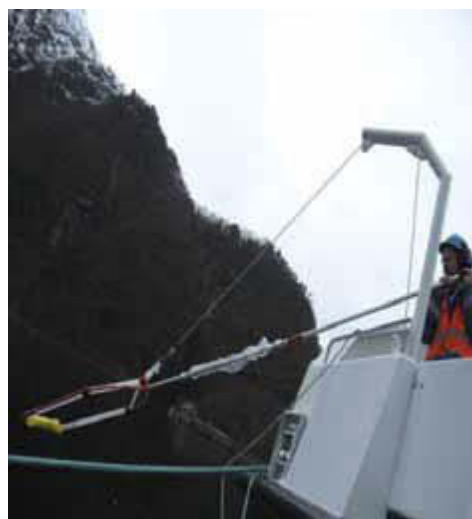
Figure 10: Photo of a rescue frame. The rescue sling (yellow and white line) lies flush with the frame. The line from the rescue sling runs through the pulley to the davit. Photo: Norled AS

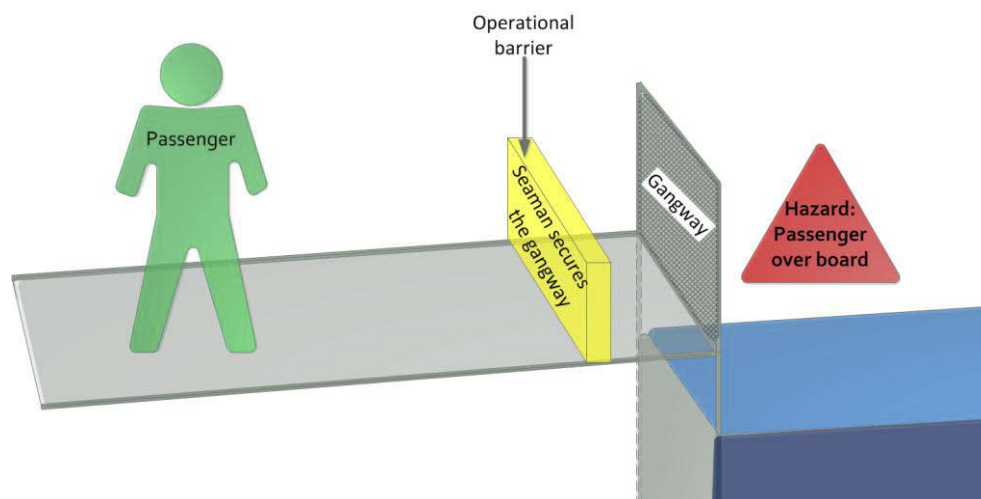
The technical solution and the work duties therefore only involved one operational barrier intended to ensure that the gangway was secured during the crossing, see Figure 12.

This barrier is deemed to be a weak one, since it is common knowledge that people easily forget, become distracted or otherwise fail to carry out their duties as envisaged in an ideal situation. The technical solution and work procedure for securing the gangway on departure from the quay have thus not taken into account that to err is human.

Figure 12: Illustration of the operational barrier intended to prevent passengers from falling overboard. This is deemed to be a weak barrier, since it is common knowledge that people easily forget, become distracted or otherwise fail to carry out their duties as envisaged in an ideal situation. Illustration: AIBN

The Accident Investigation Board Norway recommends that the shipping company Norled AS carry out the necessary assessments and measures to prevent similar man overboard situations.
