REPORT

Sjø 2013/03

REPORT ON THE INVESTIGATION OF A MARINE ACCIDENT CLIPPER SUND LAIR6 OCCUPATIONAL ACCIDENT ANTWERP 6 SEPTEMBER 2011

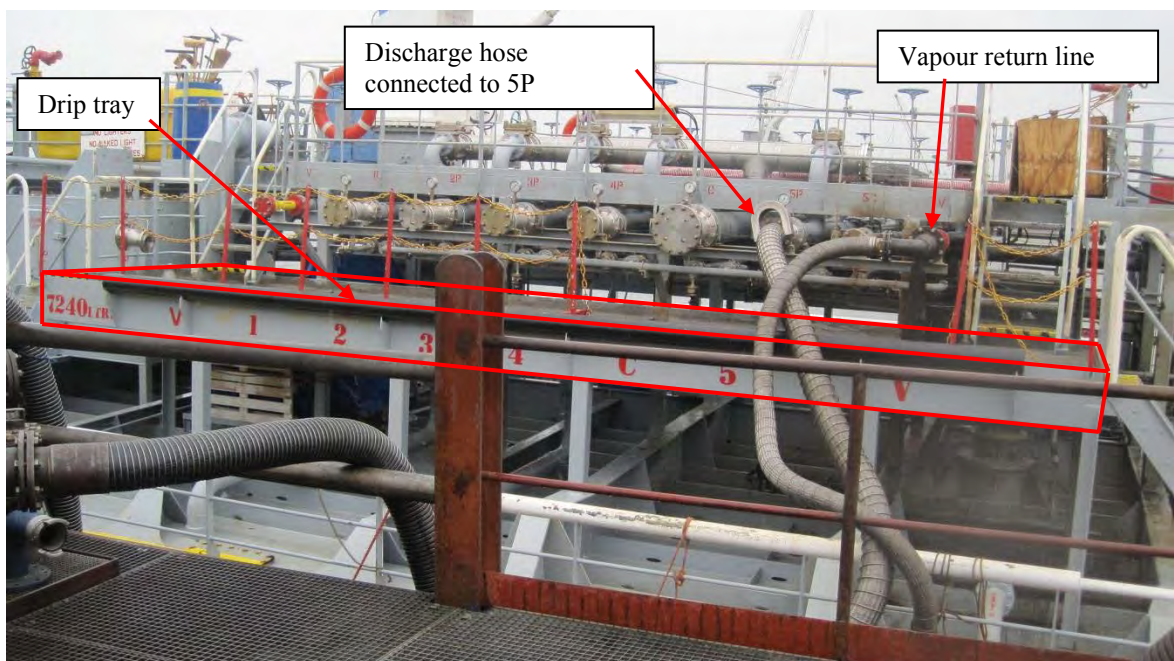
Figure 5: The photo shows how the discharge hose and the vapour return line were connected. The photo also shows the drip tray under the manifold. The drip tray's total capacity is 7,240 litres. Photo: LBC

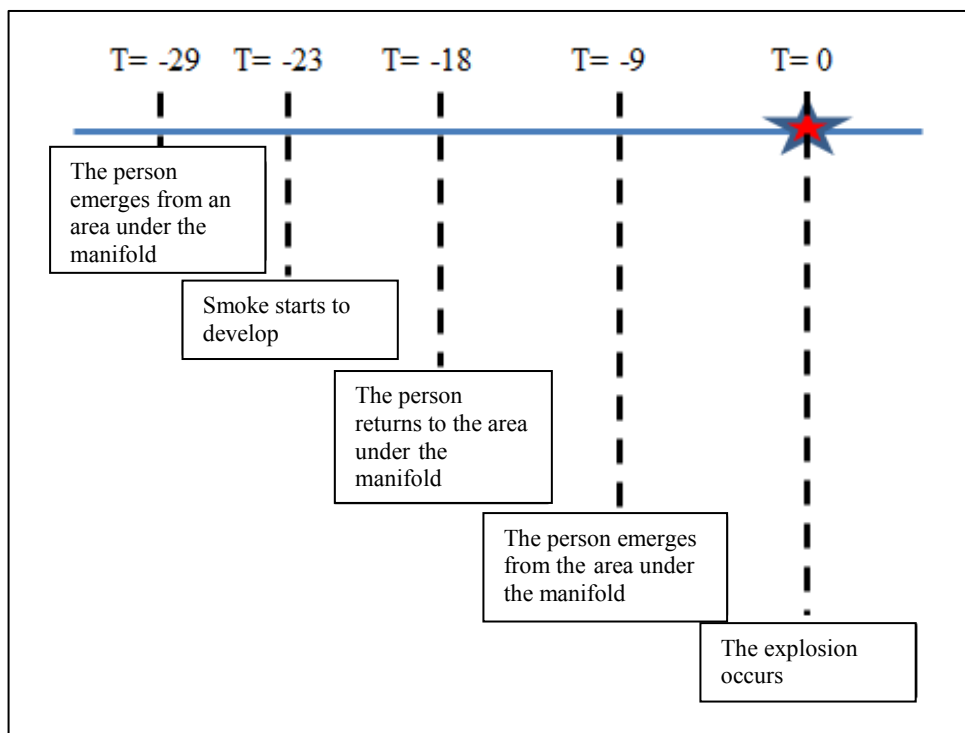
Figure 6: A timeline showing the movements of a person at the manifold just before the explosion occurred. T= -29 is 29 seconds before the explosion. Illustration: AIBN.

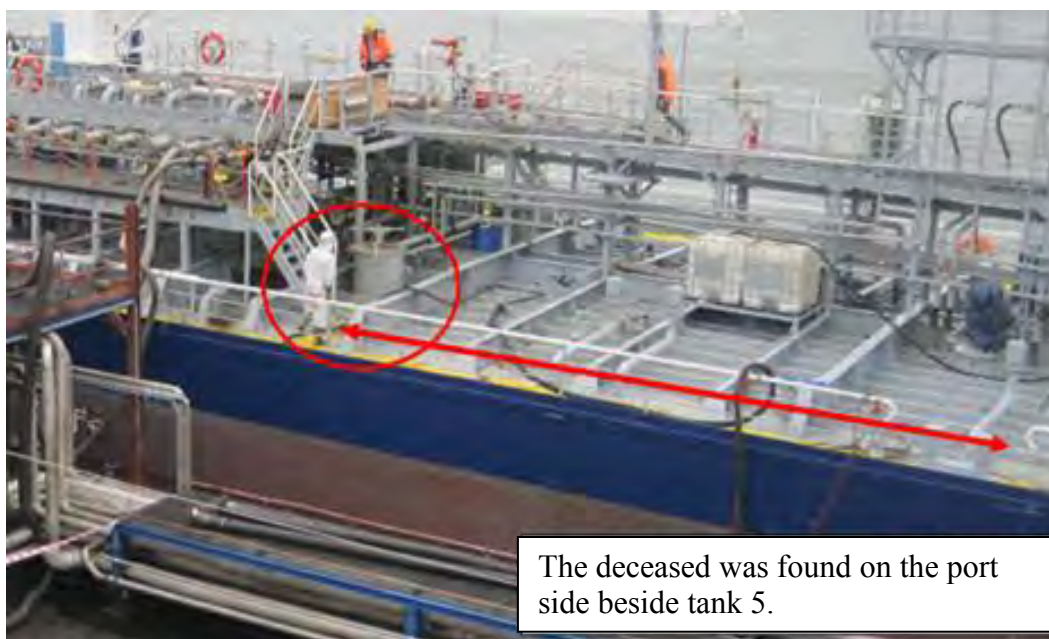
Figure 7: The photo shows the area from the manifold and aft to tank 5 on the port side. The red circle marks the area the seaman moved in and out of under the manifold. The arrow indicates the area within which the seaman moved shortly before the explosion. The photo was taken the day after the accident and the persons shown have nothing to do with the accident. Photo: LBC

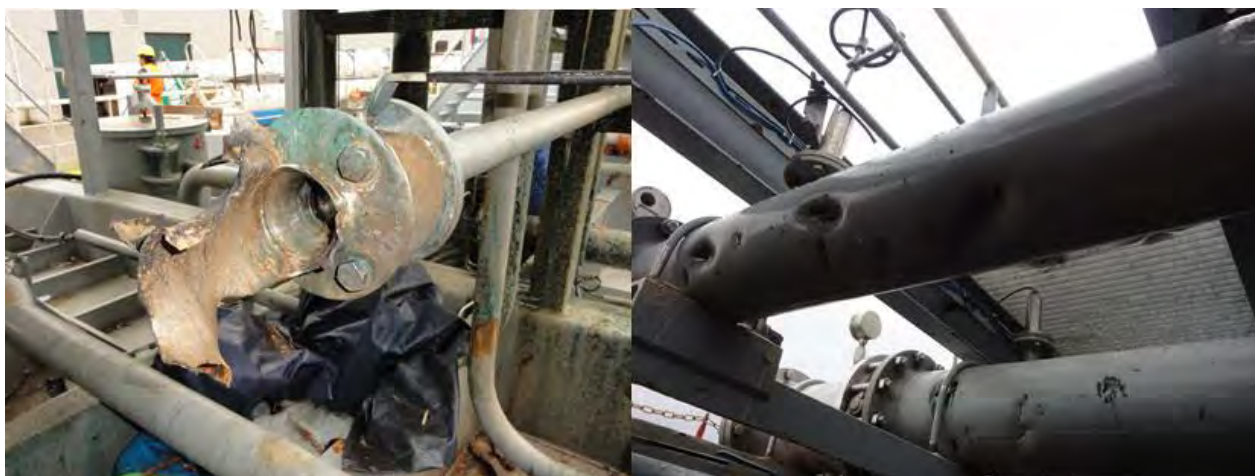
The explosion in the area under the manifold resulted in damage to different structures in the area; see Figure 8.

Figure 8: The photo on the left shows the drainline that was blown up. The photo on the right shows one of the cargo lines perforated by flying parts of the drainline. Photo: Capt. Hugo Vereckeen

In addition, parts of the drainline were found strewn over large parts of the Clipper Sund's deck. Parts of the pipe were also found in the onshore facility as far as 150 metres from the site of the explosion.

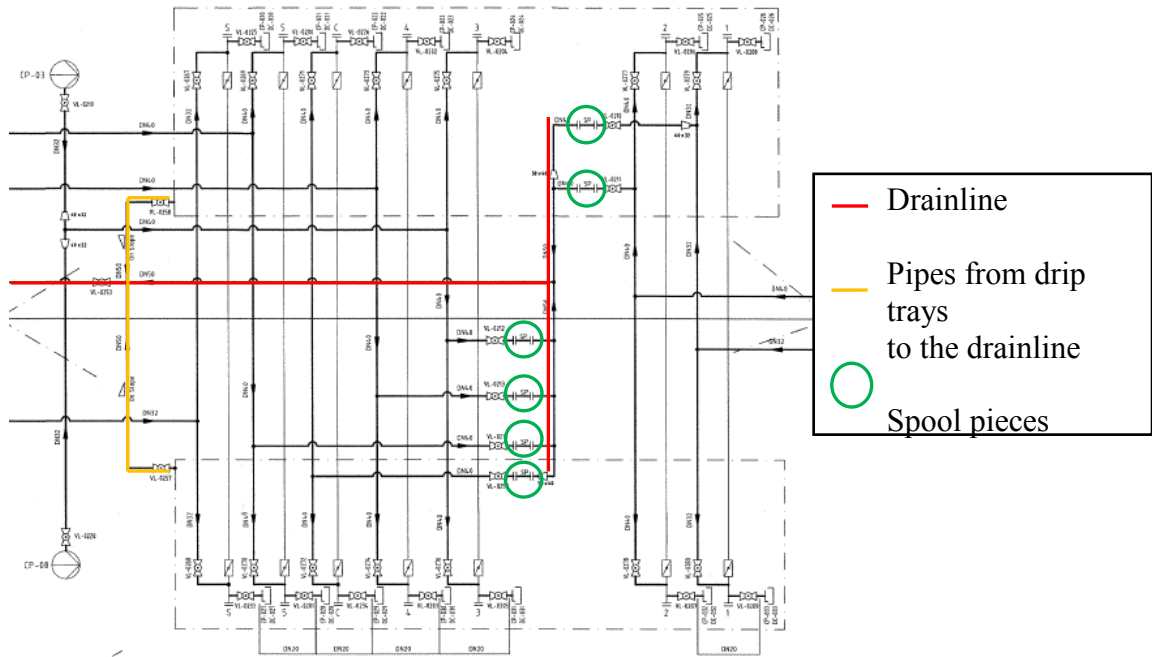
Figure 11: A section of the manifold area showing the stripping and drain system as well as the pipe connection between the drip trays and the drainline. Illustration: Brødrene Klovning Shipping/AIBN

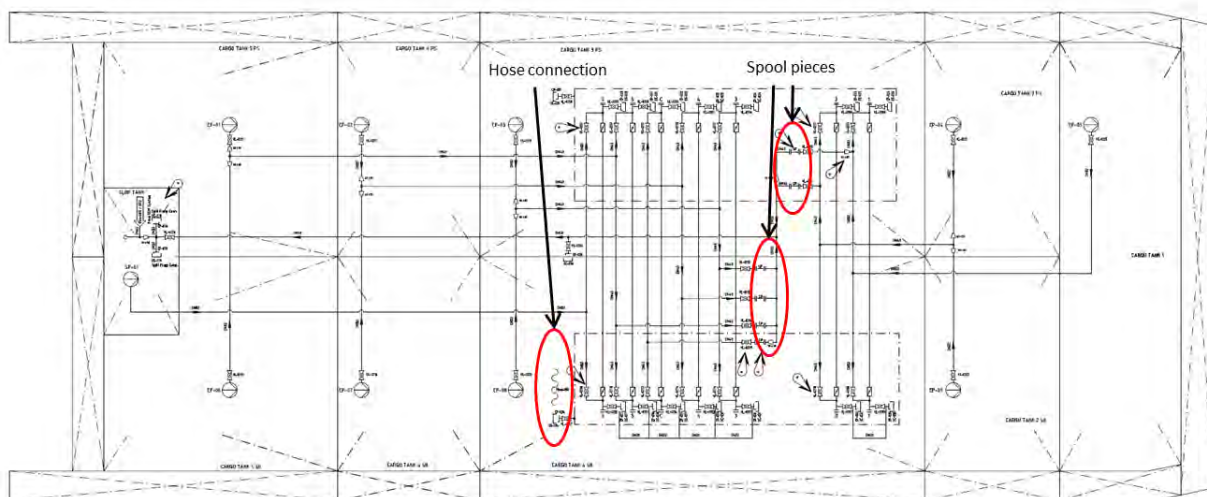
The shipyard responded to this requirement and sent revised drawings (rev. A) in which spool pieces were introduced between the stripping lines and the common drainline.

Figure 16: Revision A 'Drain and Stripping Cargo System' shows the introduction of a spool piece and hose connection from the drip tray (red circles). Illustration: Brødrene Klovning Shipping/AIBN

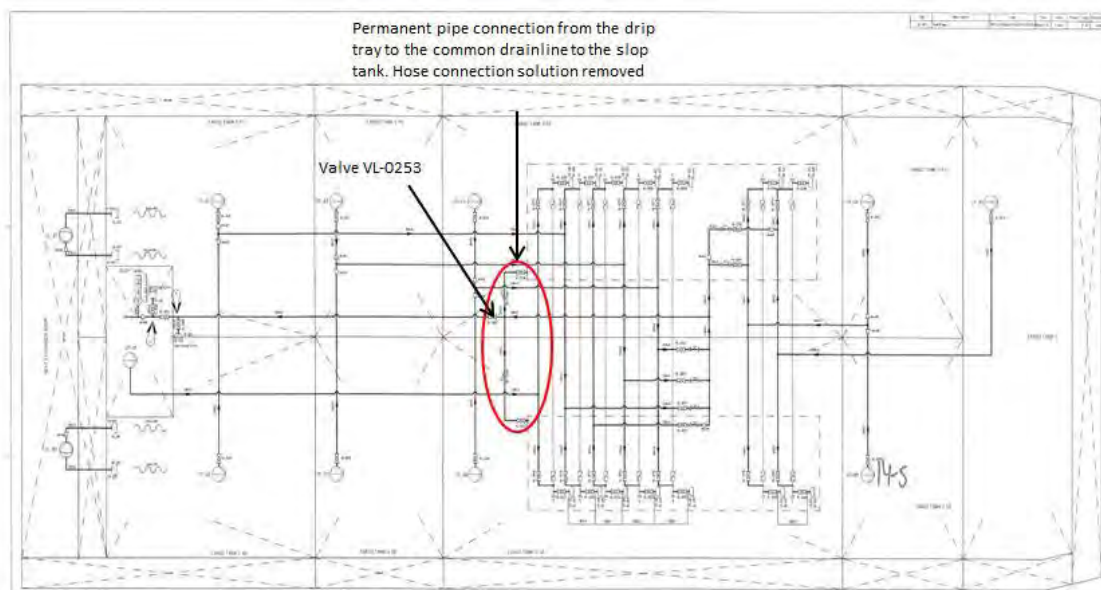
Figure 17: P&ID Drain and Stripping Cargo System revision C shows, among other things, the permanent pipe connection from the drip tray to the common drainline that was introduced in revision B (see the red circle). Illustration: Brødrene Klovning Shipping/AIBN

According to information from DNV, this was accepted by the local inspector from Veritas at the yard, and according to DNV, this is in accordance with the requirement for separation laid down in the IBC Code. This is based on the drip trays being treated as open systems and, as a result, segregation is not being required.

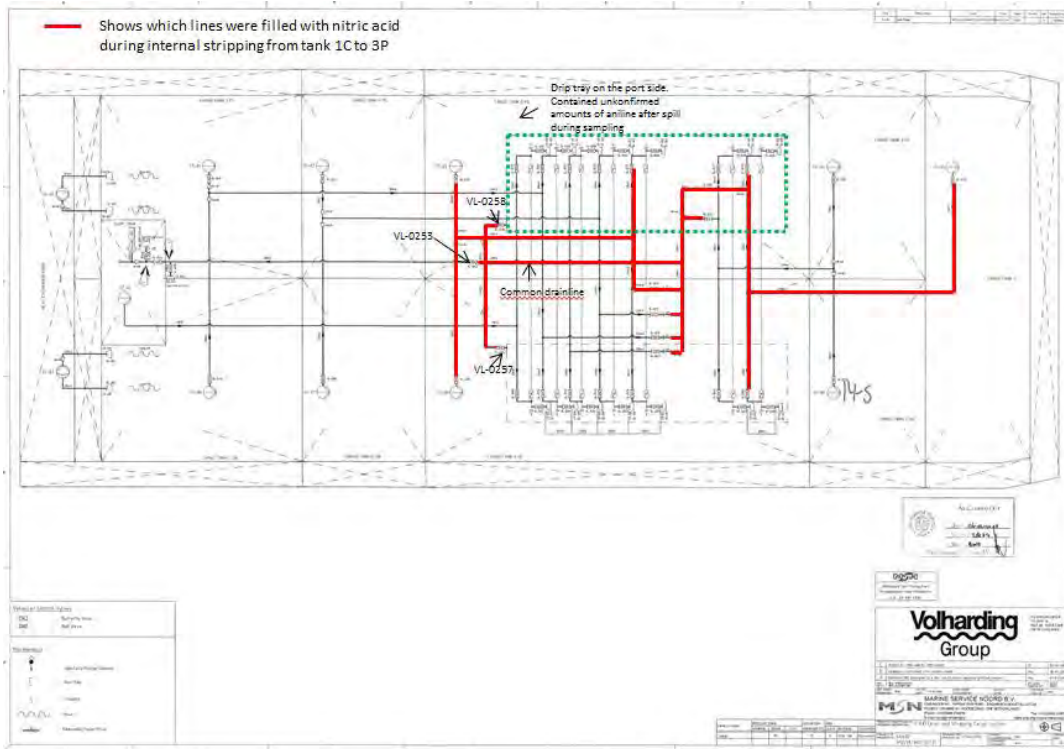
As described in the description of the chain of events, the tanks were stripped from tanks 1C and 3P to 3S following the discharging of nitric acid. This stripping was carried out via the drainline and it resulted in parts of the latter being filled with nitric acid; see Figure 18. Valves VL-0257, VL-0258 and VL-0253 were closed during the stripping of the nitric acid and in connection with the subsequent blowing of air through the lines.

Figure 18: Illustration showing which lines were filled with nitric acid during internal stripping. Illustration: Brødrene Klovning Shipping/AIBN

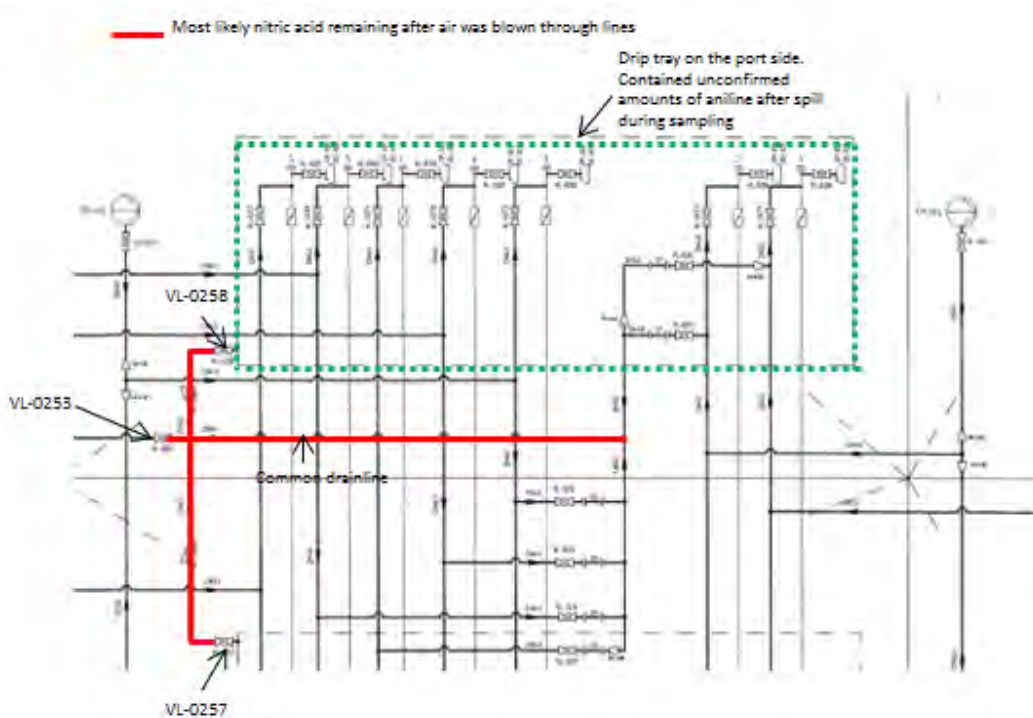
After the stripping, the lines were blown clean, but as a result of the drainline being used for stripping and the way the system is designed with a difference in height on the drainline, it is very likely that nitric acid remained in the T-joint as shown in Figures 19 and 20.

Figure 19: Illustration showing where the remaining nitric acid was most likely localised after air had been blown through the lines, and where aniline in the drip tray was localised. Illustration: Brødrene Klovning Shipping/AIBN

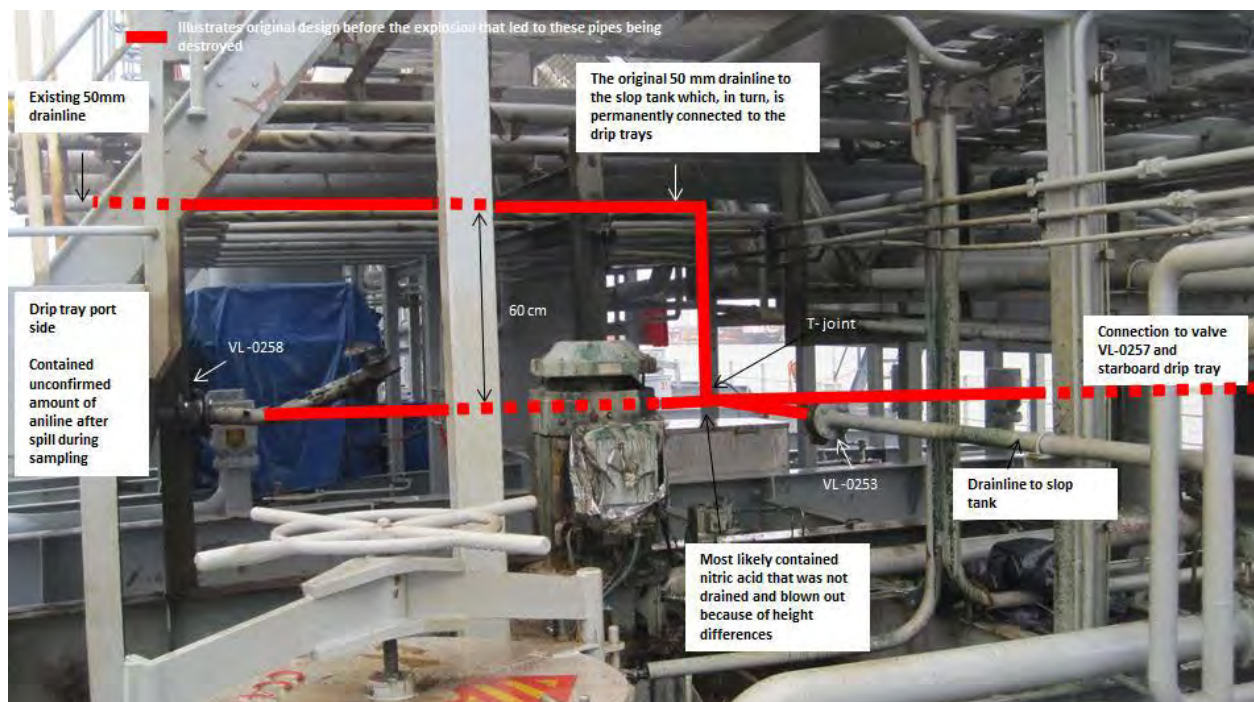
Figure 20: The figure illustrates the location of the drainline to the slop tank and where the drainline was connected to the drip tray. The figure also illustrates differences in height and the position of the pipe area, most likely containing residues of nitric acid after air had been blown through the lines. Photo: AIBN

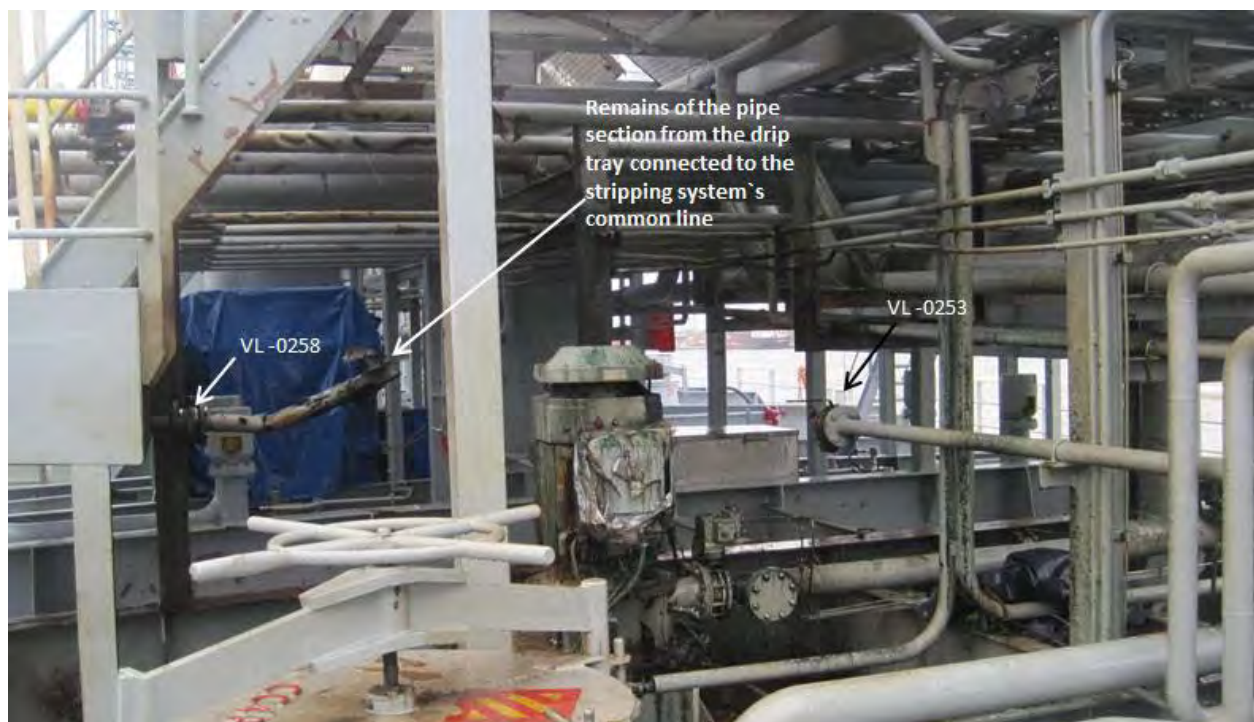
Observations made at the site of the explosion shortly afterwards show that the whole drainline between the valves indicated in Figure 20 has been destroyed or is missing.

Figure 21: The figure shows the remains of the pipe section from the drip tray on the port side to the drainline after the explosion, cf. Figure 20. Photo: AIBN

We know that the drainline contained nitric acid residues and that the drip tray contained aniline residues, possibly mixed with some rainwater.
