# REPORT

## MARINE 2014/06

## REPORT ON MARINE ACCIDENT – NORTH TUG, LG7141 (NOR) AND OCEAN PRINCESS IMO NO 9187899 (BERMUDA) CAPSIZING AND SINKING IN KIRKENES, NORWAY, 10 JUNE 2013

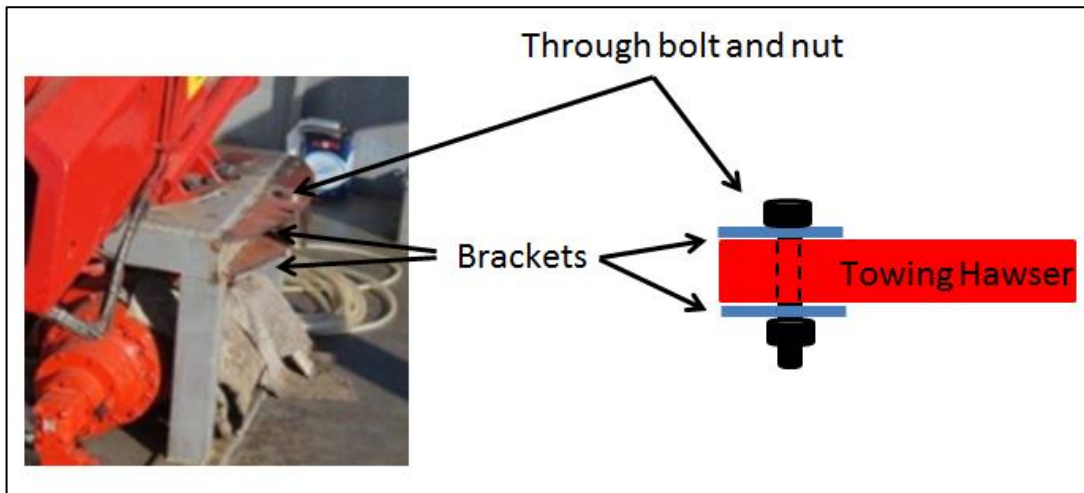
Figure 3: The photo on the left shows the fastening arrangement for the towing hook on board North Tug. The schematic drawing on the right shows how the eye of the towing hawser was locked to the fastening arrangement with a through bolt. Photo/illustration: Dykknor AS/AIBN

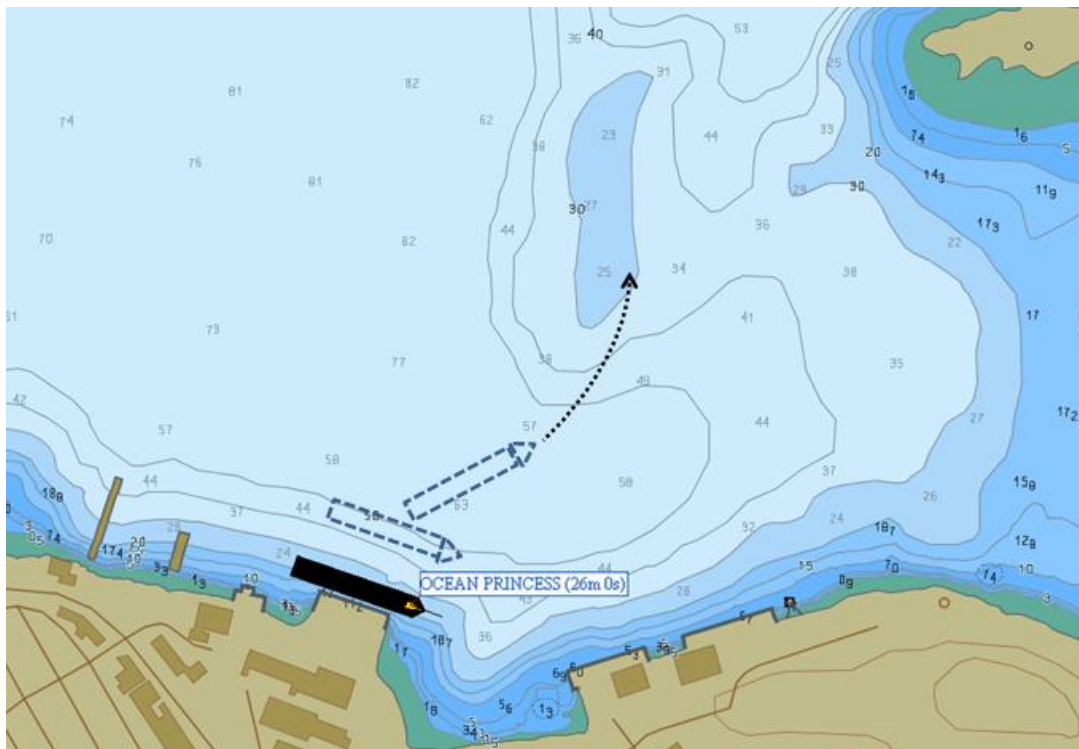
Figure 4: Schematic drawing showing the planned departure with 'North Tug' connected at the bow of 'Ocean Princess'. Source: NCA/AIBN

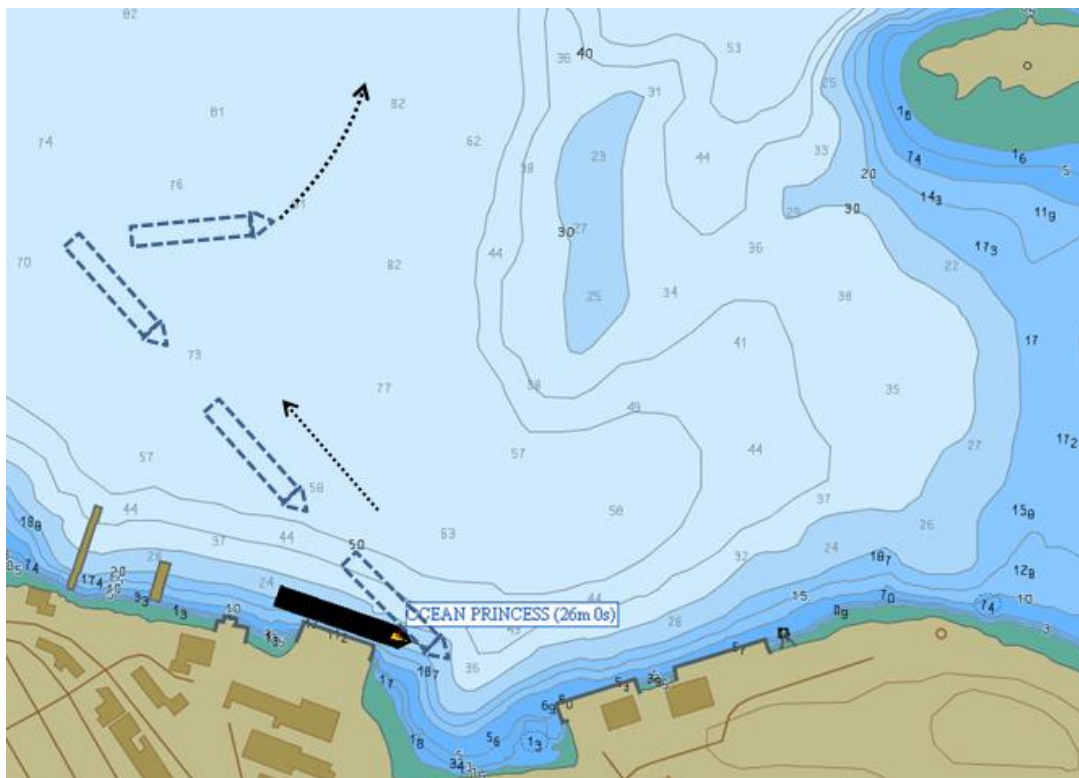
It proved difficult to manoeuvre *Ocean Princess* away from the quay. The ship managed to put a distance of only 15–20 metres between itself and the quay, while moving approximately 30 metres forward (eastwards). About 9 minutes after starting the manoeuvre, the cruise ship's captain decided to change the original plan and let the bow move over to starboard, into the bay east of the deepwater quay, and then set the engines to go astern. The aim was to come clear of the piers that were located behind the cruise ship, where several fishing vessels were moored (see Figure 5). The manoeuvre was discussed with the pilot, and they agreed that it was a satisfactory plan. The change in the planned manoeuvre was not communicated to the skipper of *North Tug*.

Figure 5: Schematic drawing showing the changed departure plan. Source: NCA/AIBN

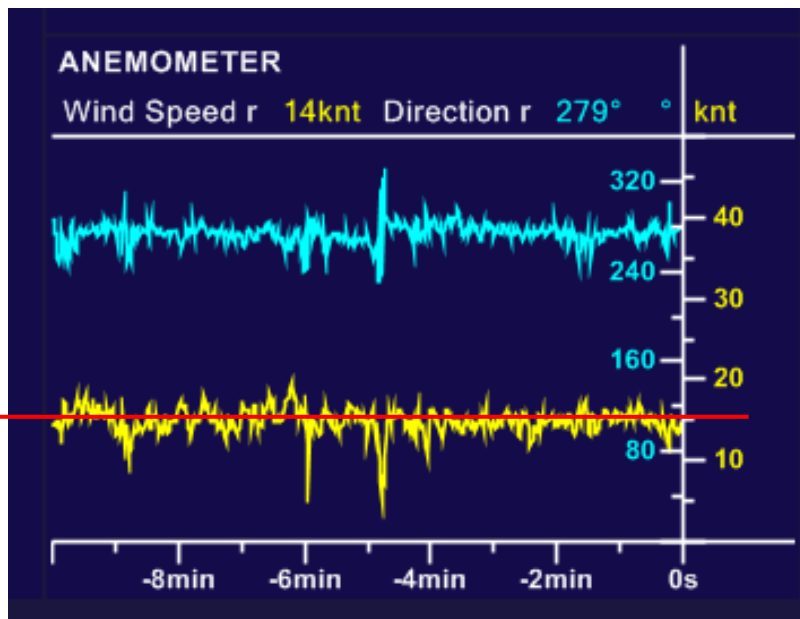
15 knots (7.7 m/s), with gusts of up to 20 knots. The figure below shows an excerpt of wind data from *Ocean Princess's* voyage data recorder (VDR).

Figure 6 Excerpt of wind data from the VDR on board 'Ocean Princess'. Shows the relative wind speed and direction in the period from 17:57 to 18:07 LT. Source: Princess Cruises /AIBN

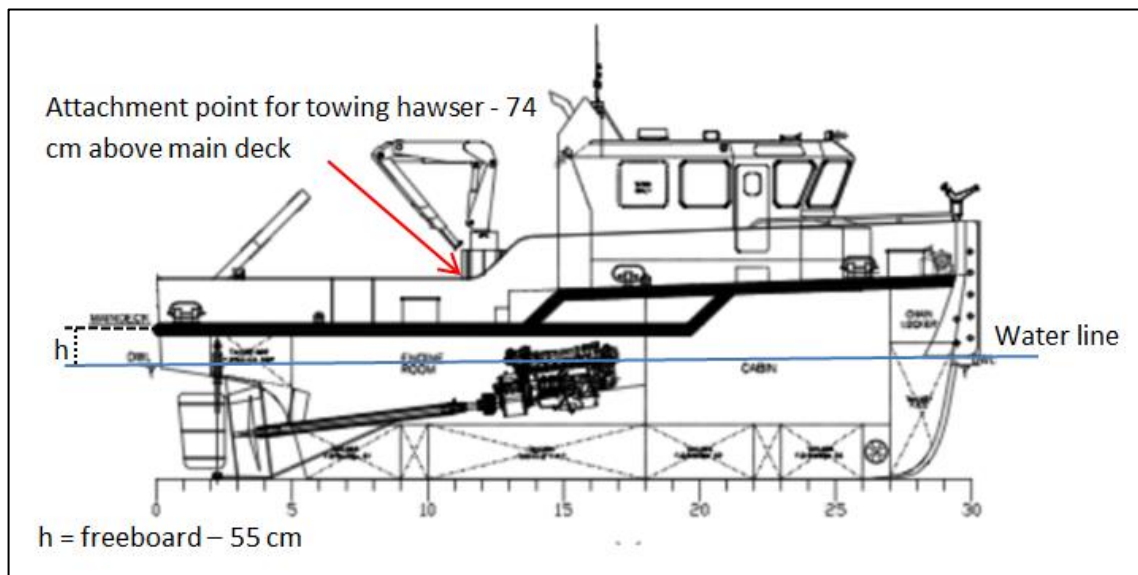
Figure 7: Schematic drawing showing 'North Tug' with indication of the height of the towing hawser's point of attachment and the stern freeboard. Source: Dykknor/AIBN

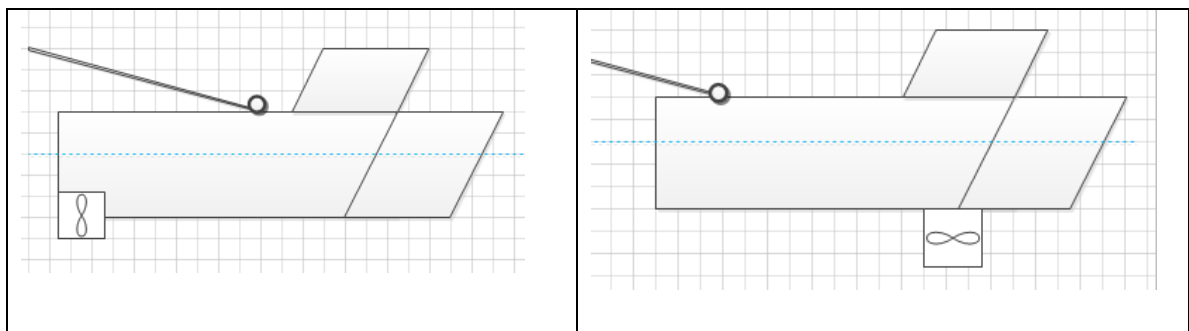
At present there are a number of different tugboat designs adapted to local conditions in individual ports and to the different vessel types that the tugboats are intended to assist. A number of methods for providing assistance to vessels have also been developed. For towing on a line, a distinction can be made between two types of tugboat: the conventional tugs on which the towing point is located forward of the propeller(s) and the tractor type on which the towing point is located aft of the propeller(s) (see Figure 9).

Figure 9: Schematic drawing of a conventional tugboat (on the left) and a tractor-type tug boat (on the right), both towing on a line. Source: AIBN

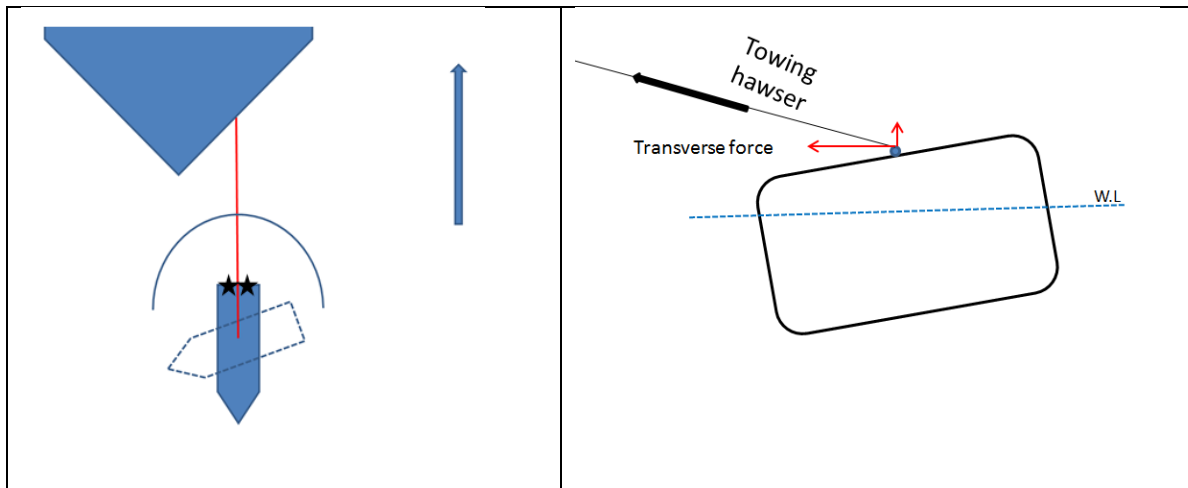
Conventional tugboats are used for all methods of towing, but these tugs have limitations when used as stern tugs<sup>3</sup>. When the vessel being assisted has a speed of more than 3 knots through the water, a conventional tugboat used as a stern tug can only operate along the side of the assisted vessel. With the towline attached at the point shown in the figure below, there is a risk that the tugboat will end up sideways on the direction of towing and be pulled over to the side.

Figure 10: The schematic diagram on the left illustrates a situation in which the tugboat is being pulled along by the vessel to be assisted. Because of the position of the propellers in relation to the towing point, the tugboat is very vulnerable to the sideways pull. The schematic drawing on the right shows the tugboat seen from behind and illustrates how the forces exerted by the tug act on a vessel being pulled sideways. The vessel will also be exposed to several other forces.  
Source: AIBN

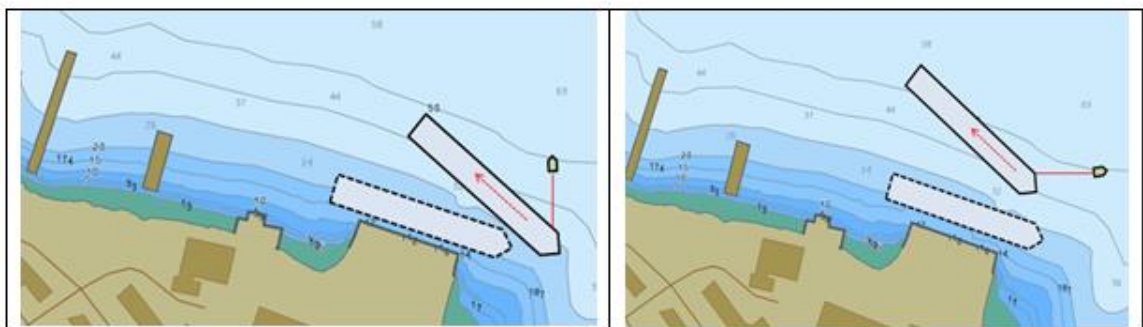
Figure 11: The schematic diagram illustrates *Ocean Princess*'s astern movement. To begin with the towline went slack and 'North Tug' remained in virtually the same position until the towline became taut again, at which time it was in a forward angle in relation to 'Ocean Princess'. 'North Tug' was pulled along by 'Ocean Princess'. Source: NCA/AIBN

*North Tug* went from being a conventional tug towing on a line over its stern and thus having good manoeuvrability, to a situation where it was being pulled along, stern first, by *Ocean Princess*. This was a situation that it was impossible for the tugboat to manoeuvre out of.

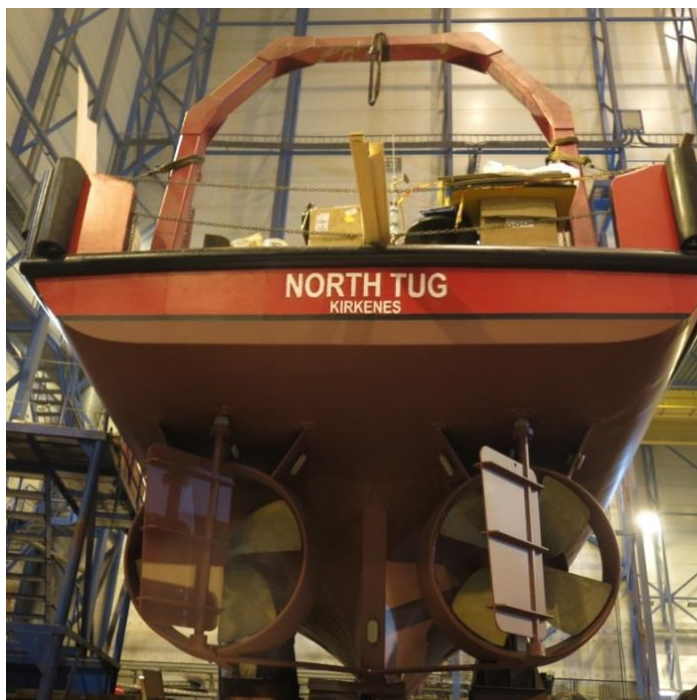
The skipper of *North Tug* set both engines to go astern to follow *Ocean Princess*, but the increased speed caused the aft deck to start filling up with water. *North Tug*'s open square stern and low freeboard made it possible for water to fill the deck (see Figure 12).

Figure 12: The photo shows the shape of the stern of 'North Tug'. The stern freeboard was about 0.55 metres. Photo: AIBN

The increasing amount of water on the aft deck contributed to reducing the boat's stability and probably caused heeling, which in turn increased the probability of the boat turning broadside. When the skipper finally understood that the situation was becoming serious, he tried to set both engines to forward. In connection with this manoeuvre, the starboard engine stopped.

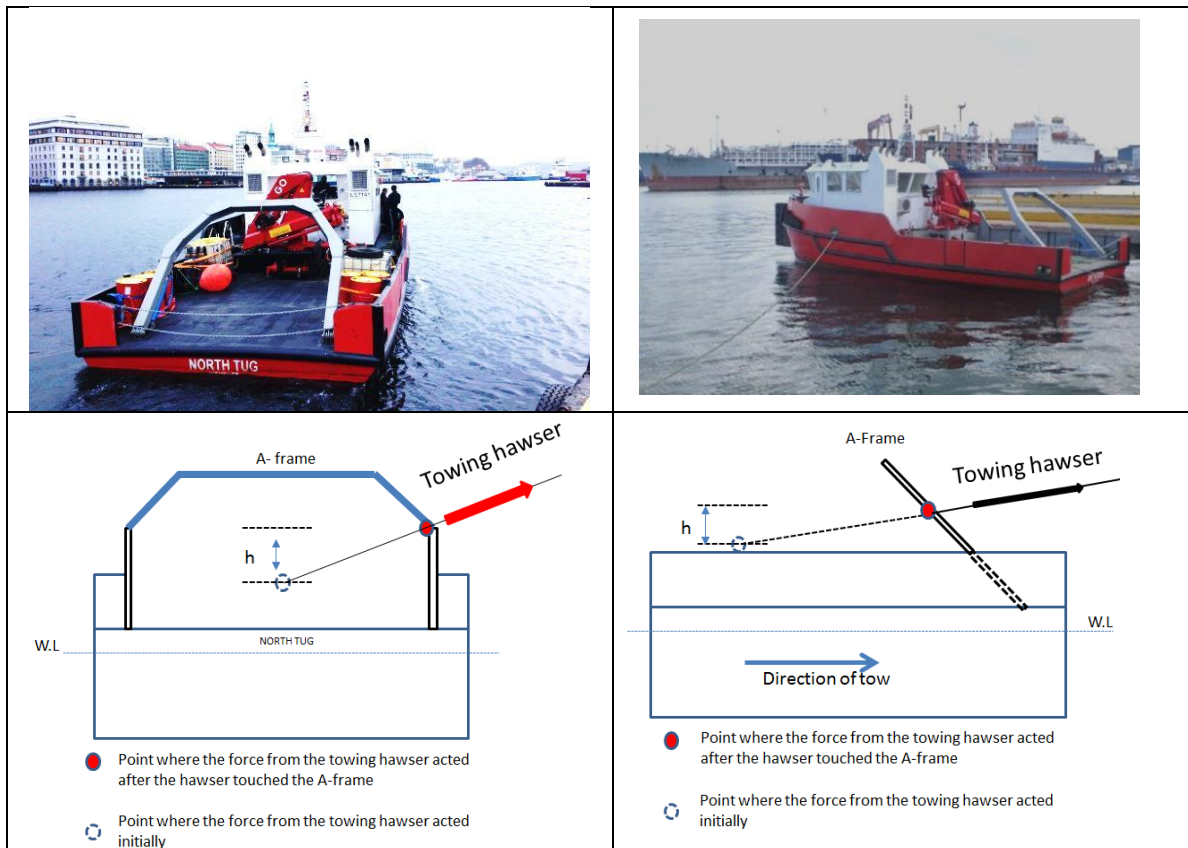
The probable capsizing scenario is that *North Tug*, in what was already a very unstable situation, turned rapidly to starboard when one of its engines failed. When the boat turned to starboard and the towing hawser made contact with the A-frame at the stern of the boat, the point at which the force exerted by the towing hawser acted shifted abaft and upwards from the point where the towline was originally attached (see Figure 13). This increased the heeling and the speed with which water filled the deck. The amount of water on deck and the forces from the towing hawser caused *North Tug* to capsize.

Figure 13: The schematic diagrams show how the point of action of the forces from the towline probably moved abaft and upwards when North Tug turned to starboard. Source: Dykknor AS/AIBN
