## MARINE 2014/07

## REPORT ON MARINE ACCIDENT POLARIS I, IMO NO 4500163, PERSONAL INJURY, YMERBUKTEN BAY IN THE ISFJORD ON SVALBARD, 21 AUGUST 2012

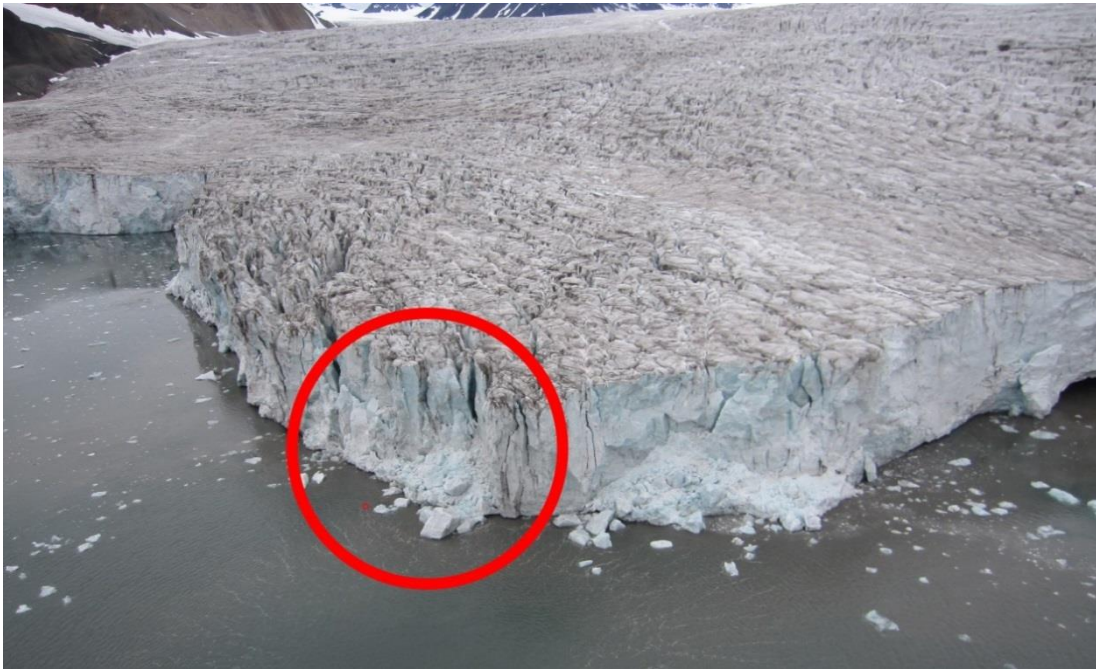
*Figure 4: Aerial photo of the front of the Esmarkbreen glacier. The photo was taken the day after the accident. At the bottom of the photo, two areas where large sections of the front have recently calved off from the glacier can be seen. These areas can be recognised by the ice in the water and by the colour of the ice being lighter (bluish green) than the rest of the glacier front. Of the two areas, the one on the left is where the calving took place when the accident occurred. To the left of this area, there are larger blocks leaning out over the fjord. The dinghies went along this part of the glacier front before the accident. Photo: The Governor of Svalbard.*

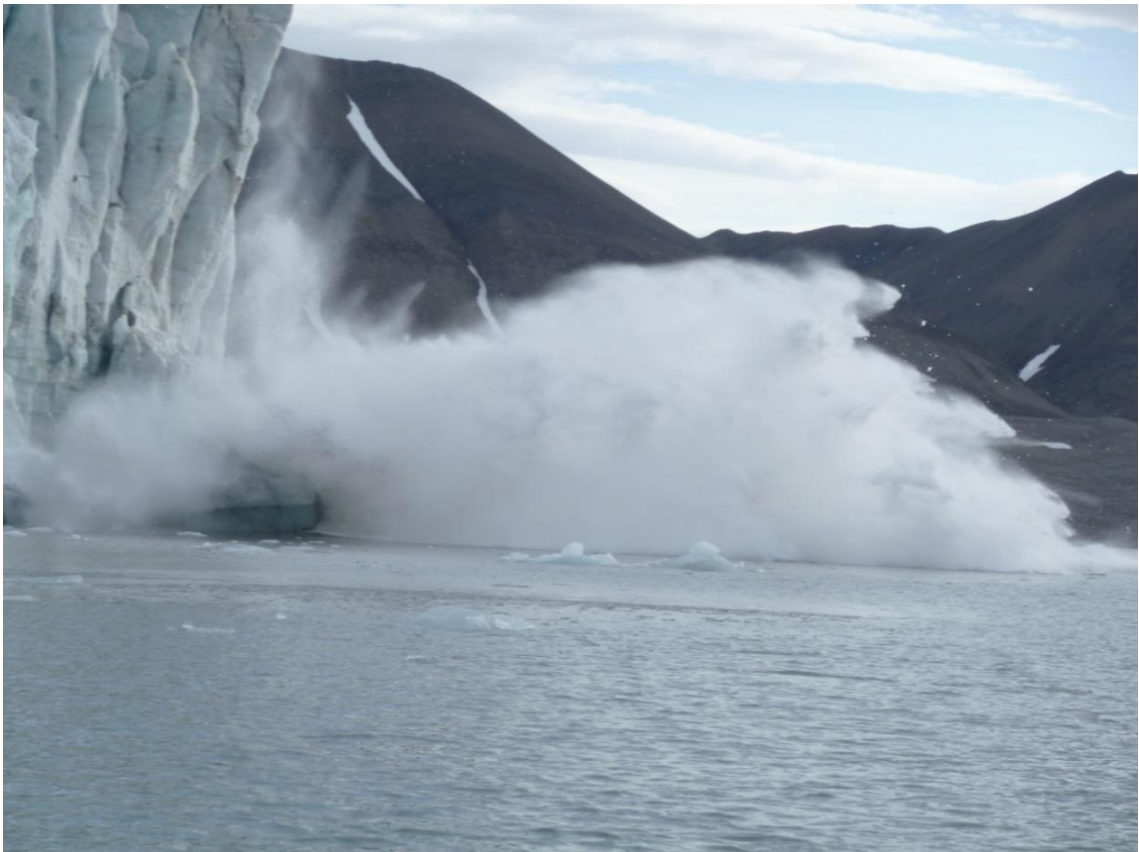
At approximately 0938, i.e. 28 minutes before the accident, the passengers and the guide on board Dinghy 2 saw that the glacier front calved. The ice hit dry land and lumps of ice were thrown horizontally from the shore; see Figure 5. This instance of calving was considerably smaller than what occurred at the time of the accident.

*Figure 5: Calving from the front of the Esmarkbreen glacier. The blocks of ice landed on dry land and lumps of ice came flying across the water. The photo was taken by a passenger approximately 28 minutes before the accident. Photo: Private.*

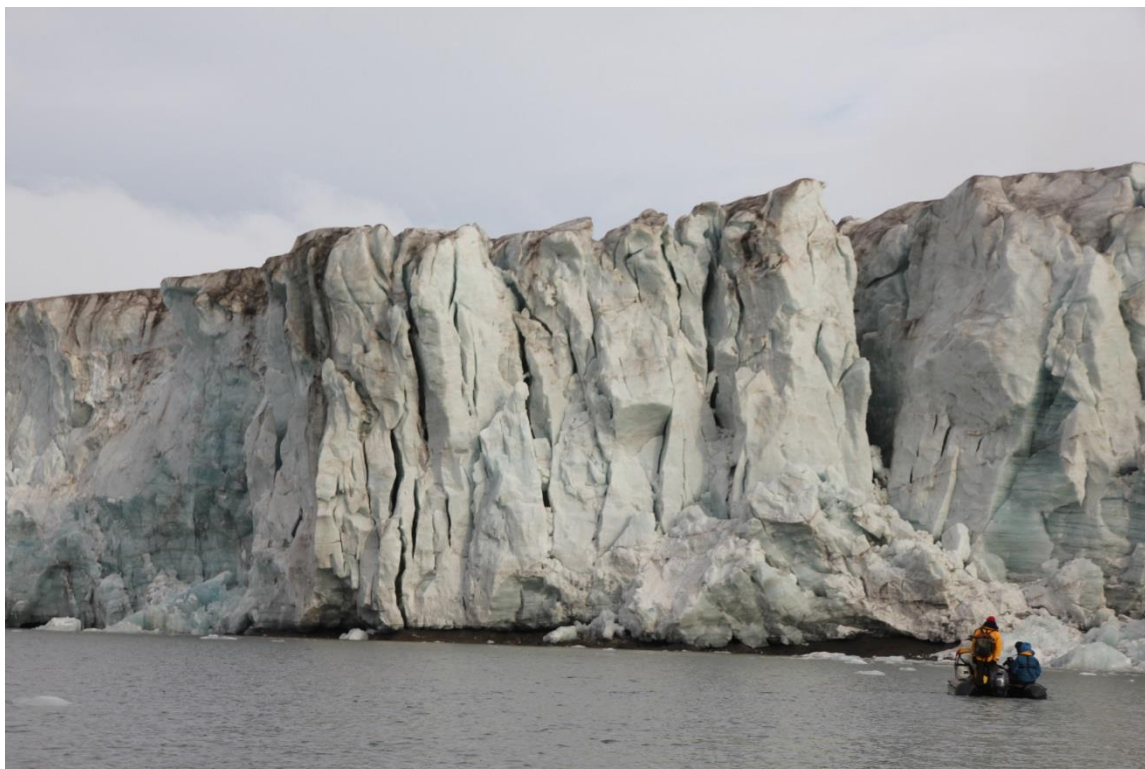
*Figure 7: The photo shows Dinghy 2 close to the glacier front. The dark area by the glacier front is dry land. The photo was taken from Dinghy 1 before the accident. Source: Private.*

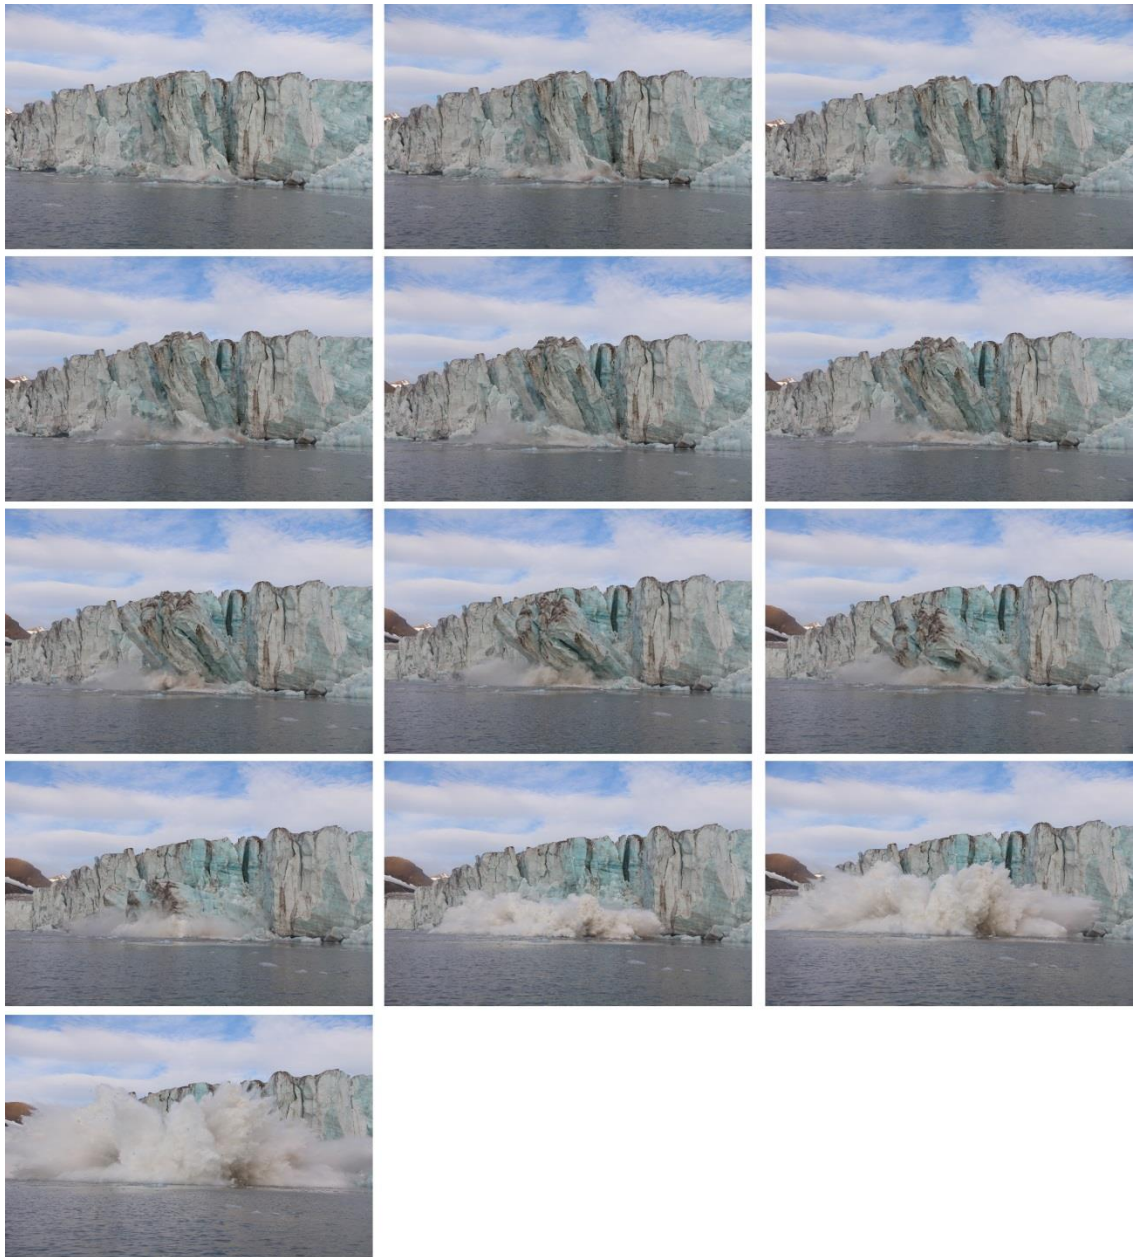
At approximately 1005, a massive calving event started. First some ice fell and a loud bang was heard, then a large section of the glacier front came loose and fell forward. The ice blocks were approximately 33 metres high, and they came down on dry land (shallow water). Because of the weight of and tension in the glacier ice, the blocks that hit dry land caused lumps of ice to fly across the fjord with tremendous force.

The passengers and guides on board both dinghies observed the massive calving event. Photos and video recordings were taken of the calving; see Figure 8, Figure 9 and Figure 10. Small and big lumps of ice came flying towards Dinghy 1 in the form of a white cloud mixed with hard ice. Most of it hit the water in front of Dinghy 1.

But some of the lumps of ice hit Dinghy 1. One of the passengers was struck by lumps of ice on the back of her neck and the left side of the back of her head. She suffered severe head injuries and died almost instantly. The deceased was 47 years old.

*Figure 8: Photos taken from the dinghy where one of the passengers died. The photos show that a large section of the glacier front calved off. The blocks of ice are about the same height as the glacier front, i.e. approximately 33 metres. The ice blocks fell down and hit dry land (shallow water). Lumps of ice were then sent flying across the fjord with tremendous force. Some of the lumps struck one of the passengers on board the dinghy, killing her almost instantly. The 13 photos were taken within the space of a minute. Photo: Private*

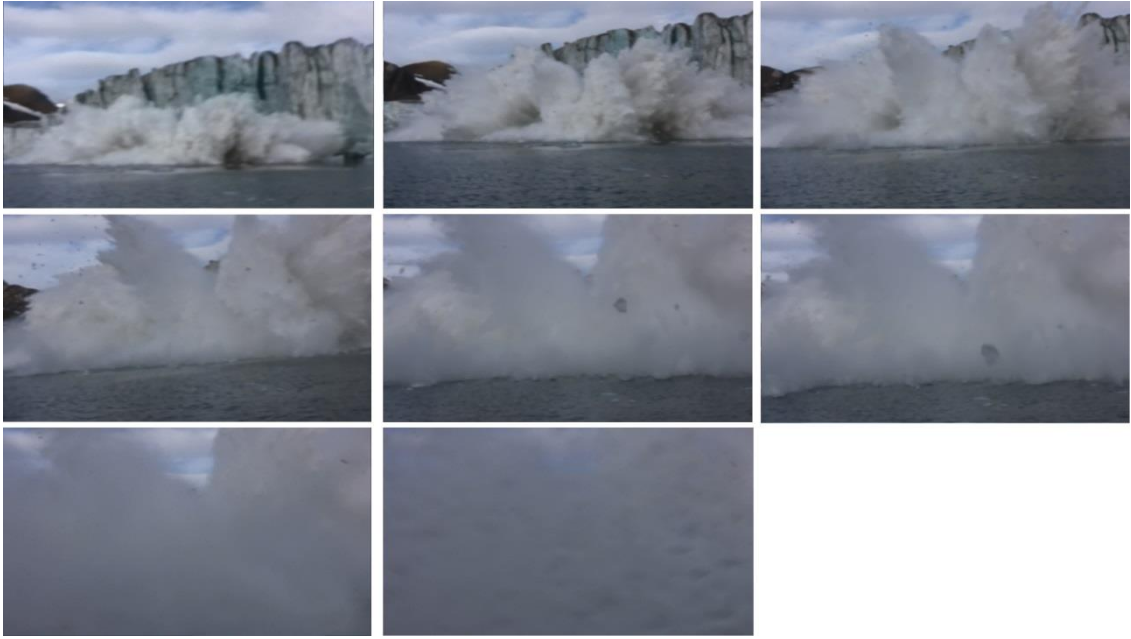
Figure 9: The photos show the same calving event as Figure 8. They are taken from a video filmed on board the dinghy in which the passenger died. Photo: Private

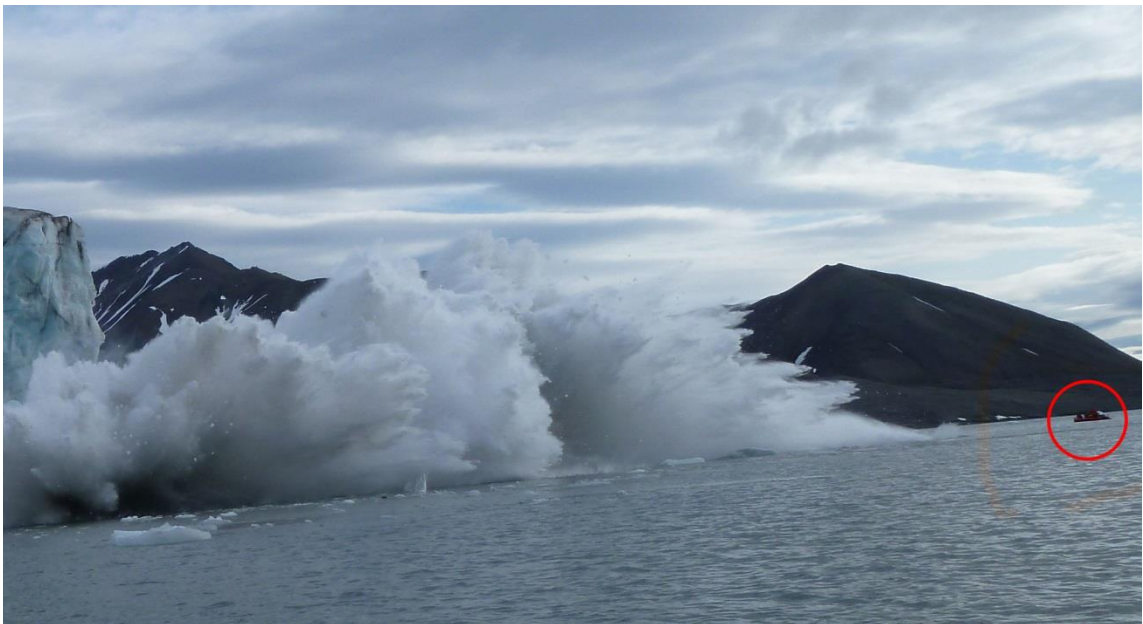
Figure 10: The photo shows the same calving event as Figure 8 and Figure 9. The photo was taken from the other dinghy. The photos show that a large section of the glacier front calved off and hit dry land (shallow water). Lumps of ice came flying across the fjord with tremendous force. The dinghy in which the accident took place can be seen on the right-hand side of the photo. Photo: Private.

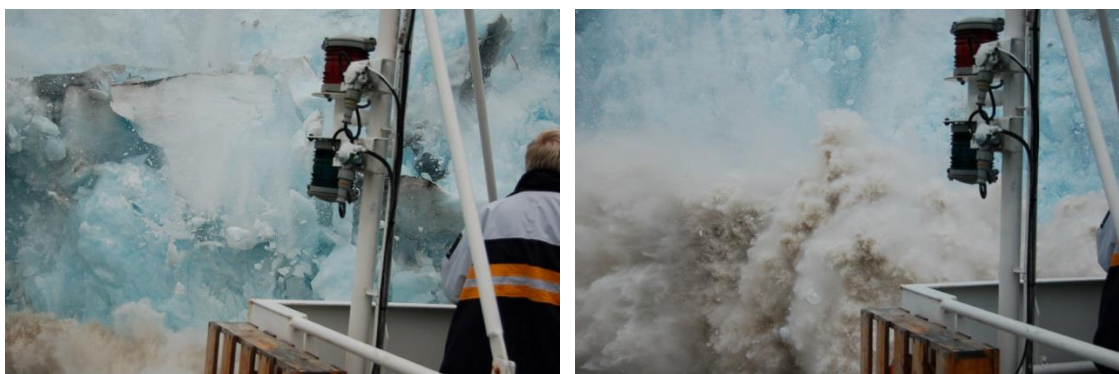
The vessel was less than 36 metres from the glacier front when a block of ice calved off. The calving event caused a big wave, and passengers on board were injured as a result.

Figure 15: The photos were taken by one of the passengers on board *Aleksey Maryshev* as a large block of ice calved off the glacier front. The vessel was less than 36 metres from the glacier front at the time. The calving event caused a big wave, and many of the passengers on board were injured as a result. Photo: Private
