## MARINE 2014/09

## REPORT ON MARINE ACCIDENT FINNØYGLIMT – LNIM FOUNDERED AT SLETTA NORTH OF HAUGESUND 7 OCTOBER 2011

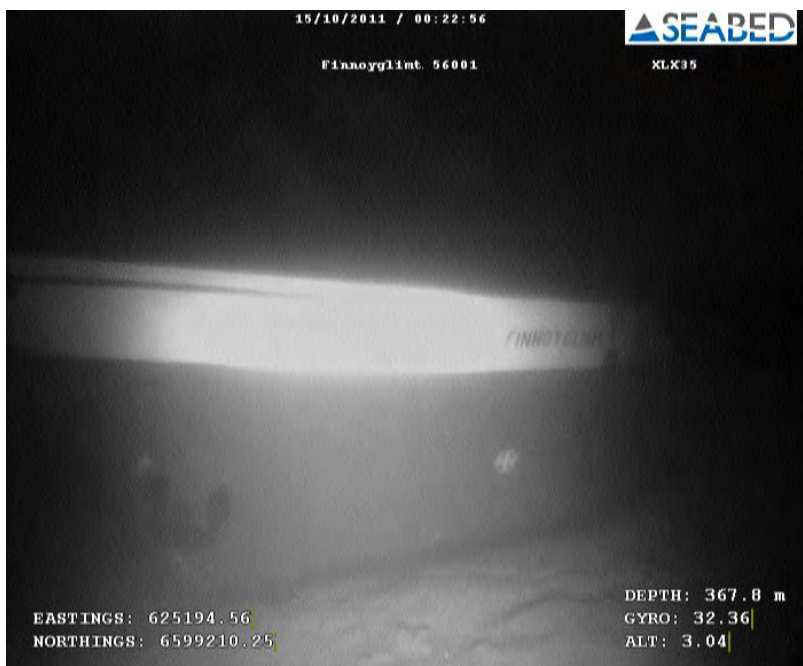
Figure 5: The photo shows the bow area on *Finnøyglimt*'s port side. Source: *Seabed Worker*'s ROV

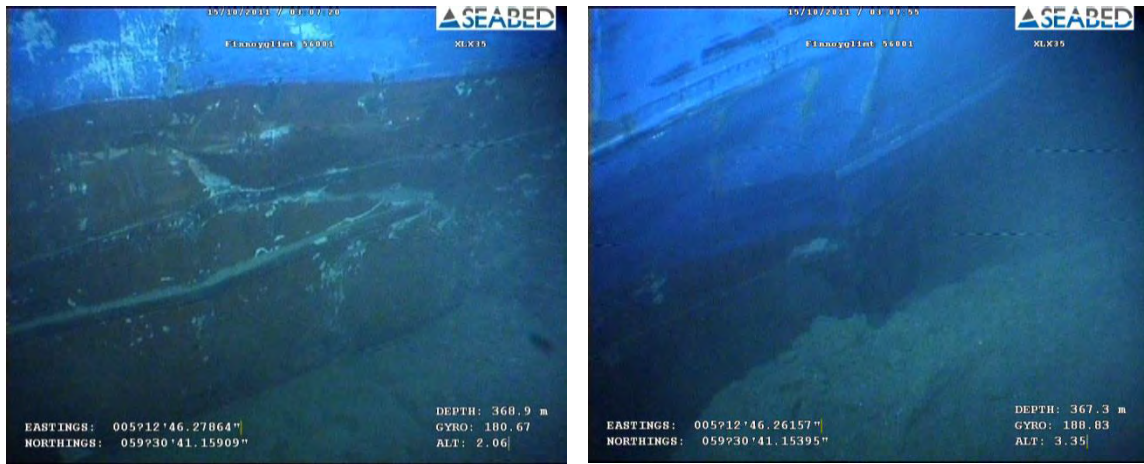
The forward shoulder was depressed on both sides, and buckling was observed in the foreship on the starboard side.

Figure 6: The photos show damage to the hull on Finnøyglimt's starboard side. Source: Seabed Worker's ROV

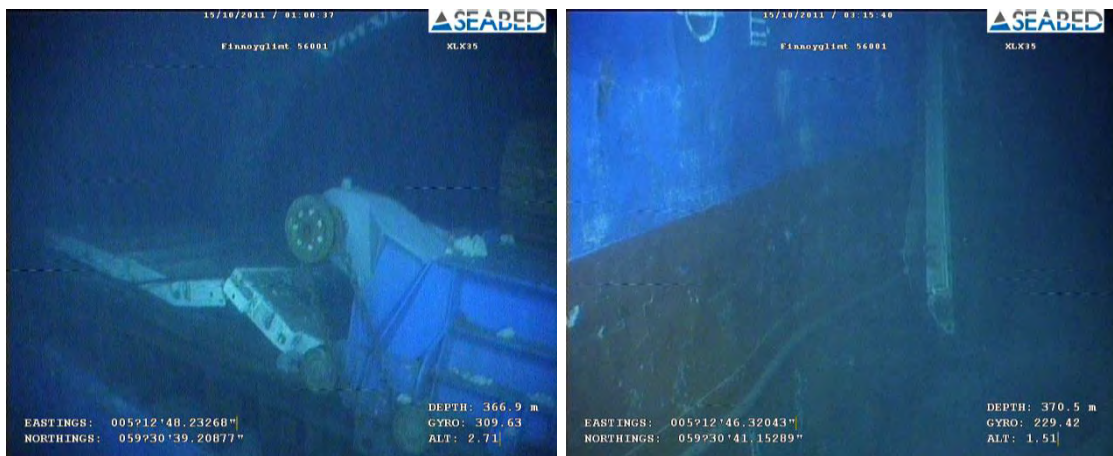
Hatch covers nos 1, 4, 5, 6 and 7 (numbered from fore to aft) lay on top of the coaming, but hatch covers nos 2 and 3 were missing. Hatch cover no 1 was clenched inwards on the port side, no 6 bent upwards at the aft end and no 7 bent upwards at the forward end. Hatch cover no 7 had been partially pushed under hatch cover no 6.

Figure 7: The photo on the left shows hatch cover no 6 bent upwards at the aft end and hatch cover no 7 bent upwards at the forward end. The photo on the right shows a cargo hatch cover that lay on Finnøyglimt's starboard side, fastened with a wire. Source: Seabed Worker's ROV

In the areas where the hatch covers were missing (nos 2 and 3), the jacks and securing devices were clearly visible. The aftmost securing device for hatch cover no 3 was missing on the starboard side. The jacks were down and the other securing devices lay unengaged in the steel frame to which they were attached.

In the areas where the covers were not missing, the jacks and securing devices were less visible. Observations of the hatch covers' sides showed, however, that none of the securing devices had been pulled up to the fastening lugs on the hatch covers and engaged.

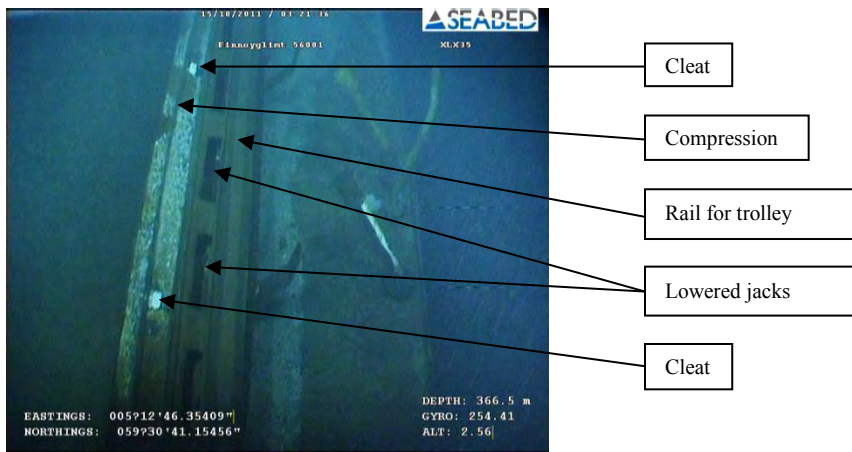
Figure 8: Hatch coaming and wheel track for excavator trolley seen from above. Source: Seabed Worker's ROV

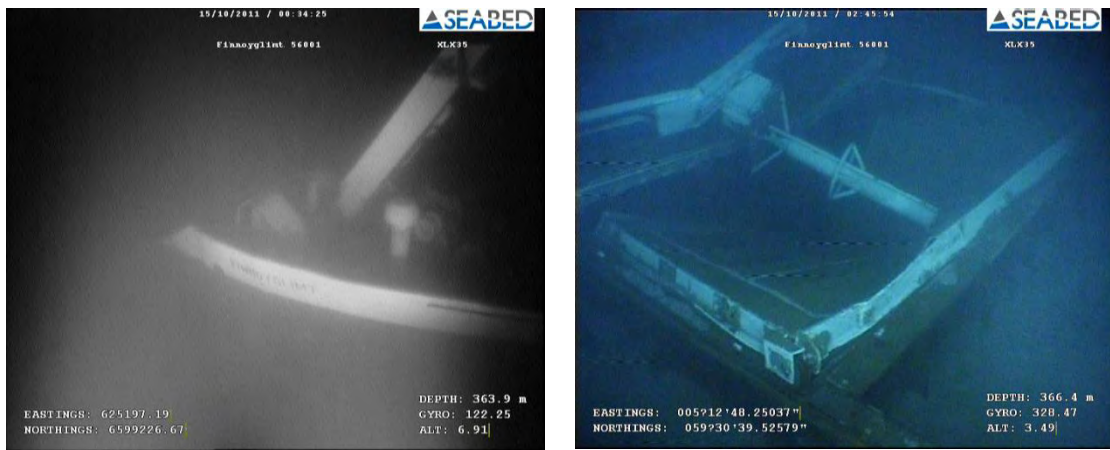
The foremast on the forecastle deck was bent (broken) forward towards starboard. The radar mast that had been mounted aft on the starboard side of the wheelhouse roof had come off and fallen down onto hatch cover no 7 just aft of the excavator trolley. The lantern mast, which also stood on the wheelhouse roof, was bent forwards (broken) on the wheelhouse roof.

Figure 9: The photo on the left shows the broken foremast, pointing forwards to starboard. The photo on the rights shows the radar mast on the wheelhouse roof, lying forward over the aftmost hatch cover. Source: Seabed Worker’s ROV

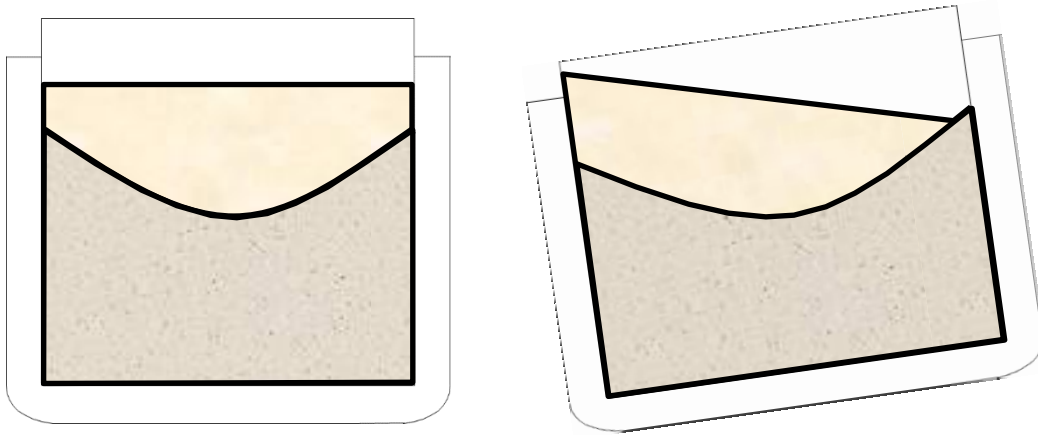
The phenomenon means that a sliding layer may arise in bulk cargoes so that part of the cargo is shifted if the vessels roll to one side or the other; see Figure 15. The sliding layer is not necessarily horizontal or linear, and the cargo will not necessarily be shifted back to where it came from by an opposite rolling movement. This means that the vessel can develop a dangerous list to one side and suddenly capsize.

*Figure 15: The figure illustrates the sliding layer that may arise in a moist bulk cargo when the particles in the cargo are compacted by the vessel's movements so that the water pressure increases and leads to reduced friction between the particles in the cargo. The reduced friction can lead to shifting of the cargo. Illustration: AIBN*

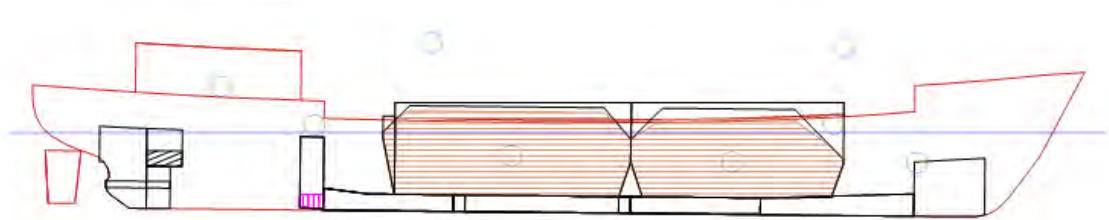
The calculations show that, on departure from Helle/Storasund, *Finnøyglimt* had a mean moulded draught of 3.588 m and a forward trim of 0.44 m; see load condition 8. The calculations show that the vessel's stability was satisfactory, see Figures 16, 17 and 18. The fact that the hatches were not secured was not taken into account.

Figure 16: Illustration of the vessel's load condition on departure from Helle/Storasund. Source: AIBN

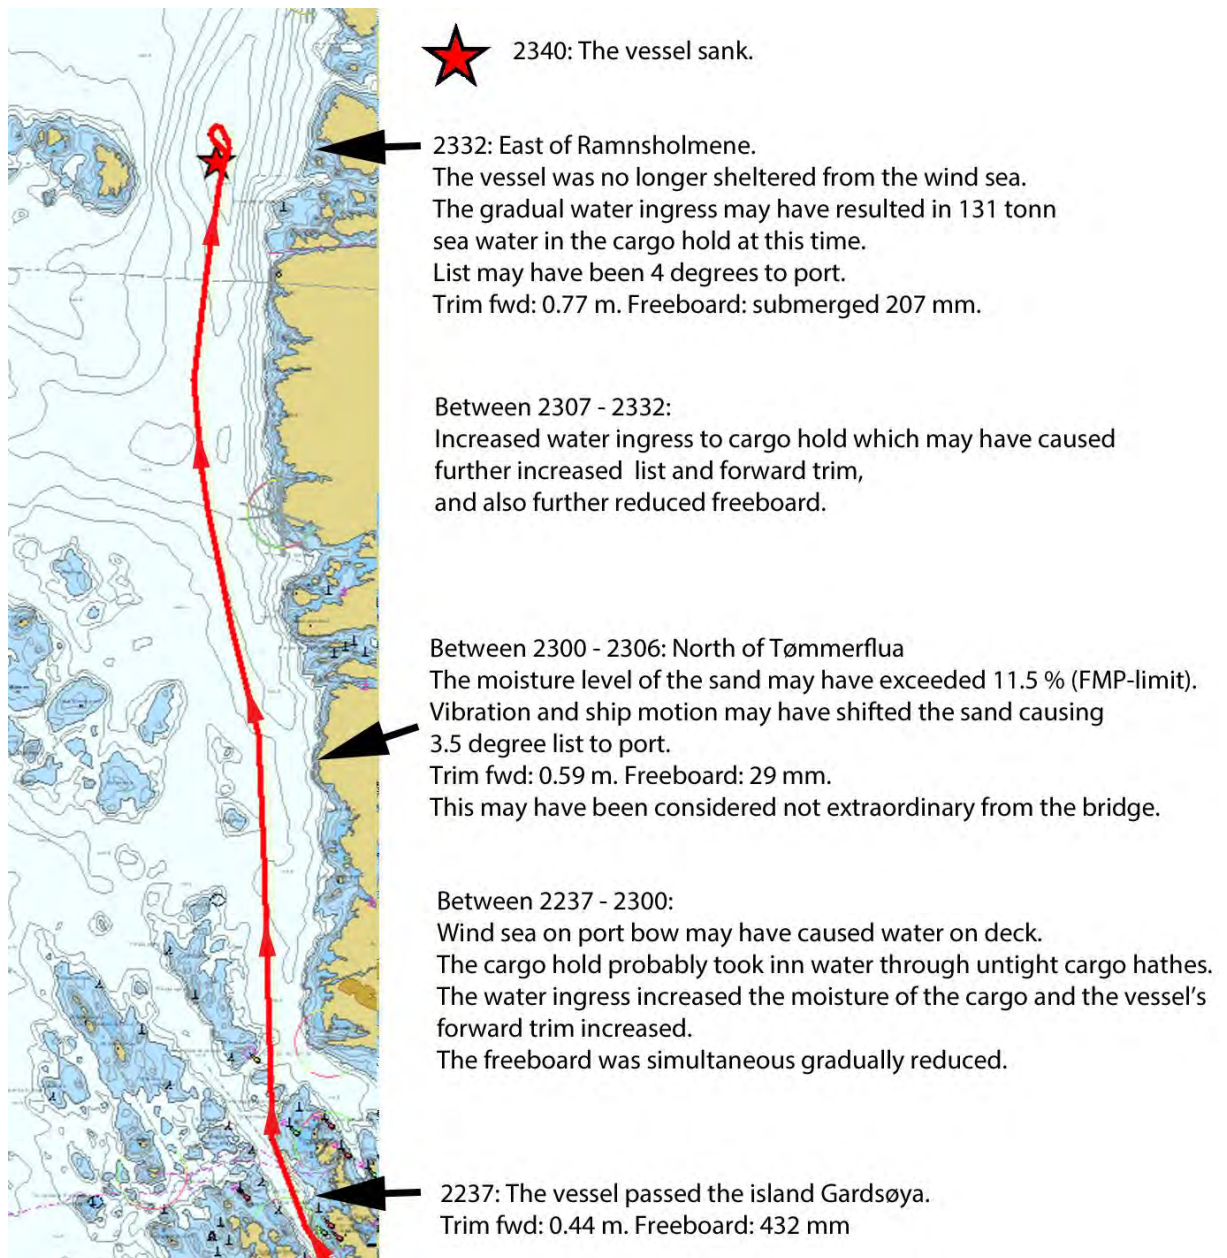
*Finnøyglimt* probably started to take in water in the cargo hold through leaking hatches as it passed Gardsøya at approximately 22:37; see Figure 19. Here, the vessel encountered bigger waves smashing against the port side of the bow as a result of the wind waves. This may have caused green sea on deck, leading to water ingress in the cargo hold. The water ingress meant that the vessel's forward trim gradually increased, at the same time as its freeboard was gradually reduced. The vessel was also exposed to longer swells against its side.

Figure 19: Illustration of assumed chain of events. Based on charts/maps provided by: the Norwegian Mapping Authority, Geovekst and municipalities) Illustration: AIBN

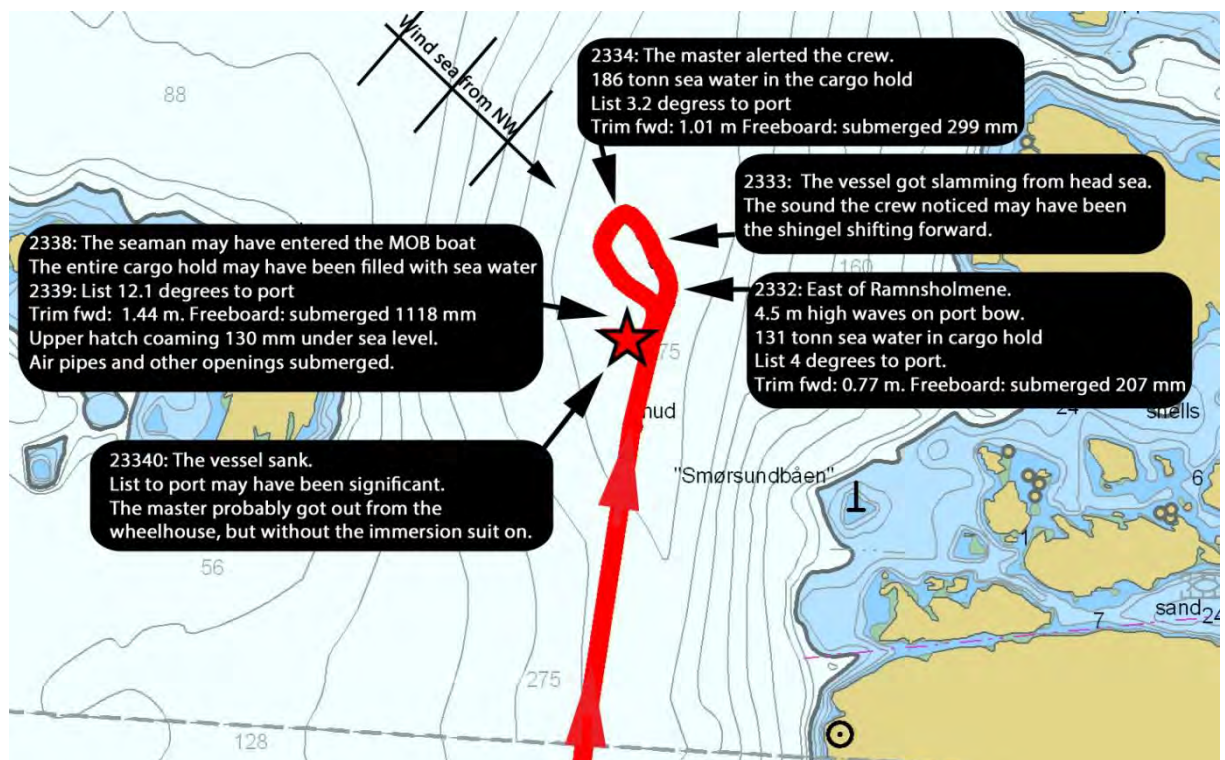
When the captain started to turn the ship near Ramnsholmene at 23:32, the amount of water may have increased to 78.31 tonnes (the sand's saturation point) in the aft part of the cargo hold and to 52.79 tonnes in the forward part of the cargo hold. If that was the case, the list will have increased to 4°. The forward trim was probably 0.77 metres, and the main deck was probably submerged under 207 mm of water. In this area, the vessel was no longer sheltered from the wind waves. The fact that the vessel, in such a condition, encountered 4.5-metre high waves smashing against the port side of the bow may have been perceived as dramatic by the captain and been one of the reasons why he decided to return to Haugesund. Details of the last few minutes of the chain of events are summarised in Figure 20.

Figure 20: Assumed chain of events during the final minutes before the vessel foundered. Based on charts/maps provided by: the Norwegian Mapping Authority, Geovekst and municipalities. Illustration: AIBN

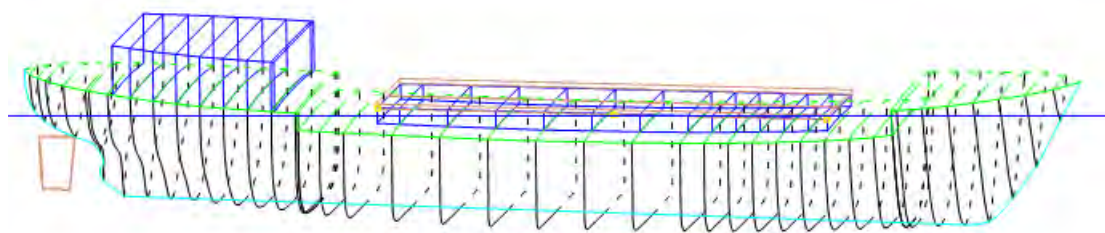
Figure 21: Illustration of load condition with the cargo hold completely flooded with water. The condition is shown with a starboard list. In reality, the vessel listed to port. *Finnøyglimt* was symmetrical around the centre line, so that the result of a starboard list would have been identical to the result of a port list. Source: AIBN
