REPORT

MARINE 2014/10

REPORT ON MARINE ACCIDENT – MV FAVORITA LAGM6/9298519 SHIPBOARD OCCUPATIONAL ACCIDENT IN THE EAST CHINA SEA ON 24 AUGUST 2013

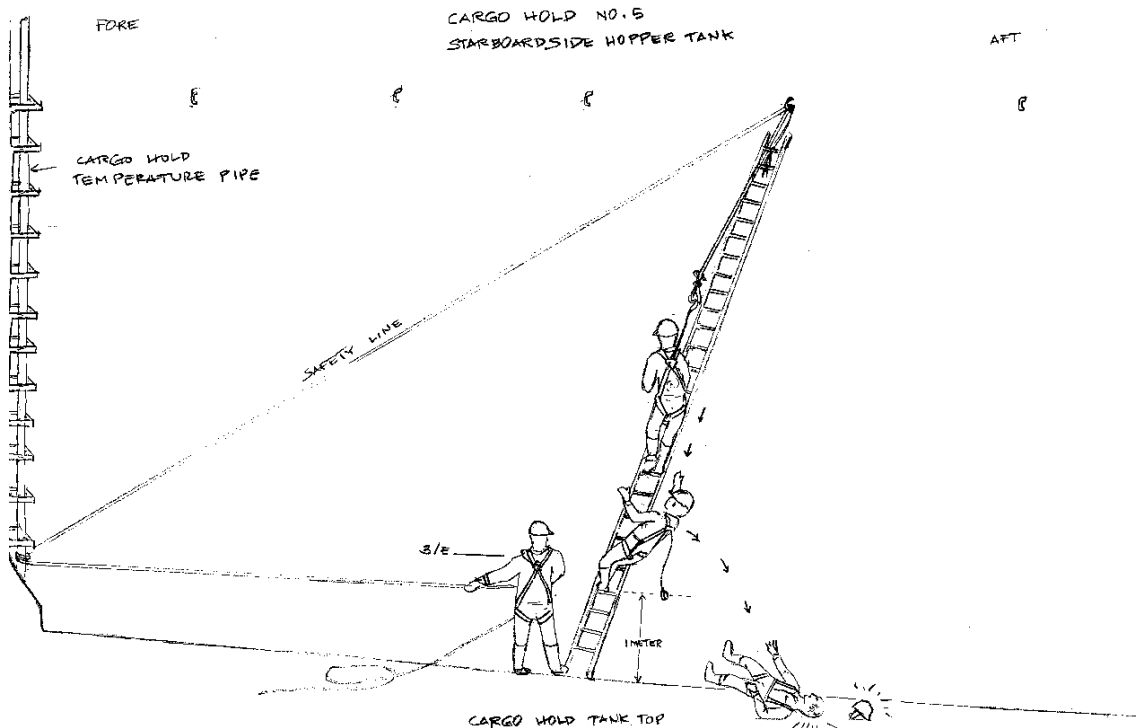
When he had finished cleaning one area, the motorman started descending the ladder to move it to the next position. The engineer who supported the ladder moved aside so that the motorman would be able to come all the way down. Approximately one metre before the bottom, the motorman reached up and disconnected the safety line. The engineer called out to remind him that he still had a way to go and should wait. But the motorman suddenly fell backwards and lost his helmet just before he landed on the back of his head on the tank top. This occurred at approximately 09:20 local time.

Figure 3: Schematic drawing of the accident. The ladder rested against the hopper tank plating, which had a slope of approximately 45 degrees. Source: 'MV Favorita'.

Cargo hold 5 had welded eye bolts along the upper part of the hopper tank plating. Ropes were threaded through these eye bolts in order to secure the ladder at the top, at the same time as the safety line for securing the crew member who stood on the ladder was threaded through one of the eyes. The safety line was then passed to a pipe to the fore (or aft) of the cargo hold, wound three times around the pipe and passed on to the crew member who was in charge of controlling the safety line; see Figure 3.

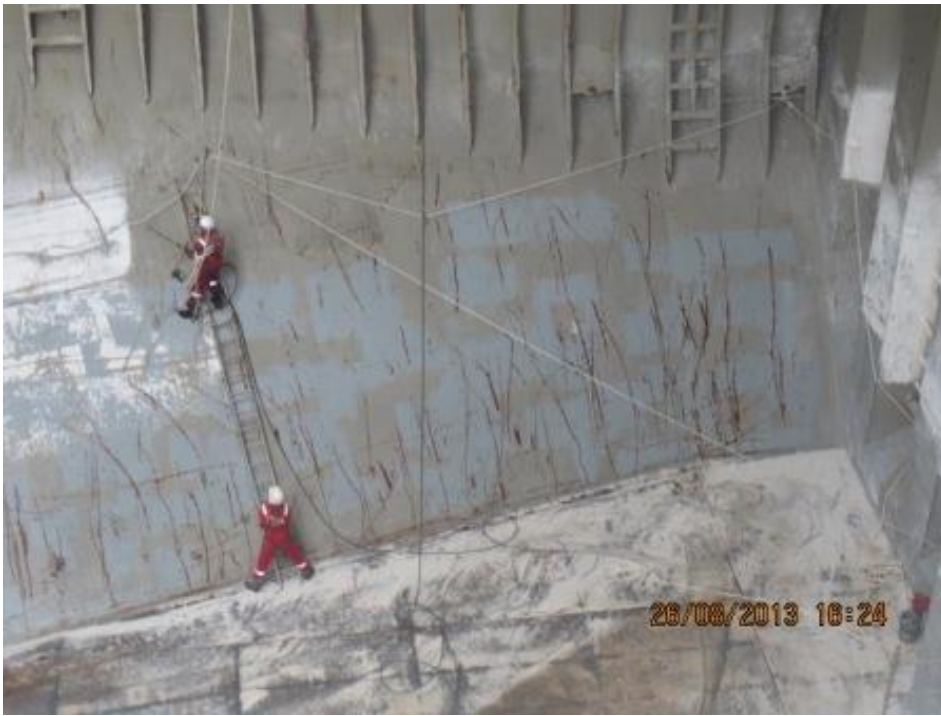
Figure 6: Reconstruction of scenario in cargo hold 5. Photo: 'MV Favorita'.

The ladders used during the cleaning of the tanks were ordinary aluminium ladders that leaned against the hopper tank plating, which had a slope of approximately 45 degrees. In cargo hold 5, it was necessary to join two ladders to reach the upper part of the hopper tank plating, while one ladder was enough in the other holds. Extendable ladders were used to some extent, which were secured by winding rope around the ladders; in other places, two single ladders were used, which were held together by ropes. The AIBN has received conflicting information about which ladders were used at the time of the accident, and it can also not say whether it had any impact on the outcome of the accident. Scaffoldings were used when cleaning the fore and aft ends of the cargo holds, as the bulkheads were vertical.

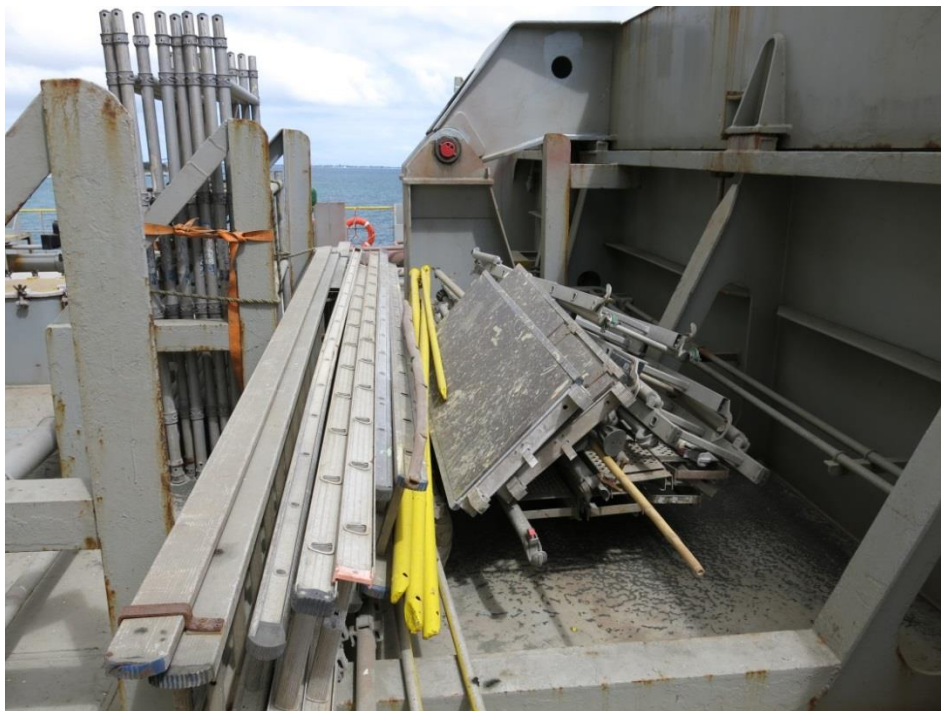
Figure 7: Ladders and scaffoldings were stored at the forward end of cargo hold 2. Photo: AIBN

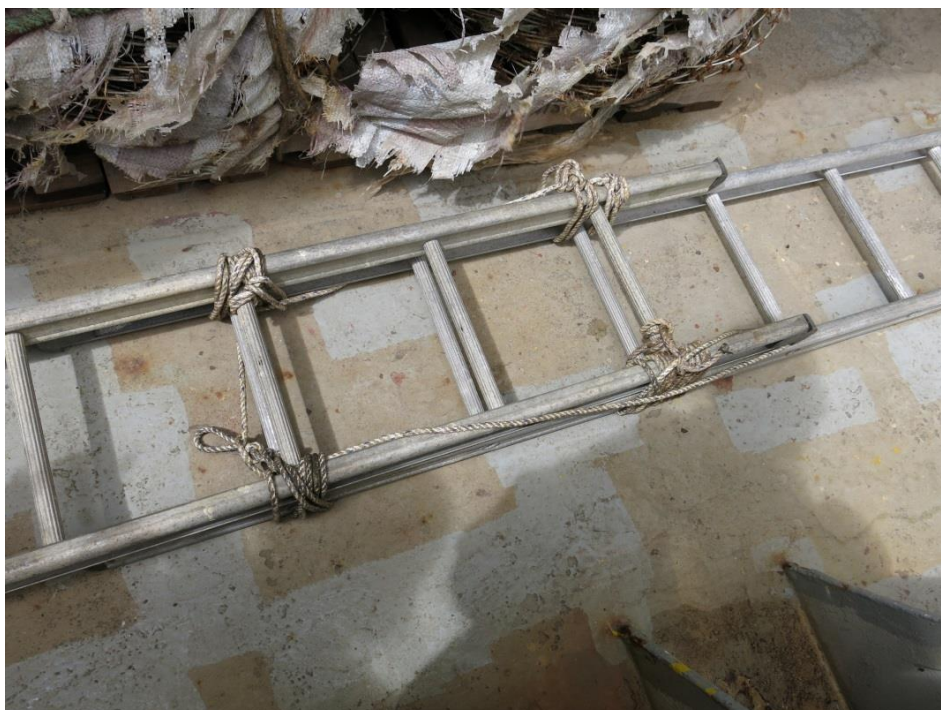
Figure 8: Ladders that were extended were always secured using extra ropes. Photo: AIBN
