# REPORT

## MARINE 2016/05

## REPORT ON MARINE ACCIDENT – FOUNDING OF M/V ØSTBANKEN IN ØSTHAVET OUTSIDE BÅTSFJORD ON 9 JANUARY 2015

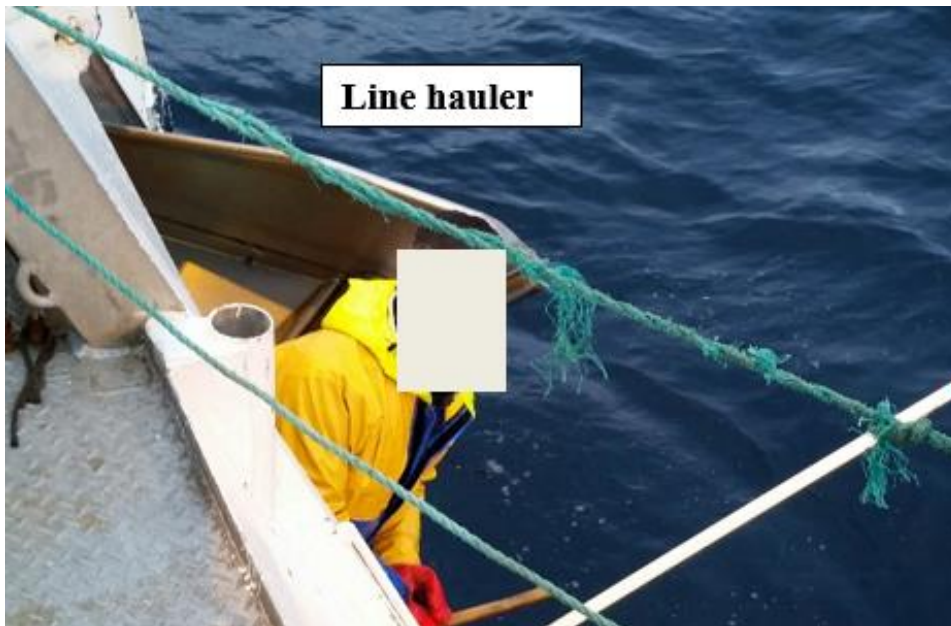
*Figure 3: The line hauler consisted of the line hauler reel and an aluminium chute. The arrangement weighed approximately 100 kg. It could be rotated and was attached to an axle inside the railing. Before hauling of the line commenced, the line hauler was lifted (tilted) up manually and swung out so that the aluminium chute stuck out from the hauling hatch. The whole arrangement was lowered into a groove, so that it was locked in place. To retrieve the line hauler, the chute had to be lifted out of the groove and swung back onto the working deck. This had to be done before the hauling hatch could be closed. Photo: The vessel owners/AIBN*

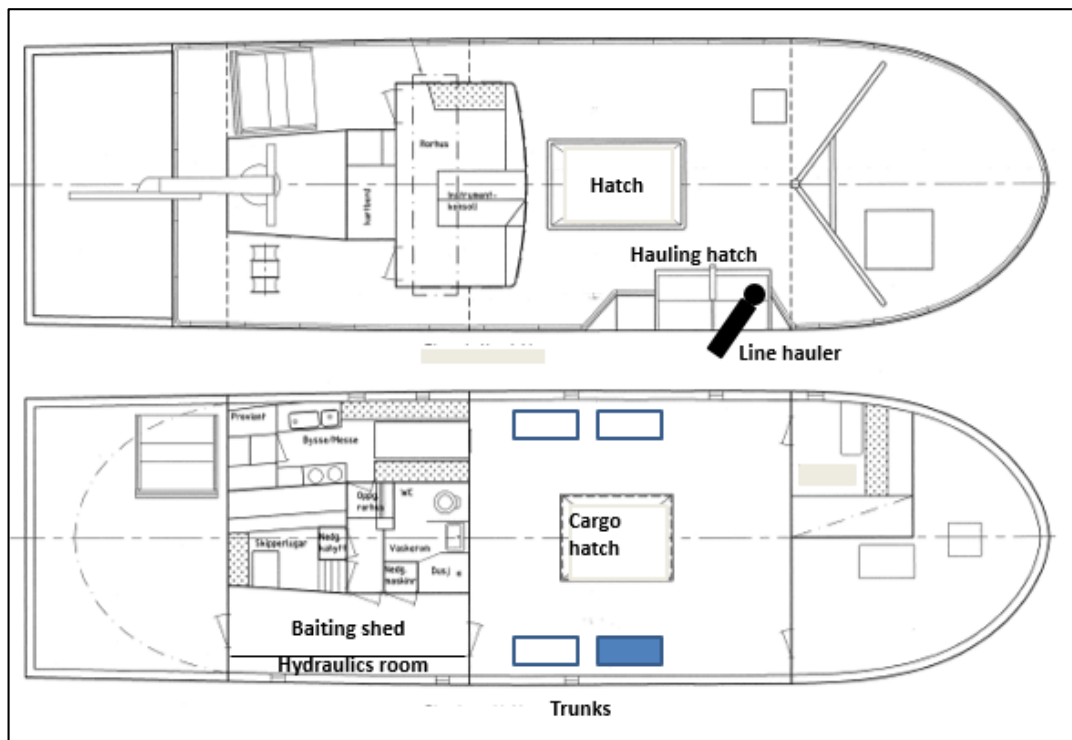
The fishermen on working deck observed that the vessel listed to starboard under the impact of several strong waves that hit the port side of the vessel. This caused a lot of water to come in through the hauling hatch and accumulate on the starboard side of the working deck. One of the fishermen looked into the hold, but was unable to observe any water there or anything else out of the ordinary. He found that, after a while, *Østbanken* was listing permanently to starboard and that there was water in the foremost trunk on the starboard side (highlighted in blue in Figure 5).

Figure 5: Simplified sketch showing, among other things, the location of the cargo hatch, the hauling hatch, the trunks and the line hauler that had been swung out through the hauling hatch and lowered into the groove. Source: Grovfjord Båtbyggeri AS. Illustration: AIBN

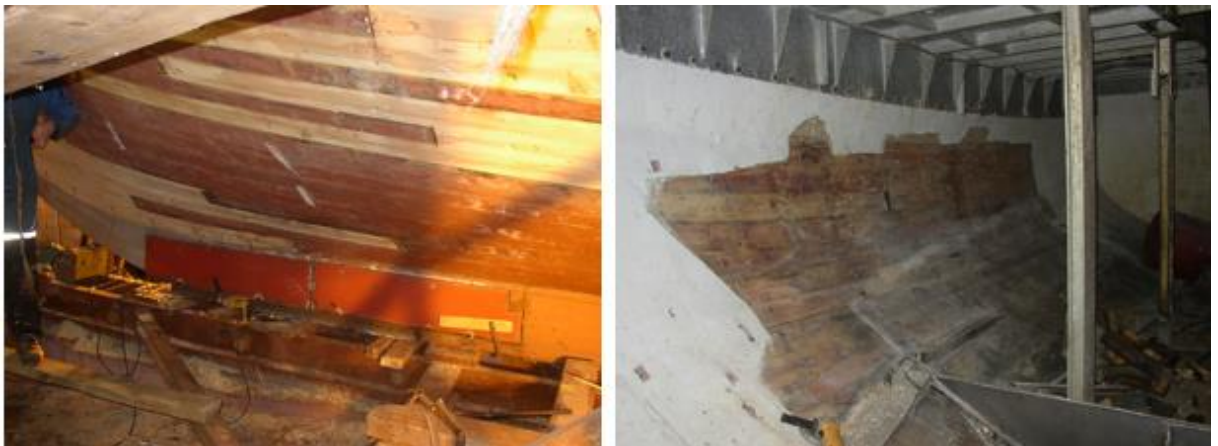
Østbanken ran aground with some force at Sørøya island in December 2003. In spring 2004, the vessel's foreship underwent major repairs whereby much of the shell planking was replaced – 12 and 13 planks on the starboard and port side, respectively. Parts of the bow were also replaced.

Figure 10: The photo on the left shows some of the replaced shell planks. The photo on the right shows the cargo hold with the bottom removed. Photo: Grovfjord Båtbyggeri AS

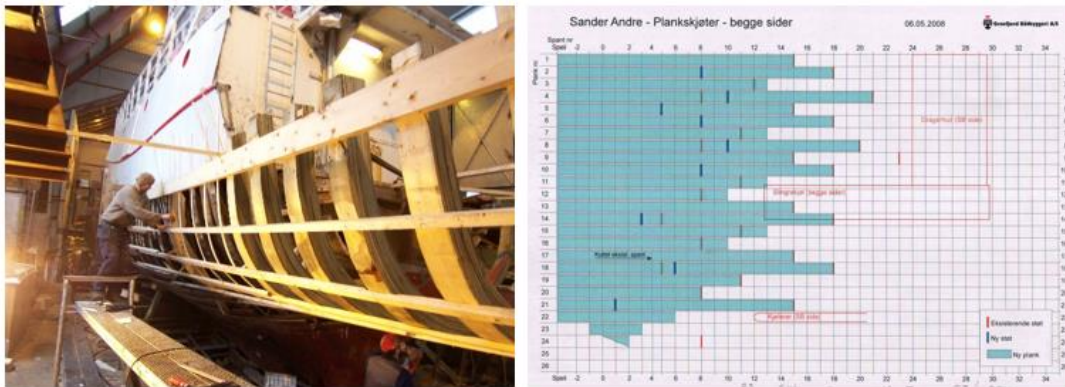
In connection with the conversion in 2008, which included the installation of a transom stern, a lot of the shell planking was replaced; see Figure 11.

Figure 11: The photo on the left shows the installation of the transom stern and replacement of shell planking during the conversion in 2008. The drawing on the right shows how the planks were joined to the existing hull. Source: Grovfjord Båtbyggeri AS

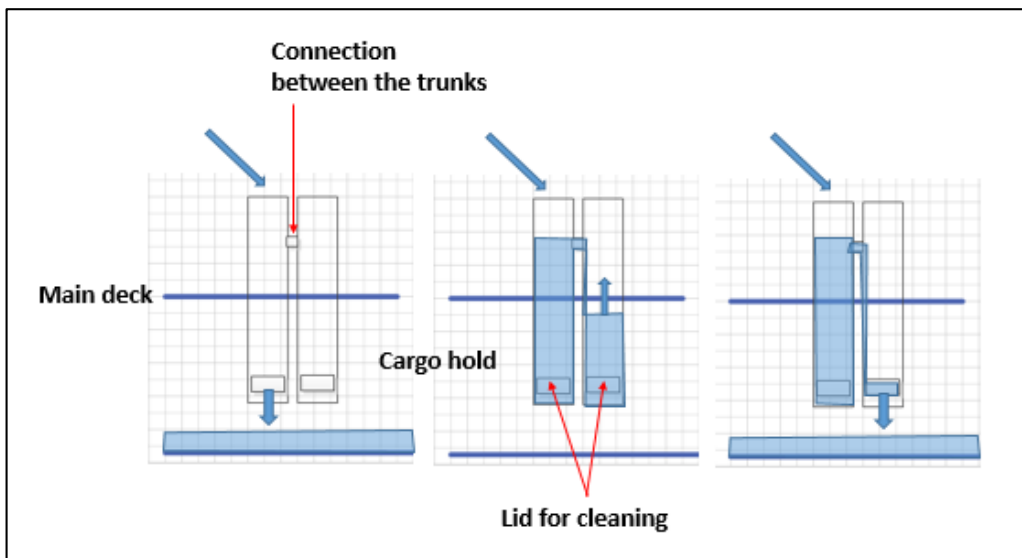
The trunks had been used to hold fish on the trip that was completed on 6 January 2015, and they had been cleaned after unloading. Nothing certain can be stated about the status of the lids after the trunks were cleaned, but the fact that one of the starboard trunks was observed to be full of water a short time before the vessel sank indicates that the lid was in place, at least on that trunk.

Figure 15: Schematic drawings showing how it was possible for water to enter the hold via the trunks. In the drawing on the left, the bottom lids are open so that water coming in through the top of the trunks would flow straight into the hold. The drawing in the middle shows that, with both lids in place at the bottom of the trunks, the water would not reach the hold. In the drawing on the right, only one of the bottom lids is in place, allowing the water to flow from one trunk to the other and then into the hold. Illustration: AIBN

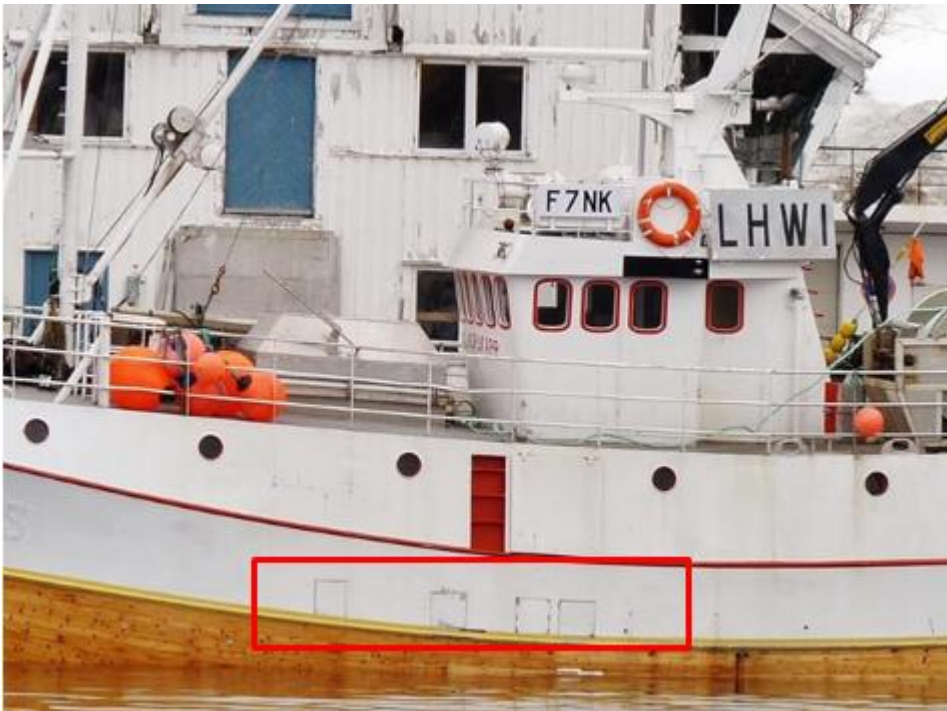
The above order was followed up by a letter to the vessel owners from the NMA's Svolvær office. In January 2010, the NMA's Svolvær office carried out an inspection on board the vessel and confirmed that there were now four freeing ports (40 cm x 40 cm) on either side of the main deck, with a total area of 0.64 m<sup>2</sup>.

Figure 18: Photo of 'Østbanken' taken 11 April 2010 on which four freeing ports can be seen within the rectangle marked by the red lines. Photo: Roar Jensen

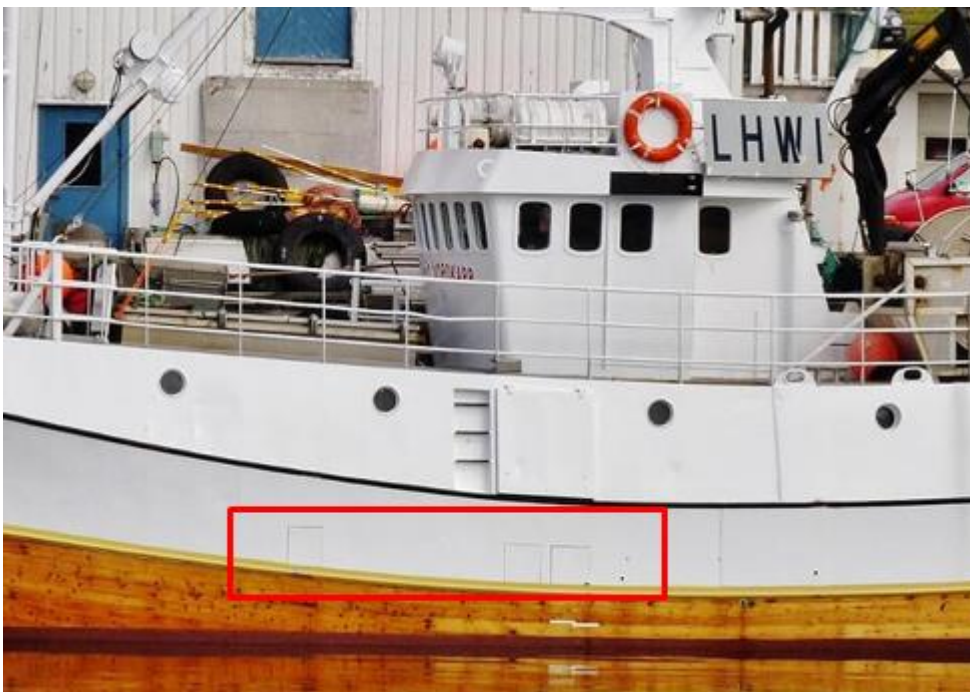
Photos taken in May 2011 and in connection with the shipyard stay in autumn 2014 show that the number of freeing ports had now been reduced to three on either side. Given that each freeing port measured 40 cm x 40 cm, the total area was thus 0.48 m<sup>2</sup> and inadequate in relation to the required 0.56 m<sup>2</sup>.

Figure 19: Photo of 'Østbanken' taken 22 May 2011 on which three freeing ports can be seen within the rectangle marked by the red lines. Photo: Roar Jensen

As far as the AIBN has been able to ascertain, the NMA was neither informed of this alteration nor was it discovered in connection with subsequent supervisory activities and approvals.

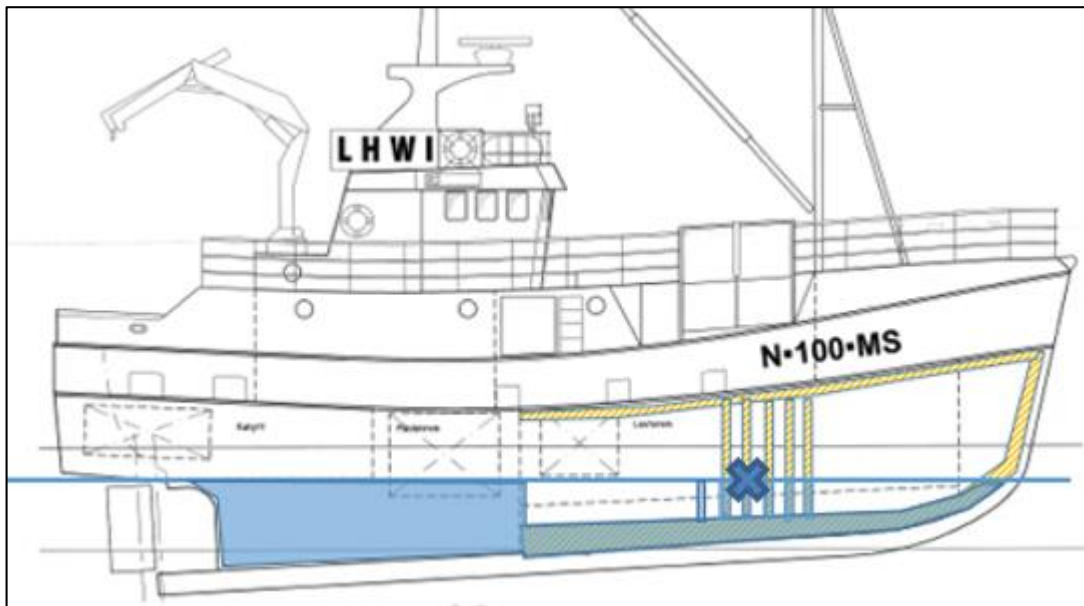
The AIBN has also carried out calculations simulating a flooding of the ‘double hull’ and the engine room. The calculations show that such flooding would have given the vessel a considerable aft trim and that the vessel would sink stern first.

Assuming that the ventilation channels through the engine room bulkhead were not blocked (discussed in section 2.2.4), there is little to indicate a leakage through the shell.

Figure 20: Illustration of how water would spread through the double hull and to the afterbody in the event of a puncturing of the shell of the vessel. Source: Grovfjord Båtbyggeri AS. Illustration: AIBN

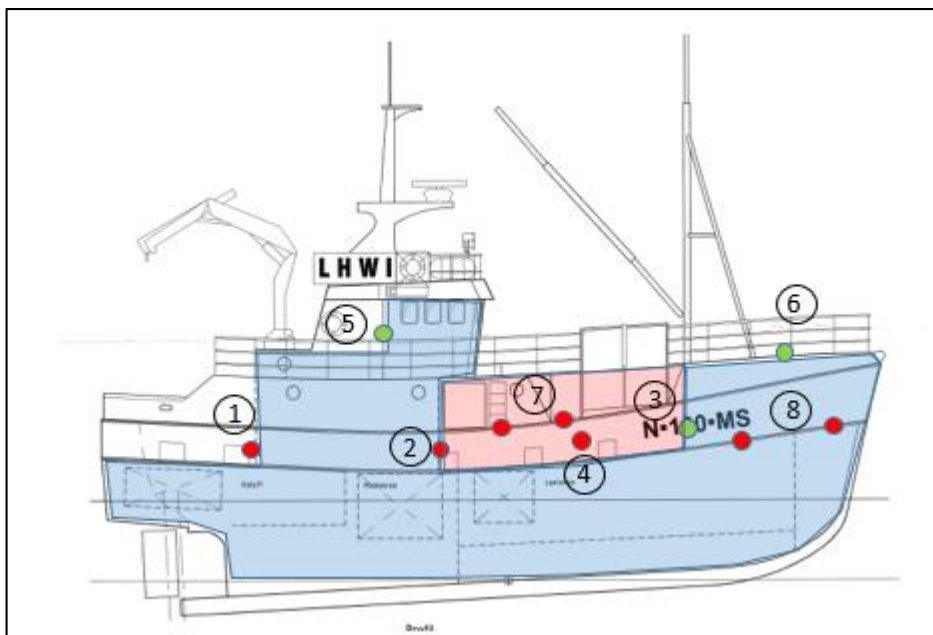
Figure 21: Overview of the vessel's flooding openings and the location of weathertight means of closing intended to prevent flooding of the buoyancy volume. Source: Grovfjord Båtbyggeri AS. Illustration: AIBN

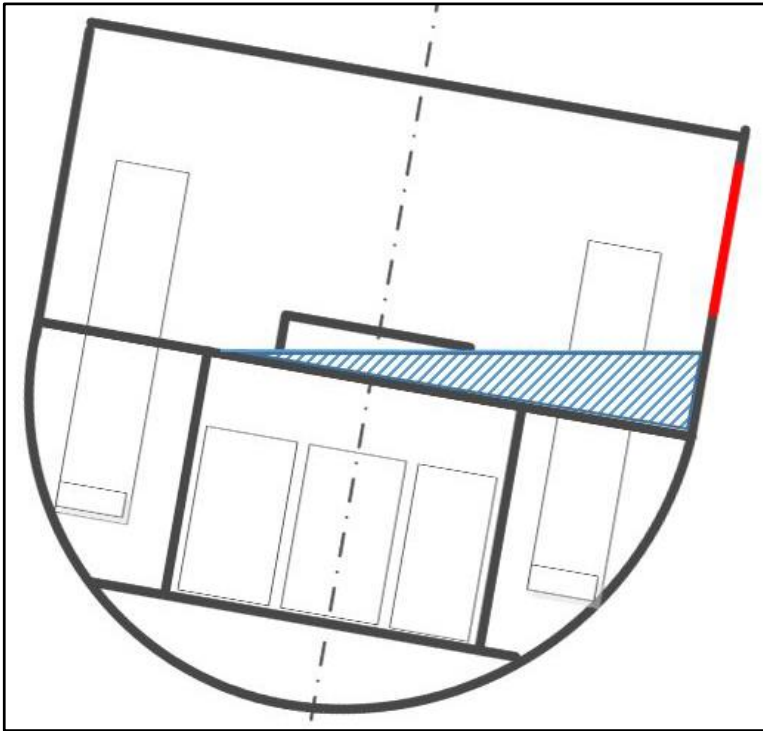
The cargo hatch was designed and could be closed in accordance with the requirements set out in the Regulations on Fishing Vessels of 15 m and over. When the crew stopped loading the containers in the hold around midnight, the forward part of the hatch was left open. Because the vessel listed to starboard for a relatively long period of time, and because the hauling hatch was open and there was a lot of water on deck, this enabled the hold to fill up with water.

Figure 22: Simple schematic diagram of 'Østbanken' listing 10 degrees to starboard. The hatched blue area shows water on deck on the starboard side. Illustration: AIBN

The current regulations clearly state that exterior hatches and doors that need to be kept open during fishing and that may lead to flooding shall be closed immediately if there is a risk of flooding.
