Accident
Investigation Board
Norway

Marine 2017/06

REPORT ON MARINE ACCIDENT – RIB, FALL OVER BOARD IN OLDEN 22 JULY 2015

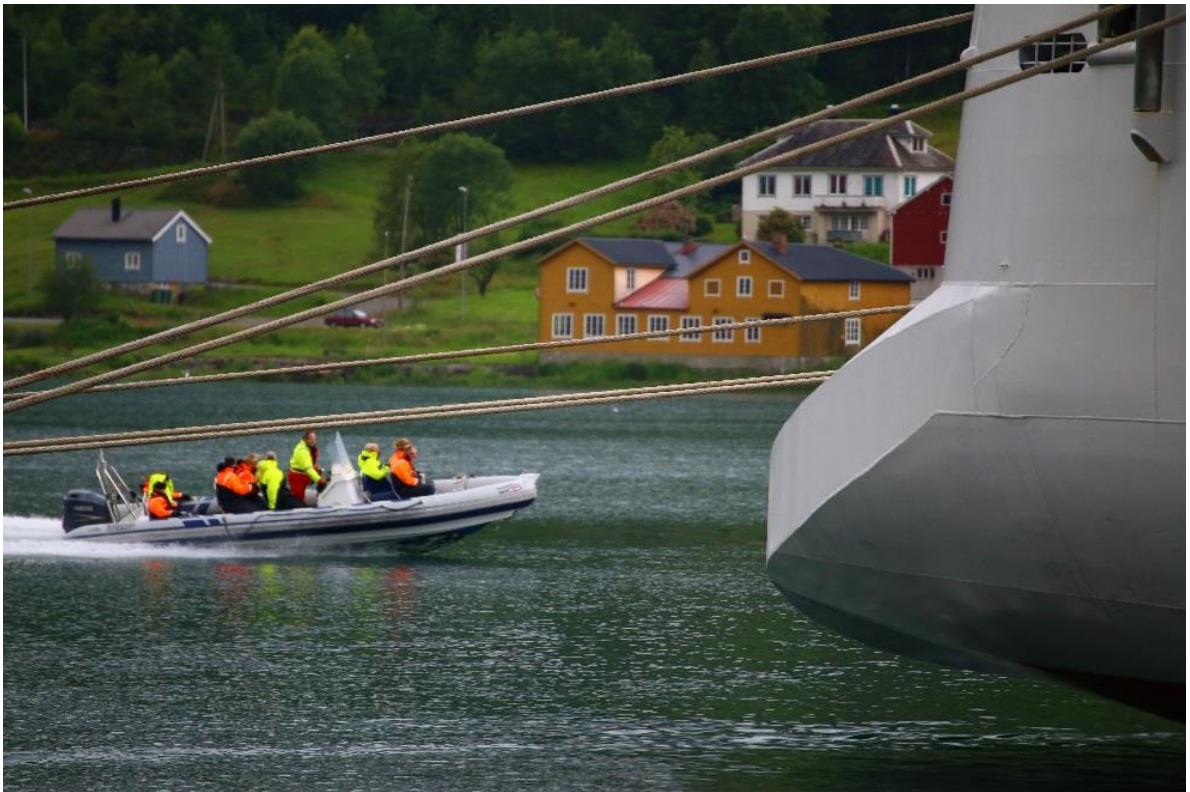
Figure 3: The RIB rounds the stern of the cruise ship just before the accident happened. Photo: Mr. Alan Jackson

When they were clear of the mooring lines the skipper increased speed. When they were abeam the cruise ship's stern the skipper probably applied full throttle and the boat presumably reached 25-30 knots in a short time (see point A in Figure 4). The skipper had started the previous trip in the same way and had then proceeded to execute a turn between the two cruise ships lying in the fjord.

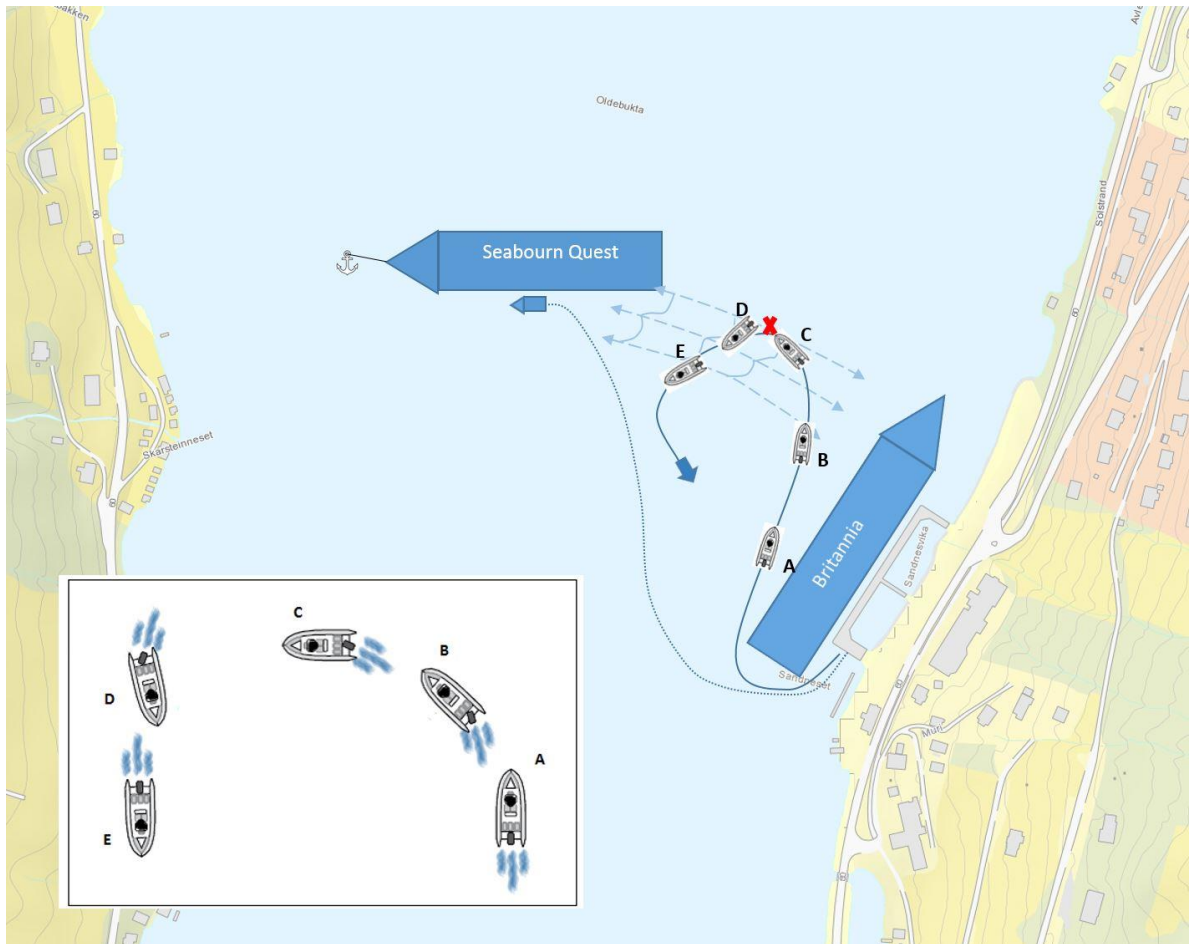
The RIB caught up with the waves made by the tender and drove into them (point B) before the skipper commenced a sharp turn to port. The boat then turned to port into the wave pattern roughly parallel with the waves (point C). Half-way through the turn the stern of the RIB skidded over a wave top, before abruptly regaining its grip on the water (point D). The boat, which was heeling sharply inwards in the turn, suddenly jerked upright as the stern regained its grip on the water and the skidding motion stopped abruptly. It was at this point that first one passenger, then the skipper and finally a second passenger fell into the sea on the starboard side of the boat. A skid like this that stops abruptly is a phenomenon known as a 'hook'. The accident occurred at 13:03.

Figure 4: A turn to port where the stern of the vessel loses its grip and skids, before the boat regains its grip on the water. Map: The Norwegian Mapping Authority. Illustration: AIBN

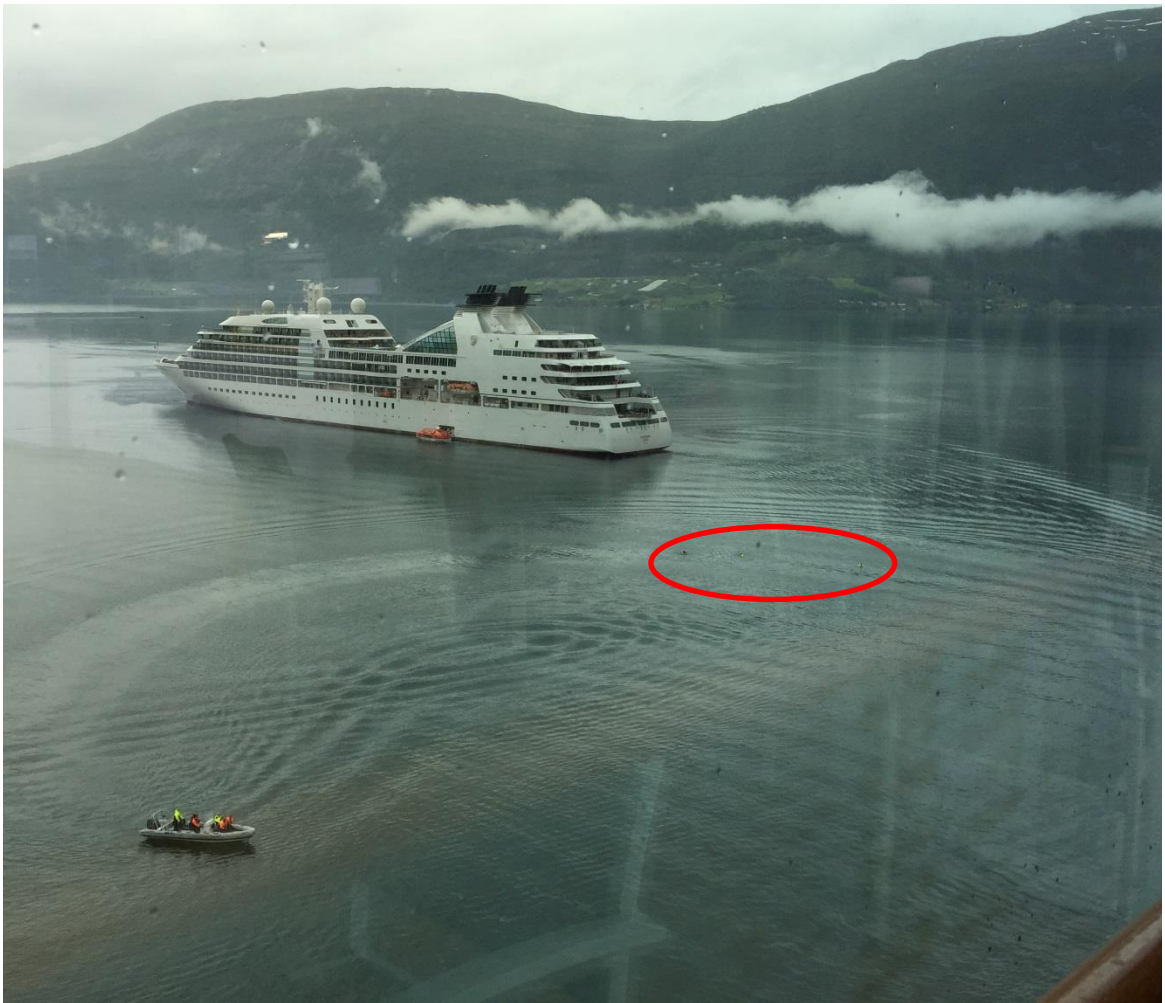
Figure 5: The photo was taken from a cabin on board 'Britannia' just after the accident. The circle marks the position of the three people in the water. Photo: Mr Hinnerk Hatecke

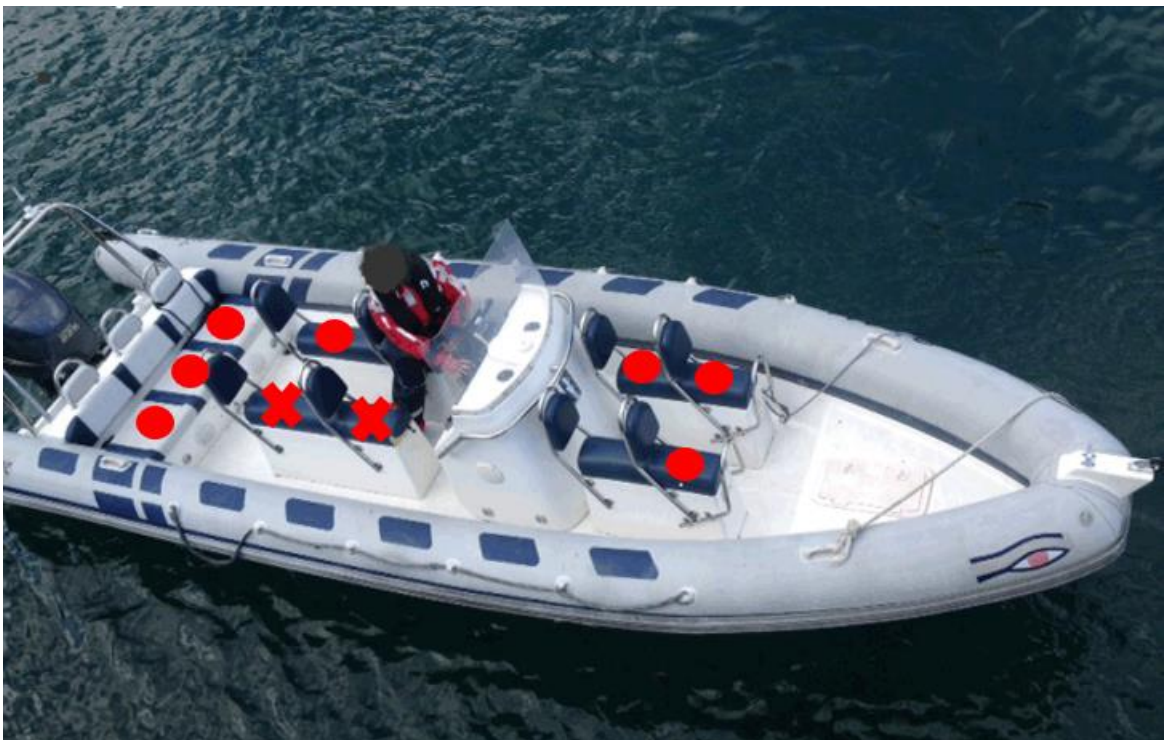
The seating configuration of the boat in question did not correspond with any of the examples in the user manual. It had four saddle seats ahead of the skipper's position and four saddle seats behind the centre console (steering position), with a further three seats in a bench configuration at the stern of the vessel, see figure below.

Figure 9: The RIB's seating configuration. The red circles mark where the passengers were sitting and the red crosses mark the passengers who fell into the water. Photo: AIBN
