## Marine 2018/02

## REPORT ON MARINE ACCIDENT – HUGIN, COLLISION IN HARSTAD ON 16 FEBRUARY 2017

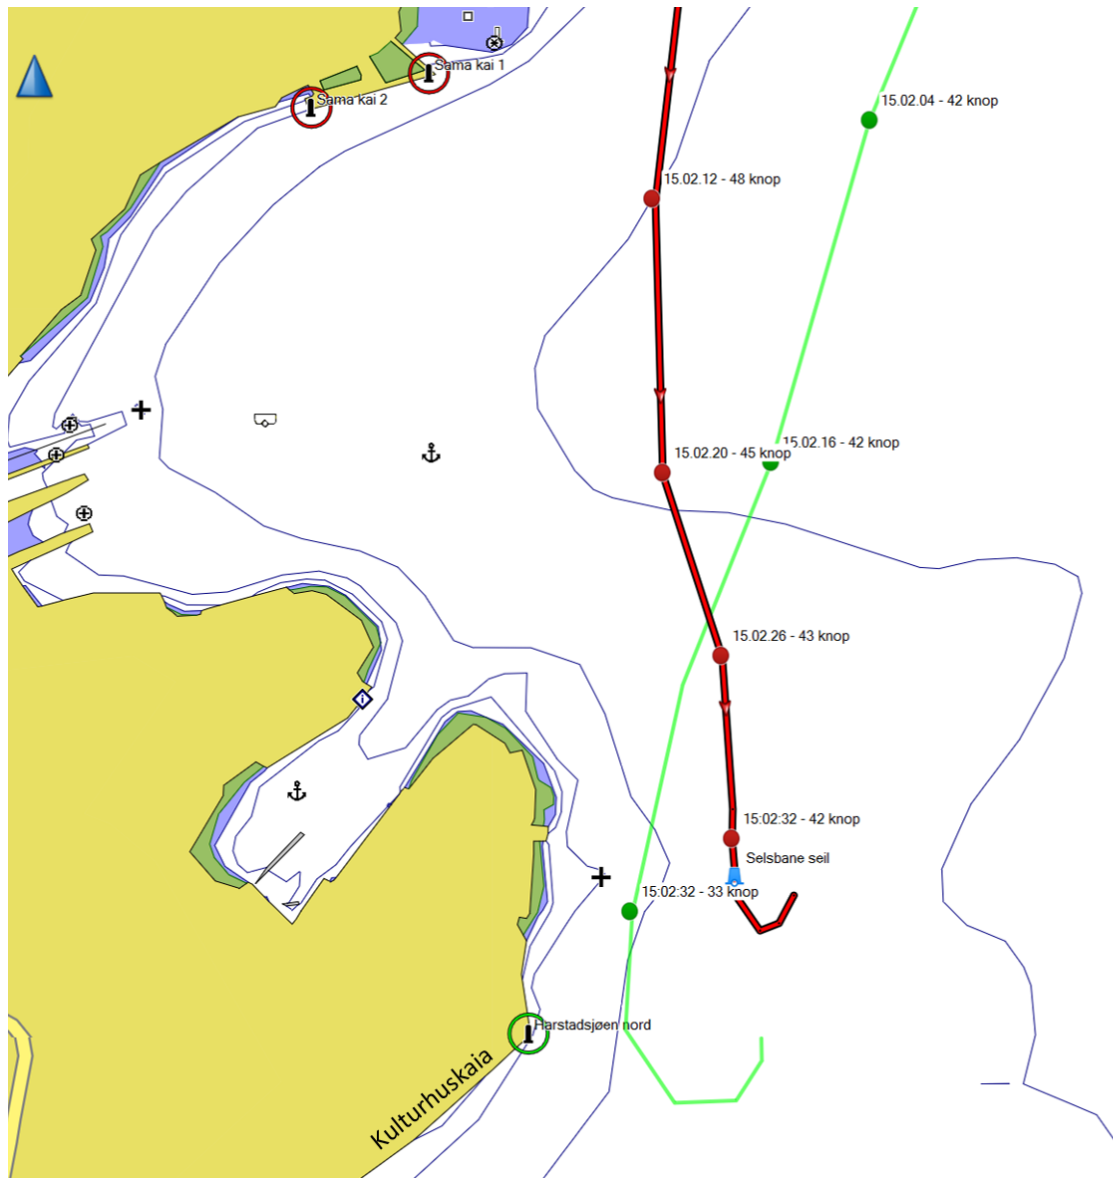
The skipper of Hugin (red line) was in his normal position astern of the lead boat on the starboard side and kept an eye on it, while switching between looking ahead and glancing at the chart plotter. He last checked his position on the chart approximately as they were passing the last two fixed beacons (see Figure 3 and the top of Figure 4).

Figure 4: The map shows the final section of the two RIBs' approach to Harstad, including times and speed in knots. The green line represents Munin and the red line represents Hugin. Source: Garmin electronic chartplotter, Homeport

The skipper of Munin (green line) was aware of Selsbanes Seil and chose a course on the landward side of the fountain to allow the passengers a close-up view of the culture centre. Just after the RIBs had passed the two fixed beacons, Hugin's skipper found that the lead boat's course would soon leave less space between the lead boat and shore than he was comfortable with.

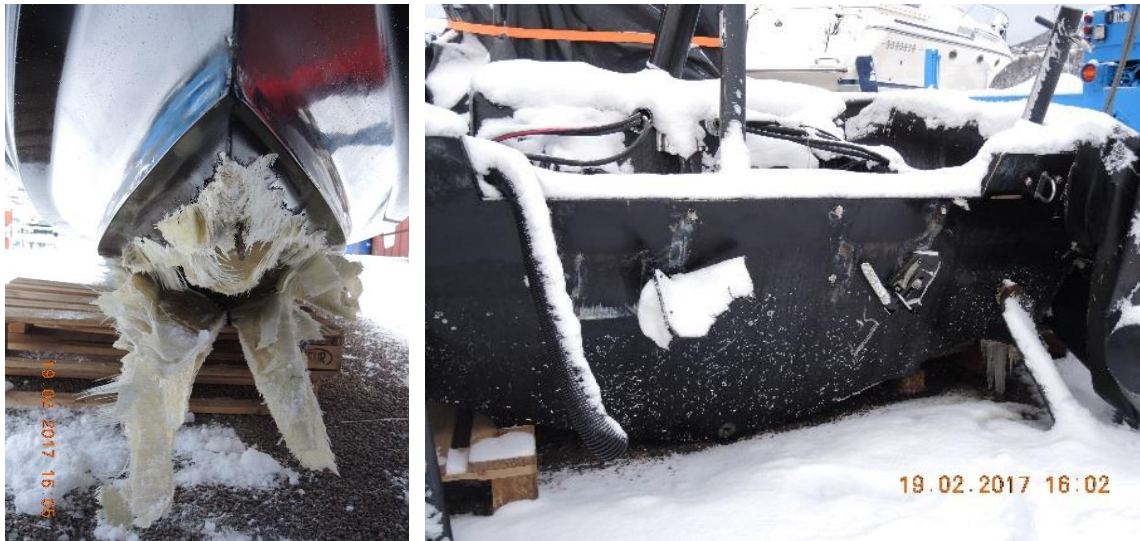
The RIB sustained significant damage in the collision. There was significant damage to the bow, and the rear starboard section of the inflatable tube was punctured, but the boat nonetheless stayed afloat after the accident. The motor mountings snapped, and the outboard motors were left hanging under water by their cables behind the boat. There was also some damage to other equipment on board.

*Figure 6: Damage to the bow (left) and damage to the stern (right). Photo: AIBN*

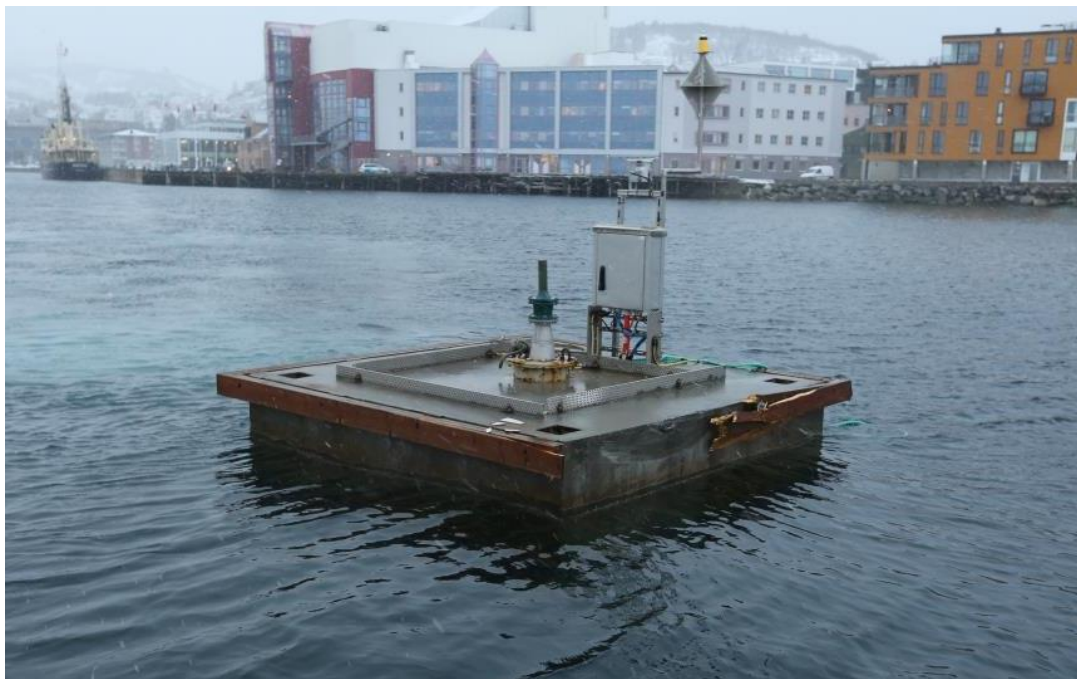
The fountain Selsbanes Seil sustained minor damage as shown on the photo below.

Figure 7: Selsbanes Seil after the accident. Photo: The police

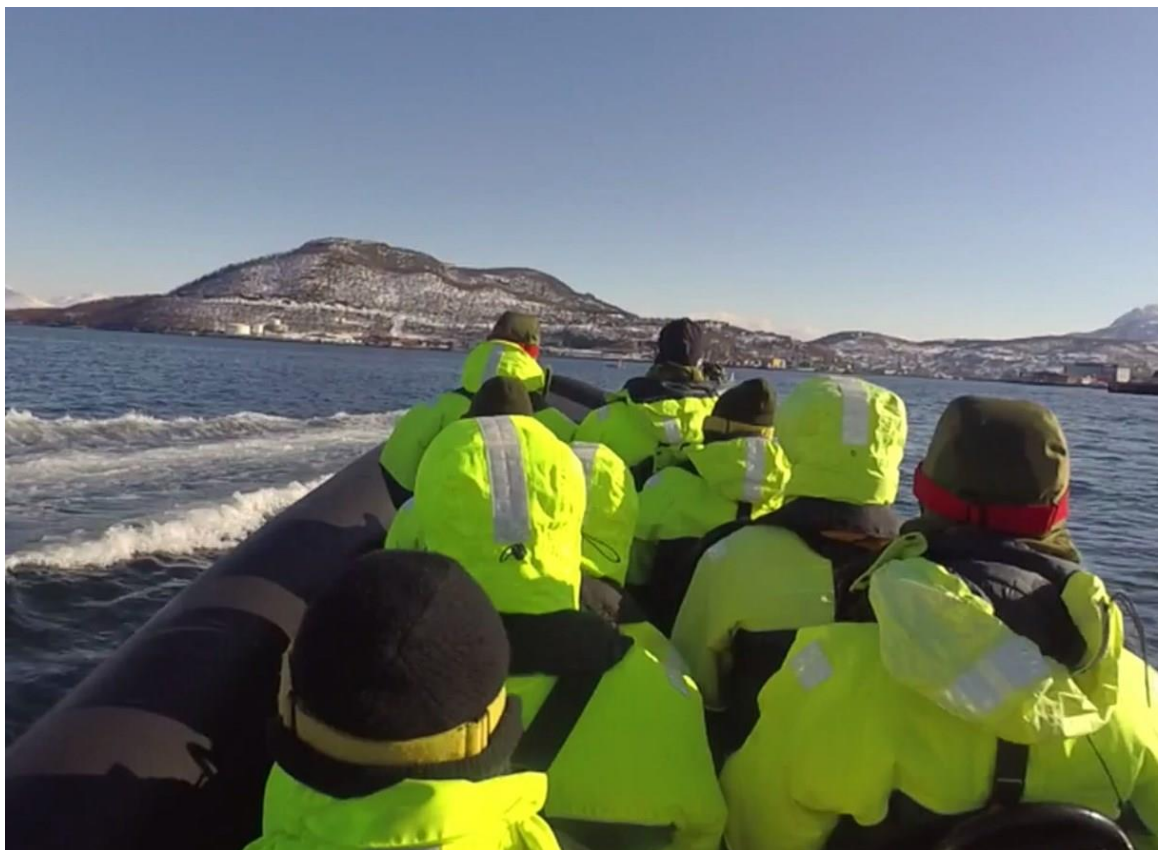
*Figure 13: From the reconstruction. This photo shows the field of vision from the helm position. The fountain can be seen in front of the boat between the heads. Photo: AIBN*

The investigation has therefore shown that the skipper's field of vision was probably obstructed by passengers, and possibly also by the boat's own bow, during the crucial seconds when the boat was on a collision course with the fountain. Neither the skipper nor the operating company had identified the limited field of vision as a potential hazard. This will be discussed in more detail in sections 2.3.4 and 2.8, respectively.

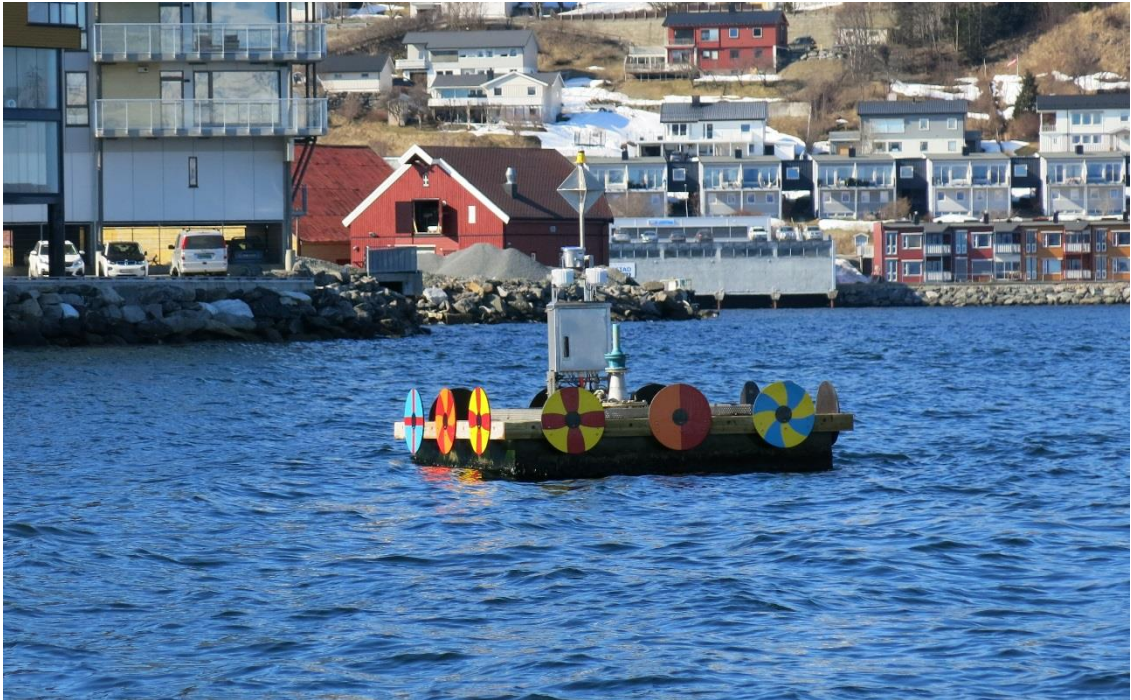
Figure 14: Selsbanes Seil with the Viking shields attached. Photo: AIBN

Following the accident, the marking light on Selsbanes Seil has been re-programmed to flash continuously around the clock. In addition, twelve Viking shields have been fitted around the platform and a new radar reflector has been installed.

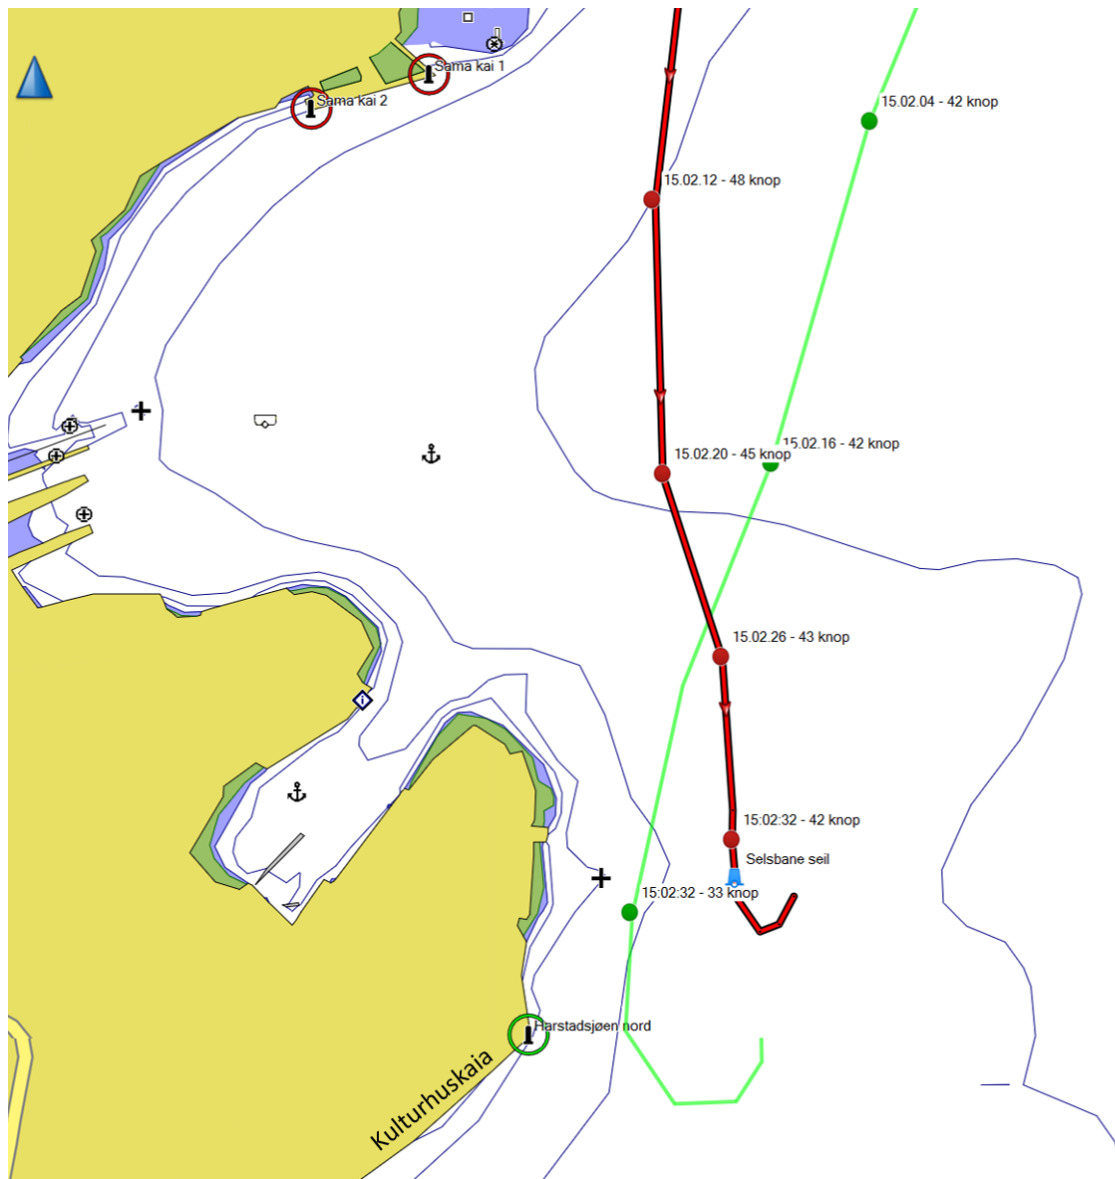
Figure 15: The map shows the final section of the two RIBs' approach to Harstad town centre, including times and speed in knots. The green line represents Munin and the red line represents Hugin. Source: Garmin electronic chartplotter, Homeport

After Hugin had passed the lead boat's wake, the skipper positioned the boat on collision course with Selsbanes Seil, which was then about 150 metres away. The AIBN does not consider this a safety problem in itself. The decisive factor was that the skipper did not become aware of the fountain in the course of the seven seconds when the boat was on a collision course. This will be discussed in more detail in section 2.3.

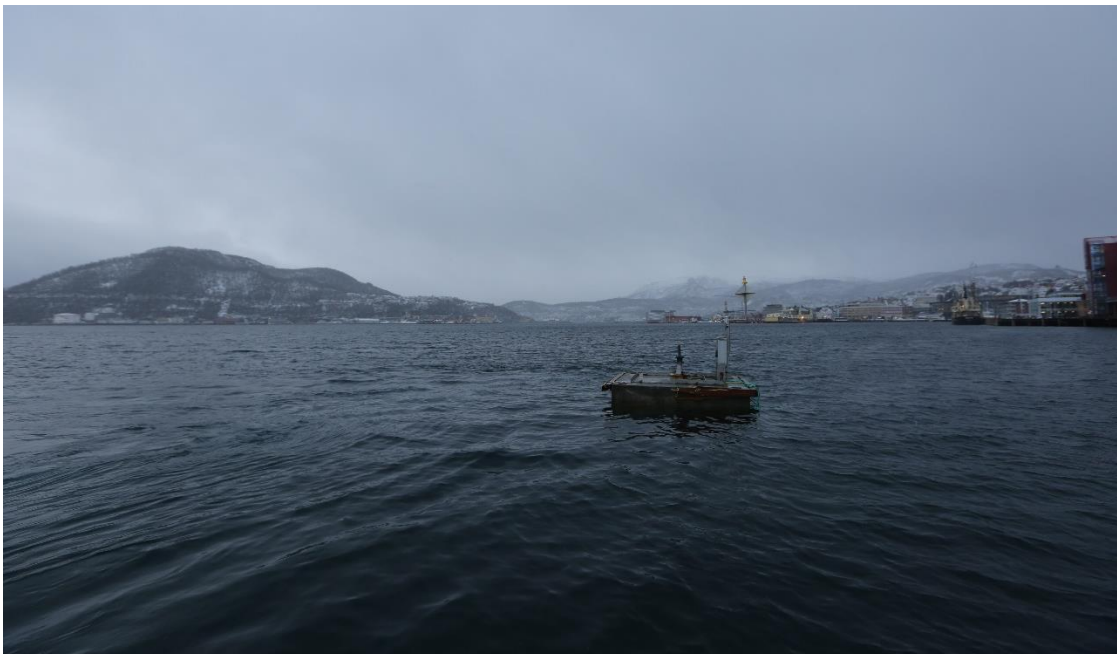
When the fountain was not active and the light was not flashing, Selsbanes Seil appeared as a colourless and relatively small object. The AIBN has observed how its visibility varies with different weather and light conditions.

At the time of the accident, the weather was grey with some small waves, low cloud cover, and the daylight was fading. Therefore, the fountain was not easily distinguishable from its surroundings at the time of the accident (see Figure 16). The fact that it was located in an area without speed restrictions, particular importance should be on the object's visibility.

Figure 16: Photo of the fountain taken the day after the accident. Photo: The police
