# REPORT

## Marine 2019/07

## REPORT ON MARINE ACCIDENT – THE GROUNDING AND FOUNDERING OF THE FFS ACHILLES OFF FARSUND ON 3 MARCH 2017

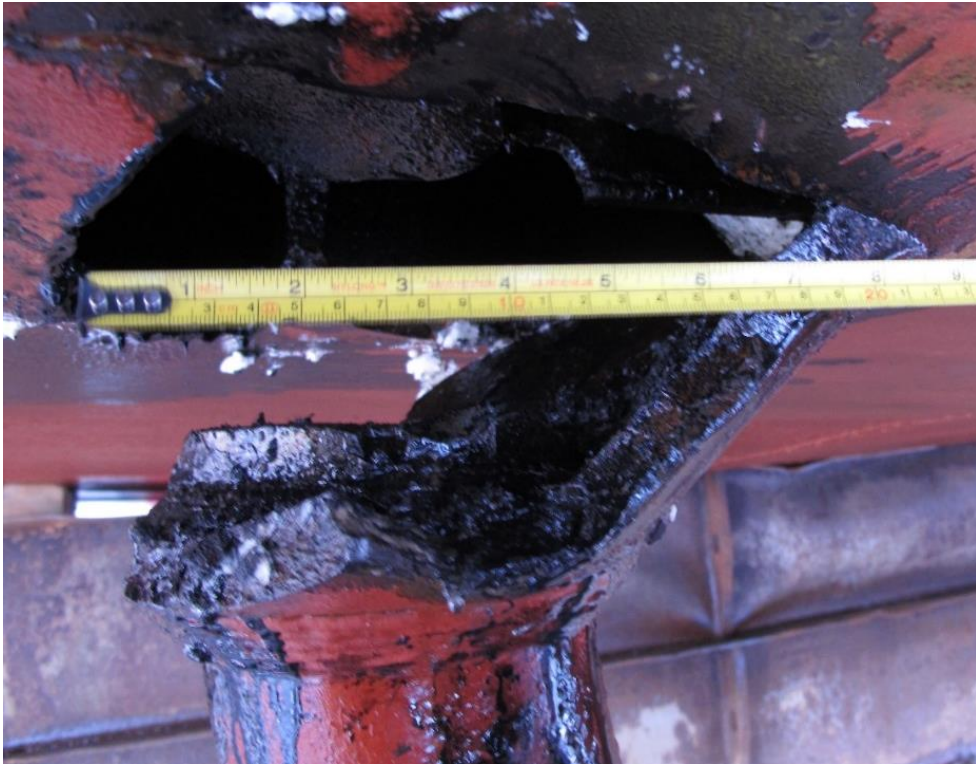
- The front of the foil (the 'foot' below the propellers) was damaged on the starboard side. It was obvious that this point had hit the reef.
- Several of the struts attaching the foil to the hull had been torn off at the point of attachment to the foil.
- The rear inner strut on the starboard side had broken off approx. 20 mm above the inside of the shell plate. The torn strut had moved downward in a way that tore open the shell plate and left a hole measuring approx. 250 x 300 mm. This hole opened the hull into the engine room.

Figure 5: The rear inner strut on the starboard side had torn open the skin of the hull.  
Photo: AIBN

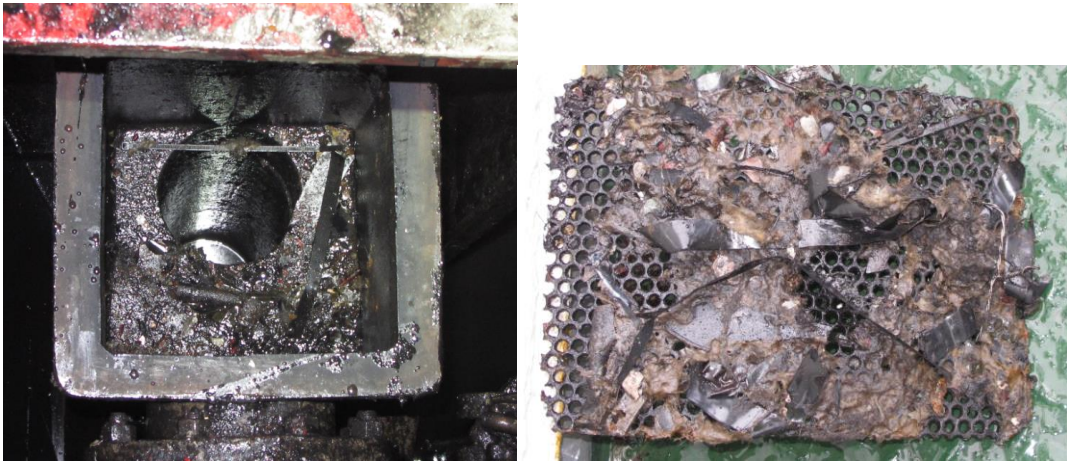
Figure 11: Mud box on a bilge line with grate on the right. Photo: AIBN

The bilge line's rear mud box was opened when the vessel was examined, see Figure 11. There were grates in the mud boxes intended to prevent debris from being sucked into the pumps. As the figure shows, the grate was largely covered in debris that would have reduced the flow and thereby the pumping capacity.

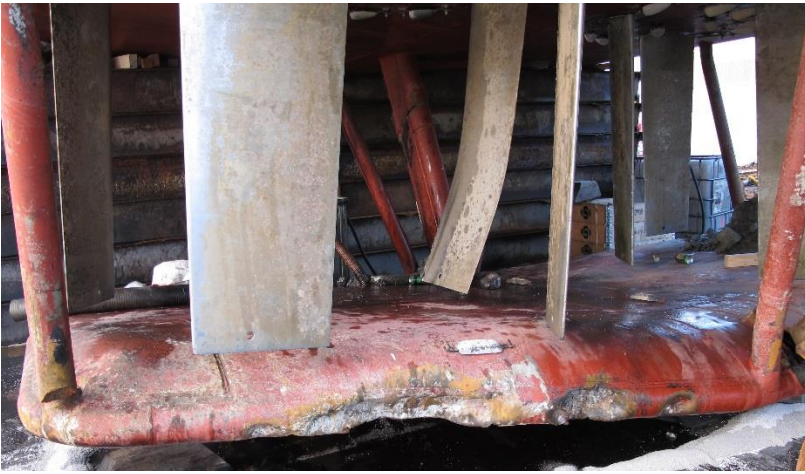
- The front of the foil (the 'foot' below the propellers) was damaged on the starboard side. It was obvious that this point had hit the reef.
- The forward and rear central struts that attached the foil to the hull had been torn off at the point of attachment to the foil. In addition, the rear central strut had cracks and was bent backwards approximately halfway between the hull and foil.
- The forward starboard strut had broken off at the point of attachment to the foil.
- The rear inner strut on the starboard side had broken off approx. 20 mm above the inside of the shell plate. The torn strut had moved downward in a way that tore open the shell plate and left a hole measuring approx. 250 x 300 mm. This hole opened the hull into the engine room.

Figure 19: Damage to the starboard forward edge of the 'foot', starboard strut knocked off and bent/twisted propeller blade. Photo: AIBN

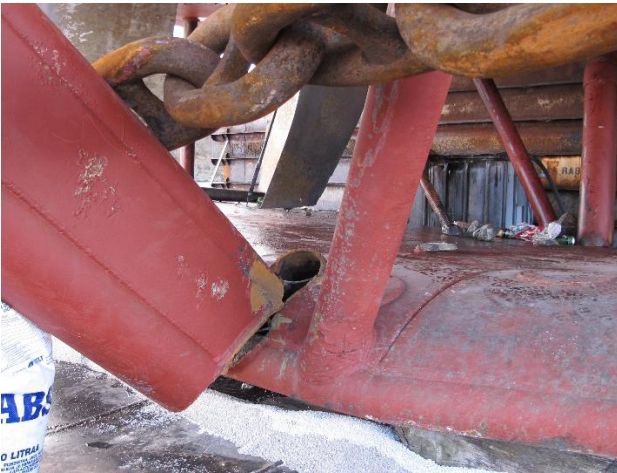
Figure 20: Forward centre strut torn off at the foil. Photo: AIBN

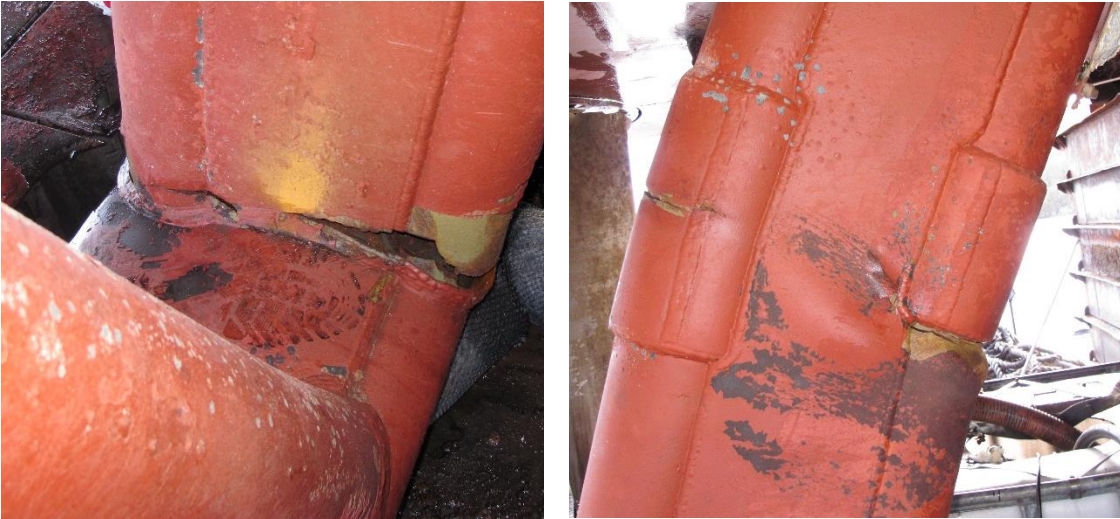
Figure 21: Rear centre strut torn off at the foil, cracked/bent halfway up the length of the strut. Photo: AIBN

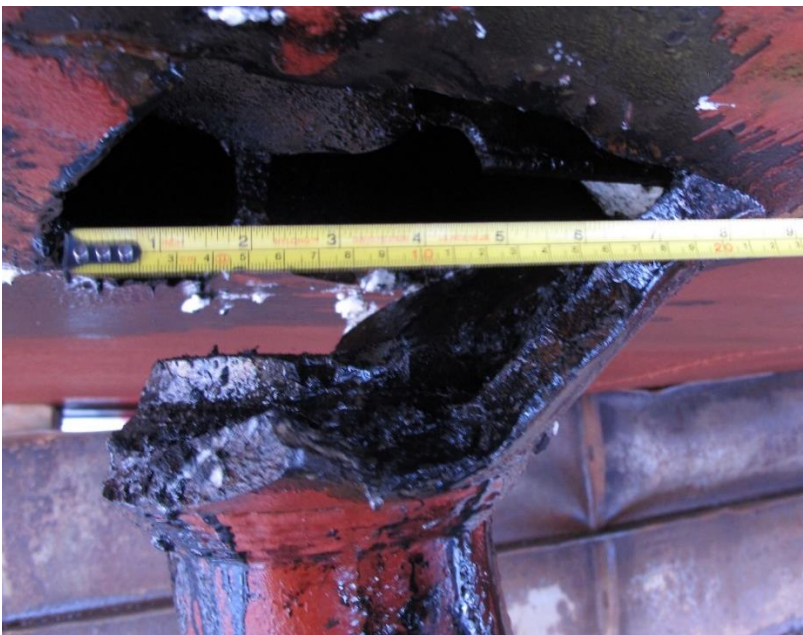
Figure 22: The rear inner strut on the starboard side had torn open the skin of the hull. Photo: AIBN

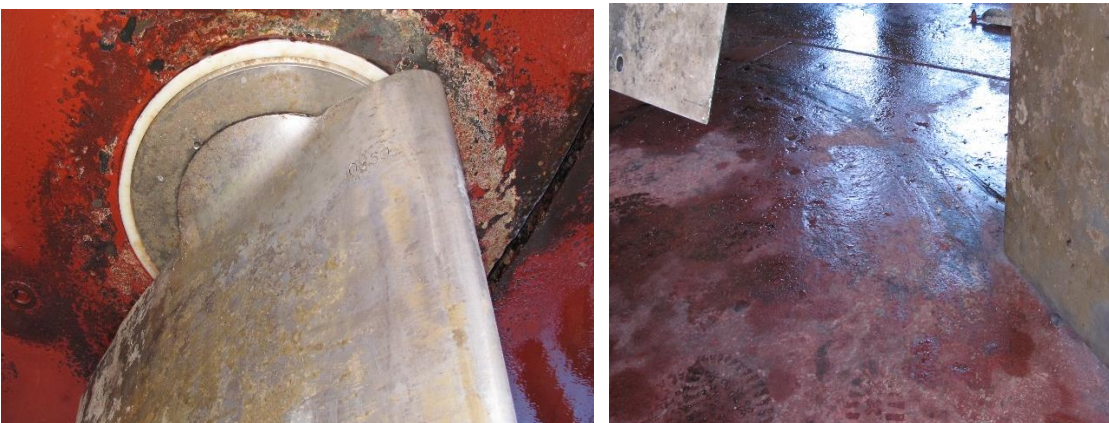
- Circular scratches were found in the surface of the foil beneath the starboard propeller. The diameter of the scratches corresponded to that of the propeller.
- One of the blades of the starboard propeller was bent and turned 180 degrees on the vertical axis (the end of the blade was facing the opposite way to the other blades on the propeller). A white gasket inside the flange attaching the blade had been pushed out (down) slightly and become visible.
- The rotating disc of the starboard propeller had been pushed out (down) slightly and was no longer flush with the skin of the hull.
- There was evident buckling of the skin in the area where the forward lifting chain had been in contact with the hull when the vessel was raised. The chain formed a sling around the hull and was threaded between the forward inner struts and the forward centre strut of the foil.

Figure 23: The blade attachment and rotating disk on the starboard side were pushed down. Scratches left by the propeller blades in the surface of the foil. Photo: AIBN

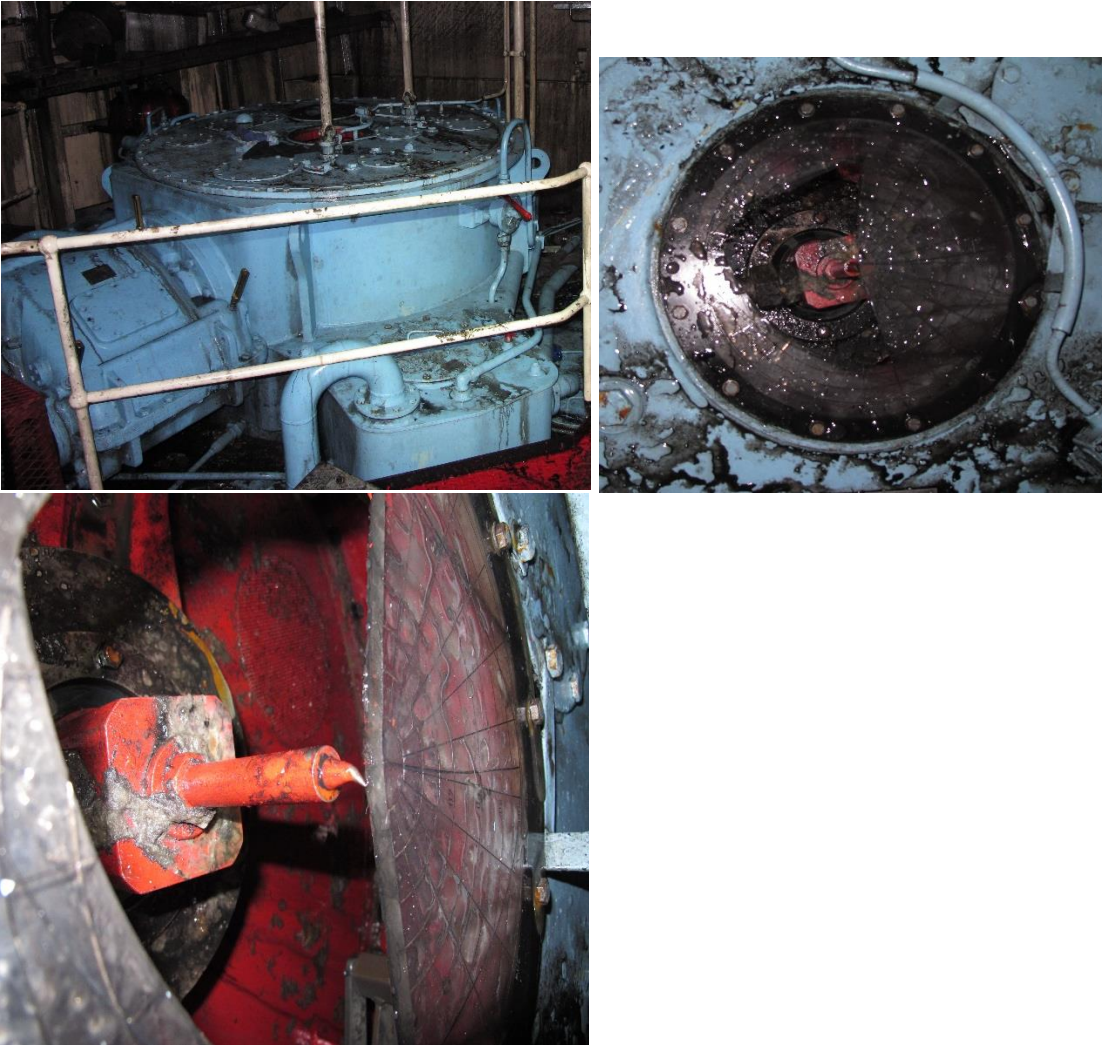
Figure 24: Port propeller unit. Photo: AIBN

- The glass cover on top of the propeller unit was cracked/broken.
- The point of the indicator was bent, and there was no clearance between the indicator point and the glass cover.
- The indicator was positioned in the centre of its area of movement.
- No oil could be observed in the propeller unit.

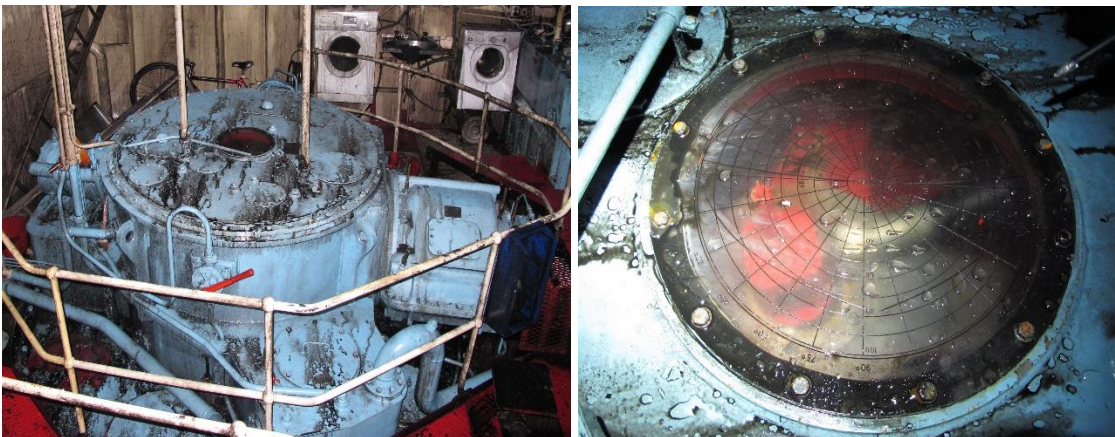
Figure 25: Starboard propeller unit. Photo: AIBN

- The indicator was positioned along the transverse axis to port (along the 0° axis and 65% to port). This indicates 0% rudder pitch and 65% driving pitch.
- The propeller unit had a visible oil level.
