Issued November 2019

REPORT

Marine 2019/08

SUMMARY OF THE PART ONE REPORT ON THE COLLISION ON 8 NOVEMBER 2018 BETWEEN THE FRIGATE HNO MS HELGE INGSTAD AND THE OIL TANKER SOLA TS OUTSIDE THE STURE TERMINAL IN THE HJELTEFJORD IN HORDALAND COUNTY

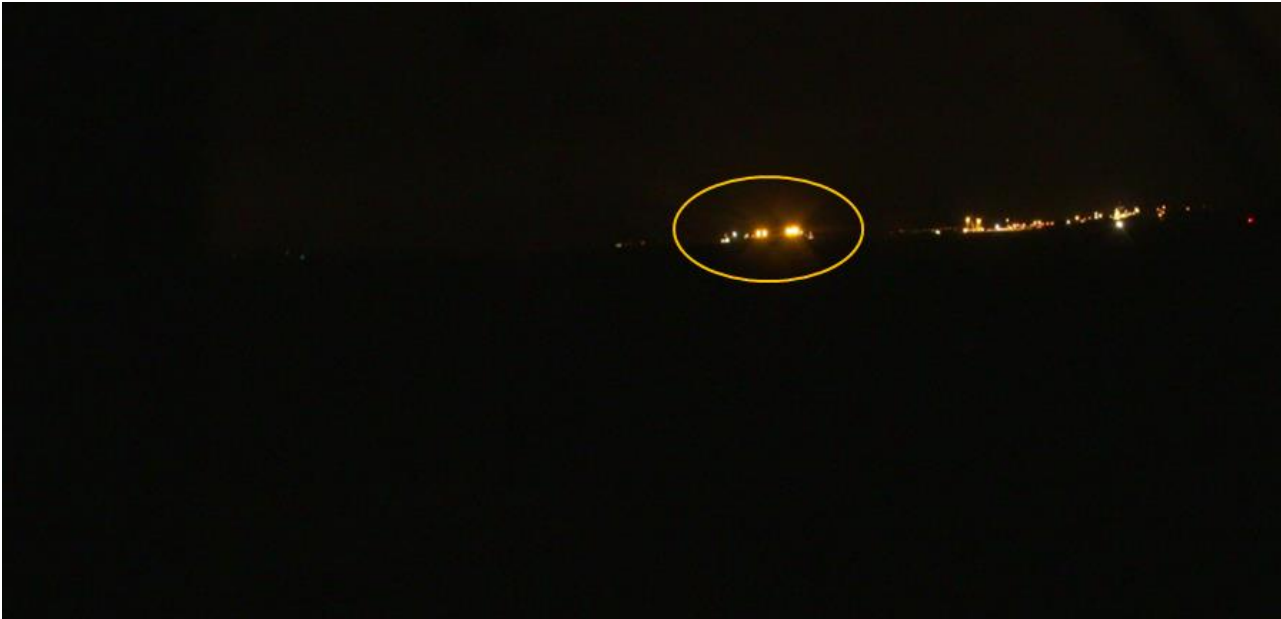
lights from the terminal. Sola TS was more clearly away from the terminal when the tanker turned her bow northwards towards Fedjeosen, so that the forward-pointing yellow deck lights became visible. The navigation lights on Sola TS were then difficult to discern because of the deck lights. The tanker appeared to be an object giving off light, and it was difficult to judge the distance in the dark.

Figure 8: Screenshot of video recording on the bridge of HNoMS Roald Amundsen on the observation voyage in the early hours of 2 April 2019, when Sola TS had turned to a north-northeasterly course (035°). This corresponds approximately to the situation at 03:49 on the night of the accident. Sola TS marked with yellow circle. Photo: The police

- **The shipping company Tsakos Columbia Shipmanagement S.A.** should establish safety measures for the use of deck lights on vessels, which ensures that the deck lights do not reduce the visibility of the navigation lights.

- **The Norwegian Maritime Authority** should address the industry in general with regards to the use of deck lighting which could reduce the visibility of the vessel's navigation lights.

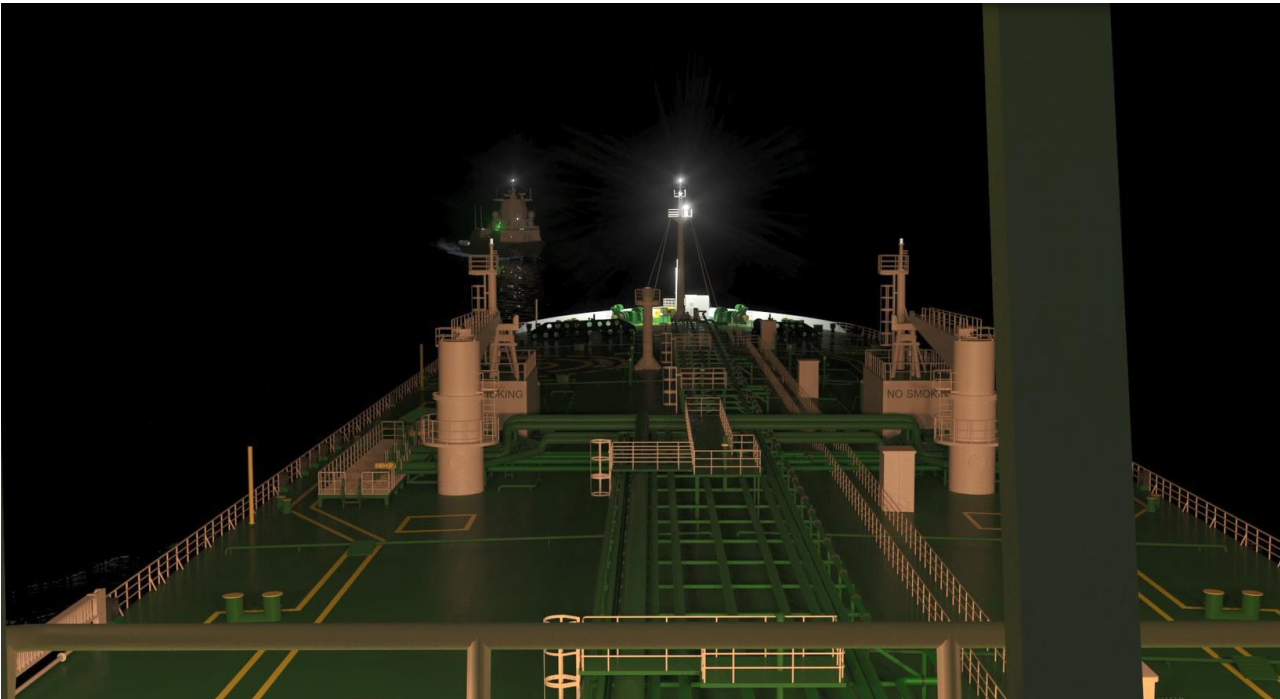
Figure 12: Illustrates the view from the bridge on Sola TS just before the collision. Illustration: AIBN
