## **Appendix H:**

# **Utilisation of resources and technical measures to avoid running aground**

### **H.1 INTRODUCTION**

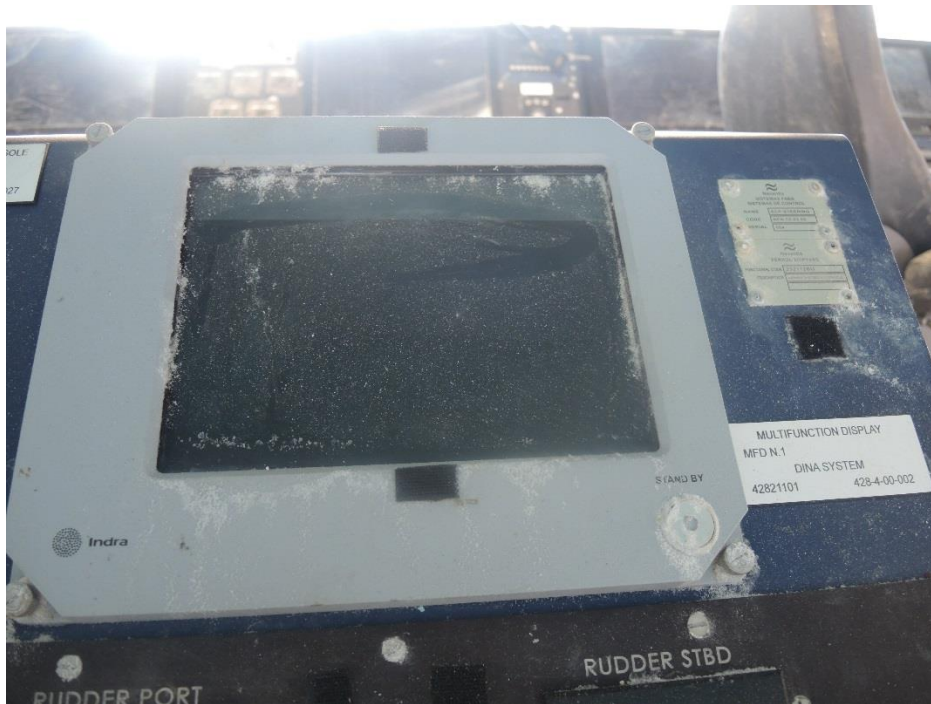
Several of the systems on the bridge displaying status and information about the steering had been dimmed or covered up to maintain night vision during the preceding voyage. The bridge team had to physically remove the temporary covers to see that the pumps were up and running. This would also be necessary in the case of the MFD, to enable retrieval of necessary information about the steering system; see Figure 1. If the bridge team had been able to utilise this information about the rudder control system on the bridge, it would have helped to correct the incorrect perception that the steering system did not work after the collision.

Figure 1: MFD9 in front of the helmsman on SSC. The photo was taken after the refloating of HNoMS 'Helge Ingstad', with the cover on the display removed. Photo: NSIA
