REPORT MARINE 2022/12

***Collision between the cargo ship 'Edmy'
and the fishing vessel 'Tornado' outside
Langesund on 4 October 2022***

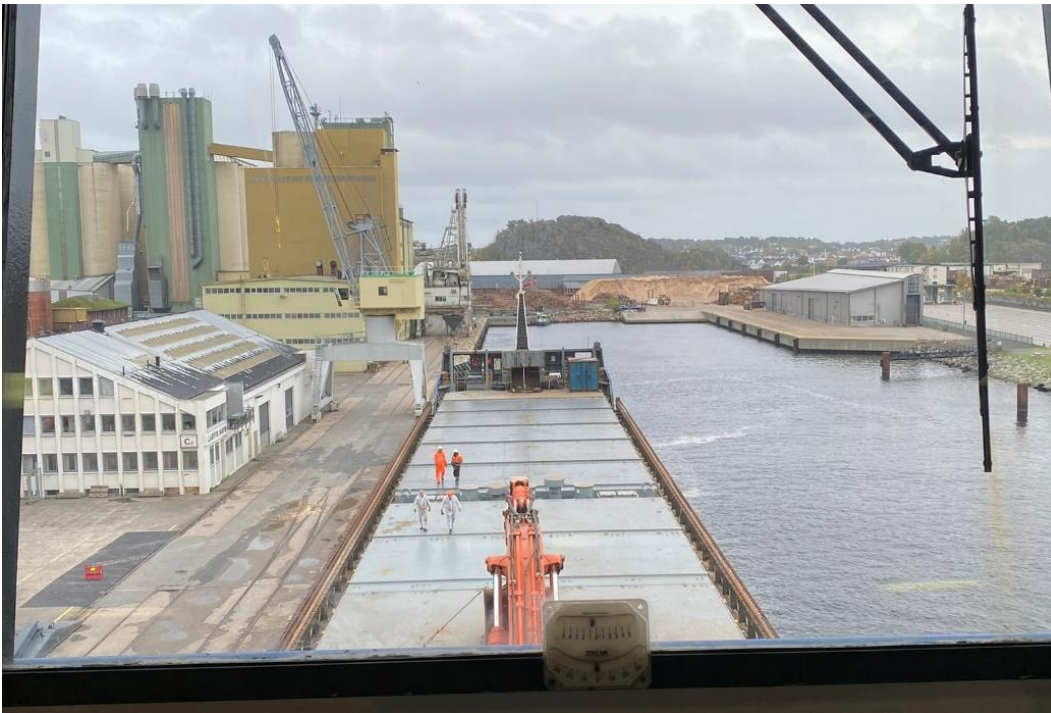
Figure 2: View from the bridge of 'Edmy'. Photo: NSIA

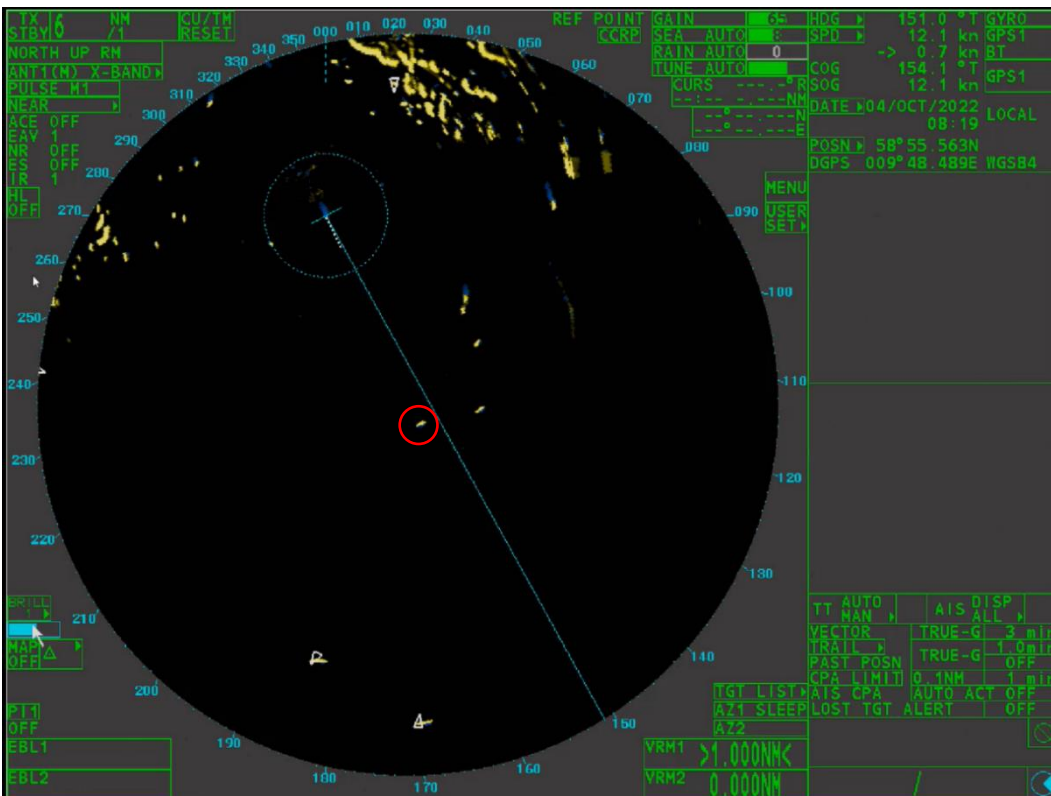
Figure 3: The radar plot the navigator checked after the pilot left the ship. 'Tornado' is marked with a red circle. Illustration: Myklebusthaug Rederi AS

The navigator of the cargo ship checked the radar for potential dangers, without identifying the fishing vessel. The NSIA believes this was because the fishing vessel was only shown on the radar as an echo, with no AIS information on the radar or ECDIS displays. Use of navigational aids such as ECDIS and AIS allows navigators to rely more on the technology and thereby engage less actively in traditional outlook-based navigation. The NSIA believes that the expectation that most vessels transmit AIS information can lead to a false sense of security, as there is a possibility that not all dangers are identified.

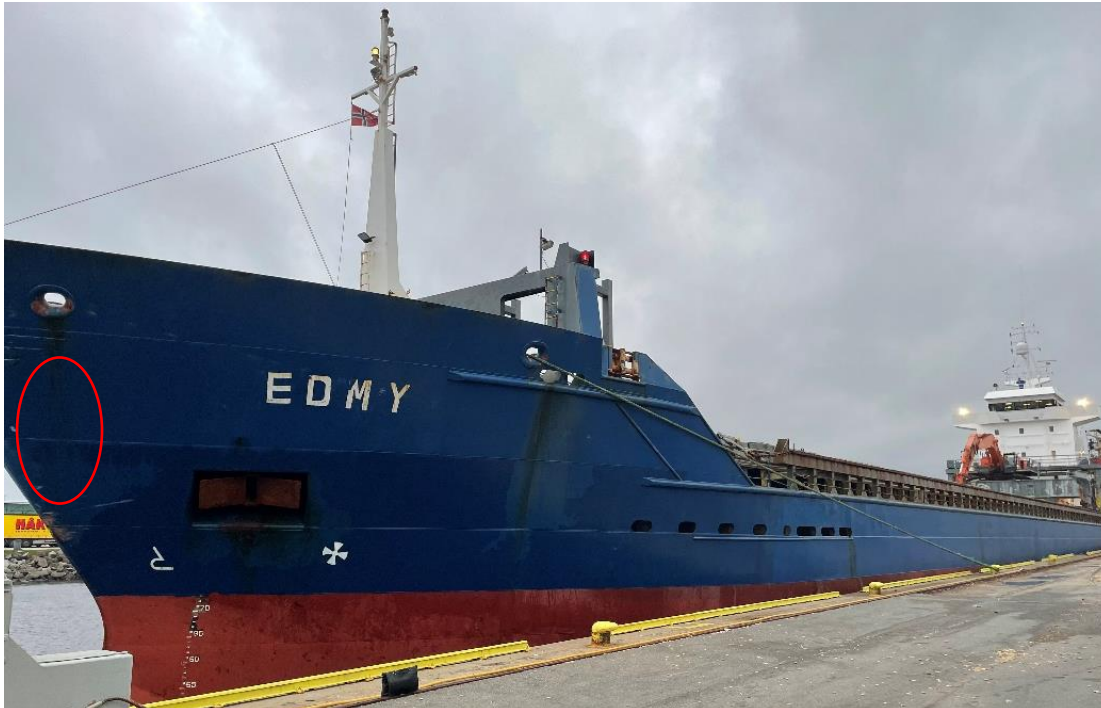
Figure 4: The cargo ship 'Edmy' alongside the quay. She sustained only minor scratches and a small dent at the bow. Photo: NSIA

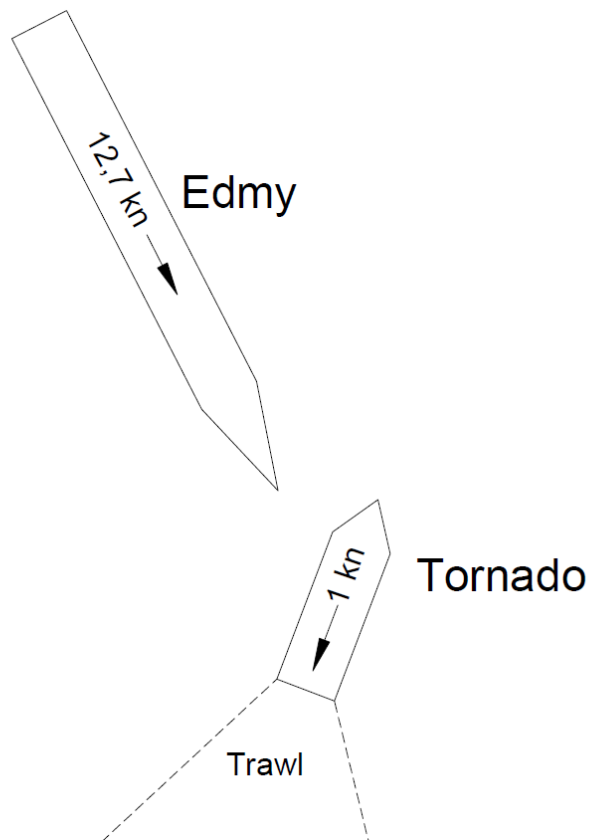
Figure 5: 'Tornado' was almost stationary, moving backwards at a speed of about 1 kt, while 'Edmy' was travelling at a speed of 12.7 kt. Illustration: NSIA

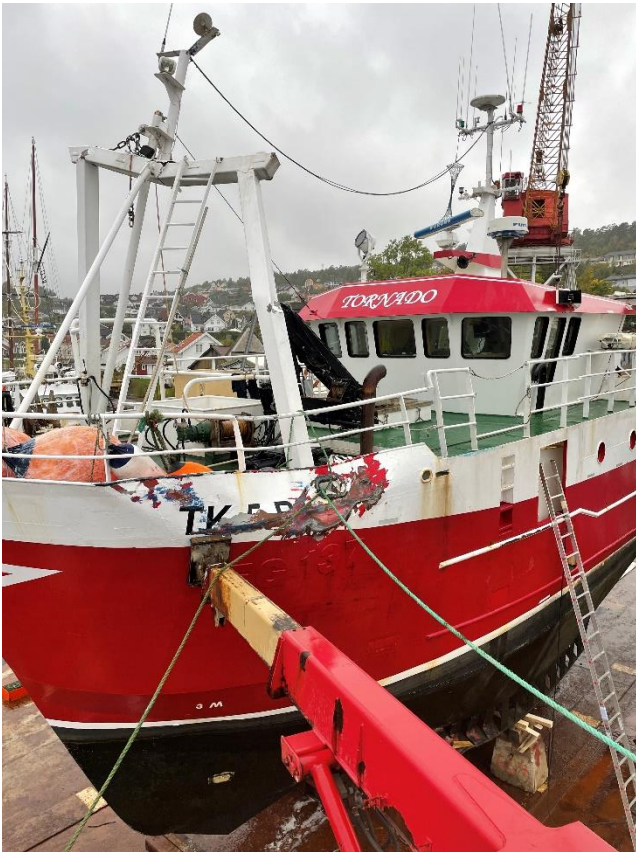
Figure 6: Damage to the forward end of the bulwark and to the mast. Photo: NSIA

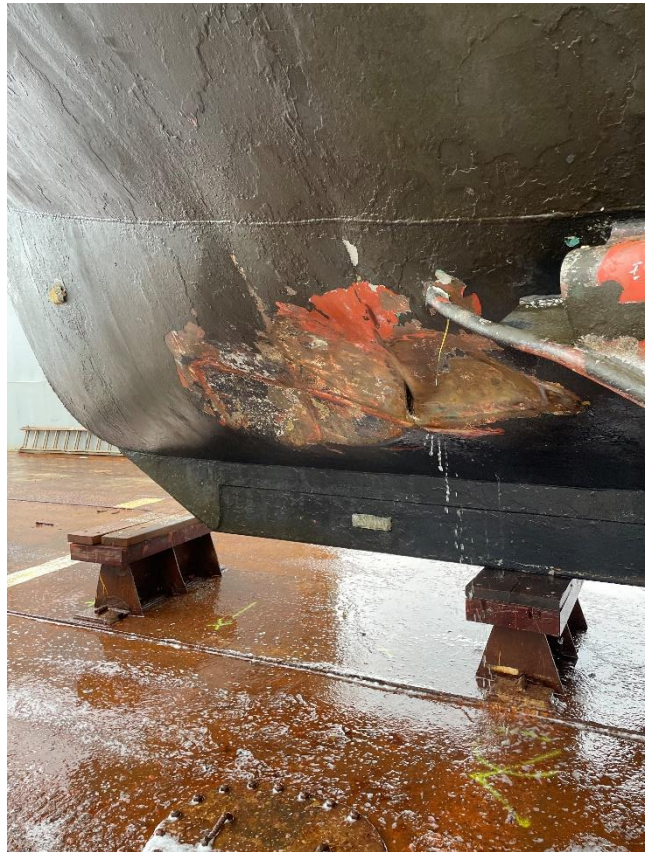
Figure 7: Damage to the hull that resulted in ingress of water into the cargo hold. Photo: NSIA
