# REPORT MARINE 2023/04

***Capsizing of the pleasure boat Malmhella  
in the archipelago off Kragerø, Norway on  
25 October 2022***

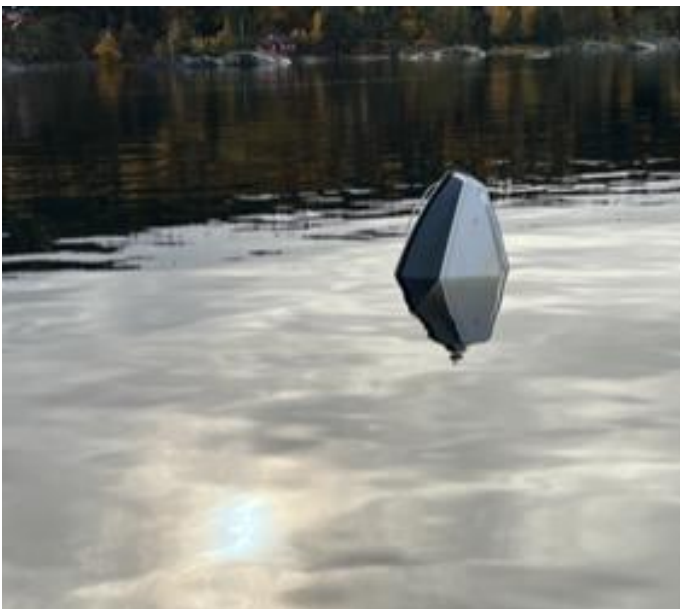
The boat was later retrieved by a local workboat owned by Kragerø port authority, brought to Kiil-Sandtangen and lifted out of the water. When the boat was located, only a small part of the bow was visible above the water, see Figure 1.

Figure 1: Only the bow of the craft was visible when the salvage operation started. Photo: Kragerø port authority

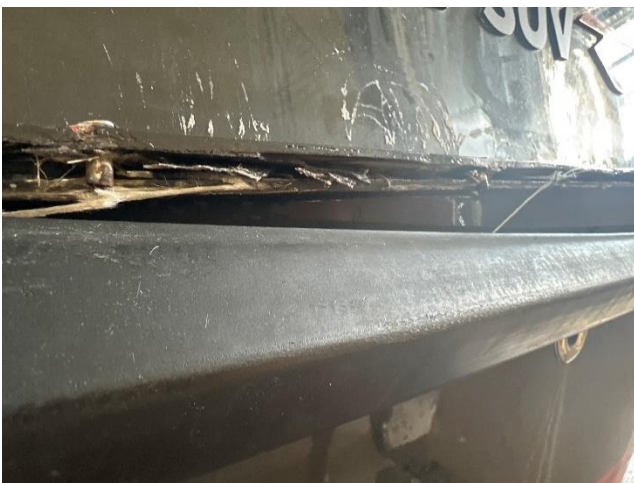
The boat sustained minor structural damage. The superstructure on the starboard side came away from the underwater hull as several pop rivets were out of position, see Figure 3 and Figure 4. The starboard pilothouse window broke when the vessel capsized, the radar mast broke off and the soft top that functions as a roof came loose, see Figure 5. There was also some minor cosmetic damage that could have been inflicted during the salvage operation.

Figure 3: Pop rivets out of position, view from the rear. Photo: NSIA

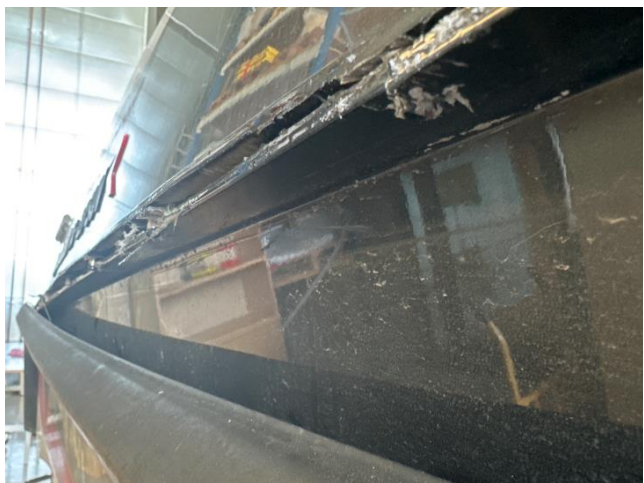
Figure 4: Pop rivets out of position, view from the front. Photo: NSIA

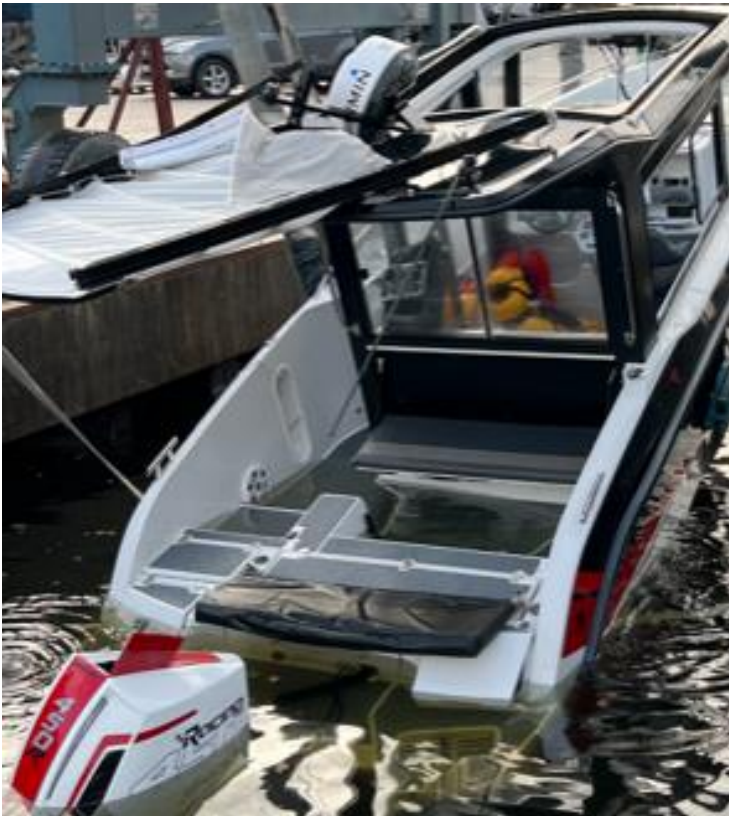
Figure 5: The boat was raised after towing. Photo: Kragerø port authority

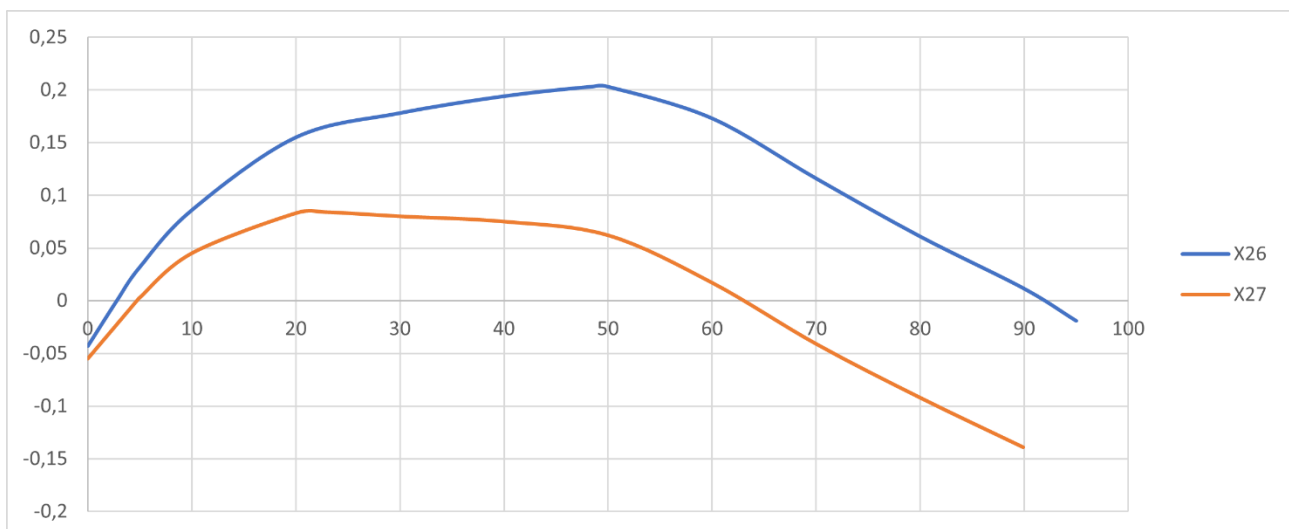
Figure 12: Comparison of the GZ curves for the boats where the capsizing condition has been assessed. Source: NSIA

The GZ curves show that the stability of the X-27 SUV is significantly reduced compared to that of the X-26 S. At an angle of heel of approx. 63 degrees, the X-27 SUV will be unable to right itself and will capsize. The X-26 S, on the other hand, can withstand significantly more heeling before it capsizes.

As a consequence of the transverse centre of gravity (TCG) of the loading condition and lightship, the X-26 S will start with a heel of 2.8 degrees and the X-27 SUV with 4.7 degrees to starboard. This is the same side as the boat capsized towards.

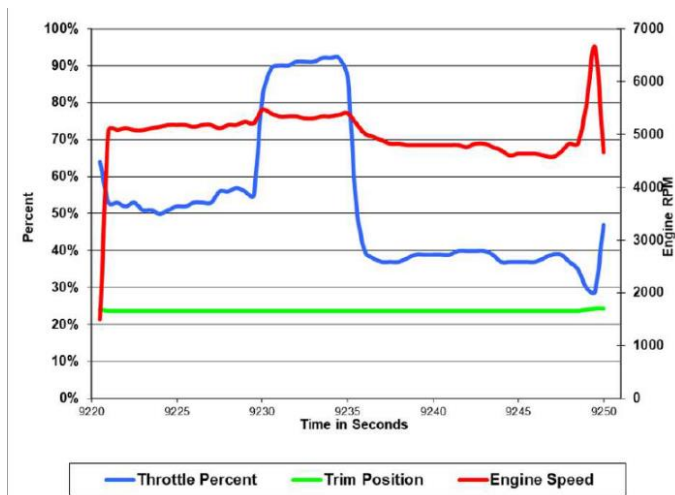
Figure 18: Engine data from Malmhella Source: Engine manufacturer

The engine's trim is stated in per cent, but this is only a relative indication of changes of position, not the actual trim in per cent. The steep increase in rpm at the end of the graph is consistent with a propeller running out of water.

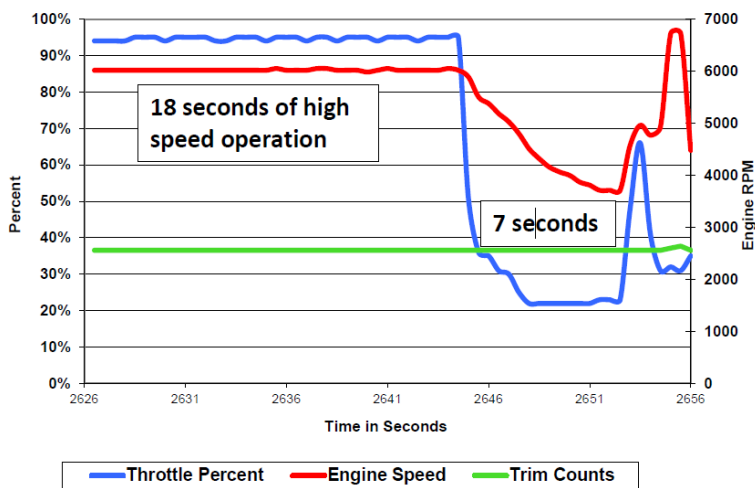
Figure 19 shows the final 30 seconds before the accident. The data show high throttle per cent, probably with the lever pushed as far as it would go, for 18 seconds, before it was reduced to approx. 20% over a period of 7 seconds before increasing again. This could be a result of the propeller briefly losing resistance before the boat made contact with the water again and capsized. This also tallies with information provided by the operator of the craft, who stated that the speed was reduced and a turn initiated before the accident occurred.

Figure 19: Engine data from the first incident involving the craft type. Source: Engine manufacturer

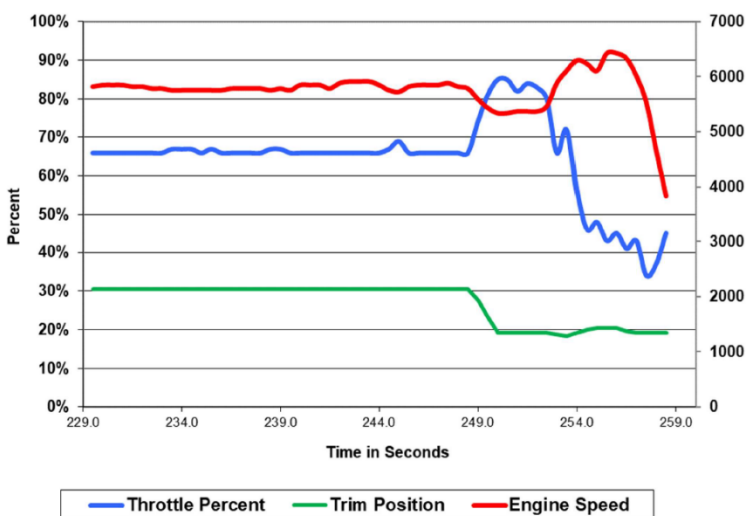
On 26 June 2022, the craft was taken for a test run, and the operator has stated that the craft was travelling in a straight line at a speed of about 35 knots when the bow suddenly and unexpectedly moved sharply to port. The boat consequently capsized and started to sink. The operator was wearing an inflatable life jacket that inflated when the operator entered the water. The operator got out of the boat and was able to summon help.

Figure 20: Engine data from the first incident involving the craft type. Source: Engine manufacturer

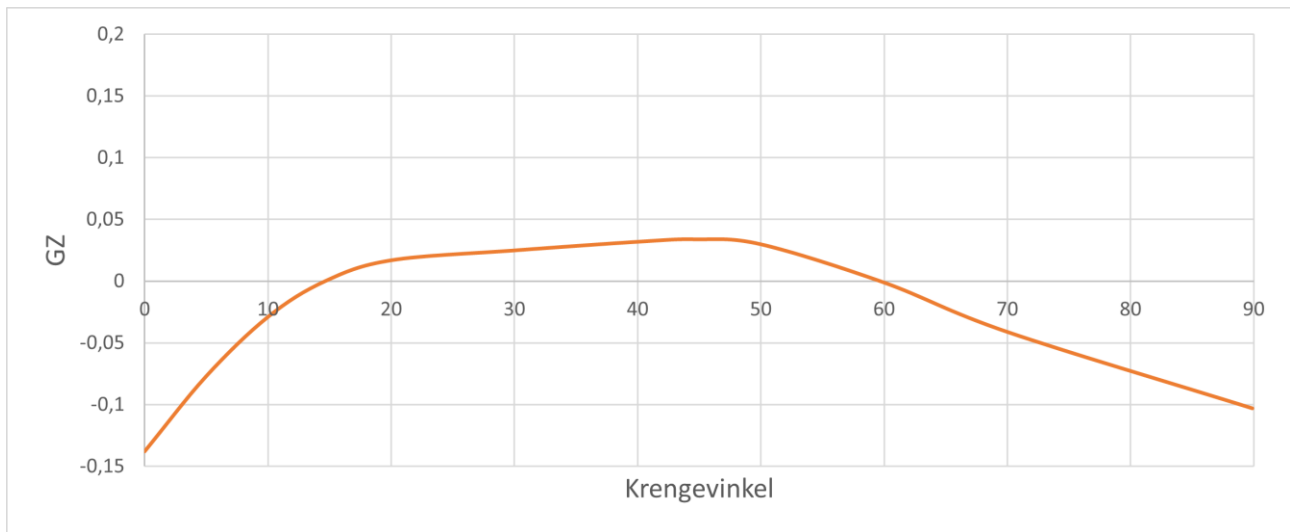
Figure 23 shows a calculation of six persons placed to starboard where the resulting angle of heel will be within the requirement for CE marking. The GZ curve shows a list of 14.6 degrees, which is within the requirement, but nevertheless shows that, although positive, the stability is very poor

between this angle and 60 degrees. In this case, a minor shift of the weights during the practical stability test will have a great effect on the angle of heel.

Figure 23: GZ curve illustrating the loading condition based on 50% fuel, a full freshwater tank and six persons on the starboard side simulating the practical implementation of testing in accordance with NS-EN ISO 12217-1:2017. Source: NSIA
