Submitted September 2023

# REPORT MARINE 2023/05

***Fatal accident on board M/V 'Oslo Wave 3',  
port of Hamina in Finland, 13 February 2023***

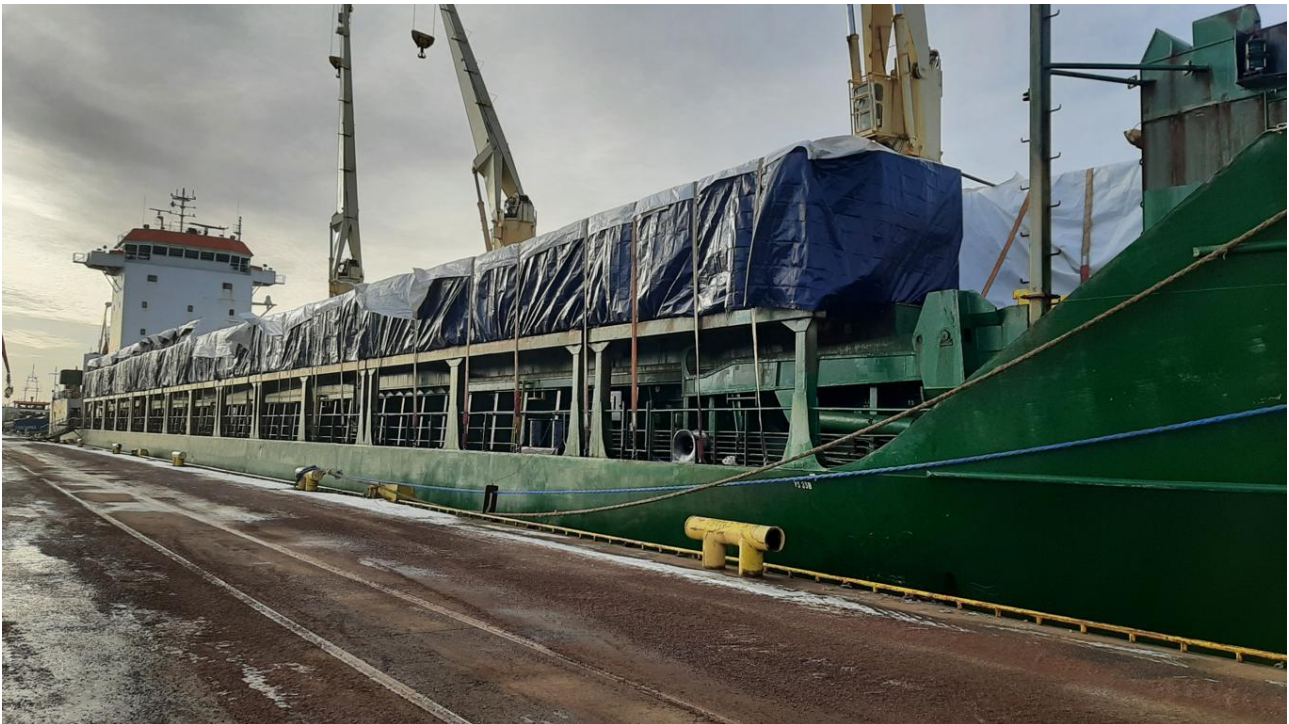
*Figure 1: Cargo ship M/S 'Oslo Wave 3' berthed in the port of Hamina in Finland. Photo: Police in Finland*
