# INVESTIGATION REPORT

## VIKING POLARIS

### NSIA PROJECT NO 22/661

This report is translated by the Norwegian Safety Investigation Authority (NSIA)

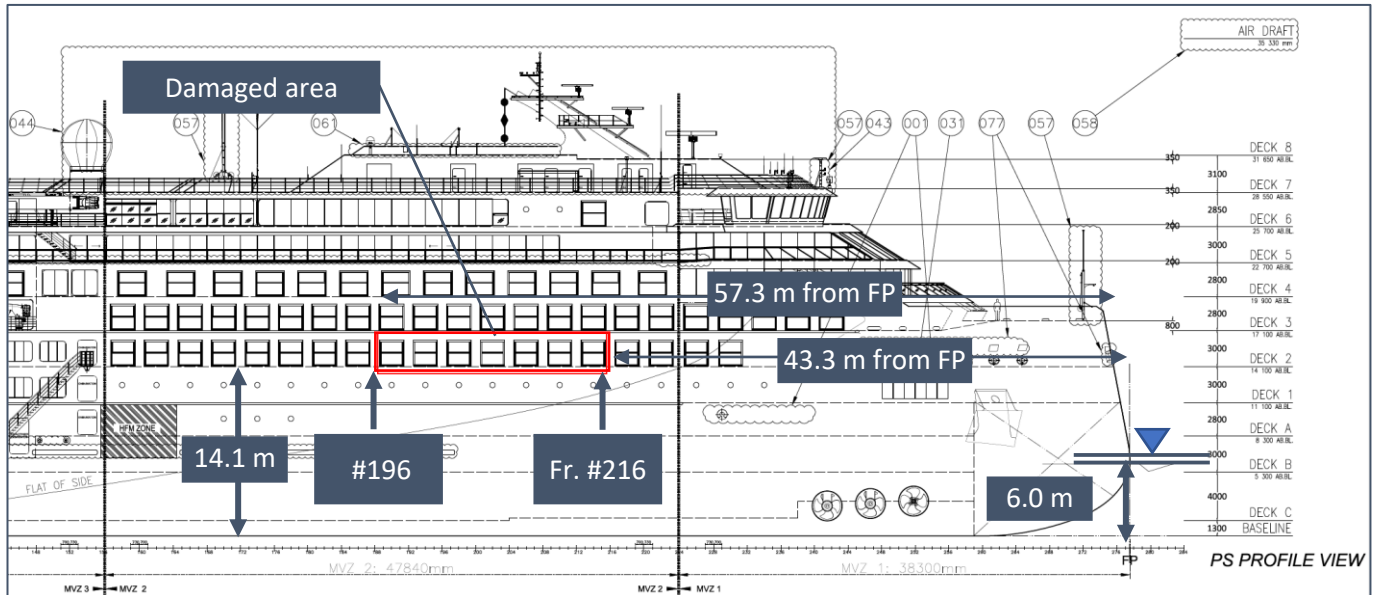
The damage consisted of windows that were partially shattered and pushed in, and subsequent damage to fixtures and fittings in the staterooms. The area that was damaged was on deck 2, 14.1 metres above the keel and

between 43 and 57 metres from the foreship (FP). The minimum still-water freeboard at the time of the accident is estimated to about 8 metres.

Figure 6-1 Illustration of damaged area – illustrated from starboard side on the drawing

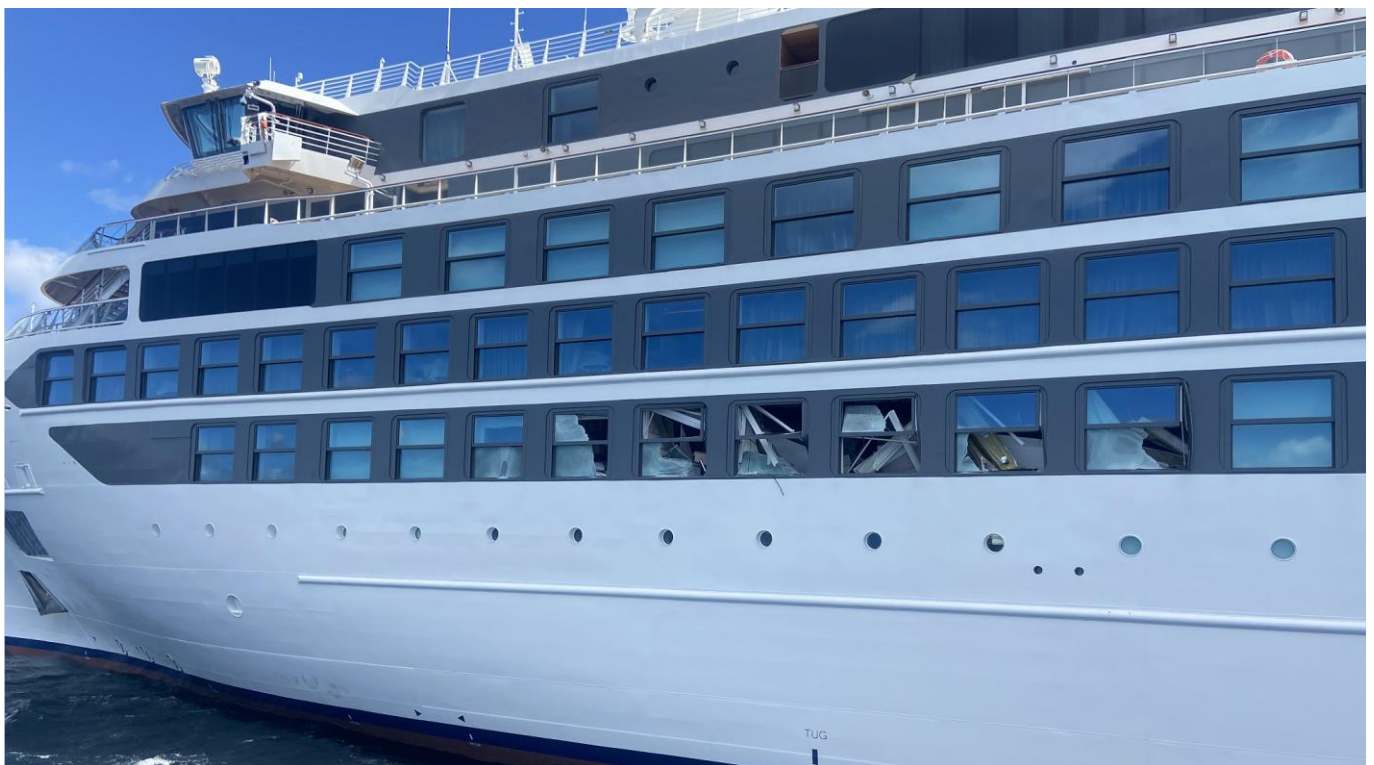
Figure 6-2 Photo of damage to the port side of 'Viking Polaris', deck 2, November 2022

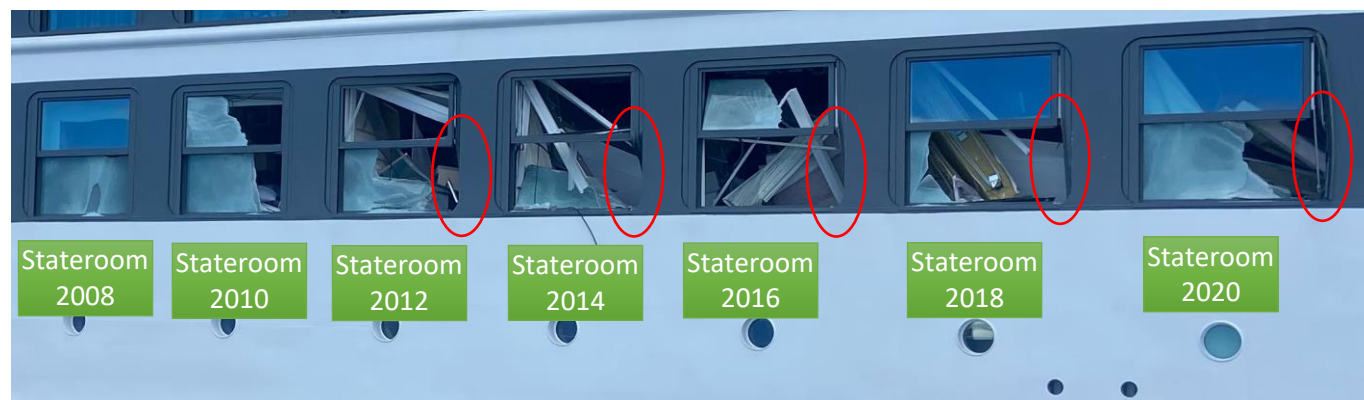
In five of seven staterooms (2012, 2014, 2016, 2018 and 2020), the aft frame post has been knocked in; see Figure 9-4 and Figure 9-5. For these windows, it can be concluded that the frame post was knocked in while pulling the shortest (aft) side of the window pane with it, thereby shattering the glass. That means that the frame yielded before the pane, and that the pane shattered as a result of high pressure and inadequate support from the frame post.

Figure 9-4 Overview photo showing the damaged staterooms on deck 2. We can see that the aft frame post is damaged on five of the seven damaged windows.

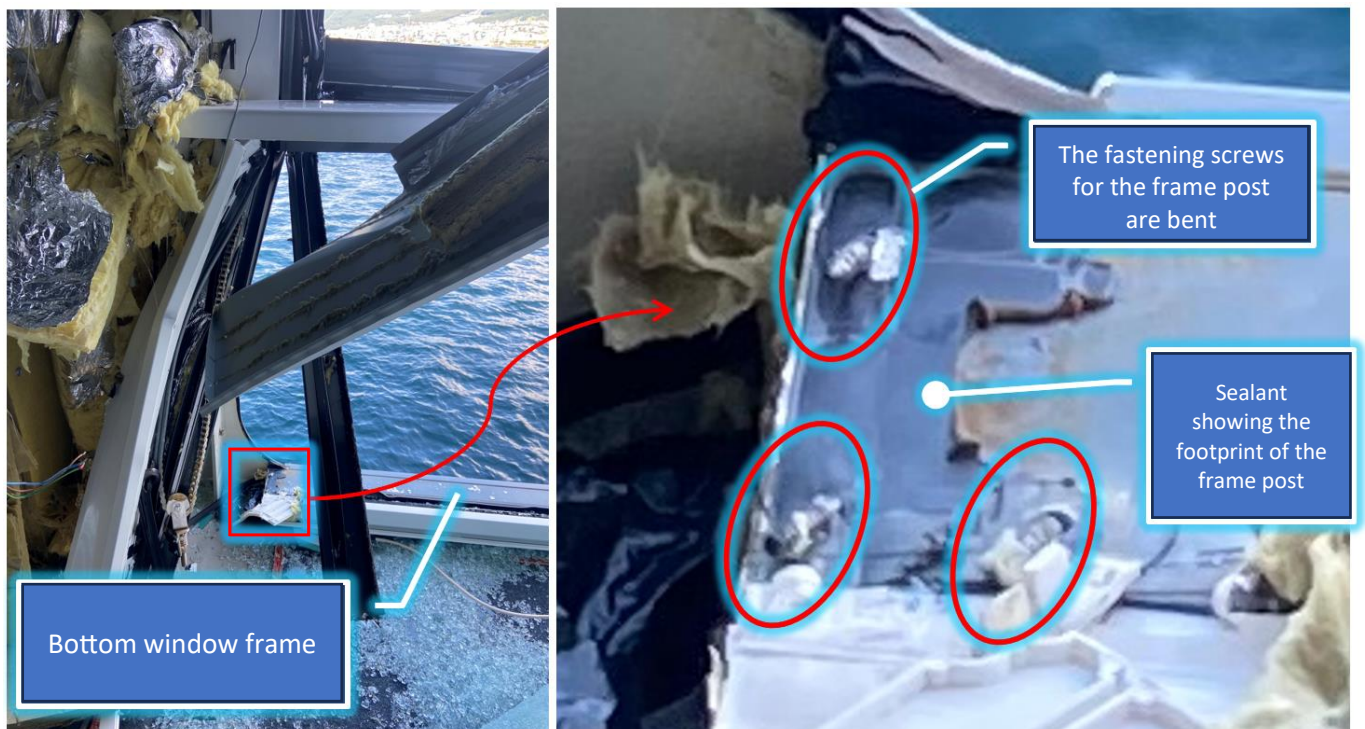
Figure 9-6 shows a close-up photo of the aft frame post. We see that three of six fastening screws are bent as a result of the frame post being pushed into the stateroom. The six fastening screws used to attach the frame post are shown in Figure 9-7.

The full-scale pressure test that was carried out (see section 10.2) showed that the frame was able to withstand a test pressure of 40 kPa. The windows and frames for these staterooms had a design pressure of 24.4 kPa. The fact that the frame withstood a higher pressure but yielded first suggests that the pressure has been higher than 40 kPa and thus far higher than what the window was designed for. If the frame post had been attached to the hull with load-bearing screw, it would have been able to withstand the pressure from the wave. As the pressure from the wave far exceeded the design pressure, however, the window would in any case have been shattered.

Figure 9-6 The weakest point of the window frame

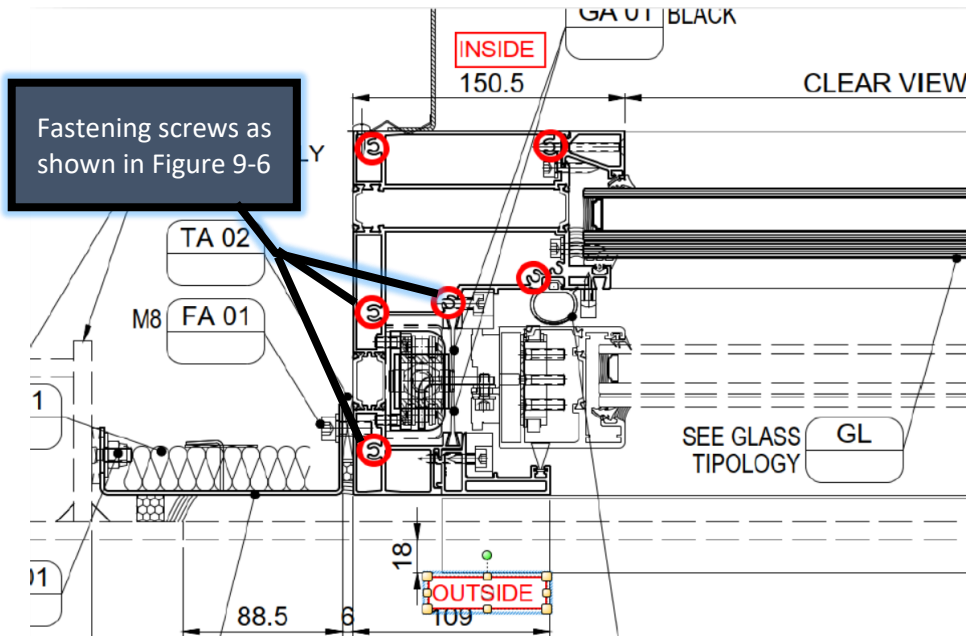
Figure 9-7 Fastening screws for the window frame seen from above

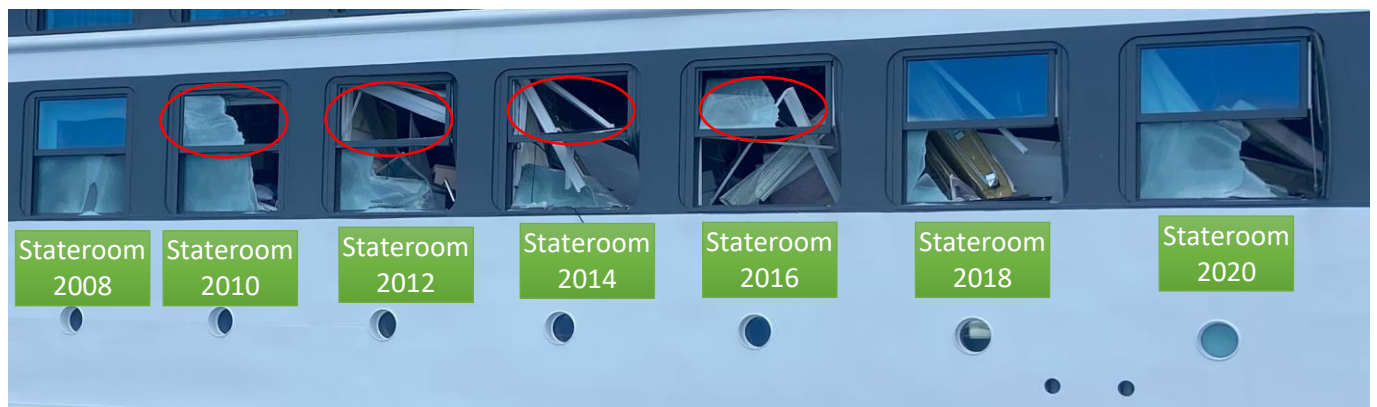
Figure 9-8 shows the four upper damaged windows, where the frame is still intact. This means that the glass was the weakest point of these windows, and not the frame as was the case for the lower windows.

Based on these findings, we can conclude that the pressure has been higher than the glass was able to withstand.

Figure 9-8 Overview photo showing the damaged staterooms on deck 2.

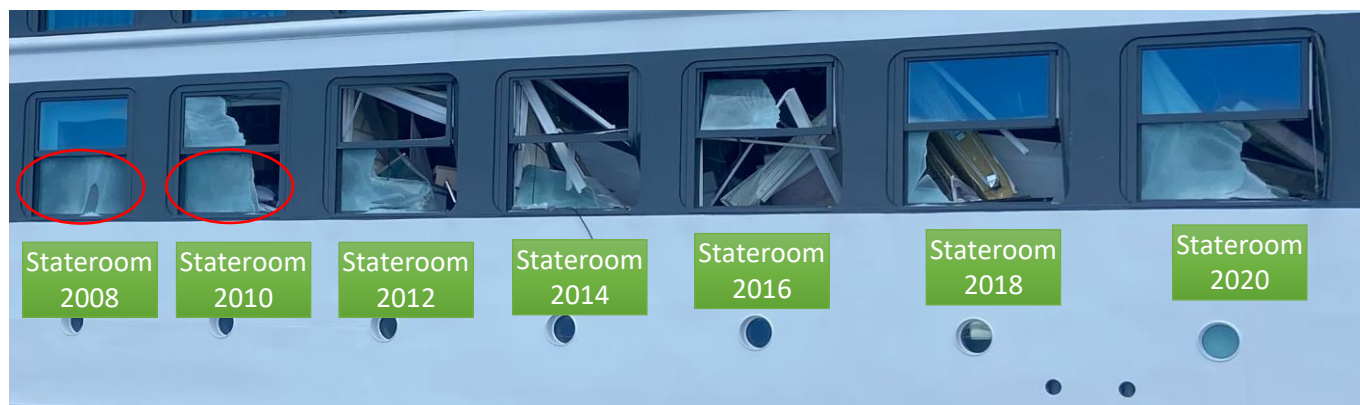
On the lower windows in staterooms 2008 and 2010 (see Figure 9-9), the frame is still intact, while the pane has shattered. In that respect, they differ from the lower windows in the other staterooms, where the aft frame post was pushed in, taking the window pane with it. For the lower windows in staterooms 2008 and 2010, the pane was the weakest point. It has not been possible to find an explanation as to why the frames are intact on these panes, while the aft frame posts of the remaining lower windows have been knocked in.

Based on these findings, we can conclude that the pressure has been higher than the glass was able to withstand.

Figure 9-9 Overview photo showing the damaged staterooms on deck 2.

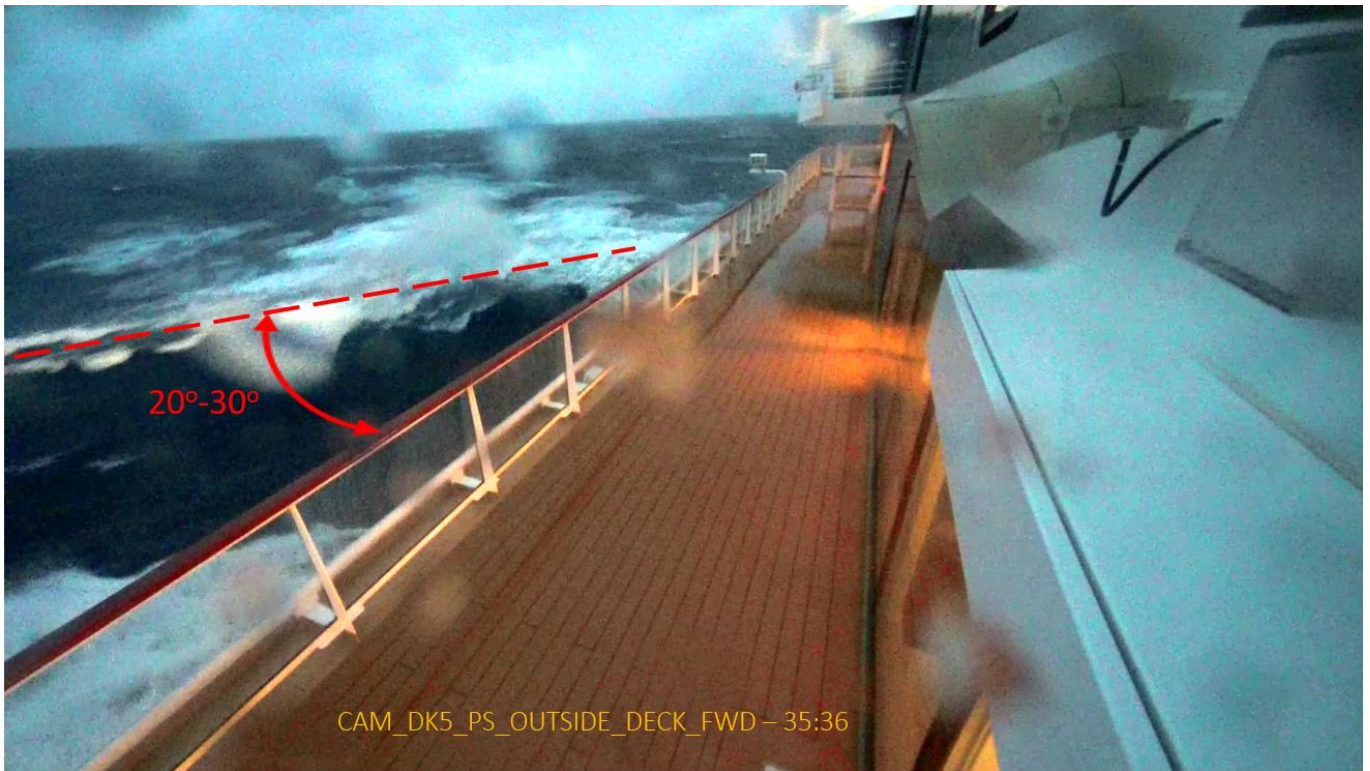
Figure 11-3 Footage from a CCTV camera on deck 5, port side at frame #162, immediately before the impact (02:35:36 UTC+1).

From the CCTV footage, it appears that the wave broke just before or as it struck the ship. Waves can break either because strong winds or an opposing current make the crest unstable [18], and/or because of the height/length ratio (wave steepness) [8]. Breaking waves are more common in a developing sea state (when the wave height and wind speed are still increasing) and when the sea is choppy (shorter waves).

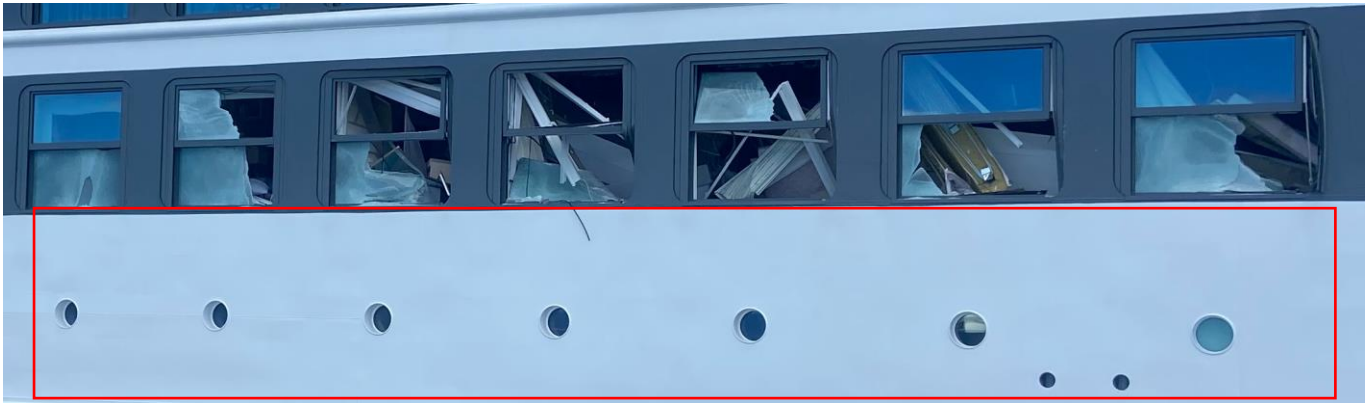
An assessment of the capacity of surrounding steel has been made to attempt to provide an upper estimate of the pressure caused by the accident wave. The hull steel plates just below the windows shows no signs of damage or deformation. It is therefore assumed that the maximum pressure this steel can withstand will therefore provide an indication of the upper interval of the pressure at the time of the accident.

The calculations show that the maximum static pressure on the surrounding steel can withstand is estimated to withstand 107 kPa. This indicate that the pressure from the accident wave must have been in the order of magnitude of 107 kPa, but greater than the test pressure of the frame of 40 kPa. It cannot be ruled out that the maximum slamming pressure has been greater than 107kPa over a very short period since the calculations are based on static pressure load.

Figure 14-1 Undamaged steel. The maximum pressure these plates can withstand has been calculated in Stipla.
