# REPORT MARINE 2023/06

***Marine casualty involving the cruise ship  
'Viking Polaris' south-east of Cape Horn,  
29 November 2022***

*The Norwegian Safety Investigation Authority (NSIA) has compiled this report for the sole purpose of improving safety at sea.*

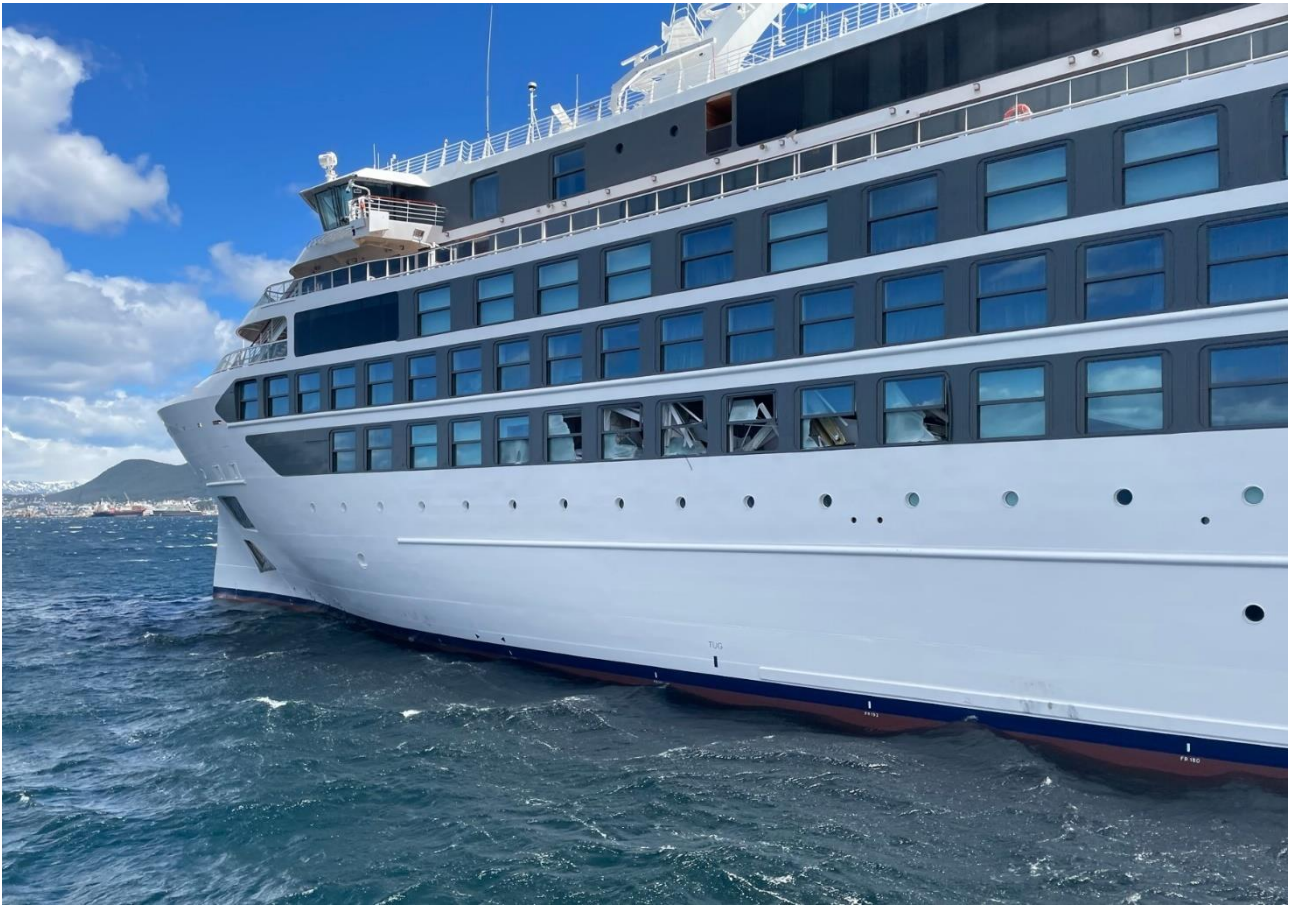
*Figure 12: Broken windows in staterooms on deck 2 on board 'Viking Polaris' after arrival in Ushuaia.  
Photo: NSIA*

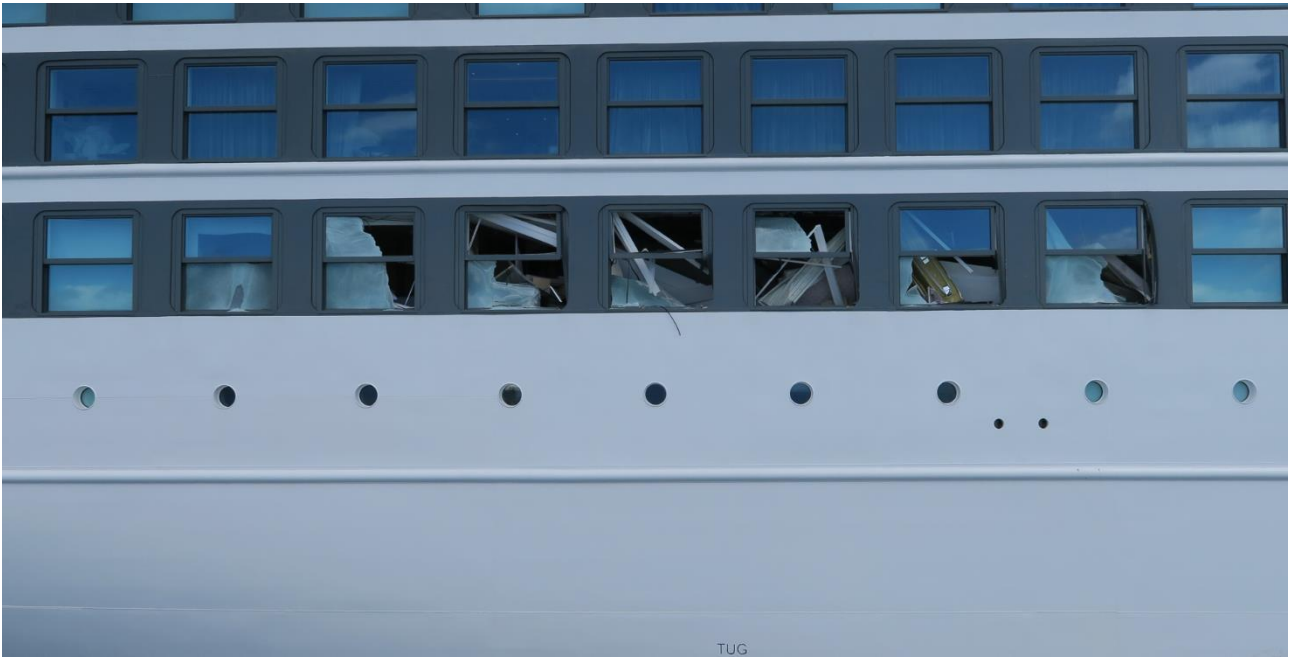
Figure 18 shows a close-up of the broken windows. In several of the staterooms where the windows had broken, the frames were damaged and had been pushed into the stateroom, mainly in the bottom aft corner. In four of the seven staterooms, both the upper and lower windows were broken, while in three staterooms, the upper window was intact.

*Figure 18: Damage to windows and frames in the damaged area on deck 2. Photo: NSIA*

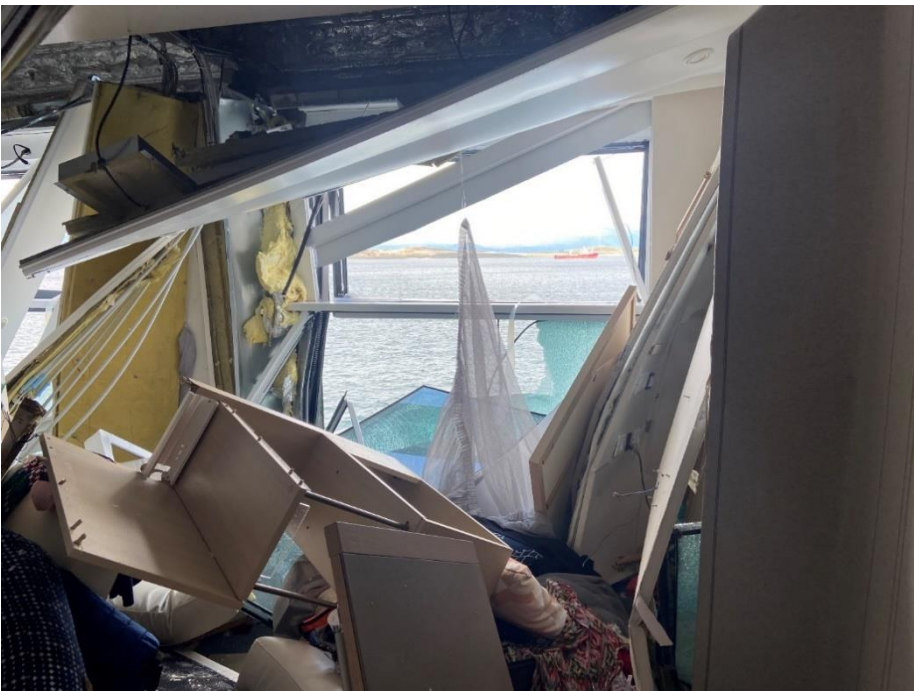
Figure 23: Damage to window, frame and stateroom 2012. Photo: NSIA

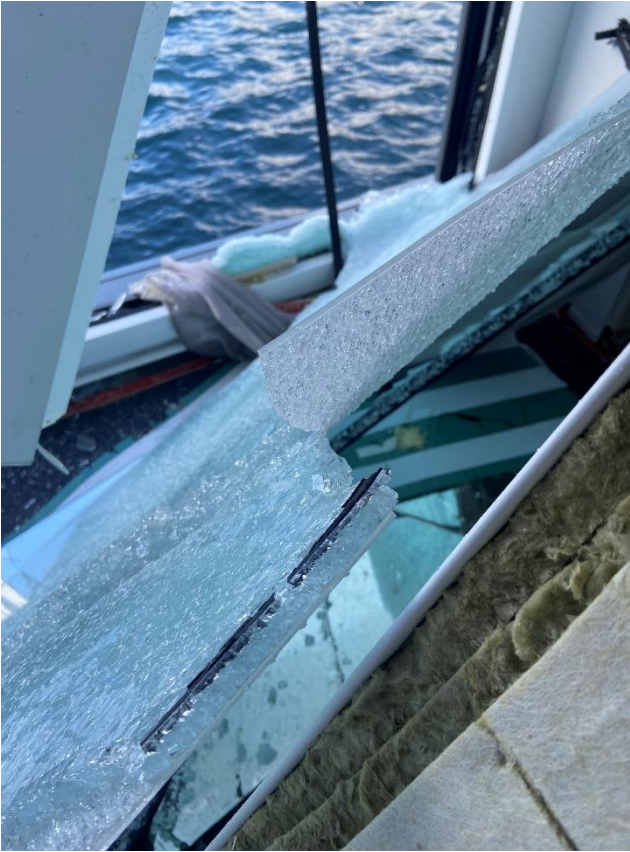
Figure 24: Damage to window in stateroom 2014.  
Photo: NSIA

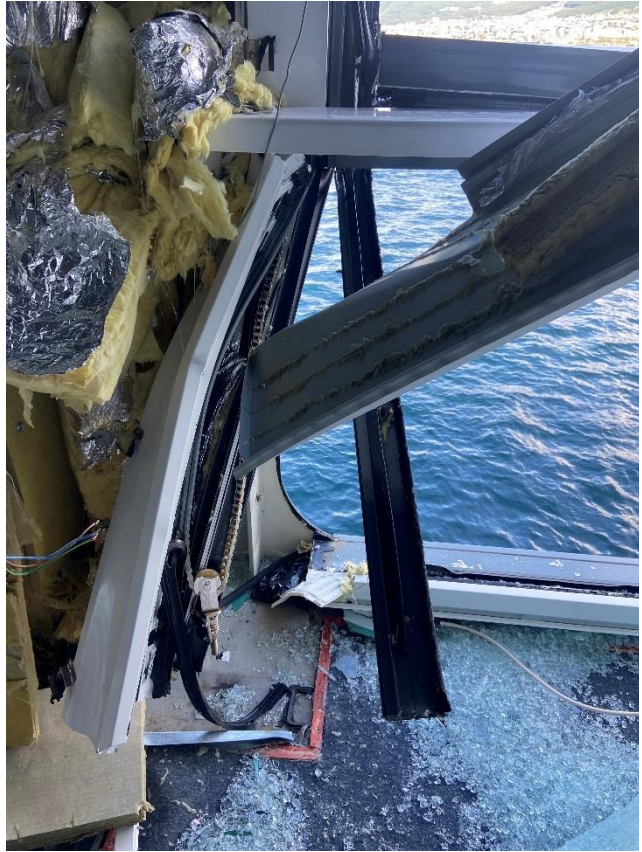
Figure 25: Damaged window frame in stateroom 2014. Photo: NSIA

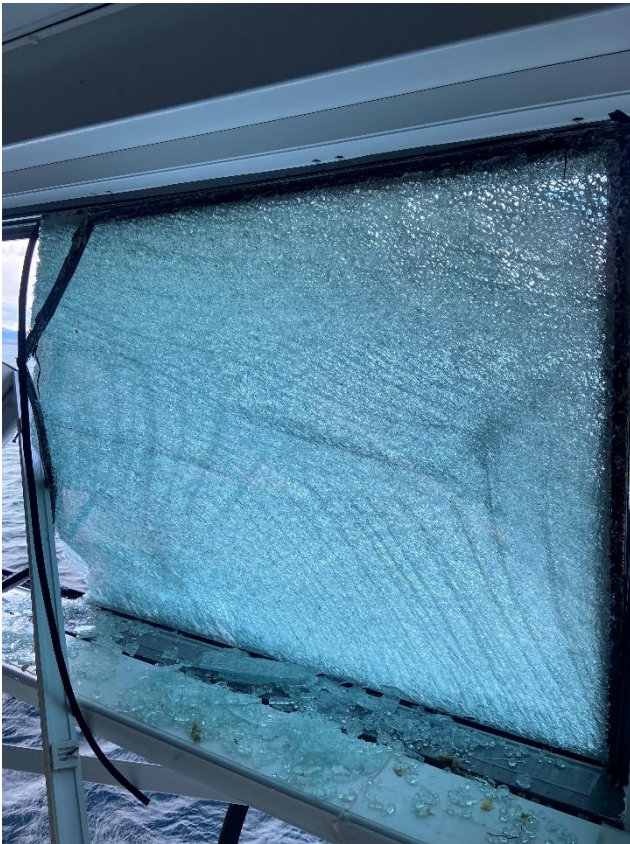
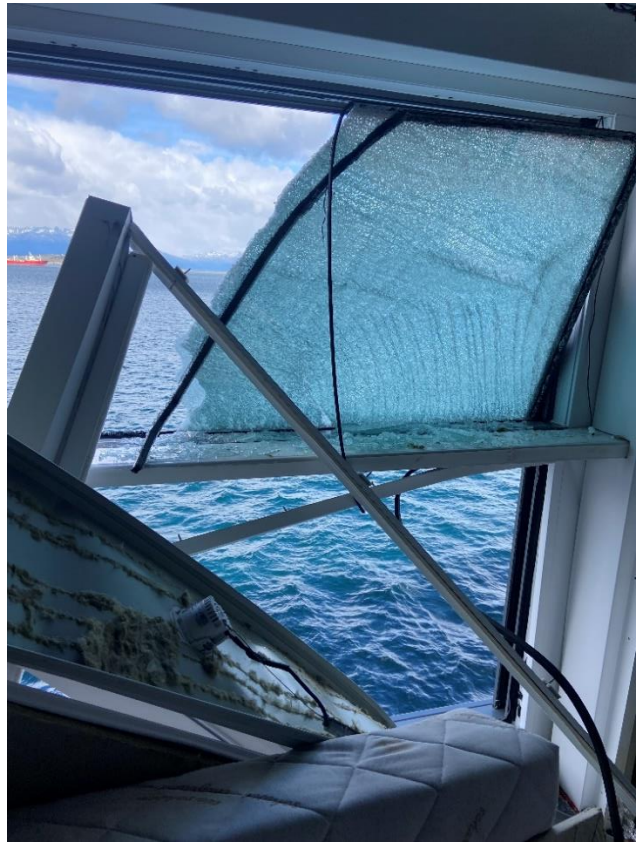
Figure 26: Broken window in stateroom 2016.  
Photo: NSIA

Figure 27: Broken window in stateroom 2016.  
Photo: NSIA

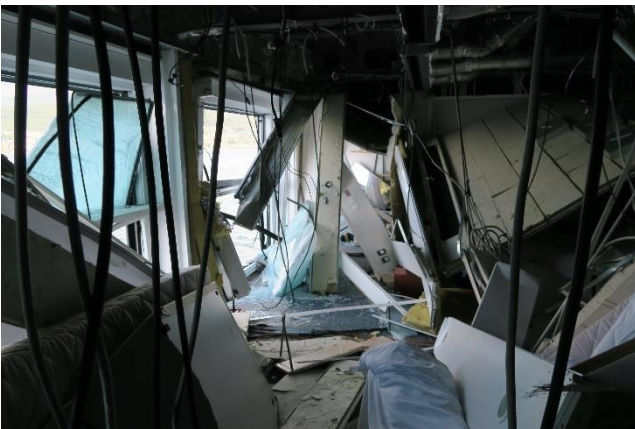
Figure 34 and Figure 35 show the part of the stateroom area that sustained the most damage. The ceiling had fallen down and walls between staterooms had been torn up and pushed backwards.

Figure 34: Photo taken from stateroom 2018 also showing damage to staterooms 2016, 2014 and 2012. Photo: NSIA

Figure 35: Photo from the damaged stateroom area showing how the ceiling and walls have been dislodged and pushed together. Photo: NSIA

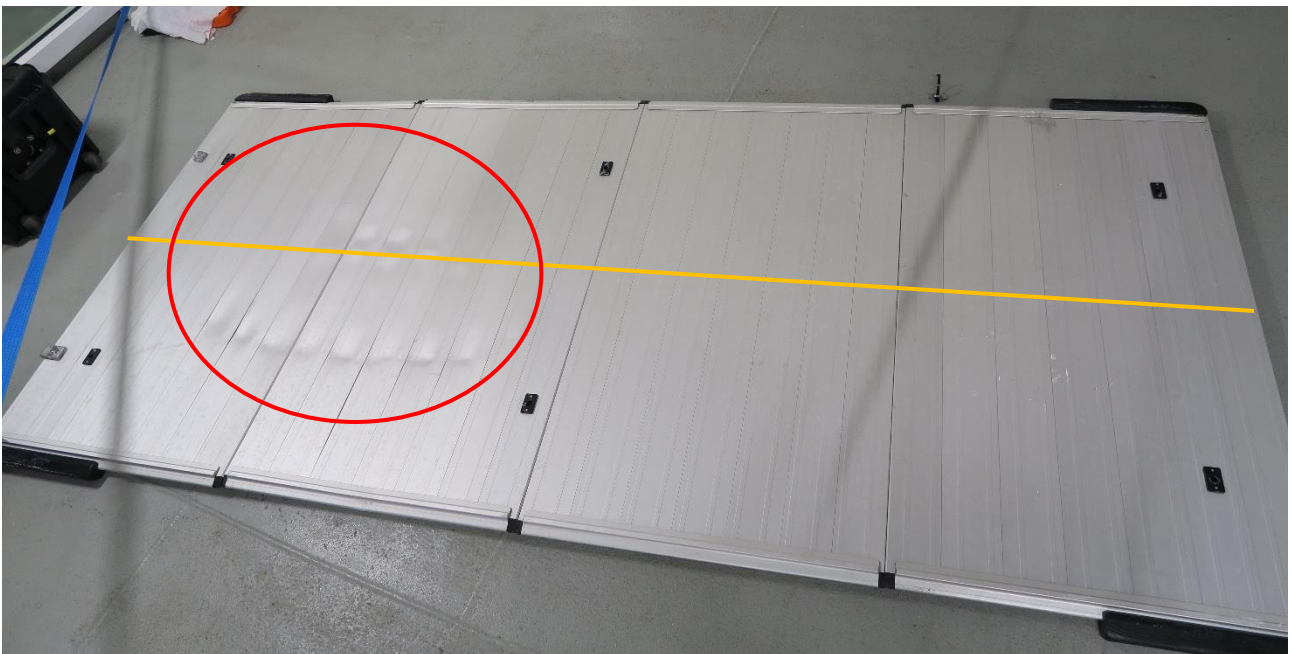
The incident on board the Zodiac occurred as a consequence of some sort of explosion below the floorboards. Obvious dents were found in the aluminium floorboards. The floorboards were removed to inspect the damage. The centre keel below the floorboards had ruptured; see Figure 40. The keel was measured to 450 cm, and the tear was measured to 187 cm. No major foreign bodies were found at the bottom of the keel, but some sand was observed.

Figure 41: Floorboards lying bottom up. There are dents (red circle) that arose in connection with the incident. The orange line indicates where the central keel was located. Photo: NSIA

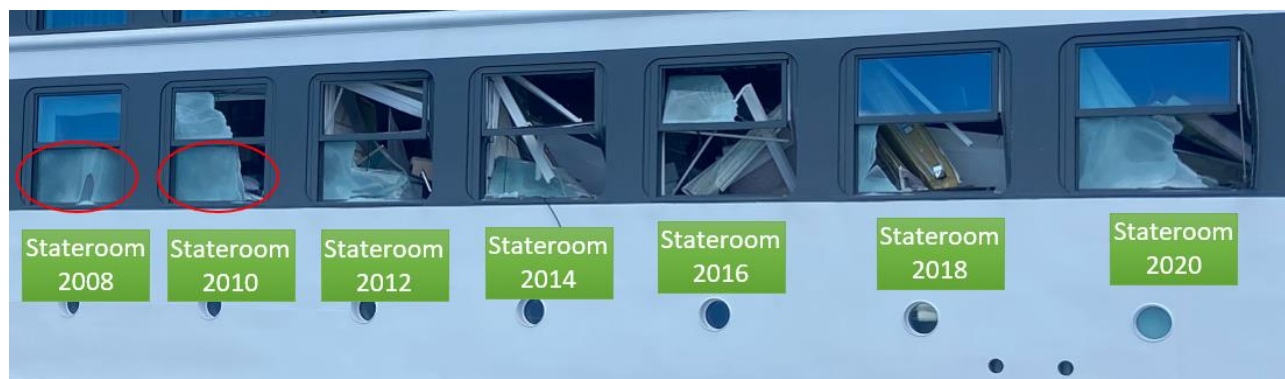
Figure 76: The windows where the window pane is broken but the frame is intact are circled in red.  
Photo: NSIA/consultant

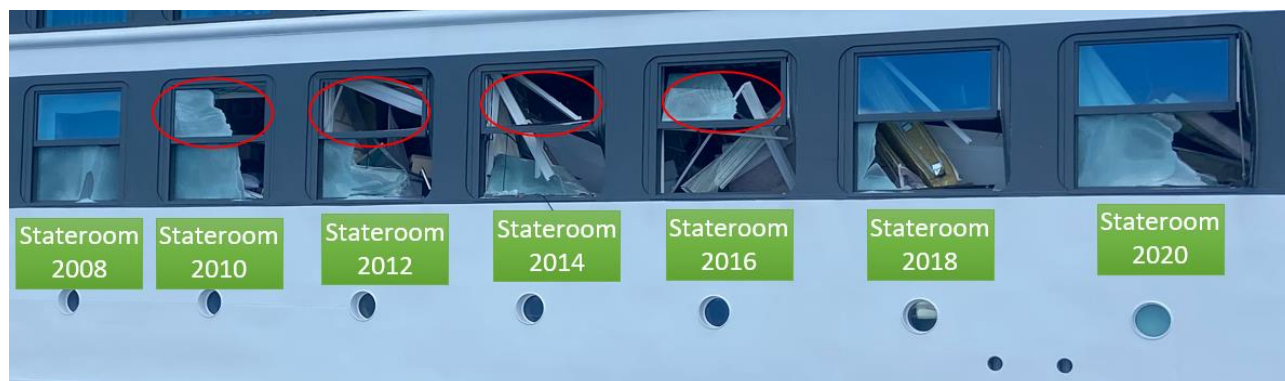
Figure 77: The windows where the window pane is broken, but the frame intact are circled in red.  
Photo: NSIA/consultant
