# REPORT MARINE 2024/01

***Fall overboard from the fishing vessel  
'Hunter' (LKUA) in the Barents Sea on  
30 January 2023***

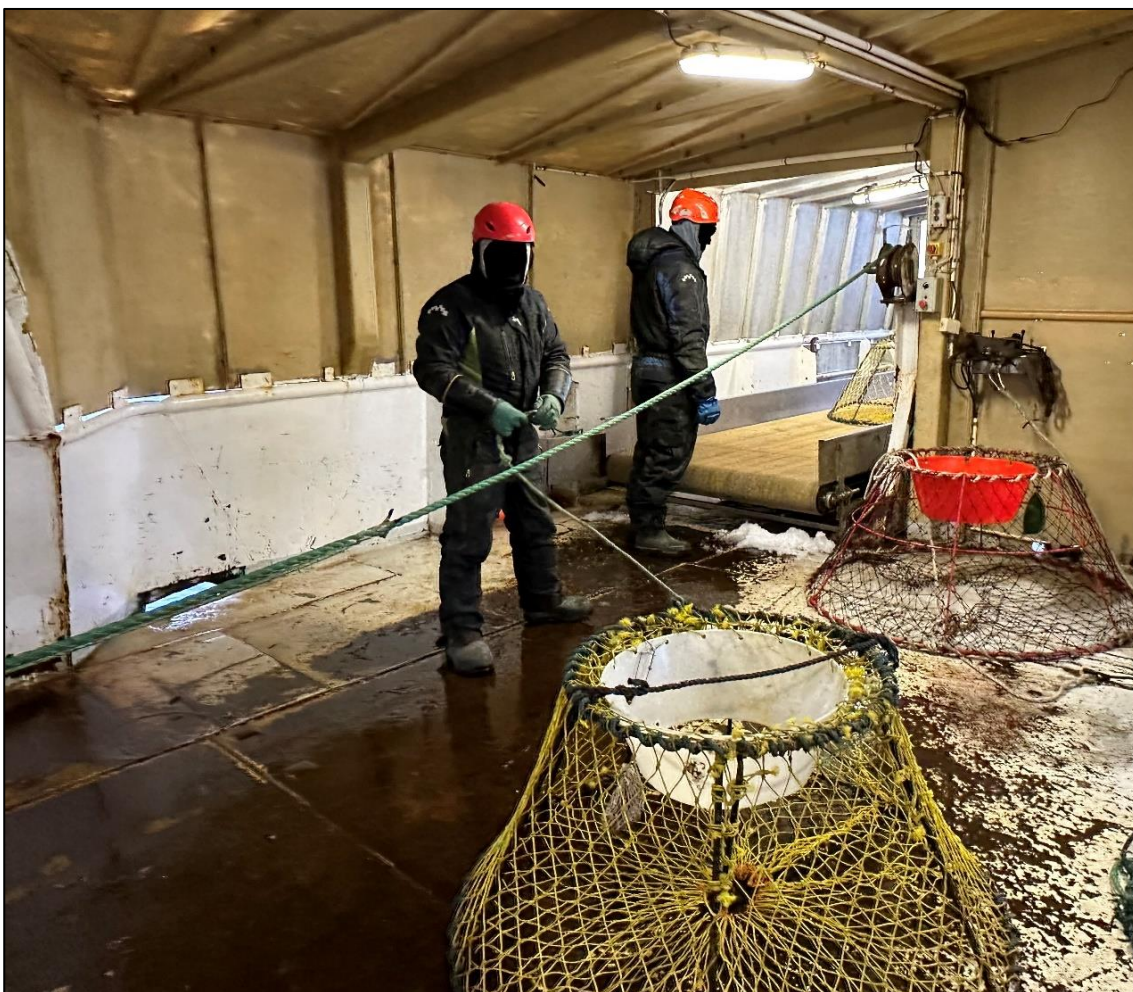
At about 17:58, after half an hour of work where around 180 out of 300 pots had been deployed, the fisherman who was lifting the pots off the conveyor belt had just given the other fisherman a pot and turned to prepare the next one; see Figure 4. He was leaning on the pots and other fixtures on the afterdeck so as not to lose balance due to the rough sea.

Figure 4: Reconstruction of the fishermen's position on the afterdeck at the time of the accident. Photo: NSIA

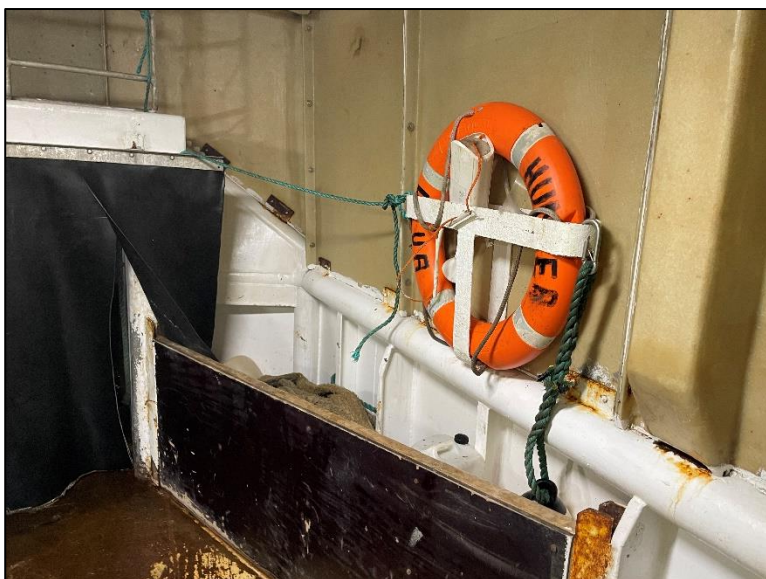
There were four lifebuoys on board; one lifebuoy with a line on the aft working deck (see Figure 7), one lifebuoy with a line on the forward working deck and one lifebuoy with light and smoke on each side of the wheelhouse.

Figure 7: Lifebuoy located on the port side of the afterdeck. Photo: NSIA

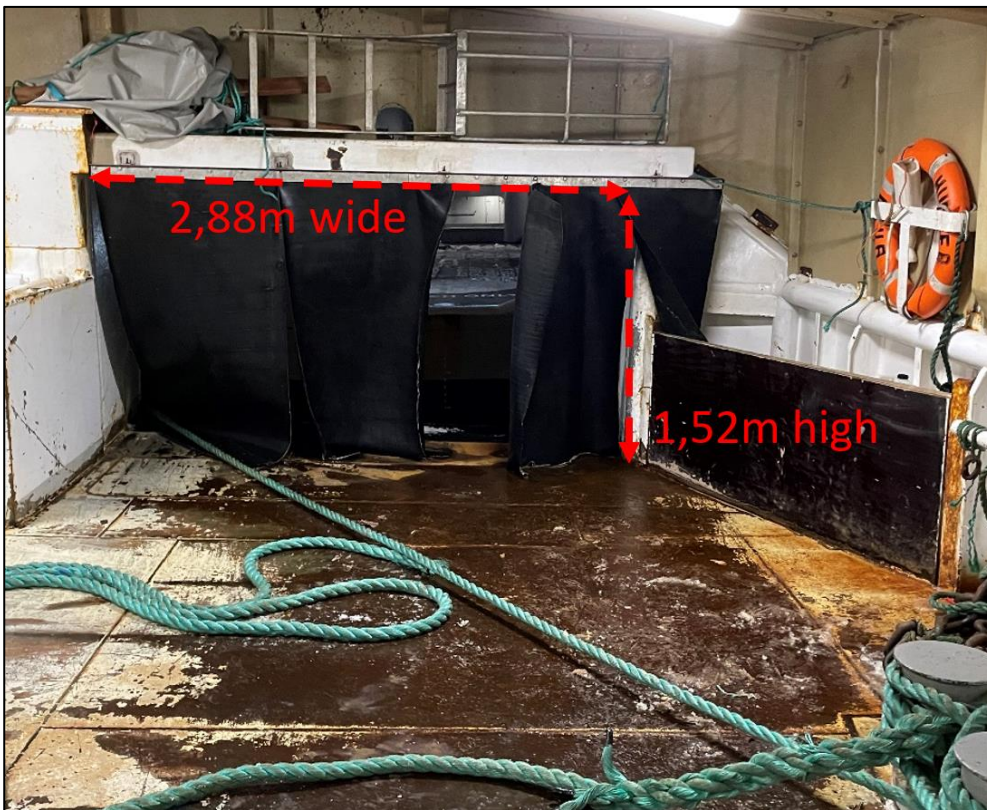
Figure 8: Setting hatch on aft working deck. Photo: NSIA

The hatch was covered by three polyurethane skirts and fixed to the top. The hatch was flush with the deck so that the pots went freely into the sea, and the arrangement had no physical barriers to prevent someone falling through the hatch and into the sea. The NMA may, upon application, reduce the height of railings and bulwarks on working decks from 1,000 mm to 600 mm, but no exemption from this requirement had been applied for.<sup>3</sup> Several of the crew considered the work operation on the afterdeck challenging in rough seas, as the possibility of holding on while working was limited. The deck was mostly bare steel, and anti-slip paint that had previously been applied was worn away in the work zone.

*The Norwegian Safety Investigation Authority recommends that the Norwegian Maritime Authority ensure that the shipping company Havøy Kystfiske A/S secures the work process of setting the line on the afterdeck to eliminate the risk of falling overboard.*

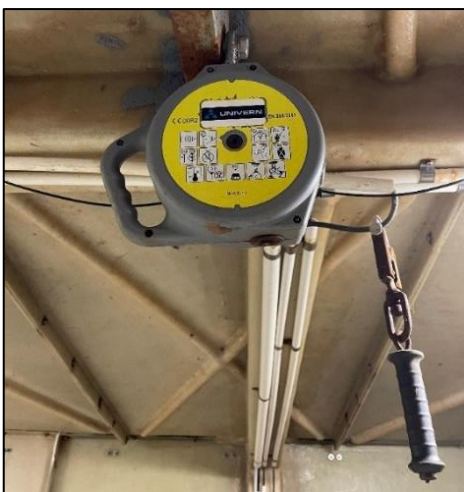
A fixed safety line was installed on the working deck.

Figure 9: Drum and handle with sling hook for safety line. Photo: NSIA

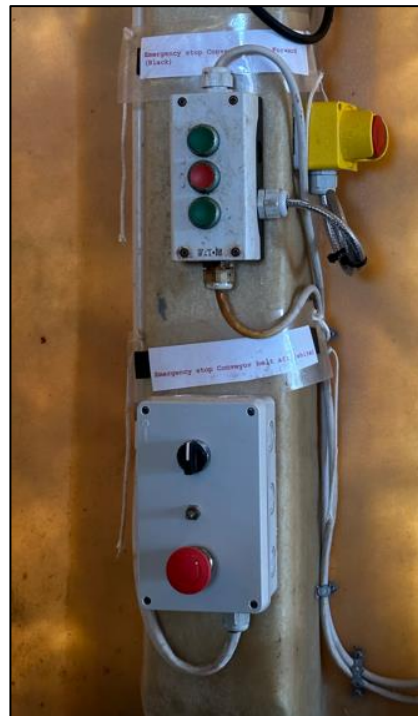
The emergency stop button for the conveyor belts was previously placed on the starboard side of the set line, which meant that the fishermen had to pass under the line to press the button. The

Figure 13: Emergency stop button, conveyor belt. Photo: NSIA
