Issued February 2024

# REPORT MARINE 2024/04

***Fall overboard from the cruise ship  
'Viking Mars' at Invergordon in Scotland  
18 August 2023***

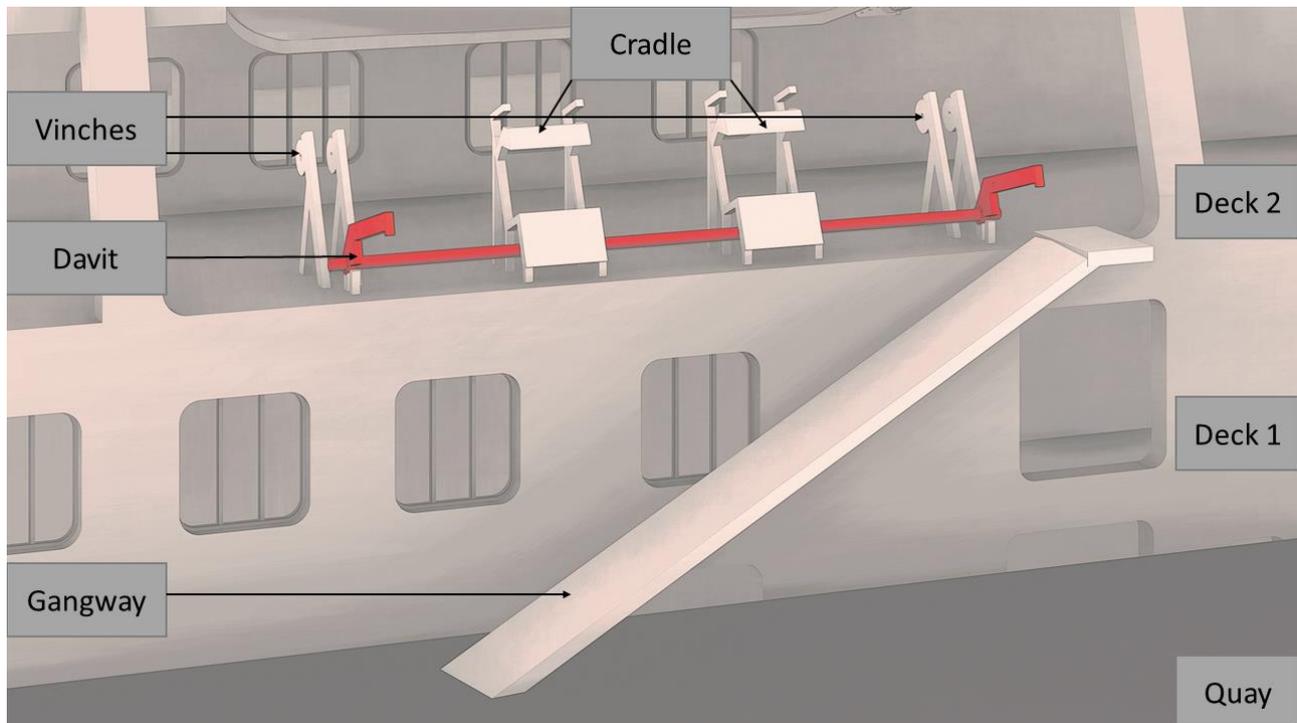
The vessel moored at the quay at just over 08:00 local time, and the gangway was prepared for use on deck 2, since the tide was at its lowest during the mooring. When the tide rose after a few hours, the height from deck 2 was too great, which meant the gangway would have to be moved to deck 1, see Figure 1. The plan was to move the gangway after a safety drill that was initiated just before 10:00.

Figure 1: Description of the gangway system and in relation to different decks and quay. Illustration: NSIA

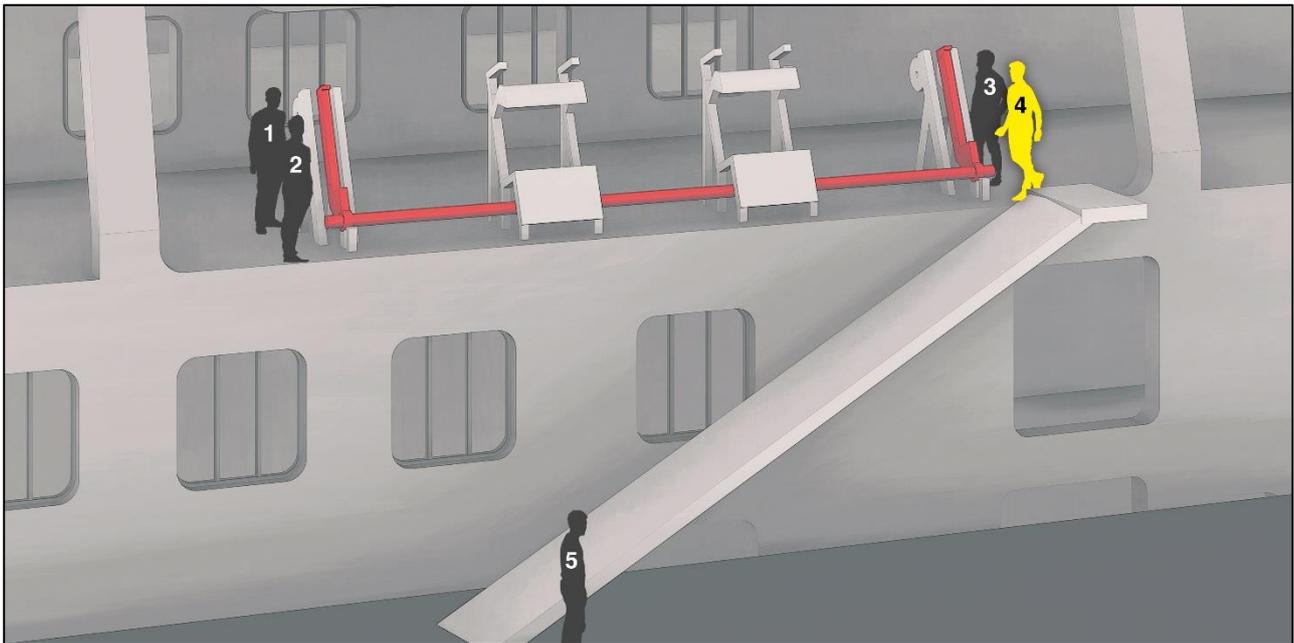
Figure 2: The four people on deck 2. In the image, person 4 has moved out onto the gangway. The davit is marked in red colour and the cradle in white colour. Illustration: NSIA

The davit was hoisted back into its cradle after it had been mounted on deck 2, so that it would not obstruct access. The deck crew first had to lower the davit into a horizontal position before the cables could be connected to the gangway. Thereafter, the plan was to connect the cables and lower the gangway to deck 1.

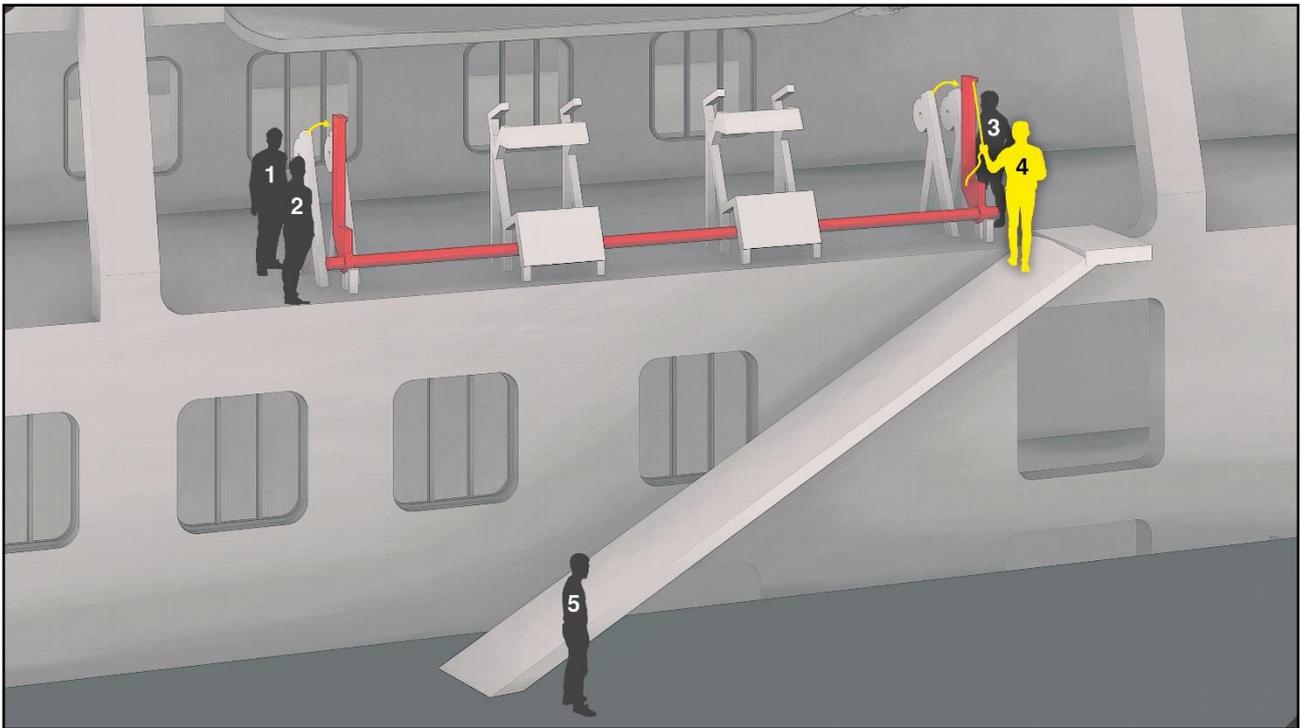
Person 3, who operated the winch, moved the cables on the instruction from person 4 standing beside them. This was done gradually. When the davit was in a vertical position, it stopped. When further cable was run out, it became slack, while the davit was stuck. Person 4 moved from the deck onto the gangway. This person pulled the cable in an attempt to loosen the davit, see Figure 3. Person 3 was told that it was enough and put the control down.

Figure 3: Person 4 pulling the cable marked in yellow colour. Illustration: NSIA

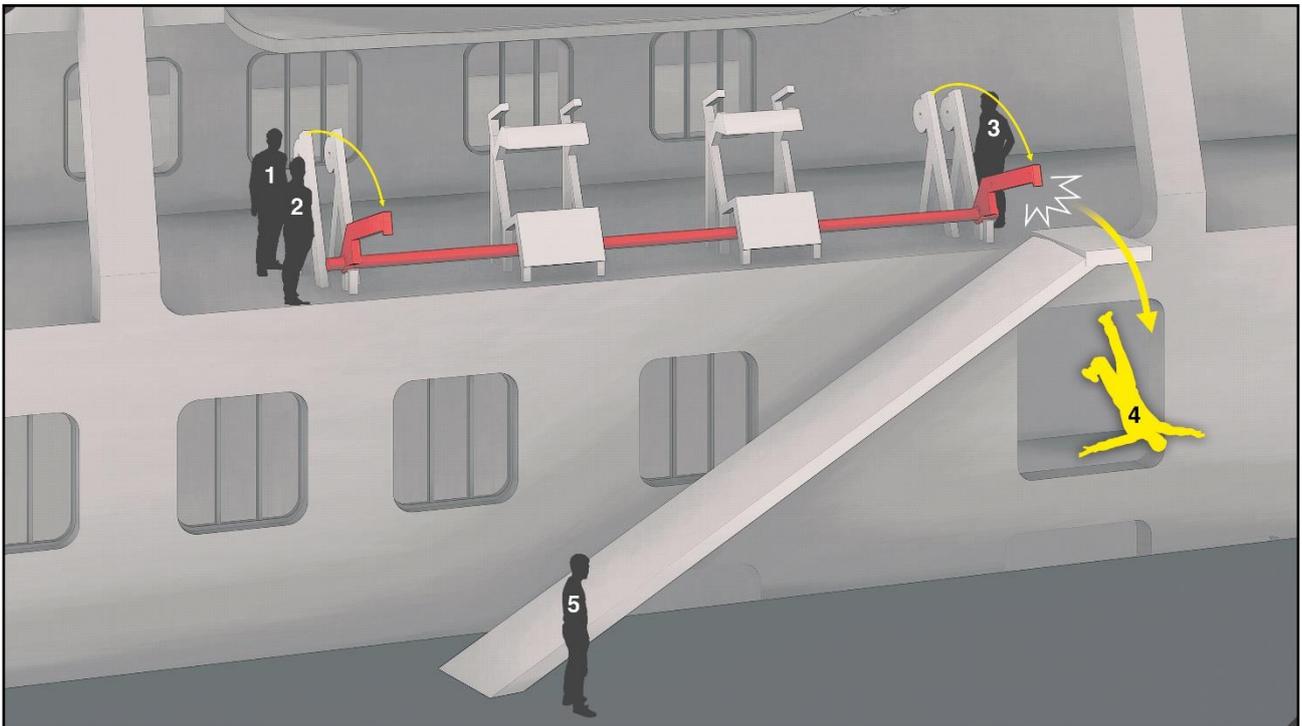
With slack cable it was nothing to prevent the davit from falling. The davit came loose and struck person 4 who lost balance and fell down on the quay.

Figure 4: Person 4 falling after being struck by the davit. Illustration: NSIA.

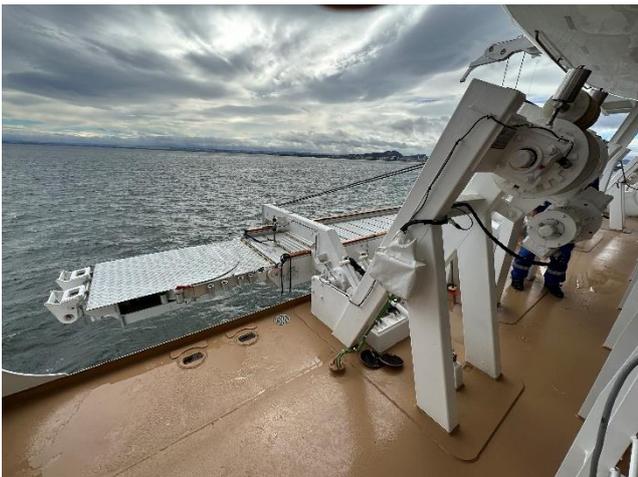
The crew did not consider preparation of the gangway work at height, as this was normally done from deck 1. The crew had not experienced such a large tidal range as in Invergordon, Scotland and had therefore never prepared the gangway from a deck above deck 1, see Figure 5 and Figure 6. The work method from deck 2 was different compared with from deck 1 since the davit had to be withdrawn back to the cradle so not to obstruct free passage.

Figure 5: The gangway system shown in connection with a demonstration. The davit lowered into horizontal position from the cradle. Photo: NSIA

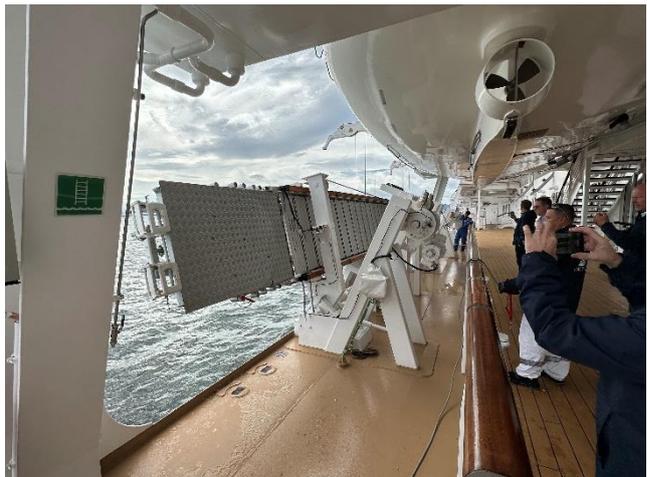
Figure 6: The davit in an approximately vertical position. Photo: NSIA

The accident happened when the crew had to lower the davit to connect the cable. Without the weight of the gangway, the davit stopped when the shock springs no longer had the force to push, and, without the weight of the gangway, a tipping point arose when there was no tension in the cable. The same happened during testing of the system with the NSIA present.
