REPORT Marine 2024/06

*Marine casualty involving fall onboard the
ro-ro ship Link Star in the Port of
Trondheim, 14 September 2023*

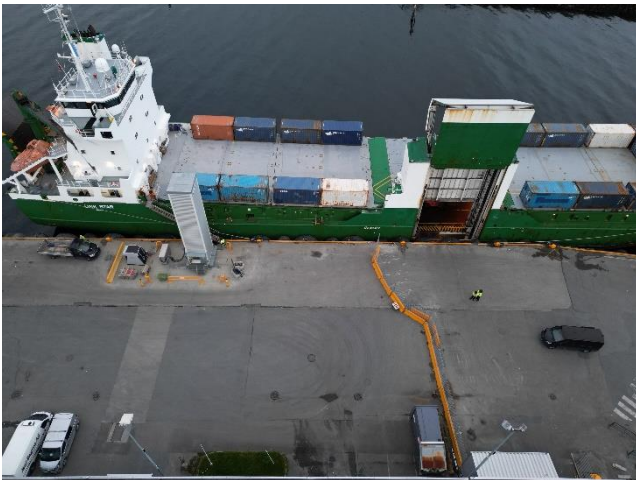
After mooring, the crew started unloading at approximately 14:30, through a cargo hatch midship on the starboard side; see Figure 2.

Figure 2: 'Link star' with open cargo hatch after the accident. Photo: The police

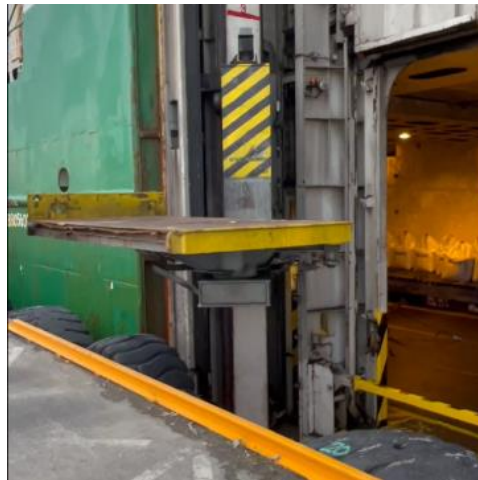
The second officer oversaw the operation through the hatch from the upper cargo deck. A forklift moved the cargo to two separate lift platforms in the lower cargo hold. The platforms were operated by a lift operator from a control room at the top of the hatch. The lift operator hoisted the platforms up to the upper cargo deck, so that they were positioned about one metre up from the quay and some way horizontally out of the hatch, thereby enabling the forklift operators on the quay to unload them; see Figure 3.

Figure 3: The aft cargo lift is positioned to enable the forklift operators on the quay to lift off the cargo. Photo: The police

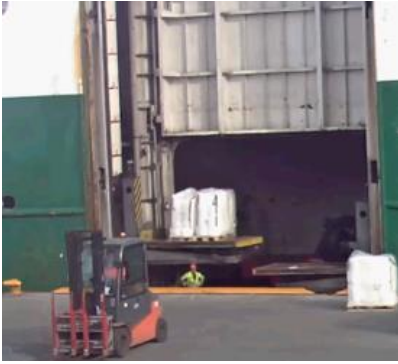
Figure 4: The second officer overseeing the unloading.
Photo: CCTV Port of Trondheim

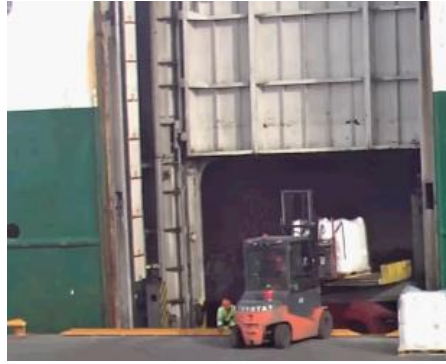
At 15:51, the unloading was almost completed and it was time for the second officer to go ashore to have the cargo documents and a cargo claim form signed by a stevedore, due to damage to one of the pallets. The aft lift platform was located slightly above the upper cargo deck, and the second officer used it to go ashore via the fenders on to the quay. See Figure 4, Figure 5 and Figure 6. Neither the gangway nor the pilot ladder had been deployed at this point.

Figure 5: The second officer climbing out of the ship through the cargo hatch. Photo: CCTV Port of Trondheim

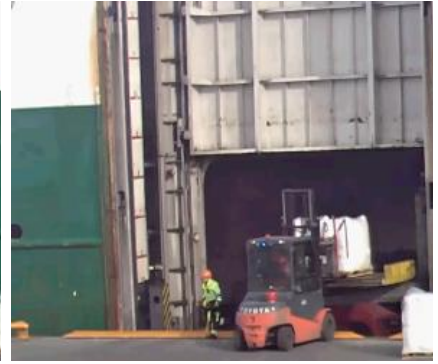
Figure 6: The second officer on the quay outside the cargo hatch. Photo: CCTV Port of Trondheim

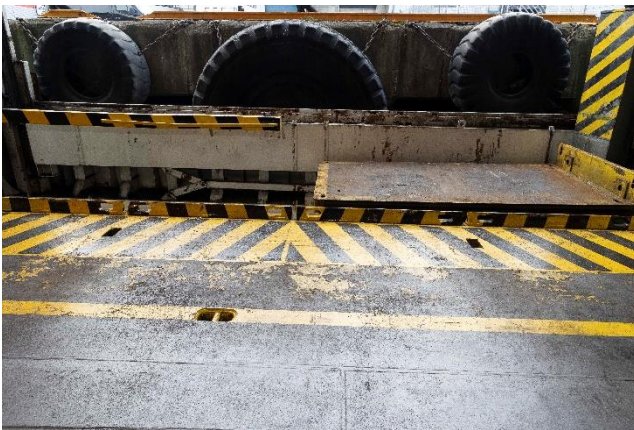
At 15:58, after the documents had been signed on the quay, the second officer returned to the ship. The lift operator observed the second officer entering the ship through the cargo hatch and then going down to the edge of the shortest side of the aft lift platform, which was stationary and located flush with the upper cargo deck; see Figure 7 and Figure 8. At this point, the other lift platform was parked on the lower cargo deck approximately 4.5 metres further down. Note that the vessel was approximately 68 cm lower in the water when the police took photos, and that there was thus shorter distance from the cargo deck to the quay at the time of the accident than shown in the photos.

Figure 7: The aft cargo lift was stationary and flush with the upper cargo deck at the time of the accident. Photo: The police

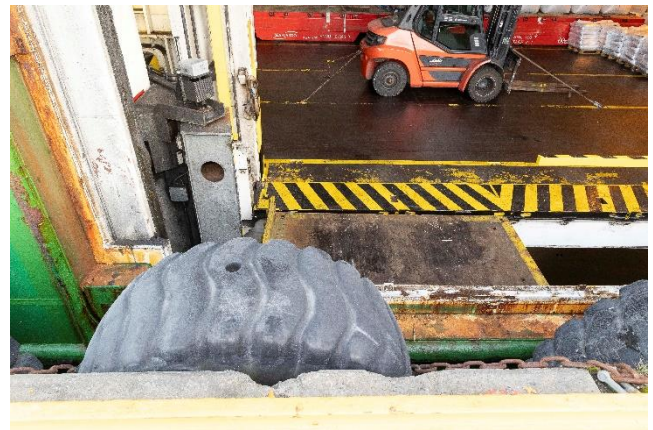
Figure 8: The aft cargo lift and the upper cargo deck seen from the edge of the quay. Photo: The police

The investigation has shown that there was a significant height difference between the dock fender along the quay and the cargo lift. This meant there was quite a drop from the deck itself to the cargo lift, in addition to the fact that the dock fender that was probably used was positioned between the two platforms. These factors made accessing the ship via the dock fender and the cargo lift a risky operation. The NSIA believes this shortcut to and from the quay was used to save time, and because it was considered the easiest way of getting the cargo documents signed. Since the gangway was not in use that day, exiting via the cargo lift was also the only option for getting from the vessel to the quay area.

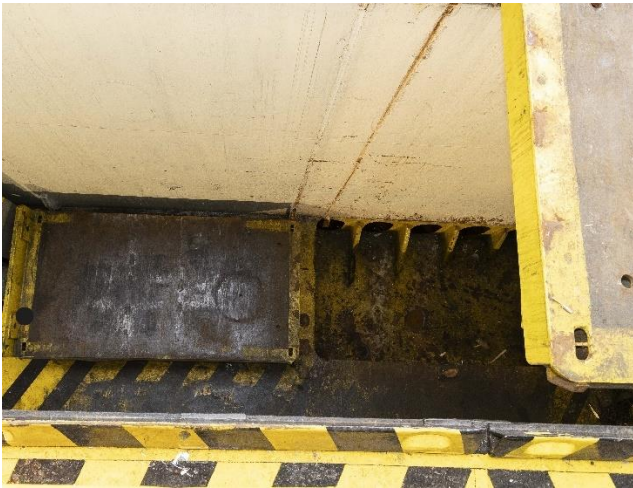
When the second officer entered the vessel at approximately 16:00, he fell down the shaft and landed on the platform on the lower cargo deck; see Figure 9.

Figure 9: The lift shaft with the aft lift platform to the right of the photo, flush with the upper cargo deck. The forward lift platform parked on the lower cargo deck to the left of the photo. Photo: The police

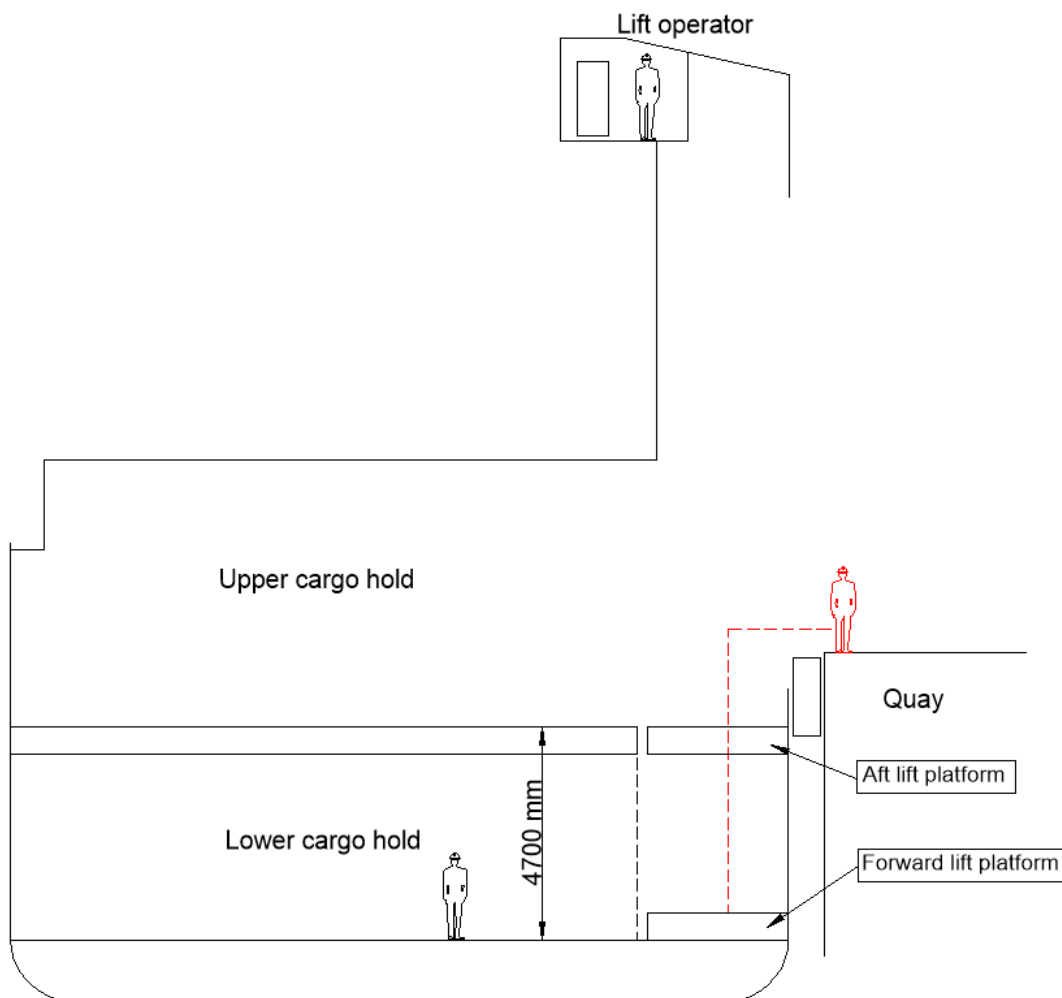
A crew member who was cleaning the lower cargo deck had his back to the lift shaft and was standing a few metres away when he heard a thud behind him. When he turned around, he saw the second officer lying lifeless face down. The crew member called the captain, who arrived at the scene of the accident shortly afterwards. The emergency services were then notified and an ambulance arrived at 16:10 and initiated life-saving measures. The second officer was later pronounced dead. See Figure 10 for an illustration of the accident site.

Figure 10: The cargo lift operator observed the second officer entering through the cargo hatch. A crew member was standing with his back to the lift platform in the lower cargo hold. The second officer fell approximately 4.5 metres from the aft lift platform down onto the forward lift platform. Illustration: NSIA.

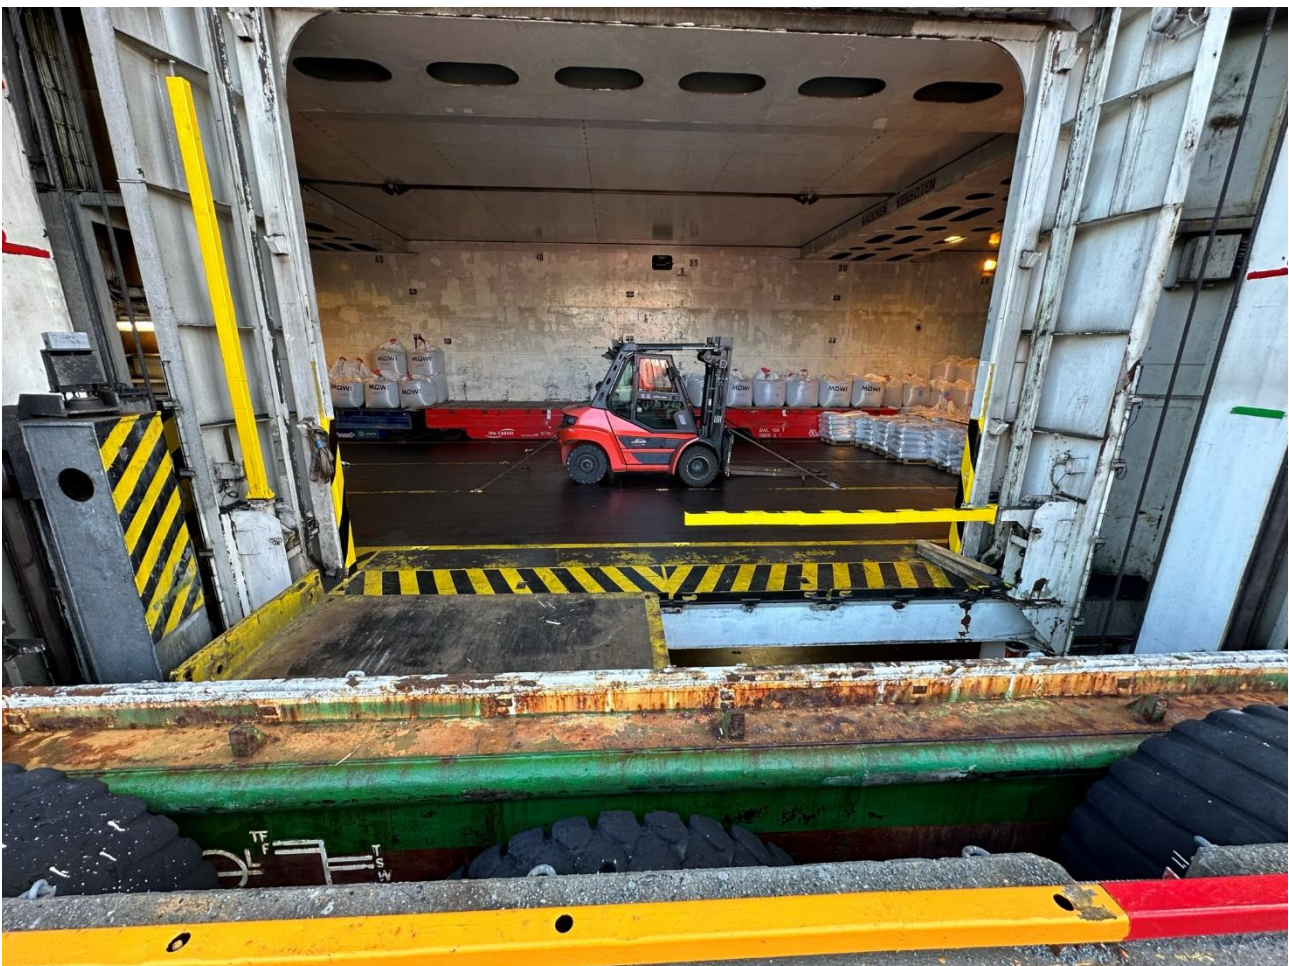
The vessel has one cargo hatch aft and one midship on the starboard side. The cargo hatch on the starboard side midship was used for loading and unloading at the time of the accident; see Figure 11. Two parallel cargo lifts were used for loading and unloading through the hatch from the ship's two cargo decks. No railings or other physical barriers were fitted on the cargo lifts. When both platforms were on the same level, there was a gap of about 30 cm between them.

Figure 11: The side hatch with one of the cargo lifts on the upper cargo deck and one on the lower. The boom is lowered when the cargo lift is not flush with the cargo deck. Photo: NSIA

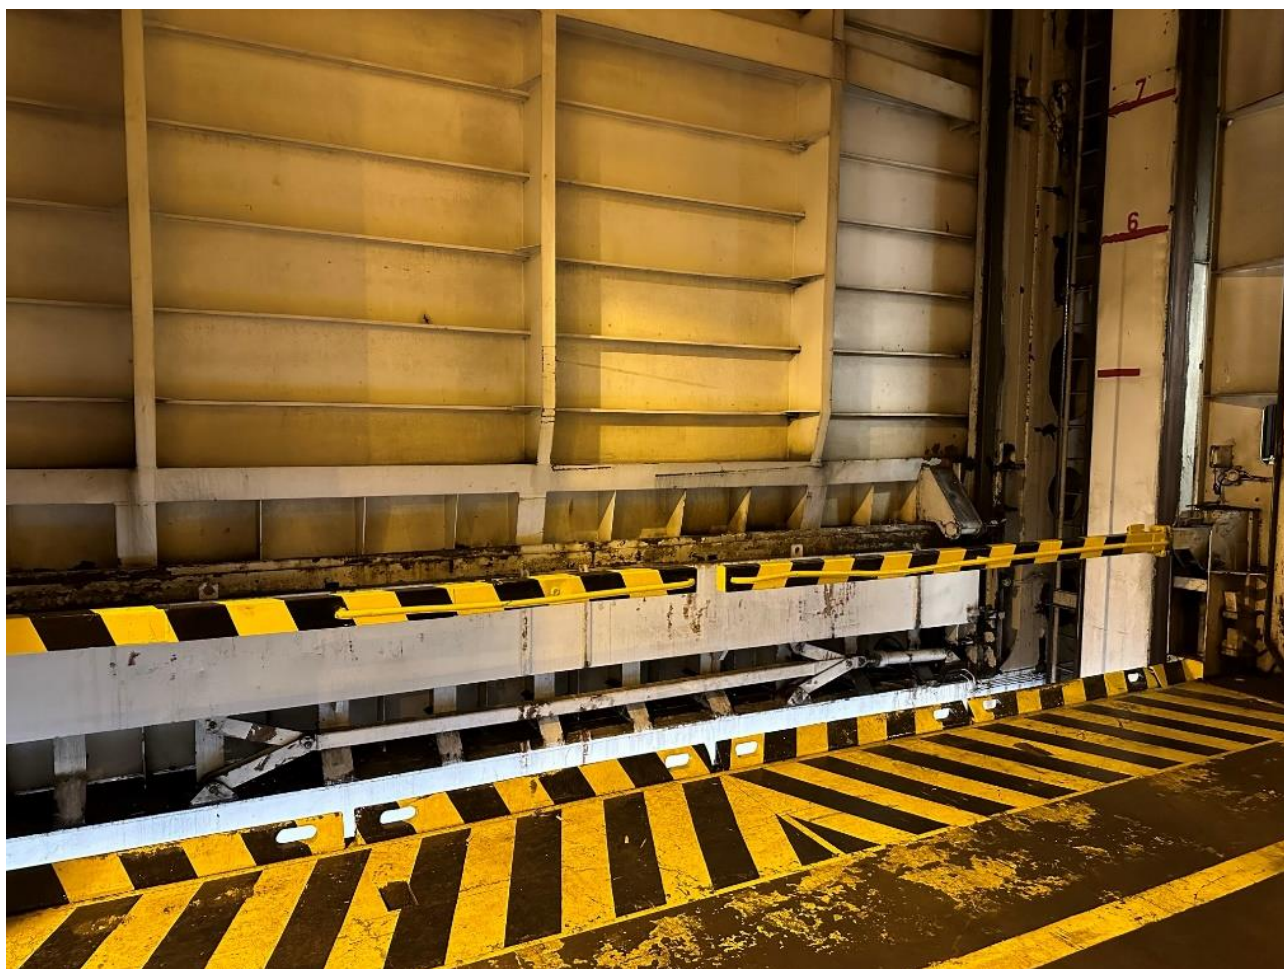
Along the edge of the upper cargo deck towards the lift shaft, there were warning stripes, a boom and a raised edge towards the shaft opening; see Figure 12. The two platforms were approximately 3.2 metres long and 1.8 metres wide, with a warning strip along each of the short

Figure 12: Boom, warning stripes and raised edge along the lift shaft opening on the upper cargo deck. The cargo hatch is closed. Photo: NSIA.

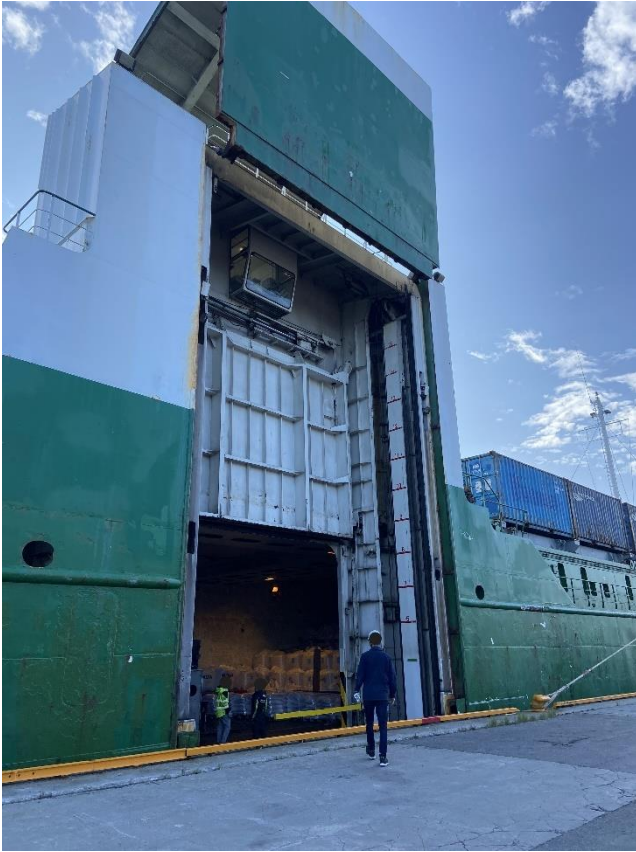
The cargo lifts were operated manually by an operator from the control room on the upper cargo deck, in the upper part of the shaft; see Figure 13 and Figure 14. From the control room, the operator could see down the lift shaft through a plexiglas window. The operator was equipped with radio communication.

Figure 13: The control room can be seen at the top of the lift shaft. Photo: NSIA

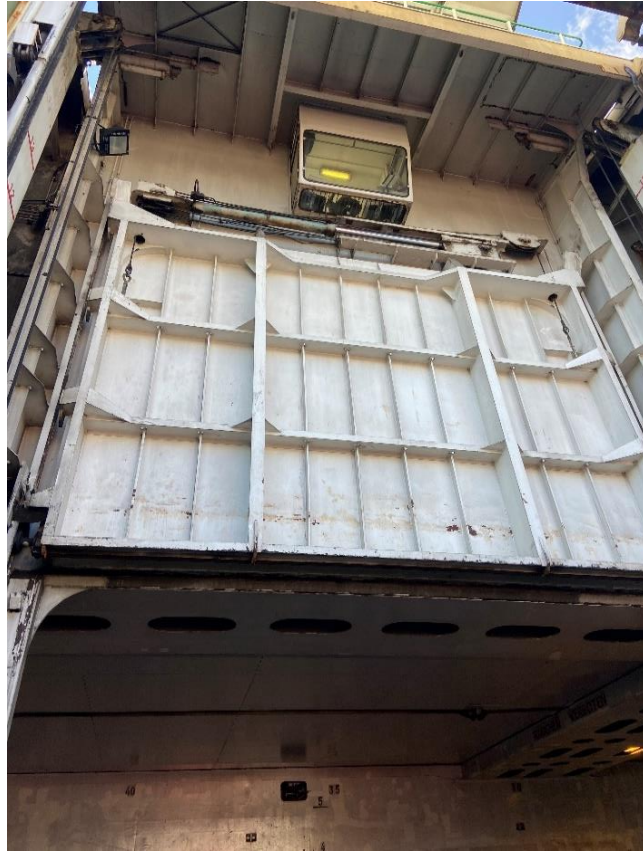
Figure 14: The control room with a pexiglas window for looking down the shaft and out towards the quay. Photo: NSIA

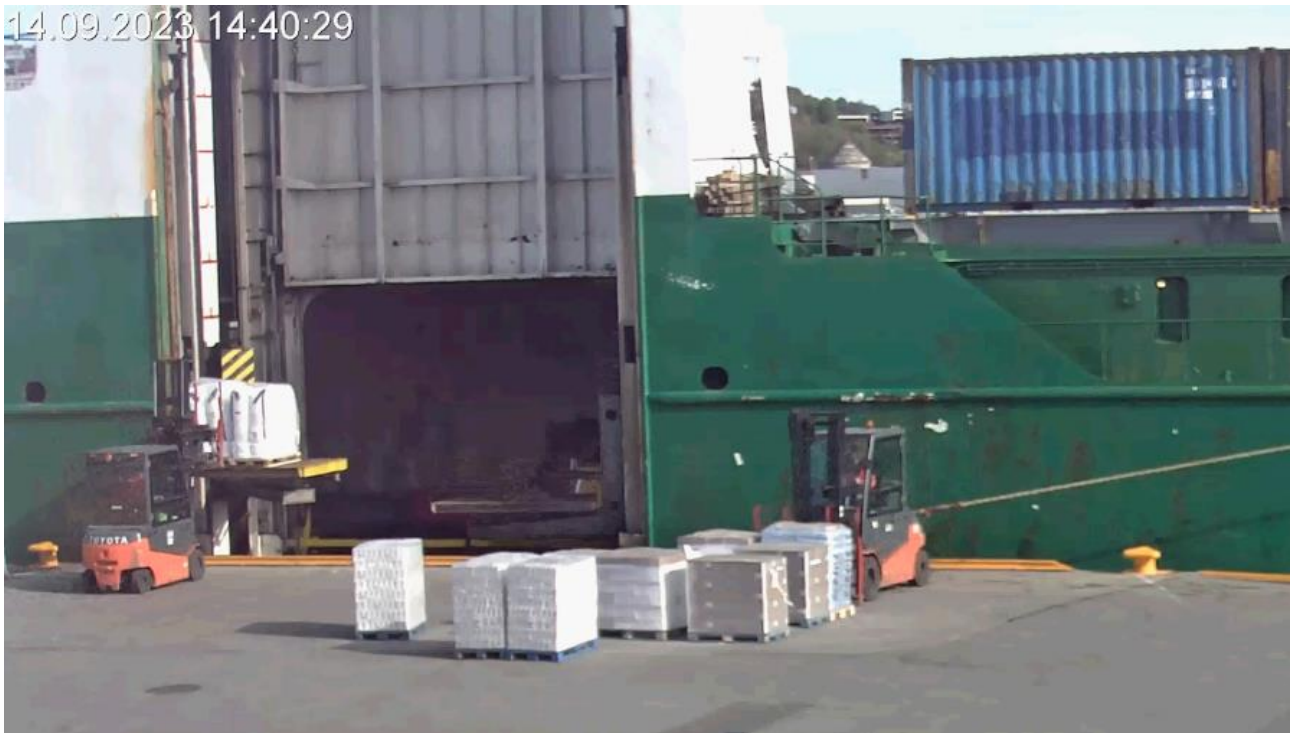
The NSIA has been informed that the cargo lift was sometimes used for handover of cargo documents, especially during short port calls, because the gangway was normally deployed and used for longer calls and for visitors. Figure 15 shows how the cargo was transported via the cargo lifts. The NSIA has also been informed that during the coronavirus period when physical contact was not permitted, the vessels used electronic signing of cargo documents, including claim forms in the event of damage to cargo.

Figure 15: The cargo was transported via the cargo lifts to be picked up by forklifts on the quay. Photo: CCTV from Port of Trondheim

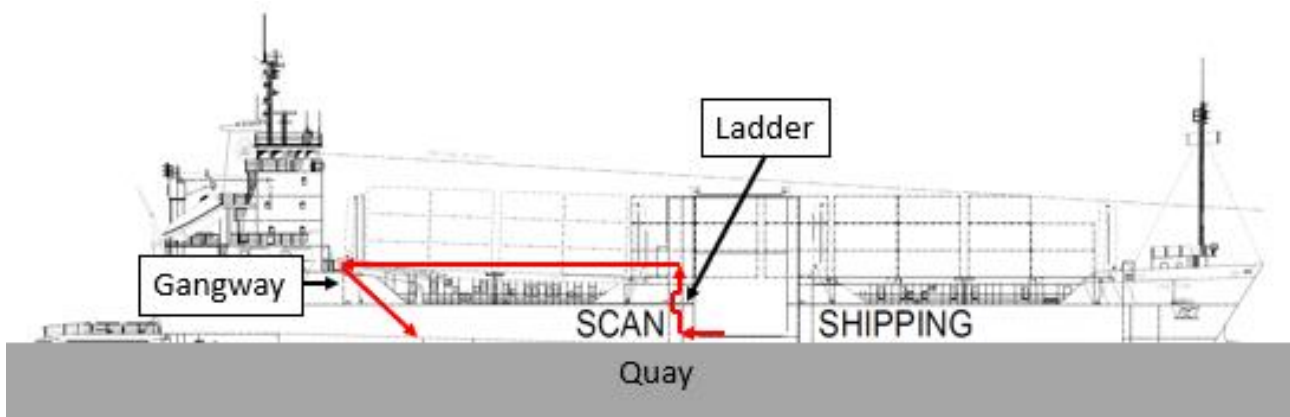
Figure 16: Access route from the upper cargo deck to the quay via the gangway. Illustration: Shipping company/NSIA

The design involving a long walk and roundabout path from the upper and lower cargo deck where the unloading took place, to the quay via the gangway, was inexpedient for getting the cargo documents signed. It led to the crew using the cargo lifts as a shortcut and access route.

The Norwegian Safety Investigation Authority recommends that Norwest Ship Management AS change the working method for getting cargo documents signed to prevent cargo lifts being used for personnel transport.
