Issued April 2026

REPORT MARINE 2026/03

Marine accident involving a rental vessel north-east of Kråkenes Lighthouse in Vestland County, 4 May 2025

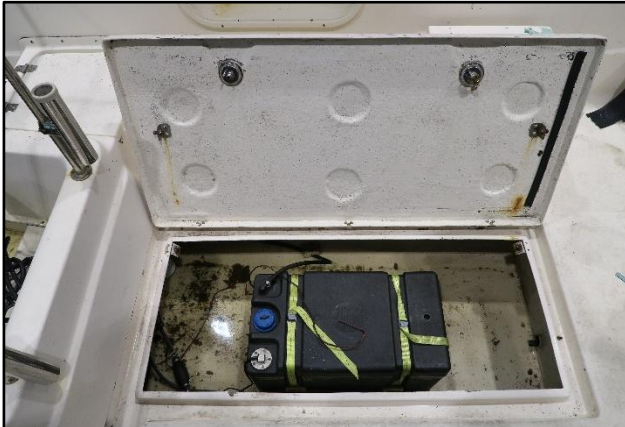
Figure 11: Flush hatch in the open position. Photo: NSIA

The flush hatch lacked sealing aft and along the sides (see Figure 11). The locking mechanism on the toggle latches was not functioning, and it was not possible to secure the flush hatch as intended (see Figure 12). The NSIA has been informed that prior to the accident there were deficiencies in the hatch seals and that one of the toggle latches was broken. A replacement toggle latch had been ordered to replace the broken one.

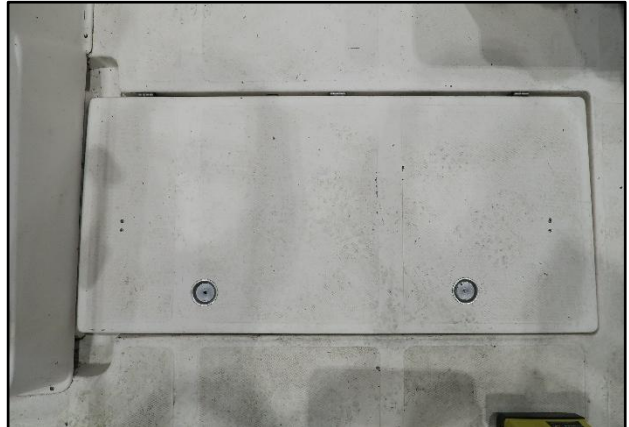
Figure 12: Flush hatch in the closed position. Photo: NSIA

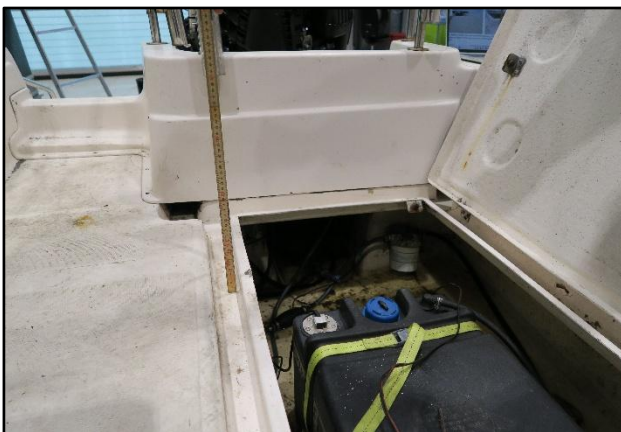
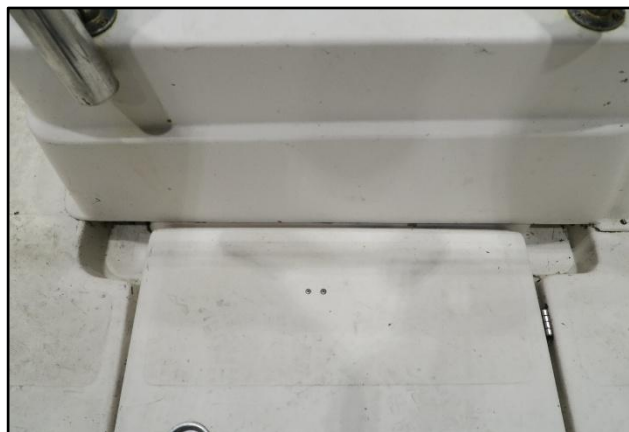
Figure 13: Drainage channels around the hatch coaming. Photo: NSIA

Figure 14: Drainage channels that lead the water out through the drain openings. Photo: NSIA

The hatch coaming had a height of approximately 35 mm above the bottom of the drainage channel and 20 mm below the level of the aft deck.

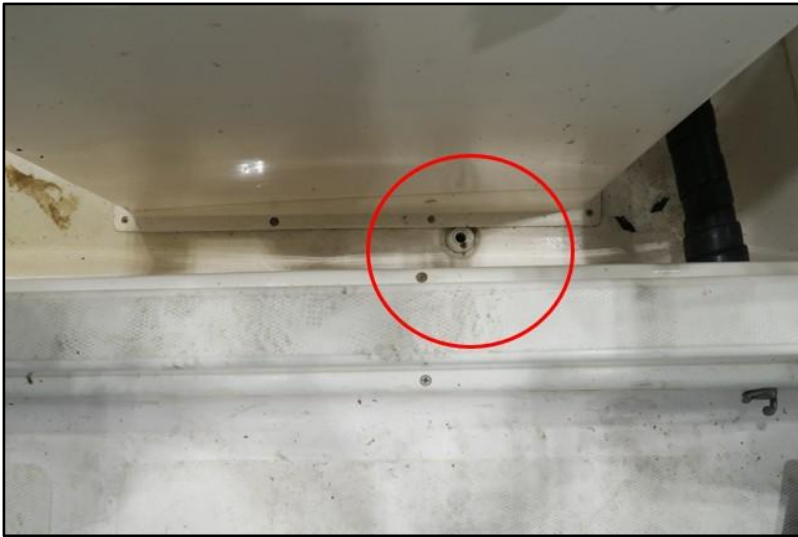
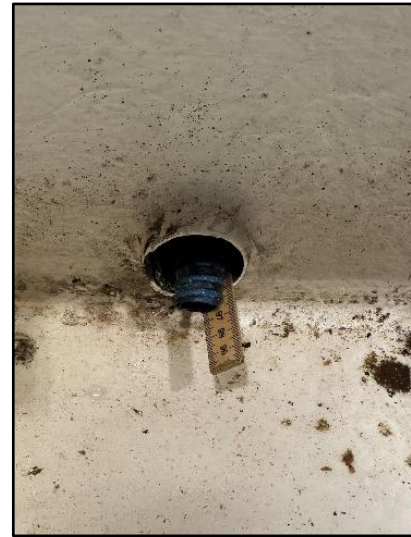
Water entering the recessed well in the wheelhouse drained directly into the hold (see Figure 15 and Figure 16).

Figure 15: Drainage holes from the deck in the wheelhouse.
Photo: NSIA

Figure 16: Penetration from the drain in the wheelhouse and into the hold.
Photo: NSIA

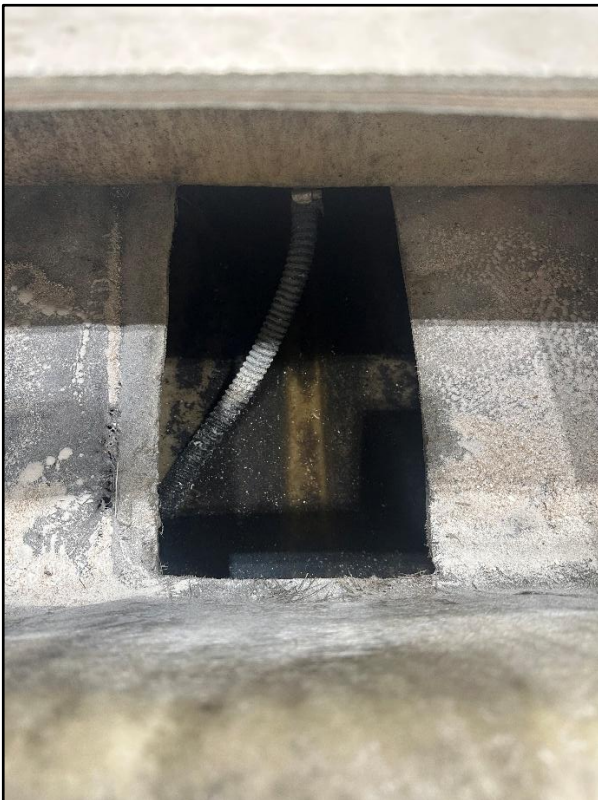
Water entering the wheelhouse therefore had to be pumped out using the bilge pump in the hold. The supply hose had a significantly smaller diameter than the penetration in the stiffener, with the result that water in the hold could flow forward and accumulate beneath the inner liner and within the stiffeners. The opening was located 32 mm above the lowest point in the hold. Water that accumulated beneath the inner liner could therefore not be pumped out, as this area was deeper than the hold (see Figure 17).

Figure 17: The drainage pipe ran from the wheelhouse and through to the hold, beneath the inner liner. Water could enter via the penetration from the hold, as the area beneath the inner liner was deeper than the floor of the hold. Photo: NSIA

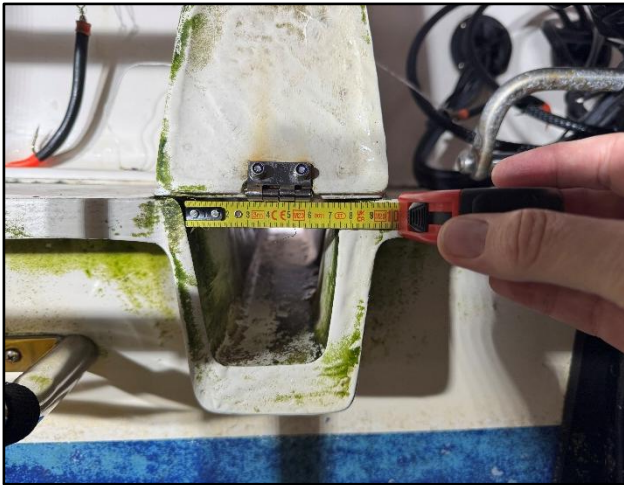
The design of the drain openings had been somewhat modified following the accident involving Viking 7 in 2014. The accident vessel featured external flaps (see Figure 19), whereas the drain openings on Viking 7 were positioned further inside the drainage channel (see Figure 20).

Figure 19: Port side drain opening on the accident vessel. Photo: NSIA

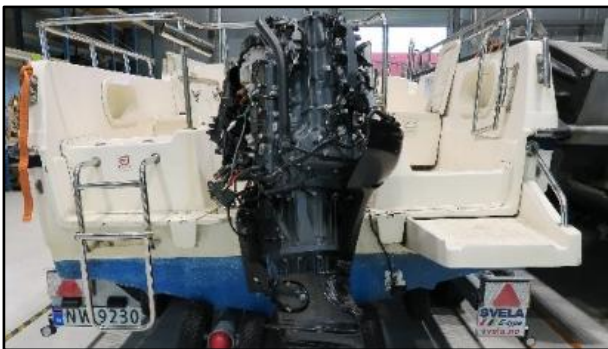
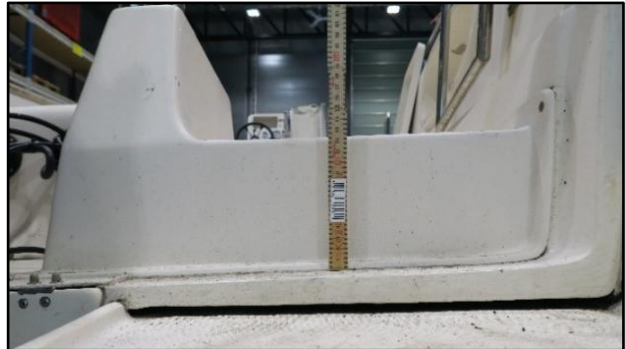
On the transom, the freeboard height was lower on the starboard side due to an integrated boarding step. The height from the deck was approximately 12.5 cm (see Figure 21 and Figure 22). This is discussed further in section 1.11.1.1 concerning the dialogue between the manufacturer and the Norwegian Maritime Authority (NMA).

Figure 21: Transom and recessed boarding step on the starboard side. Photo: NSIA

Figure 22: Recessed step on the starboard aft side, 12.5 cm above the deck. Photo: NSIA

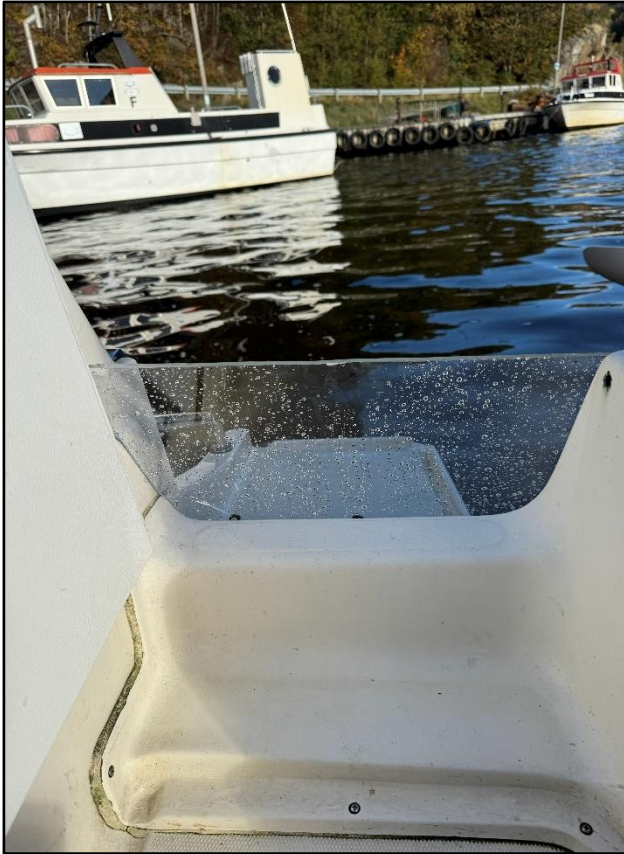
Figure 23: Plexiglas plate to increase the freeboard.
Photo: NSIA

On several occasions, sea spray also reached the sheet of plexiglass serving as a raised freeboard on the starboard aft side. The plexiglass was not sealed around the edges and was only a few millimetres thick. Cracking in the plexiglass was also observed.

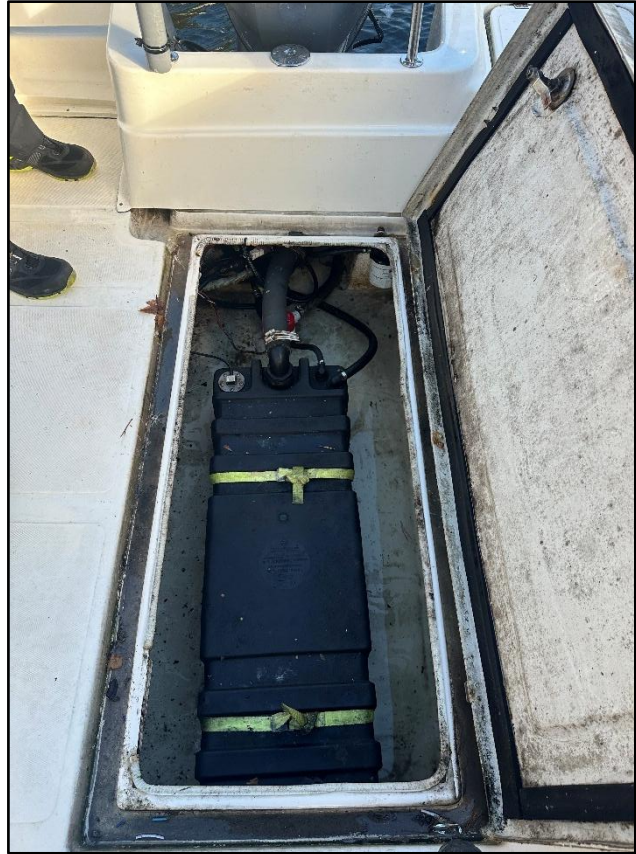
Figure 24: New hatch seal in the flush hatch.
Photo: NSIA

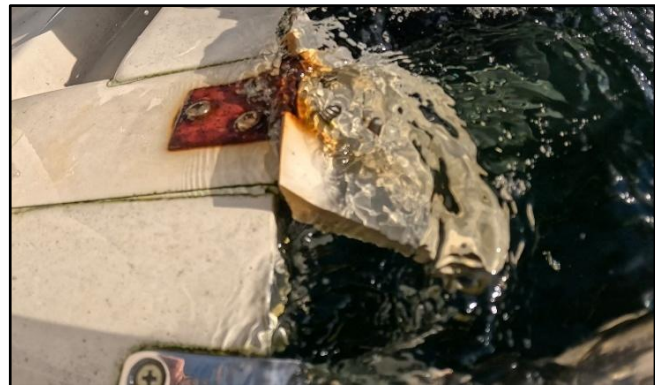
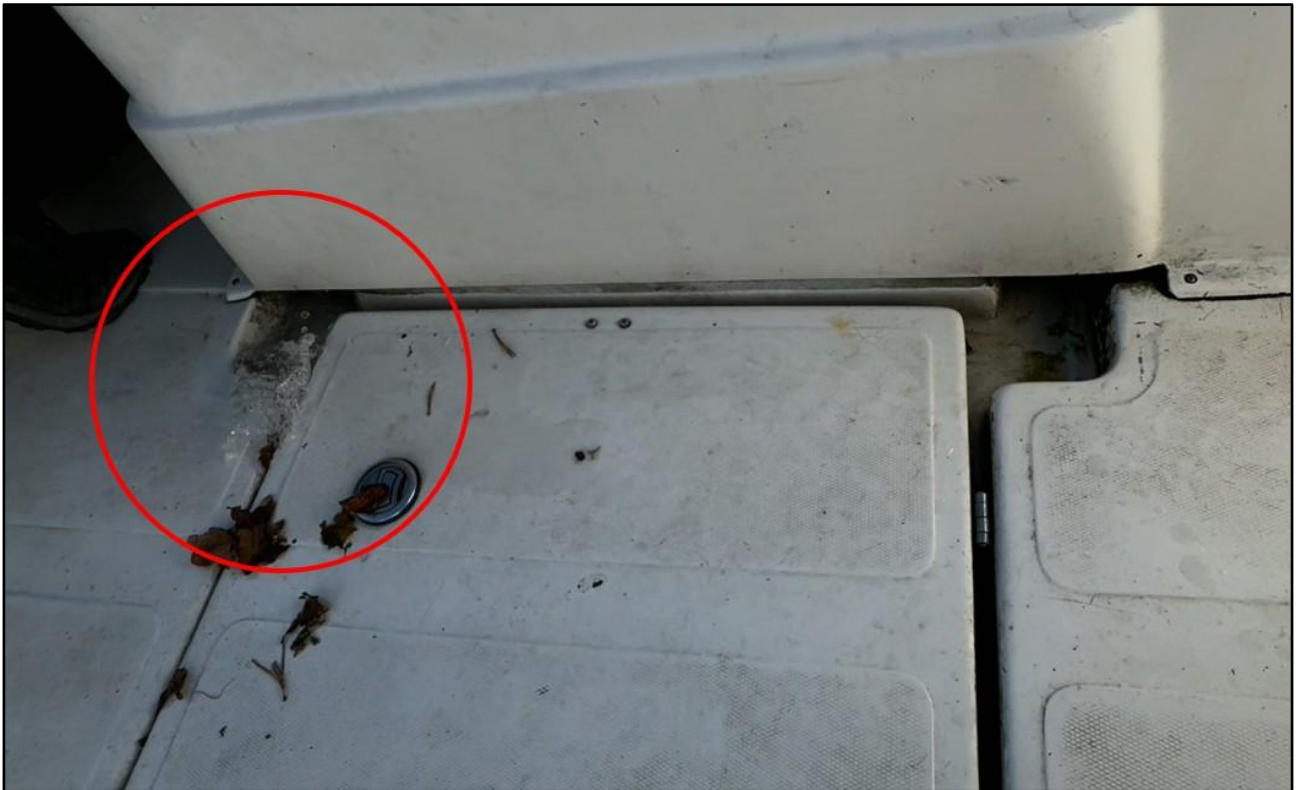
Figure 26: Port drain opening in open position as a result of aft trim in a wave trough. Photo: NSIA

The NSIA's testing focused on assessing the drainage design during fishing operations. The vessel was therefore left stationary in the water to simulate a fishing situation. After a short time, the vessel naturally positioned its stern towards the wind and sea. The sea conditions caused the stern to be pressed down into the water while in wave troughs, causing the drain openings to open and allowing water to ingress onto the aft deck (see Figure 26 and Figure 27).

Figure 27: Image from the aft deck showing how the drainage channel around the main hatch merges with the aft drainage channels. The red circle shows water entering the deck through the starboard drain opening in sea conditions with a significant wave height of approximately 0.5 metres. Photo and illustration: NSIA

The test illustrated the importance of a watertight hatch seal and properly secured toggle hatch latches to prevent flooding of the hold via the drain openings during fishing operations.

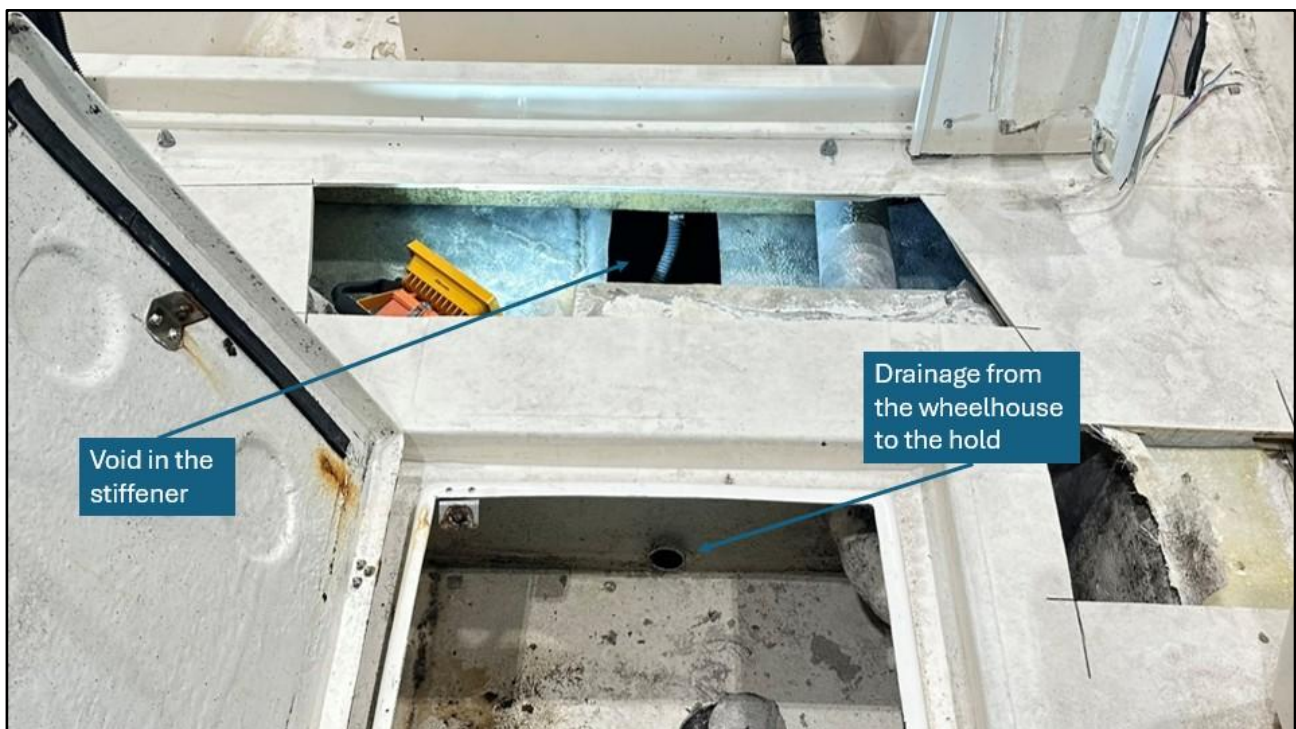
Inside the hold, a drainage pipe from the wheelhouse passed through an unsealed penetration located 32 mm above the bottom of the hold. This penetration had a significantly larger diameter than the drainage pipe itself. Water entering the hold via the non-watertight flush hatch could therefore flow into the penetration and into a void within the stiffener (see Figure 34). From there, water could continue further beneath the inner liner and into stiffeners that were not foam-filled. Water in these areas could not be drained or removed by the bilge pump installed in the hold.

Figure 34: The image shows the penetration in the drainage from the wheelhouse to the hold and the void in the stiffener. Water from the hold could flow unhindered forward in the vessel if the water level exceeded 32 mm. The NSIA has cut a hole in the deck to show drainage and voids in the stiffener. Photo: NSIA

These quantities of water would not have been easy for the anglers to detect unless they inspected the hold directly. Even then, the visible water level might have appeared limited, as water would drain further beneath the inner liner and into stiffeners because of the unsealed penetration near the bottom of the hold.
