Issued May 2026

REPORT MARINE 2026/04

***Marine accident involving a rental vessel
in Bergsfjorden in Loppa municipality,
19 May 2025***

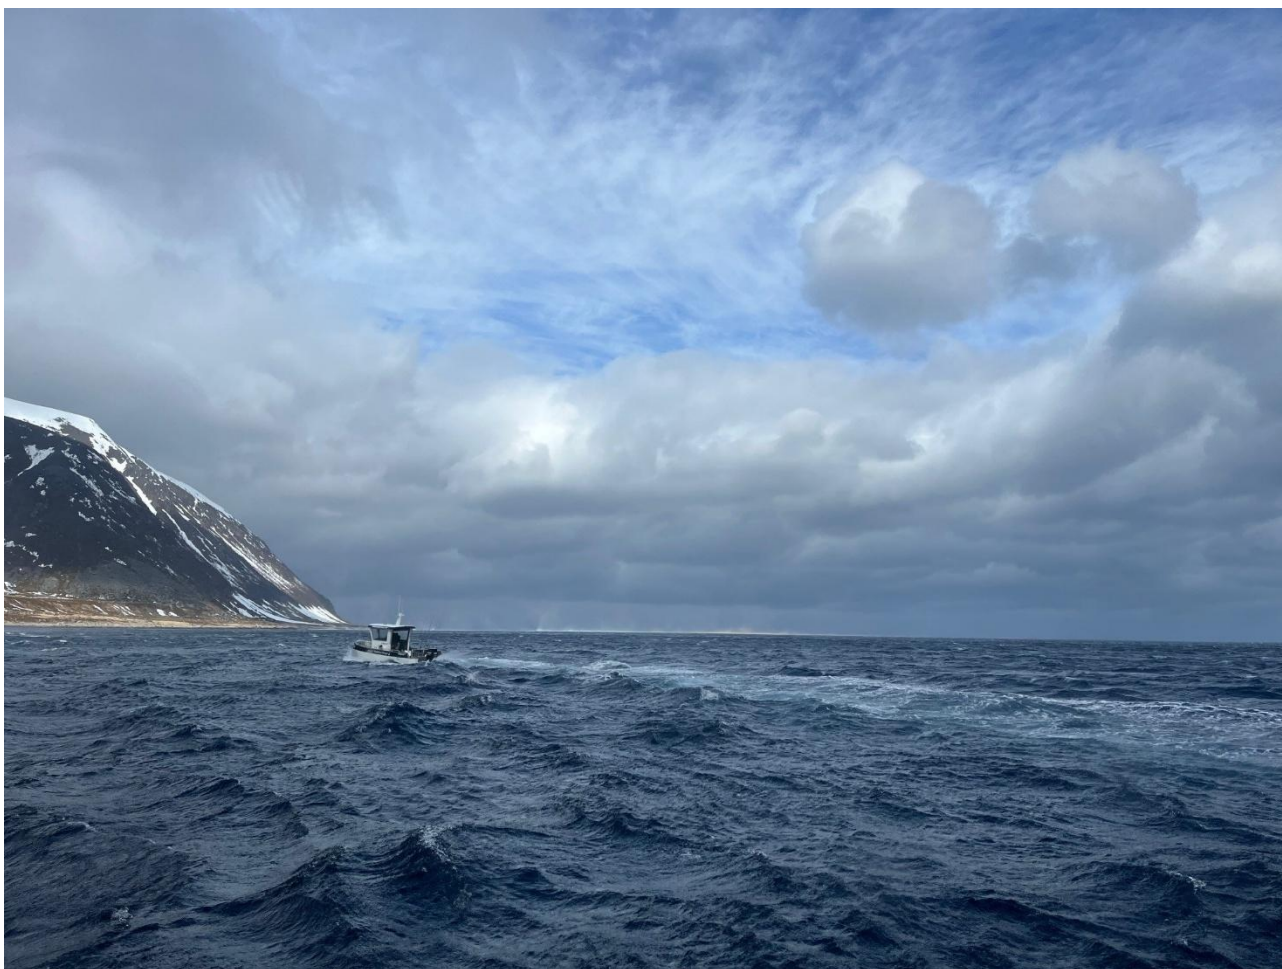
Figure 2: The accident boat Loppa heading out into Bergsfjorden on 19 May 2025. Photo: Private

While heading out, those on board Loppa observed something ahead on the horizon which they described as ‘tornadoes’. They saw the wind lifting the sea, felt anxious, and decided to turn around and head back. At one point, while proceeding south along the eastern side of Silda, they were suddenly overtaken by one of the ‘tornadoes’. The vessel was exposed to strong winds from the port side, causing the boat to heel to starboard and capsize within a few seconds. Both persons on board were inside the wheelhouse when the boat capsized, but eventually got out and reached the surface. Figure 3 shows the approximate position where the vessel capsized.

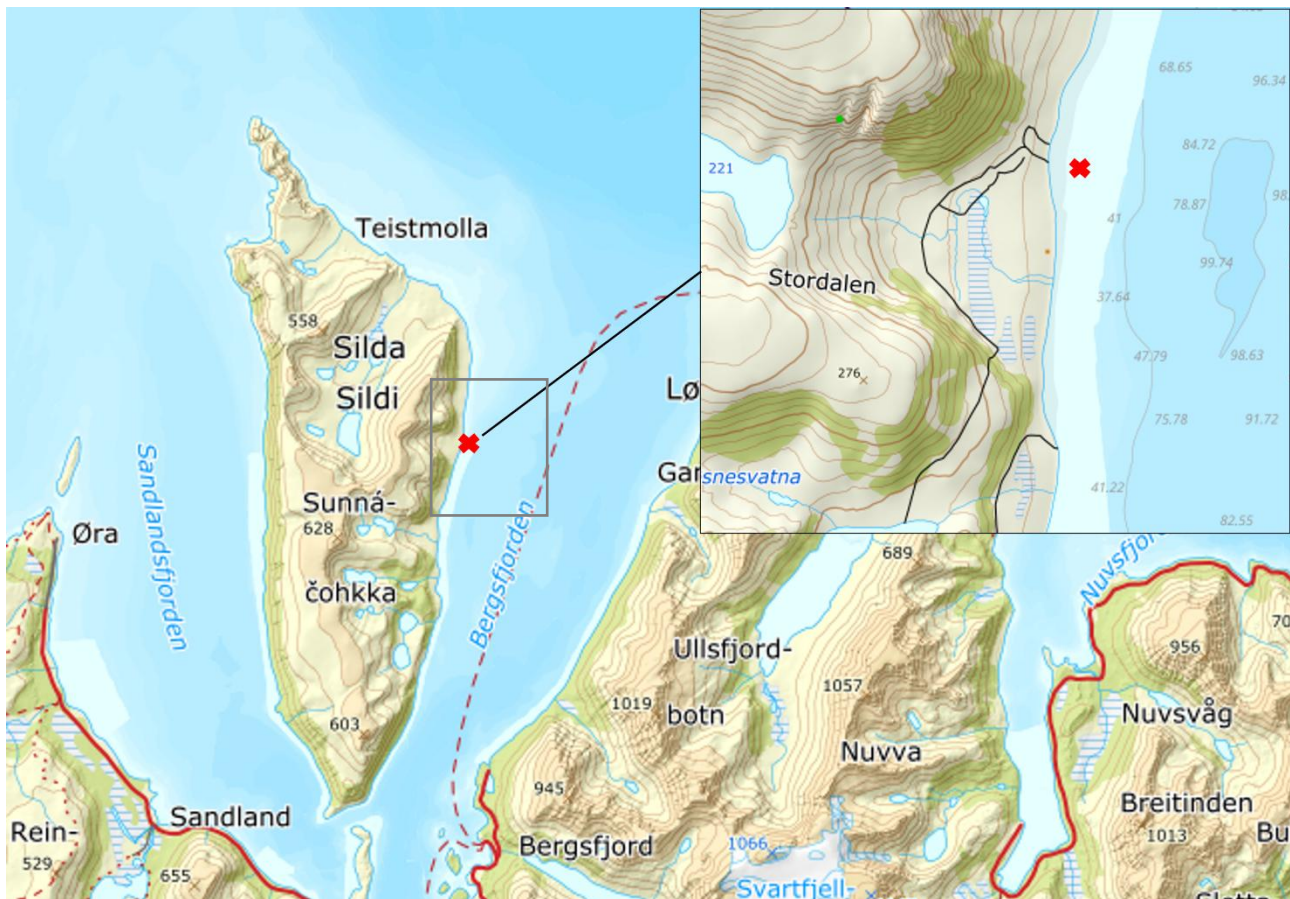
Figure 3: The red cross indicates the approximate location where the boat capsized. Map: Kystinfo, Norwegian Coastal Administration / NSIA

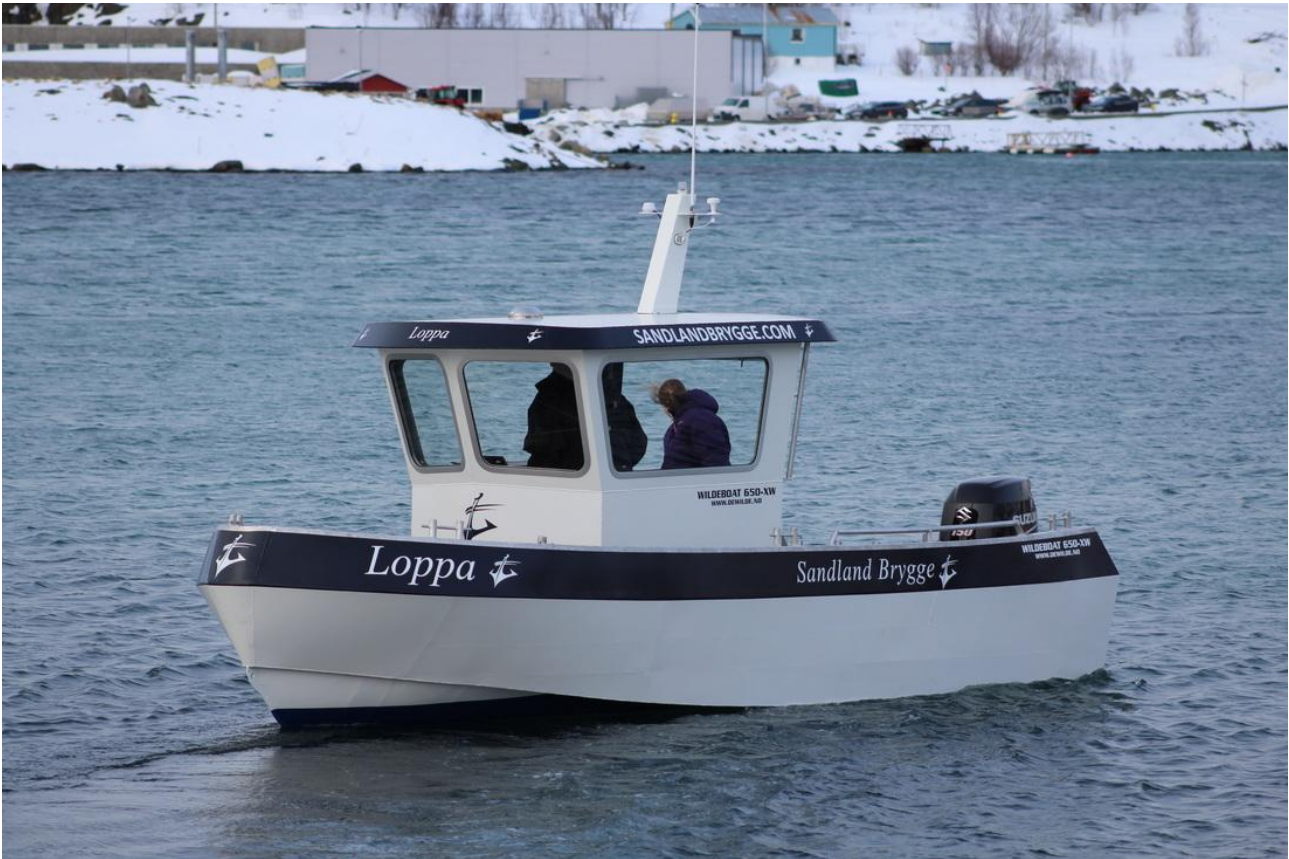
The vessel was self-draining, and a wheelhouse was installed at the centre of the boat measuring 1.9 m high, 1.9 m long and 1.5 m wide (see Figure 6)

Figure 6: Wildeboat 650XW. Photo: Manufacturer

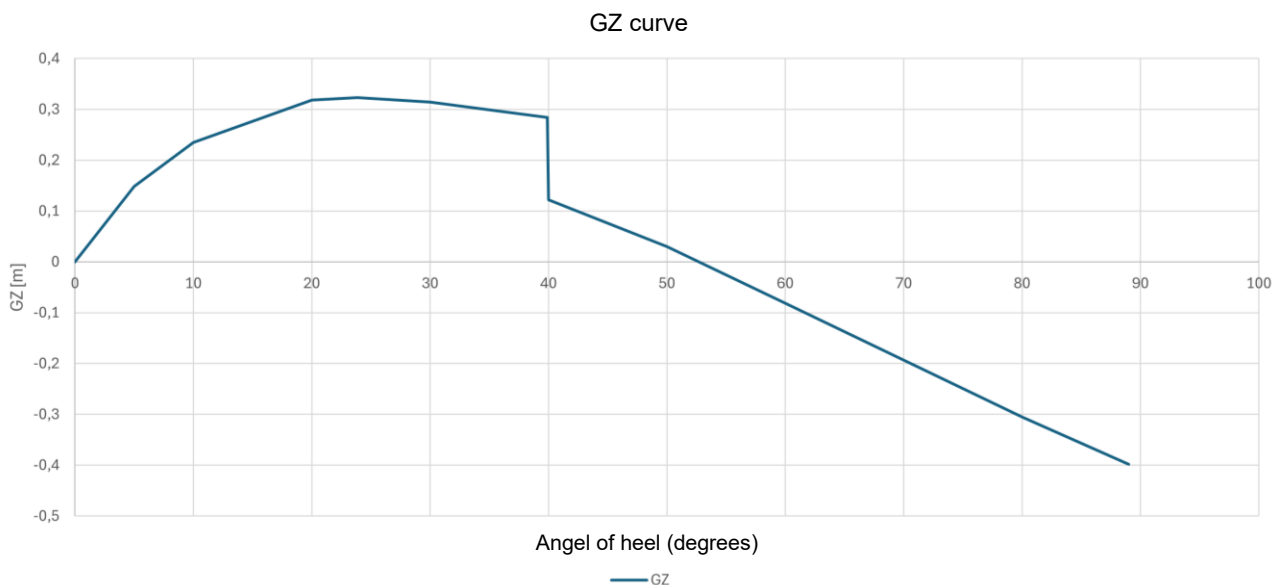
Figure 9: Calculated GZ curve for the vessel at the time of the accident. Source: NSIA

The GZ curve in Figure 9 shows that the vessel has good stability until water comes over the transom and onto the deck. The vessel then loses the buoyancy from the volume defined by the deck, the sides of the boat, and the transom. This is shown as a reduction in the GZ curve at approximately 40°.

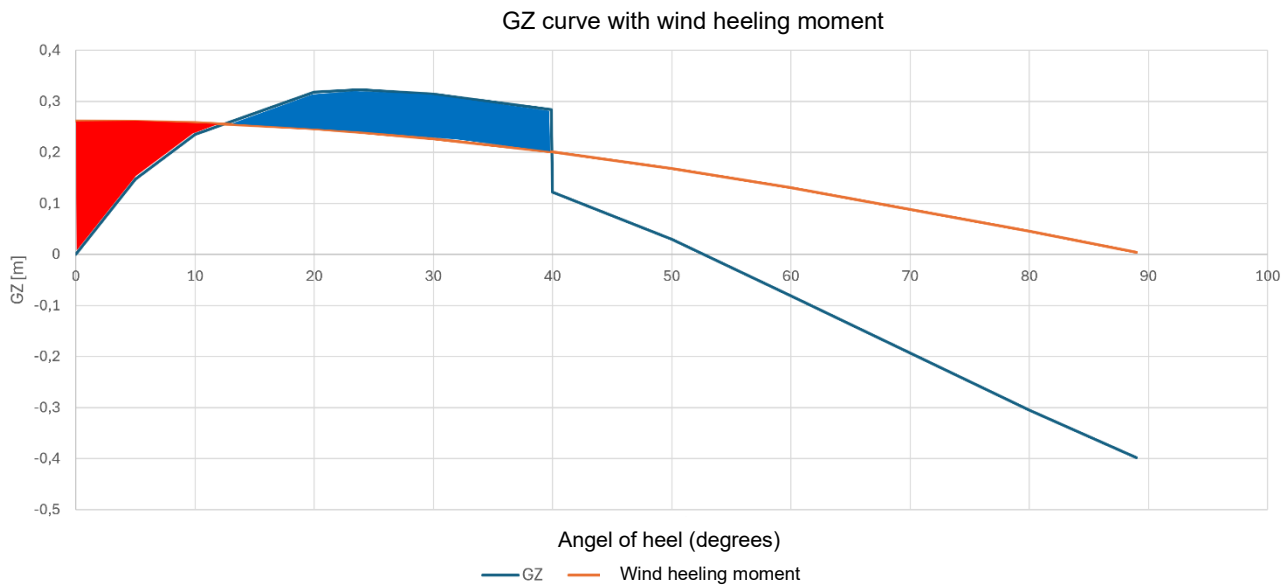
Figure 10: The calculated GZ curve for the vessel is shown as a blue line, and the heeling moment curve from 30 m/s wind gusts shown as an orange line. Source: NSIA

The area in red represents the heeling energy caused by the gust. This will cause the vessel to begin to heel. The heeling energy must be absorbed by a corresponding amount of righting energy before the heeling ceases. Heeling will therefore continue until dynamic equilibrium is reached. This is indicated by the red area being equal in size to the blue area, where the blue area represents the righting energy. Thereafter, the vessel would have righted itself to its original equilibrium if the wind ceased, or to approximately 13° list if the wind remained constant at 30 m/s. If the red area becomes larger than the blue area, the vessel will not achieve dynamic equilibrium, and the vessel will capsize. As Figure 10 shows, the red and blue areas are approximately equal, and theoretically, the vessel would just manage to right itself at approximately 40°. If the vessel was subjected to wind gusts exceeding 30 m/s, it would have capsized, as the blue area would then be smaller than the red area.

Based on calculations performed by the NSIA, as well as witness observations and measurements of wind gusts in the area, it is likely that the gusts on the day of the accident were powerful enough to cause the vessel to capsize. Although the calculations only accounted for the loads from wind gusts, the influence of waves may also have contributed to the capsize. The calculations also demonstrated that the windage of the wheelhouse had a significant impact on the vessel's heeling moment during the wind gusts on the day of the accident.

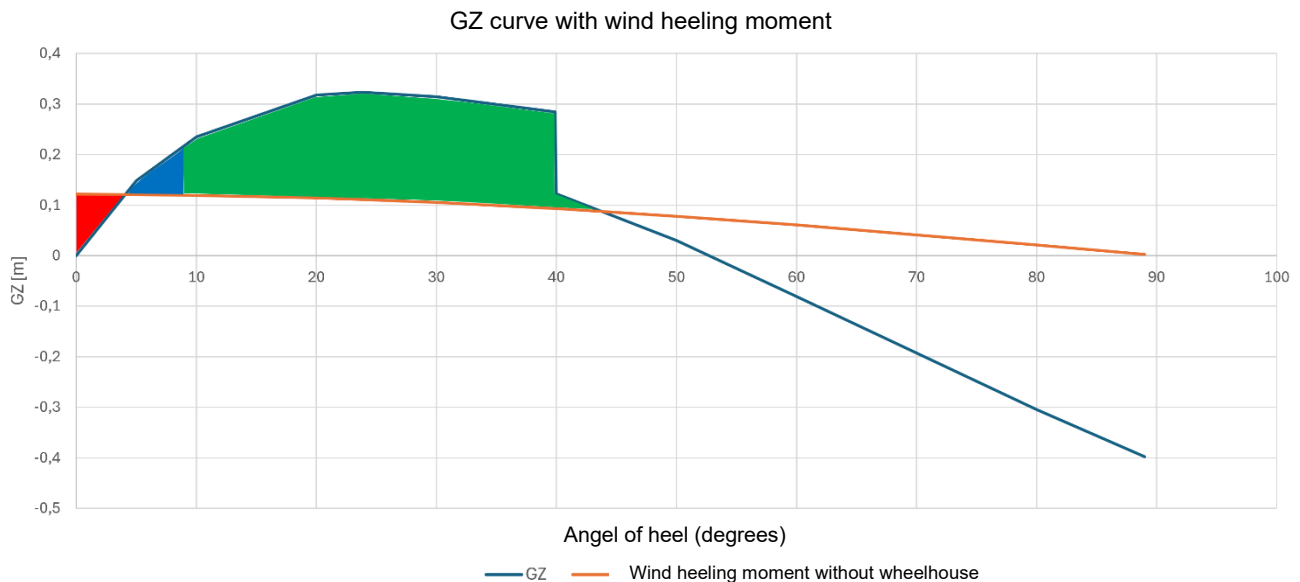
Figure 11: The calculated GZ curve for the vessel is shown as a blue line, and the heeling moment curve from 30 m/s wind gusts, excluding the wheelhouse as windage, shown as an orange line. Source: NSIA

As Figure 11 shows, a wind gust of 30 m/s would have heeled the vessel to approximately 9°. The red and blue areas are then of equal size. Thereafter, the vessel would have righted itself to its original equilibrium if the wind ceased, or to approximately 4° list if the wind remained constant at 30 m/s. The green area indicates the vessel's residual stability when subjected to the wind gust. This demonstrates that the windage of the wheelhouse contributed significantly to the heeling moment, thereby resulting in a reduced capacity to counteract dynamic loads, such as wind and waves, compared to the results obtained without the wheelhouse.
