# REPORT

JB 2013/02

## REPORT ON DERAILMENT NEAR NYKIRKE STATION, THE VESTFOLD LINE, ON 15 FEBRUARY 2012, TRAIN 12926

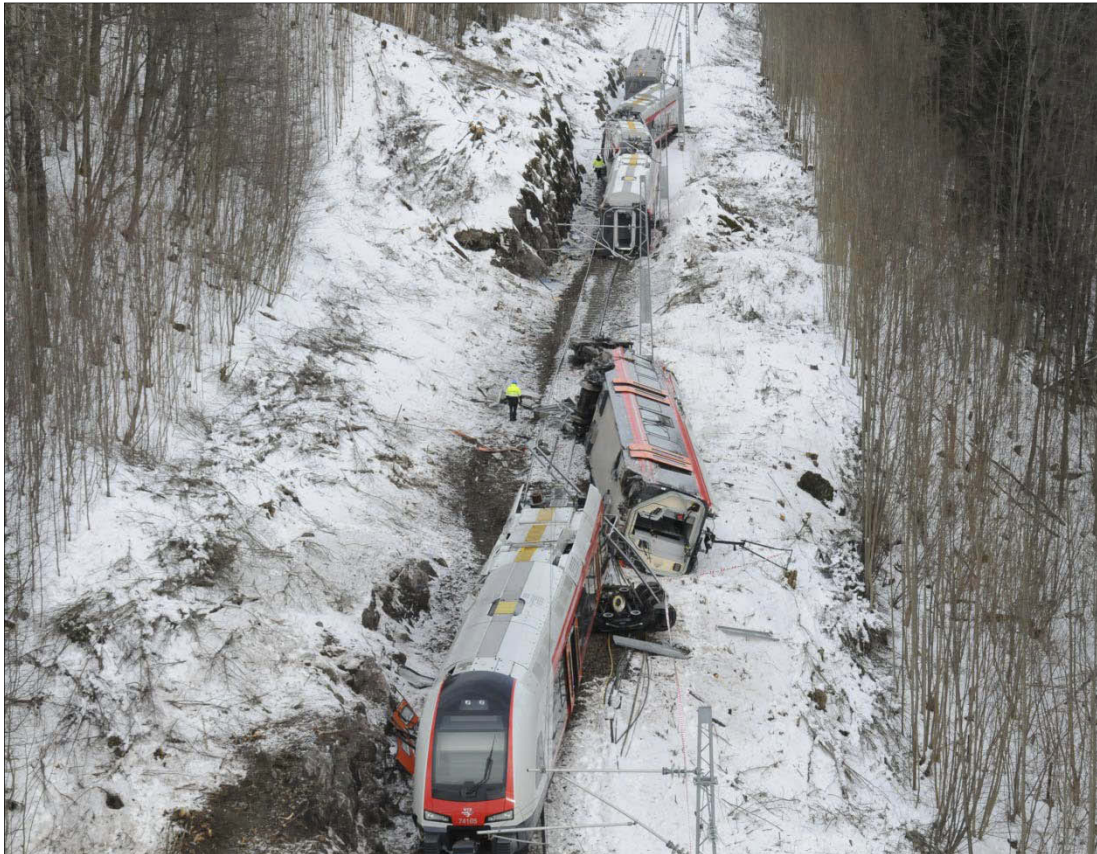
*Figure 2: Overview photo of the accident site. The carriage furthest away from the camera belongs to the rescue unit. (Photo: the police)*

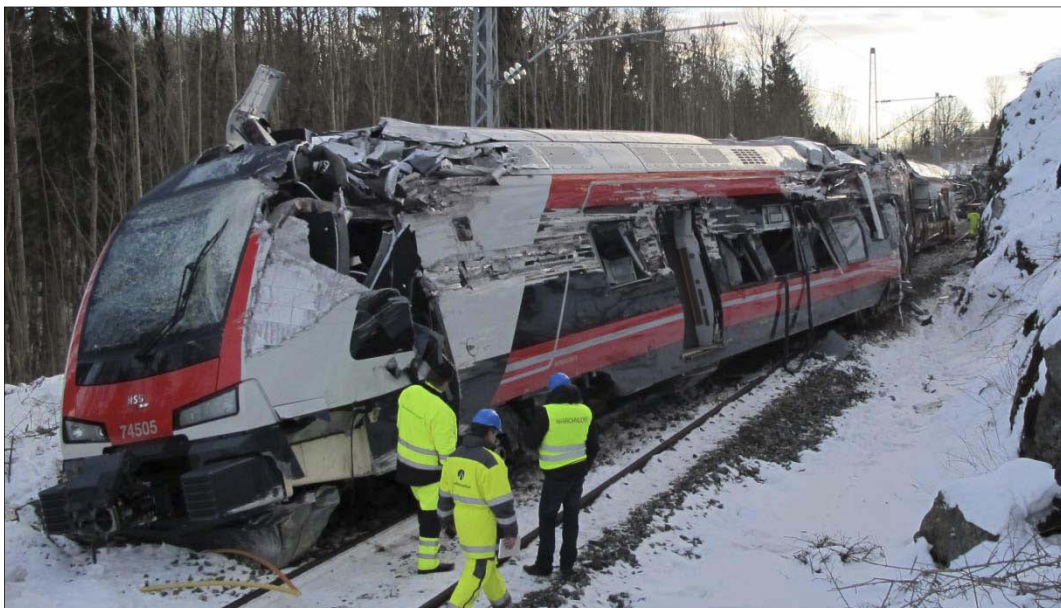
The train set involved was totally destroyed in the accident. None of the carriages could be removed using the tracks; they all had to be divided up and removed using a crane and lorries.

Figure 4: The front of the train (photo: AIBN).

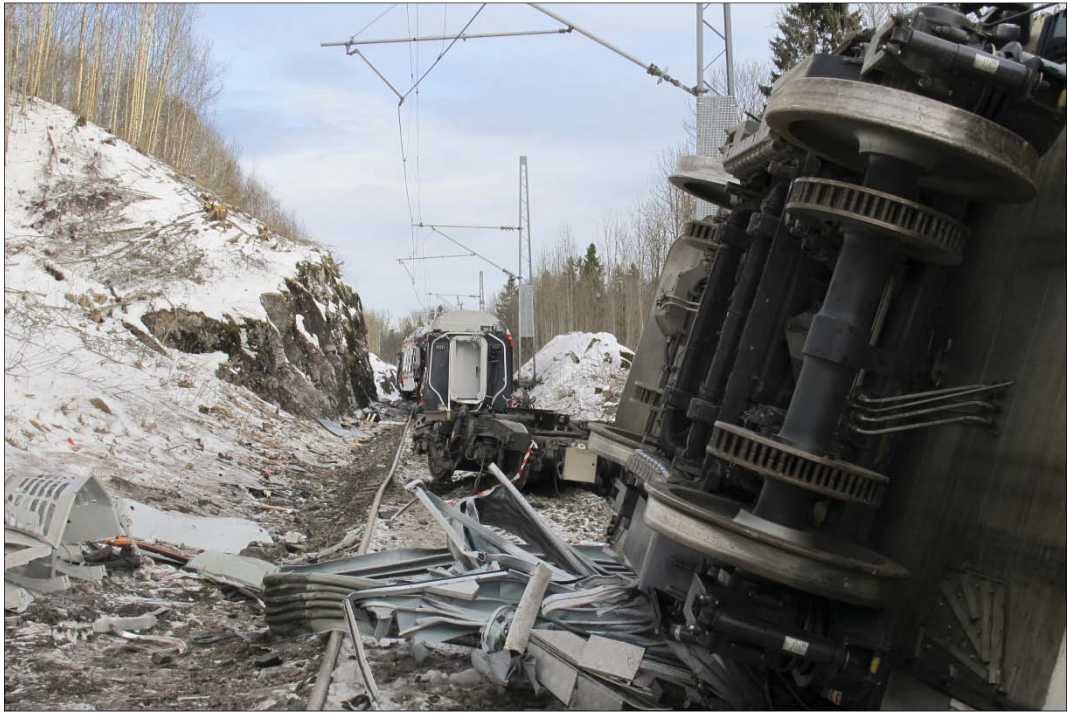
*Figure 5: The train set was split into three parts (photo: AIBN).*

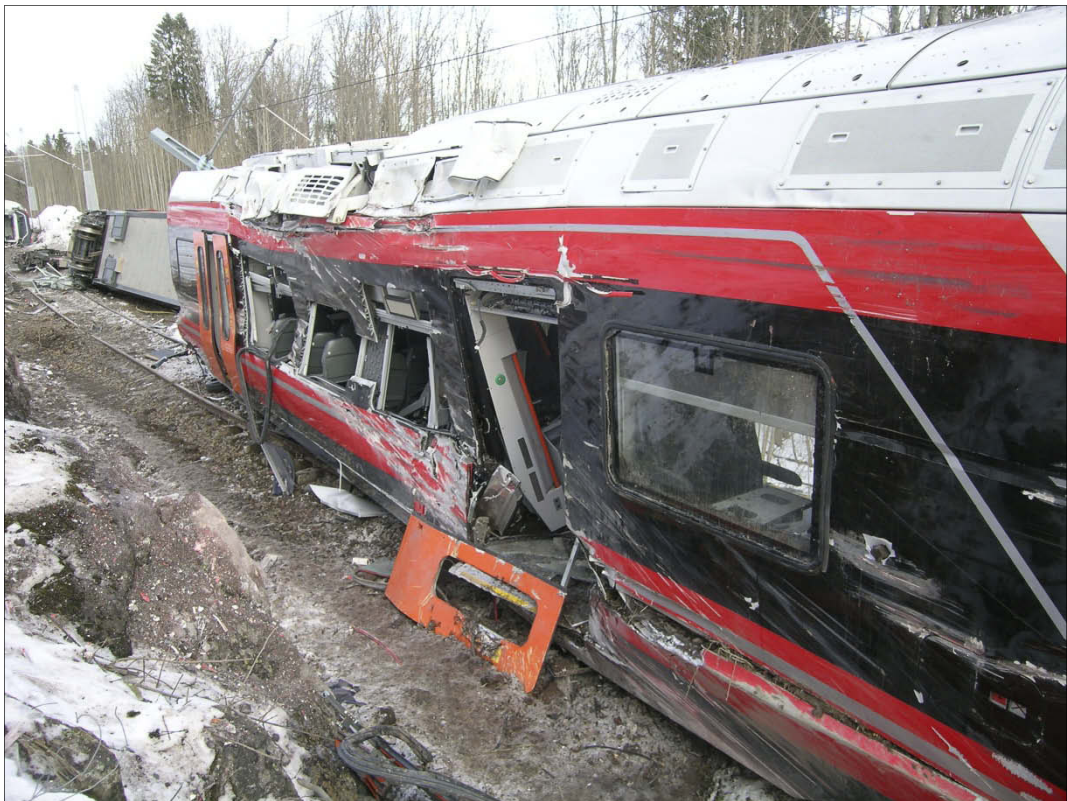
*Figure 6: The side of the rearmost carriage (photo: AIBN).*

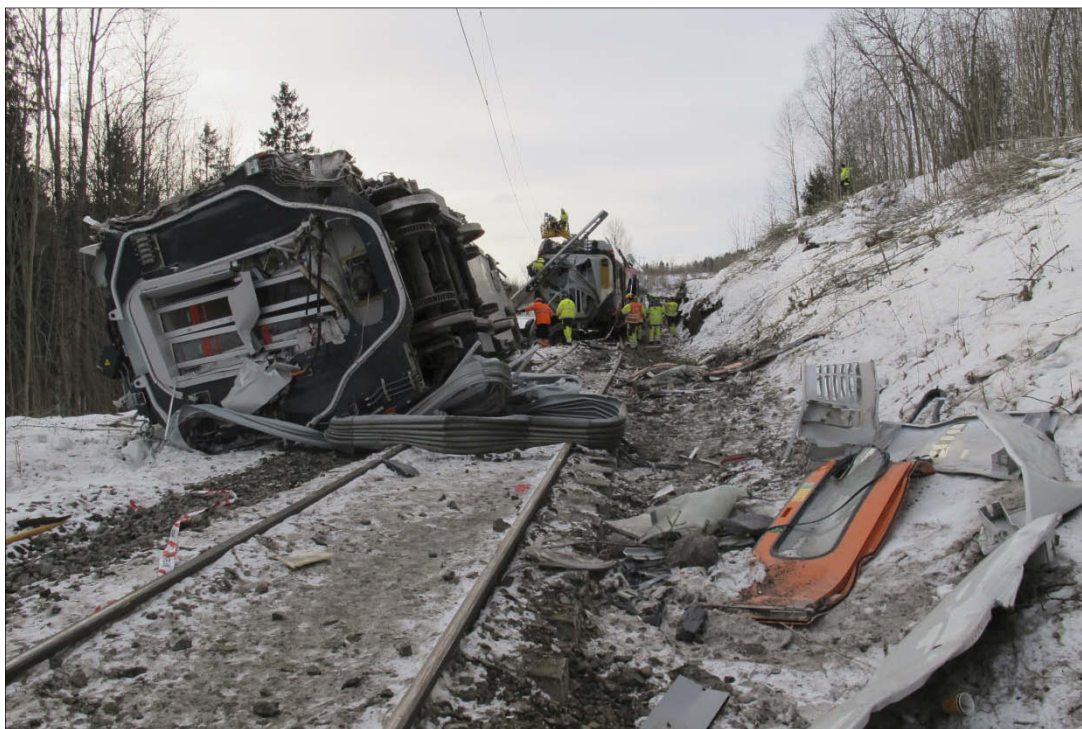
Figure 7: Carriage rolled on its side (photo: AIBN).

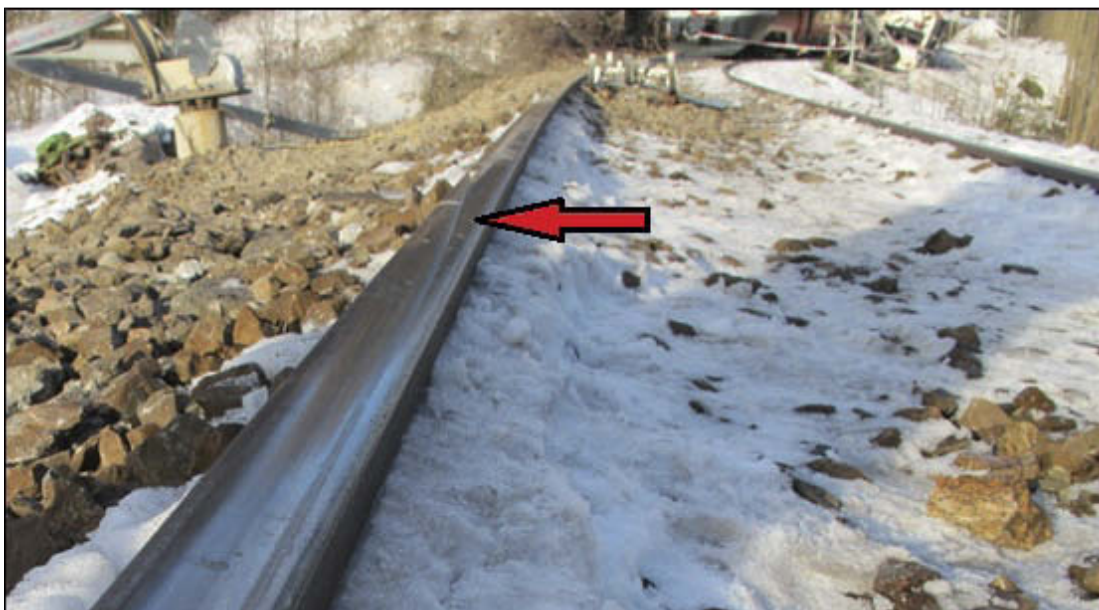
After a derailment, there will normally be marks known as climb marks on the rails where the wheel climbed up onto the rail head. At the site of this accident, the marks were minimal, and were only found on the left rail in the direction of travel (Figure 12). Even at an early stage of the investigation, this indicated that the speed of the train had been so high that the weight of the wheels on the rail was minimal. The fact that marks were only found on the left rail suggested that the train had lost contact with the right rail and was in the process of rolling over.

Figure 12: Derailment marks only on the left rail (photo: the AIBN).

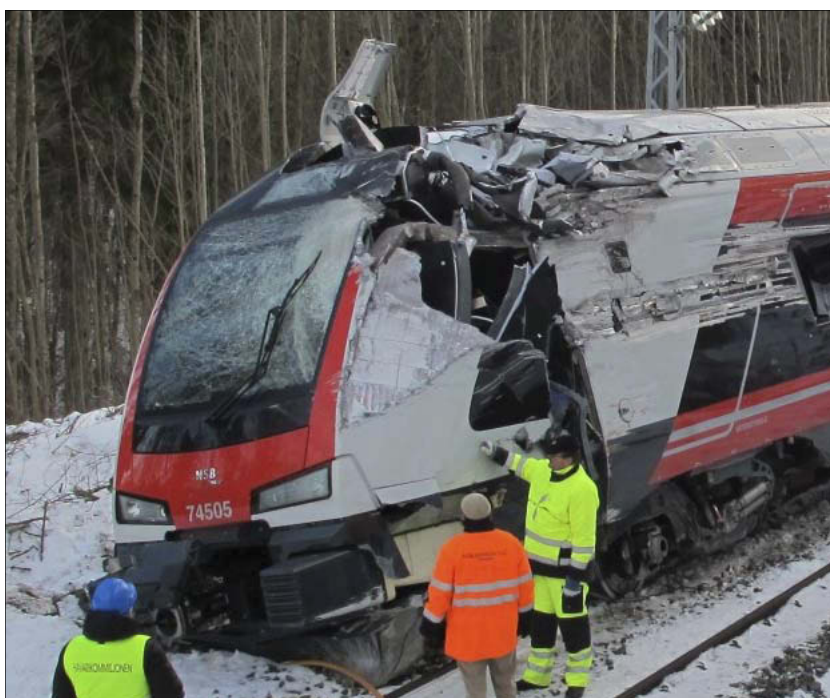
The driver's cab in NSB Type 74 has extra reinforcement intended to protect the driver in the event of impact (Figure 25 and Figure 26). This probably helped to reduce the extent of injuries to the two people who were in the cab when the train hit the cliff. The driver has also pointed out in interviews that the train appears to be very strong and robust. The locomotive supervisor agrees, and is glad they were in precisely this safe train set which has a very safe driver's cab, among other things.

Figure 26: The front of the train with reinforcements visible (photo: the AIBN).

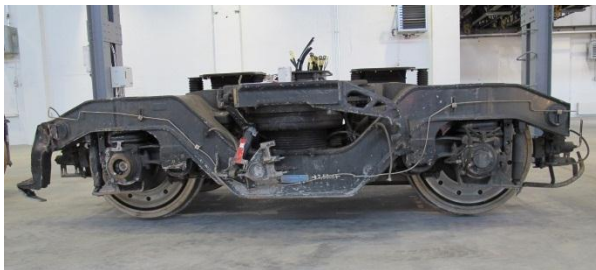
Figur 1: Boggi nr. 64-022 MB 7.

- Vestre hjul: slagmerker etter kontakt med terreng
- Høyre hjul: bare mindre skader
- Akselhylse har brudd ved den venstre elastiske koplingen.
- Venstre elastiske kobling har merker etter kontakt sannsynligvis med en skinne.
- Ingen observerbare skader på aksel inne i hylsen, observert gjennom sprekkene i hylsen. Ikke demontert for videre undersøkelse
- Drevkassen har mindre lakkskader
- Bremseskiver, klosser og holdere ok på begge hjul
- Pusseklosser ok på begge hjul

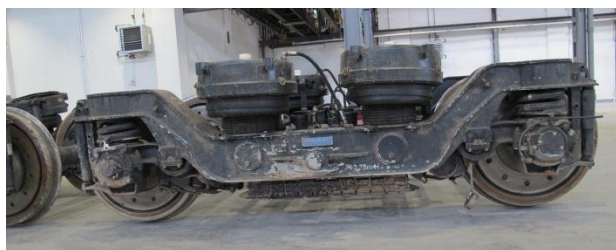
Figur 2: Boggi nr. 62-023 JTB 6.

- Aksel tilsynelatende uskadet
- Moderate til små skader på begge hjul
- Bremseskiver ok på begge hjul
- Ytre bremseklossholder (og kloss) borte på venstre side
- Bremsklosser ok på høyre side og indre venstre side ok.

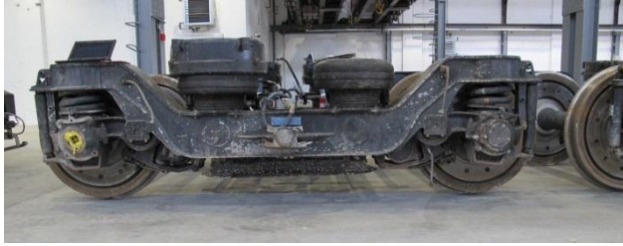
Figur 3: Boggi nr. 62-022 JTB 5.

- Aksel tilsynelatende uskadet
- Grove slagskader på venstre hjul, ytterkant
- Moderate skader på høyre hjul
- Bremseskiver, klosser og klossholdere ok på begge hjul
- Løftesikring venstre side brukket og bøyd
- Slitasjemerker etter kontakt med terreng/pukk under akselkasse venstre side

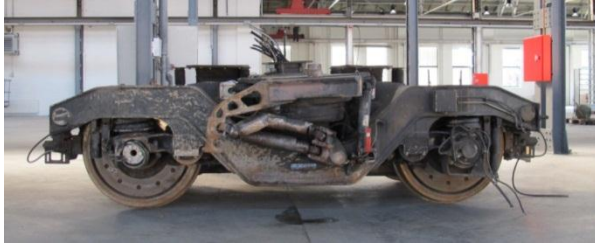
Figur 4: Boggi nr. 64-023 MB4.

- Aksel, akselhylse og elastiske koplinger er tilsynelatende uskadet
- Drevkassen tilsynelatende uskadet
- Mindre skader på hjul begge sider
- Bremseskiver, klosser og klossholdere ok på begge hjul
- Pusseklosser ok på begge hjul
- Løftesikring venstre side defekt
- Akselkasselokk høyre side er skadet
- banemotor tilsynelatende uskadet men kabler og rørforbindelse til vogn er slitt av
- kjøleluft inntak er deformert

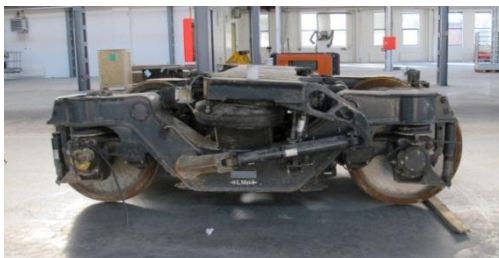
Figur 5: Boggi nr. 60-008 TB3.

- Aksel tilsynelatende uskadet
- Indre bremsekloss høyre side mangler, ingen slitasjemerke på holderne
- Bremseskiver, klossholdere og øvrige klosser er ok
- Minimale skader på begge hjul

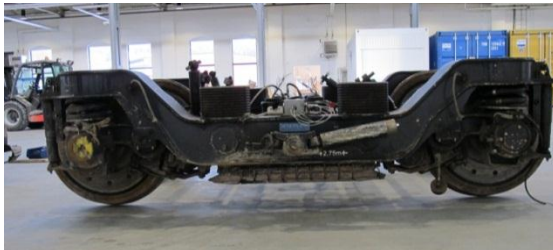
Figur 6: Boggi nr. 62-024 JTB 2.

- Mindre ripe- og lakkskader på aksel
- Store slagskader på venstre hjul utside
- Små skader på høyre hjul
- Bremseskiver, klosser og klossholdere ok på begge sider.

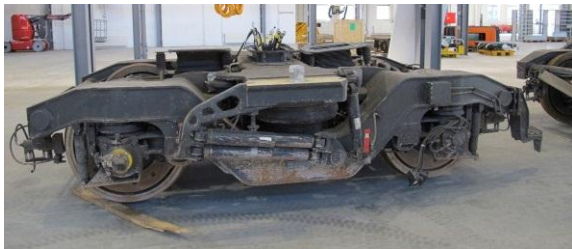
*Figur 7: Boggi nr. 64-025 MB 1.*

- Aksel, akselhylse og elastiske koplinger tilsynelatende ok
- Drevkasse tilsynelatende ok
- Begge hjul har minimale skader
- Bremseskiver, klossholdere og klosser på begge hjul
- Mindre slitemerker under venstre akselkasse
- Banemotor tilsynelatende uskadet
