Issued December 2022

# REPORT RAIL 2022/08

***Faulty interlocking system at Jar metro station on the Kolsås line, 27 November 2021***

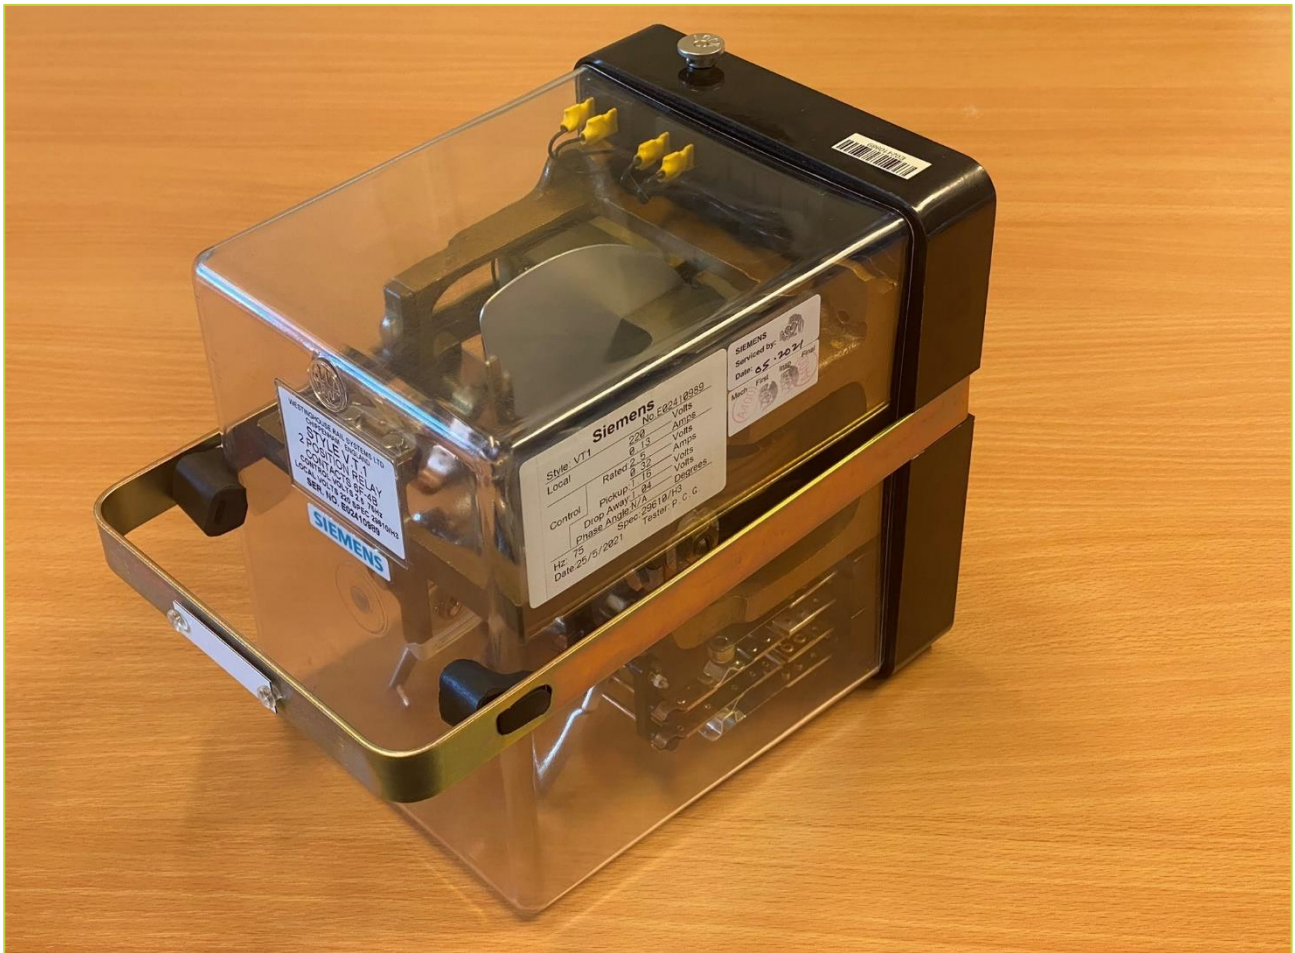
The relay involved in the incident at Jar was of the type Westinghouse Rail Systems Ltd Style VT1-6F-4B with serial number E02410989, manufactured by Siemens Mobility Ltd (Figure 2).

Figure 2: VT1-6F-4B relay. Photo: NSIA

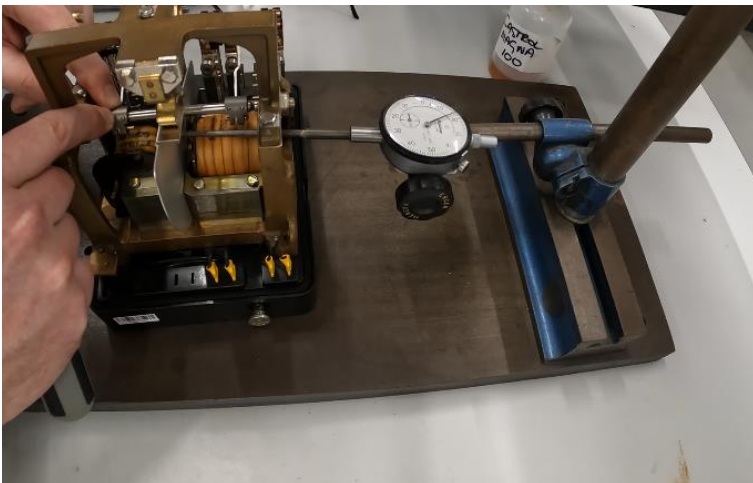
1. When the relay was checked in relation to the specifications for final testing and inspection, the vane was found to have been displaced laterally by 1/1,000 inch.
2. When the relay was disassembled, particles were found inside the vane bearings (Figure 6, Figure 8).

Figure 5: Measuring lateral vane clearance. Photo: NSIA

The NSIA found that the lateral vane displacement at the pivot was greater than the limit set for final testing and inspection. Nonetheless, the lateral displacement was not great enough to cause the aluminium plate to come into contact with the coils that drive the relay, and it can therefore not explain why the relay did not open.

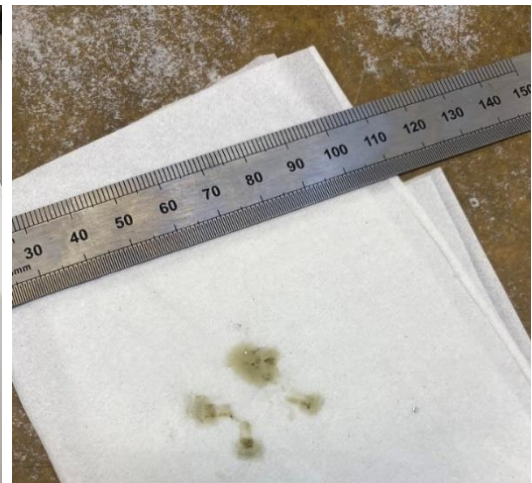
Figure 6: Wiped-off material from the vane. Photo: NSIA

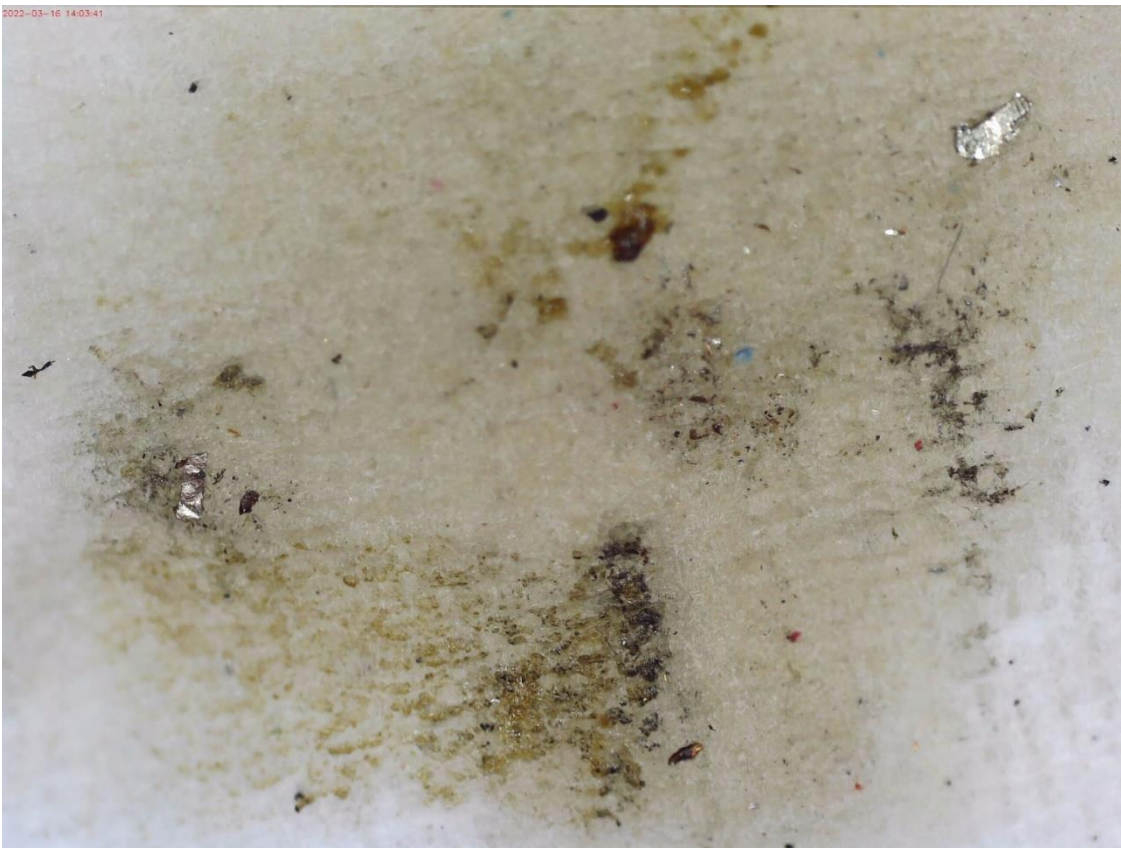
Figure 8: Fragments found on the pivot ends using a microscope. Photo: Siemens Mobility Ltd.

Furthermore, metal fragments were found in the lube oil when the pivot ends were wiped clean. The fragments were of a brass alloy, the source of which was neither the pivot ends nor the bearing housing. During normal operation, the relay is not expected to produce shavings or fragments, and the horizontal position of the vane makes it highly unlikely that anything could fall, by force of gravity, into the clearance gap between the bearings and pivot ends. The NSIA therefore considers it probable that the fragments entered the bearings when the relay unit was

The NSIA has been unable to finally conclude why the relay did not open when the track circuit was short-circuited by the vehicles, but nonetheless concludes that vane rotation was most probably prevented by small metal fragments found in the bearings of the relay's vane.

The NSIA does not propose any safety recommendation following the investigation. The NSIA does not issue any safety recommendations following the investigation. Siemens Mobility has shortly after the investigation of the relay changed their method for cleaning the bearings in the assembly process

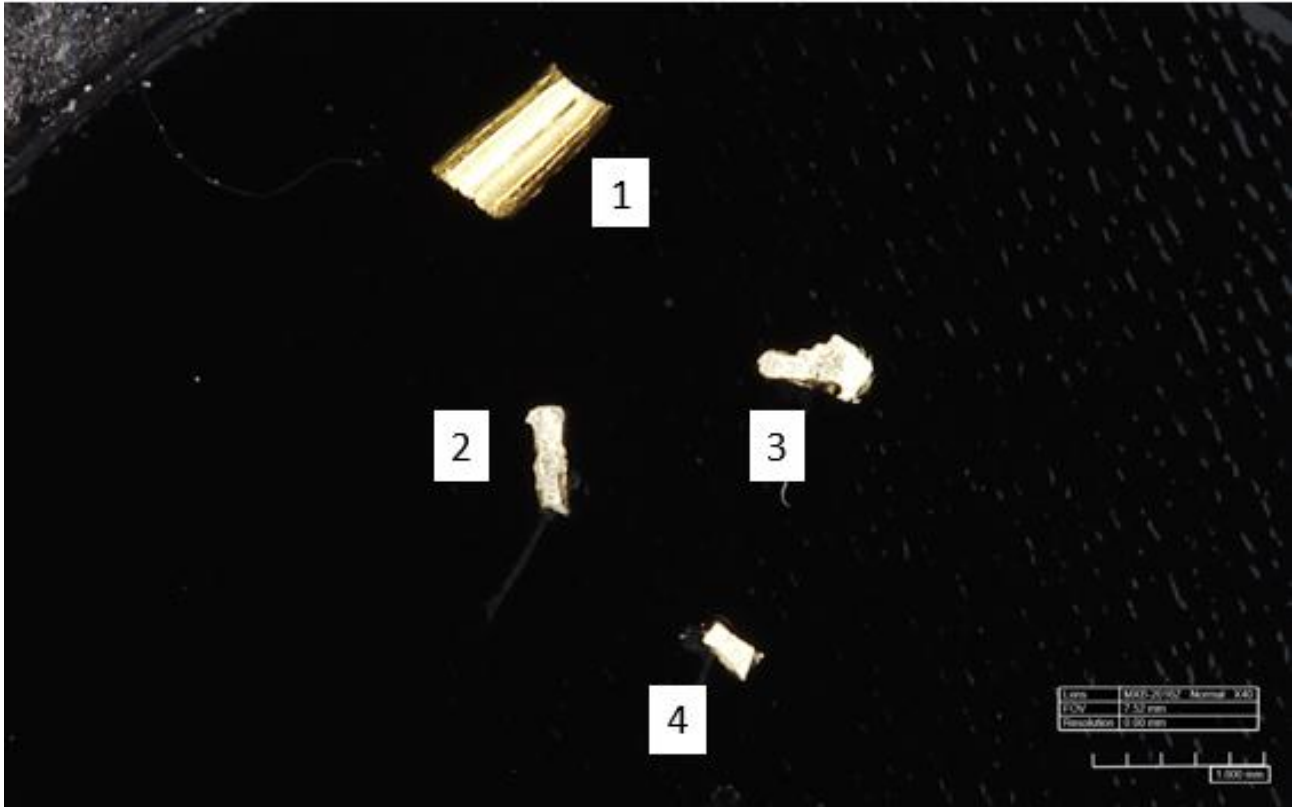
Given that the bearings were found to contain fragments, the NSIA requested further examinations of the fragments by the Norwegian Armed Forces Laboratory Services. These examinations enabled documentation of fragment sizes and alloys. The particles were described as consisting of a brass alloy, using energy-dispersive X-ray spectroscopy (EDS). The NSIA did not observe any wear on the pivot ends or bearings that could explain the fragments.

Figure 9: Overview of the fragments found on the pivot ends. Fragment sizes are stated in Table 4.  
Photo: FOLAT

Fragments found in the bearings, ref. Figure 9	Width (imp)	Length (imp)
1	0.0193	0.0358
2	0.0114	0.0256
3	0.0083	0.0240
4	0.0055	0.0126

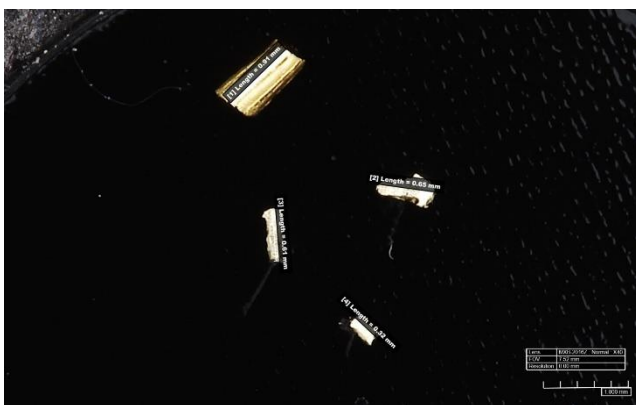
Figure 10: Fragments marked with length.  
Photo: FOLAT

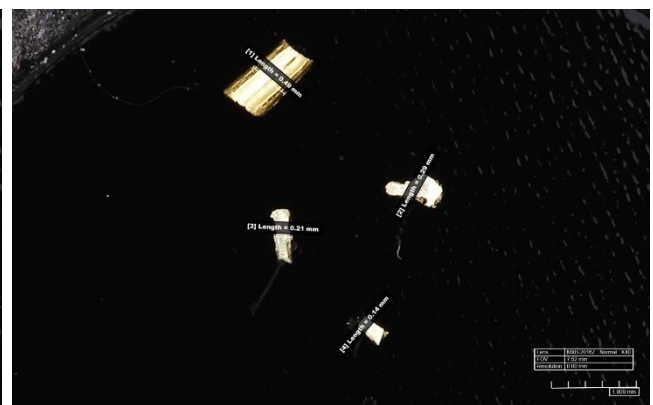
Figure 11: Fragments marked with width.  
Photo: FOLAT

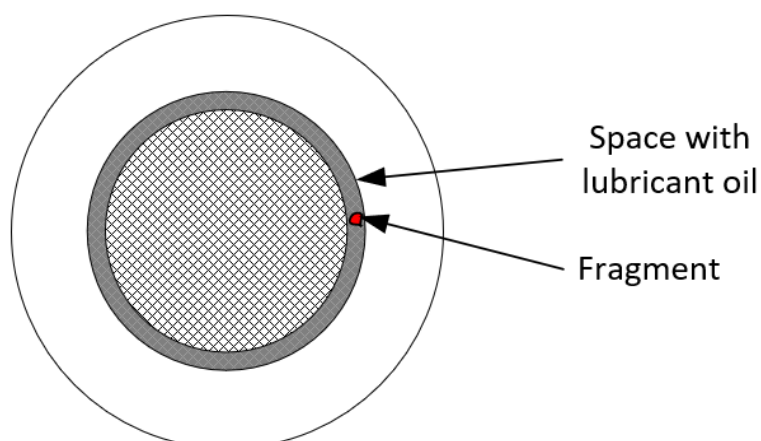
When compared to the measurements in section 1.10.3, the measurements highlighted in red in Table 4 indicate cases in which the maximum fragment size exceeds the available clearance gap between the bearings and pivot ends (illustrated in Figure 12).

Several fragments may also have been co-located and thereby jointly exceeded the size of the separate fragments.

Figure 12: Sketch of bearing, pivot end, bore and fragment. Sketch: NSIA

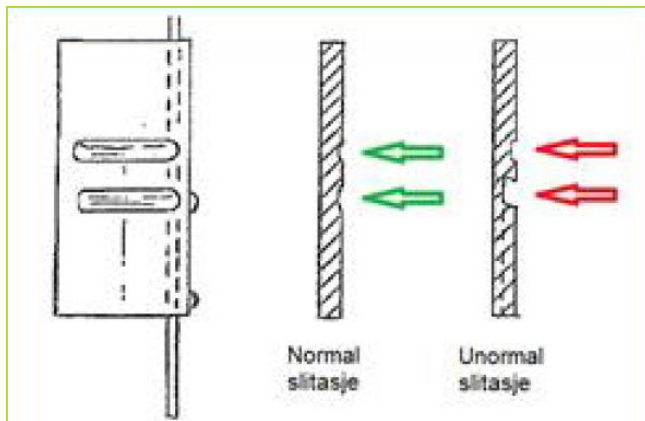
- In one case, the relay had remained closed as a consequence of extraordinary wear on the vane's stop plate/contact plate and where the relay contacts got stuck / mechanical conditions prevented the vane from returning to the open position (Figure 15). This fault is common knowledge, and is followed up by Sporveien T-banen in periodic inspections described in the standard job procedure 'Standardjobb 20'. The inspection is carried out visually and is easily done by the signal engineer. The fault is known to have occurred in several similar systems and, as far as the NSIA is aware, it is dealt with by infrastructure managers who use this type of relays.

Figure 15: Description of fault where the VT1 relay's stop plate/contact plate has suffered extraordinary wear. Source: Sporveien T-banen 'Standardjobb 20' version 10.20.
