REPORT

ROAD 2016/03

REPORT ON COACH FIRE IN THE GUDVANGA TUNNEL ON THE E16 ROAD IN AURLAND ON 11 AUGUST 2015

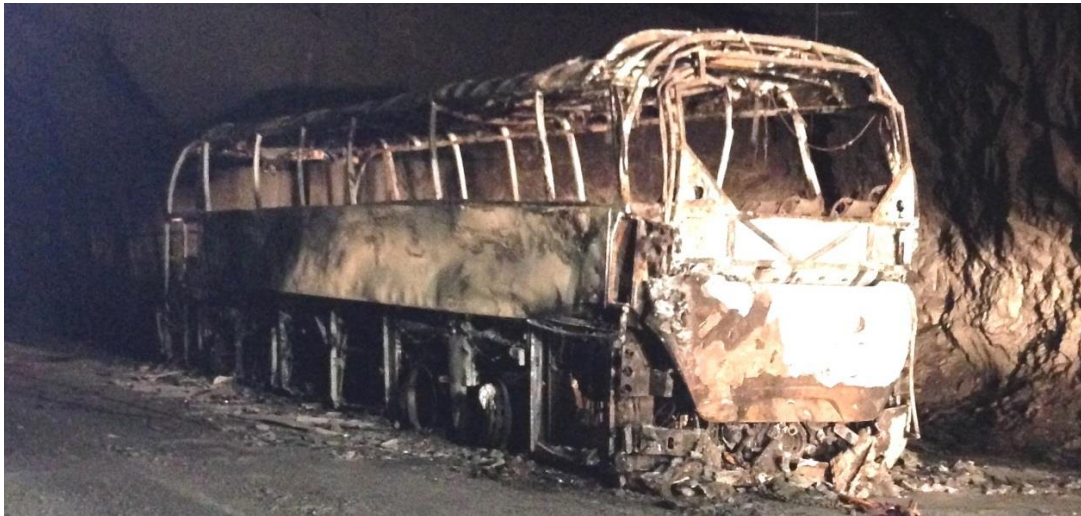
The coach was completely burnt out; see Figure 5.

Figure 5: The burnt-out coach inside the tunnel. Photo: AIBN

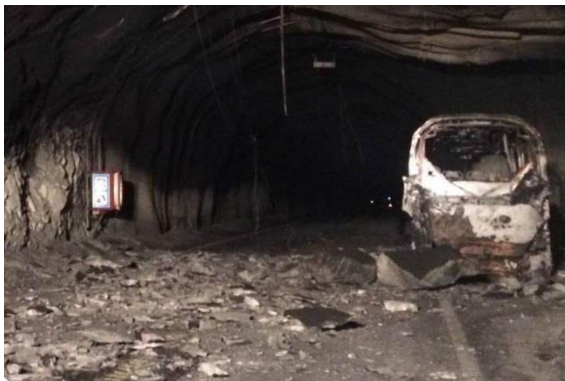
The tunnel ceiling was seriously damaged, with fractured rock in the area above the coach. Debris and rocks had fallen from the ceiling above the coach and along an almost 50-metre long section of tunnel in the direction of Flåm. When Aurland fire service arrived at the scene at 13:30, the response personnel were unable to get close to the burning coach because of the falling debris.

Figure 6: Fallen debris, viewed from the Flåm side. Photo: Aurland fire service

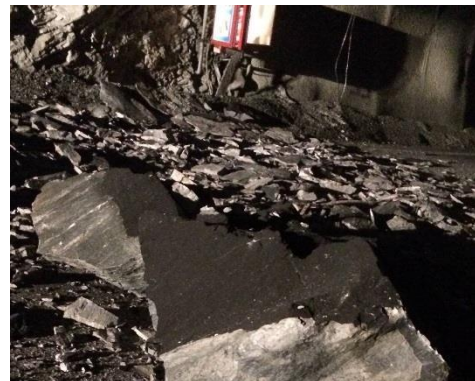
Figure 7: Close-up of fallen debris. Photo: Aurland fire service

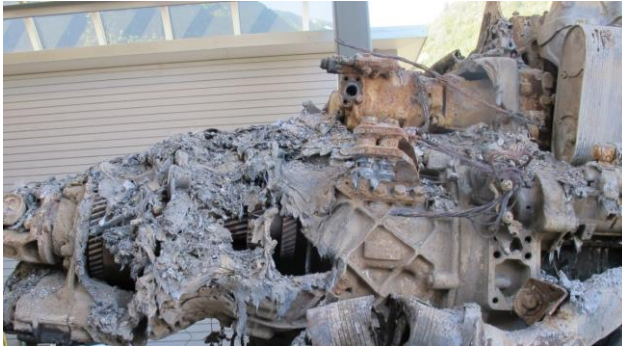
Figure 8: The damage to the coach's gearbox as a result of the fire. Photo: AIBN

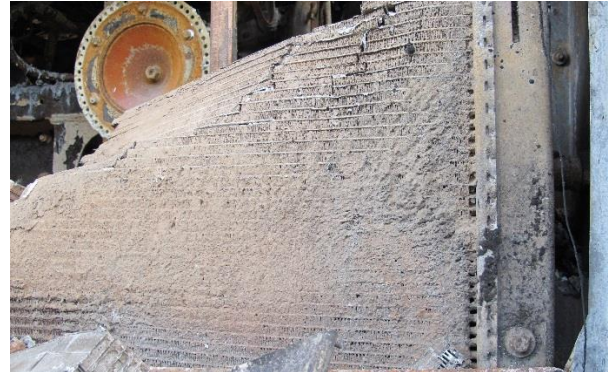
Figure 10: There were soil marks on the radiator. Photo: AIBN

The radiator was partially burnt out and soiled. The AIBN took samples of the deposited material, which consisted mainly of mineral and salt particles. This suggests that there may have been deposits in parts of the radiator before the fire occurred. This may have affected the cooling performance of the engine's radiator, which is an important component in the cooling system.

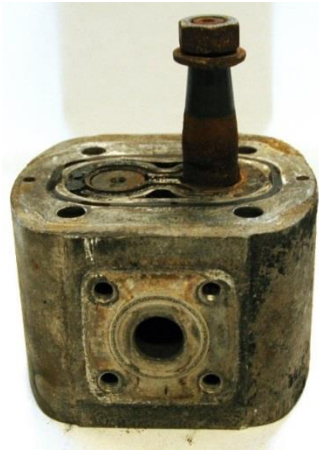
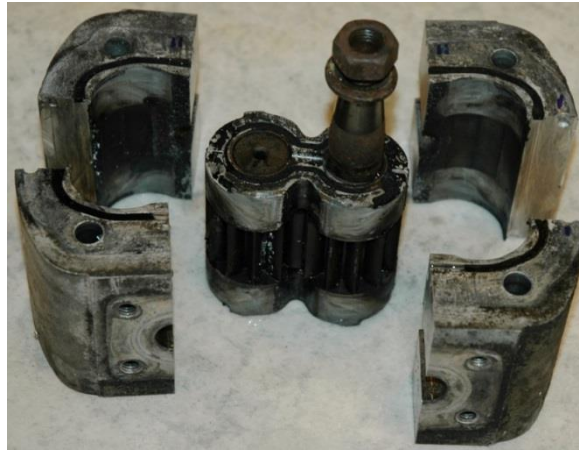
Figure 15: Fan motor for the cooling system. Photo: FOLAT

Figure 16: A radiographic examination was carried out of the fan motor before it was taken apart. Photo: FOLAT

The examination of the fan motor showed no indication of the motor having been defective prior to the fire (see Figure 15 and Figure 16).

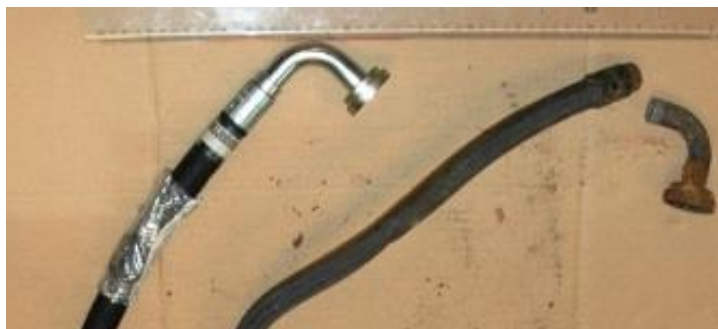
Figure 17: For reference purposes, the photo shows a new hydraulic hose on the left. The burnt-out and broken hydraulic hose is shown on the right. Photo: FOLAT

The burnt-out hydraulic hose was compared with an identical, unused hose and hose end fitting for reference purposes (see Figure 17). Traces of aluminium were found in the soldering inside the burnt-out hose end fitting (see Figure 18 and Figure 19). Only silver/copper were found in the reference fitting. FOLAT provided the following description:

'The oil hose had sustained significant burns, and the temperature probably exceeded the melting point for the silver/copper solder used in the soldered connection, i.e. 800–900 °C. For reasons unknown, the solder was mixed with aluminium, deposits of which were also found on the inside of the hose. The traces of aluminium could be observed symmetrically around the soldered connection, and on the hose end fitting that had separated from the hose.'

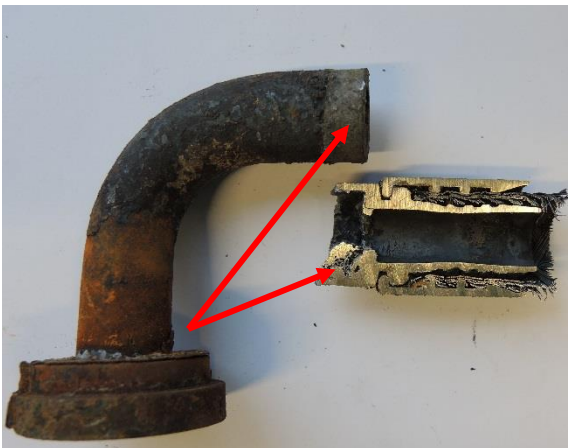
Figure 18: Broken hose end fitting. The red arrows mark the aluminium in the soldered hose end fitting. Photo: AIBN

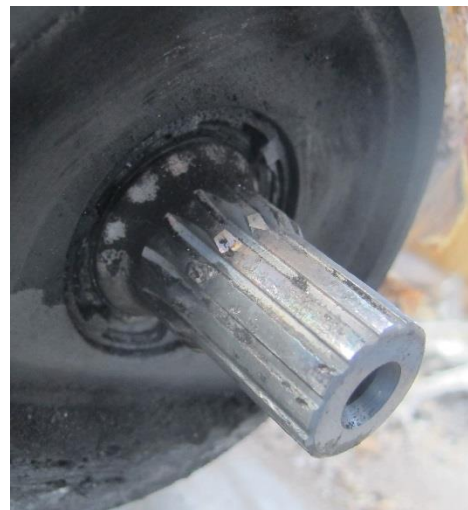
Figure 21: Worn drive shaft splines. Photo: AIBN

No damage was found on the pump to suggest internal pump failure, but the drive shaft splines were completely worn down. This may have caused the pump to stop working at some point while the engine was running for the last time.

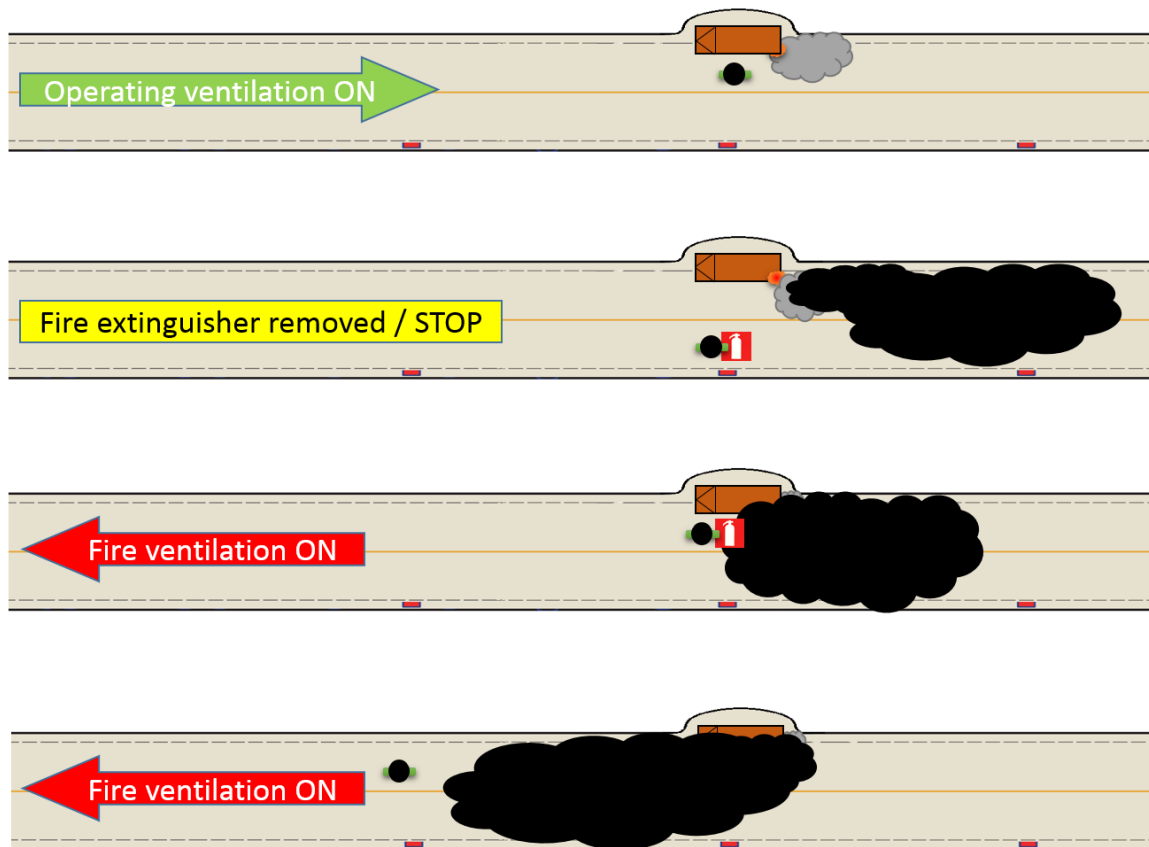
The AIBN sees no natural connection between removal and use of a fire extinguisher, on the one hand, and automatic change of ventilation direction on the other, as this will necessarily entail the possibility of smoke being present on both sides of a burning vehicle. From a road-user perspective, it is both unexpected and illogical to find that the smoke has been turned towards you in the direction of the longest section of the tunnel after the shortest section has been blocked by smoke. It is also unexpected and illogical for a road user to unknowingly change the direction of ventilation while attempting to extinguish a burning vehicle.

Figure 25: The effect of an automatic change of direction activated by removing a fire extinguisher, as in the Gudvanga tunnel. Illustration: AIBN
