# REPORT

## Road 2016/04

## SPECIAL REPORT II ON SAFETY-CRITICAL FACTORS RELATING TO HOOKLIFT CONTAINER TRANSPORT

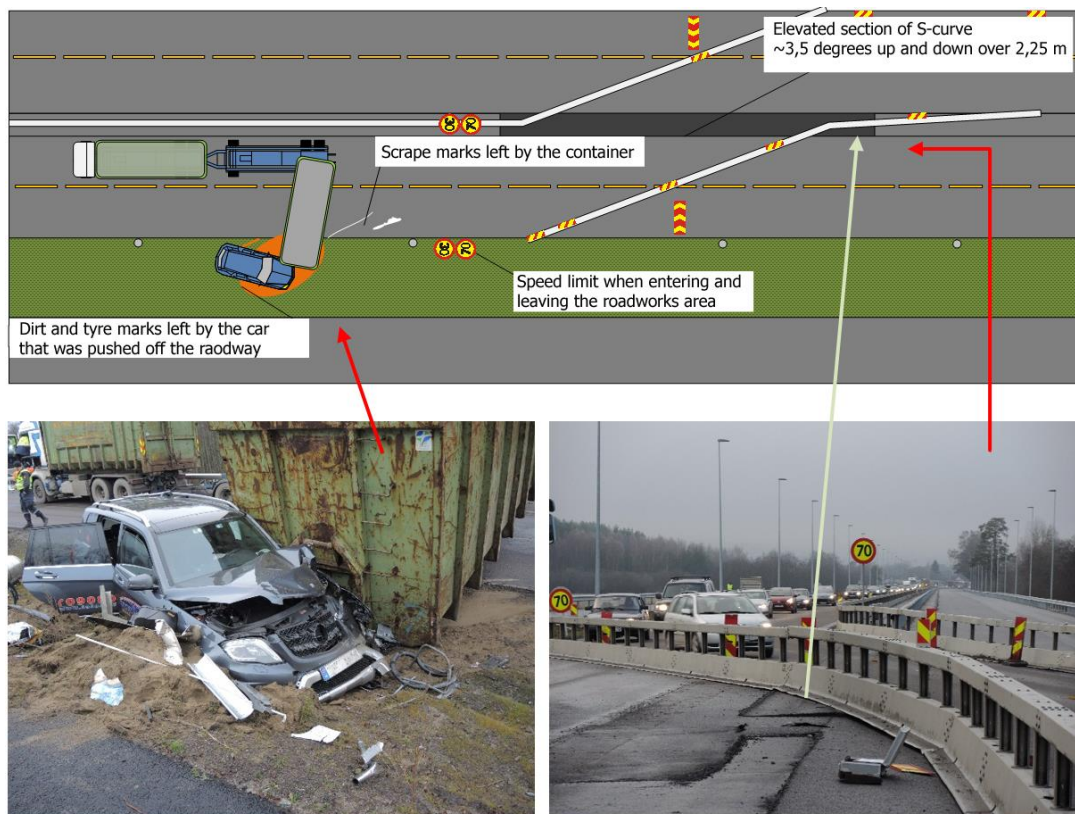
The heavy goods vehicle was negotiating an S-curve between the new and the old road. Where it entered the S-curve, there was an elevated connecting section of tarmac between the two roads (see figure 2). As the vehicle left the S-curve, the front securing arrangement for the container on the trailer loosened. The container slid leftwards onto the roadway and came to rest in the opposite lane, at approximately 90 degrees to the lanes. The container crashed into the front of an oncoming passenger car. The driver of the passenger car realised what was happening and drove the car into the ditch. One of the two people in the car was slightly injured.

Figure 2: Schematic drawing of the scene of the accident, photo showing the final position of the container/vehicles and photo providing an overview of the roadworks area. The red arrows show the position/direction from which the photos were taken, and the green arrow shows the elevation in the tarmac. Photos and illustration: AIBN

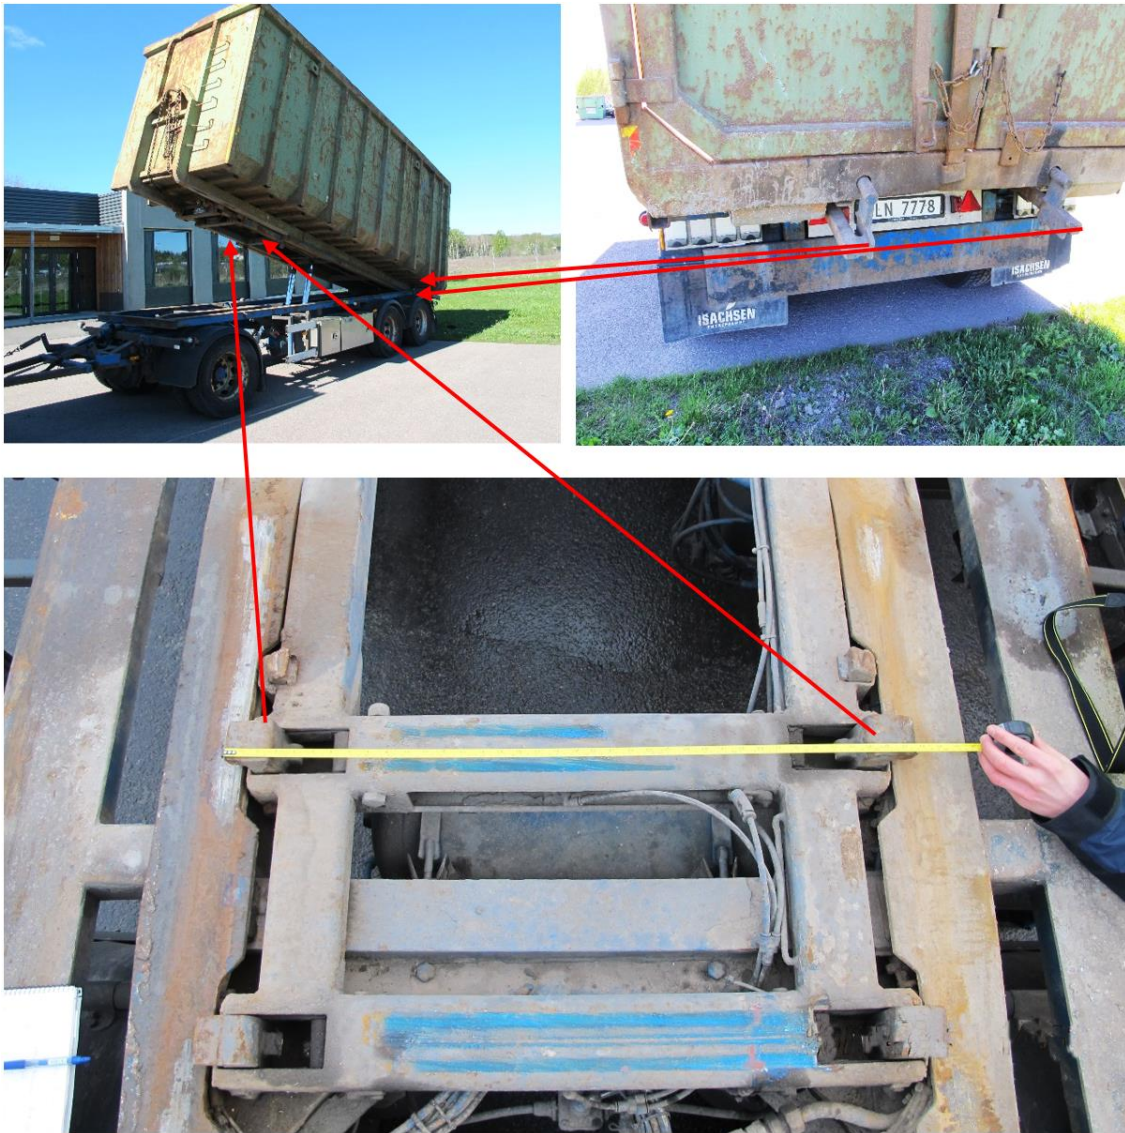
When tidying up after the accident, the container was loaded onto the trailer in question by first running it towards the rear until it was stopped by the rear stoppers, and then activating the pneumatic locks. For the locking studs to engage in the locking holes on the inside of the container's bottom side rails, the container had to be pulled slightly forwards. Figure 4 shows how the locking stud has been marked by the container's lateral movements.

*Figure 3: The container securing points: four pneumatic locking studs inside of the bottom side rails at the front and two stoppers at the rear. The rearmost locking studs were aligned to the recesses in the container's bottom rails at the time of the accident. The upper left photo shows an implemented measure whereby a chain is used between the container and tilt frame. Photo: AIBN*

Following the accident, the company has replaced the pneumatic front locks on the trailer in question. The company has also revised its internal procedures and now requires its drivers to use chains for added safety when securing hooklift containers on trailers.

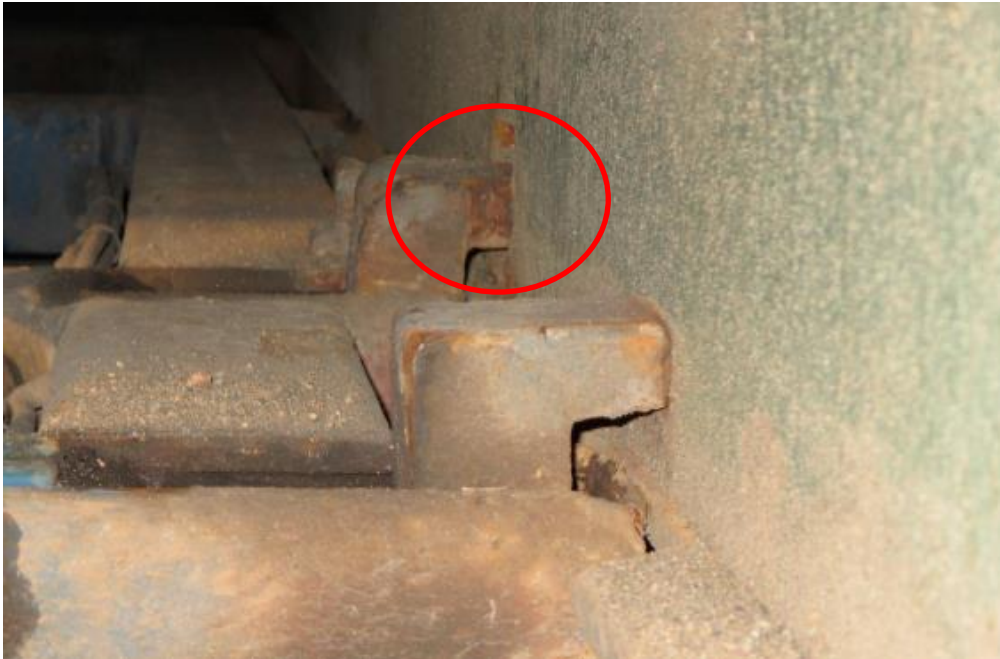
Figure 4: Marks on the locking stud from the container's lateral movements. Photo: NPRA  
Illustration: AIBN

In meetings with Nor Slep AS, the AIBN reported on the slack that was found in the front locking system on the trailer, and asked for any guidelines the company might have on what constitutes acceptable wear from a safety perspective. Nor Slep AS told the AIBN that it had not prepared any wear tolerances and that nobody had ever requested this.

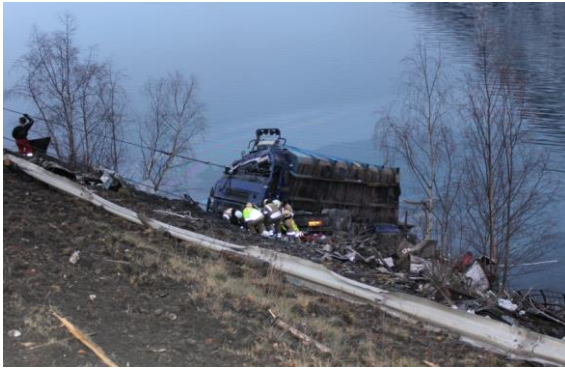
The truck and trailer crashed through the crash barrier on the right side of the road and continued down a steep slope. They finally came to rest at the edge of the water (Figure 6). The driver's cabin was heavily damaged (Figure 7) in the accident, and the driver died.

Figure 6: The truck in its final position. The trailer is still coupled to the truck, but is partially submerged in water. Photo: NPRA

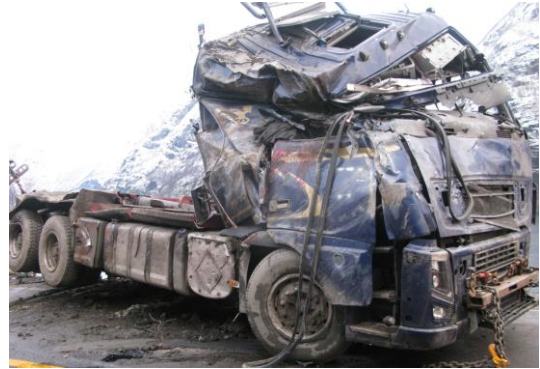
Figure 7: The driver's cabin was heavily damaged in the accident. Photo: The police

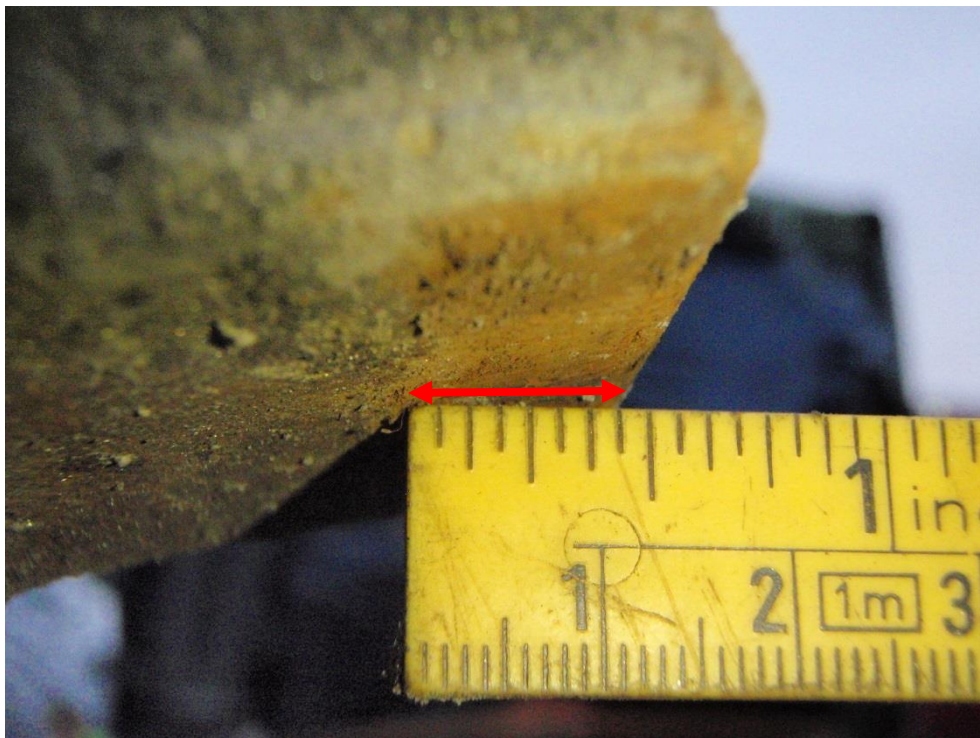
Figure 9 shows the left locking clamp marked by contact with the container's bottom side rail. During the AIBN's examination of the truck, it was not possible to move the locking clamps manually.

Figure 9: Left locking clamp marked by contact with the container's bottom side rail. The red arrow shows the worn down area. There was slightly more than one centimetre of wear. Photo: NPRA

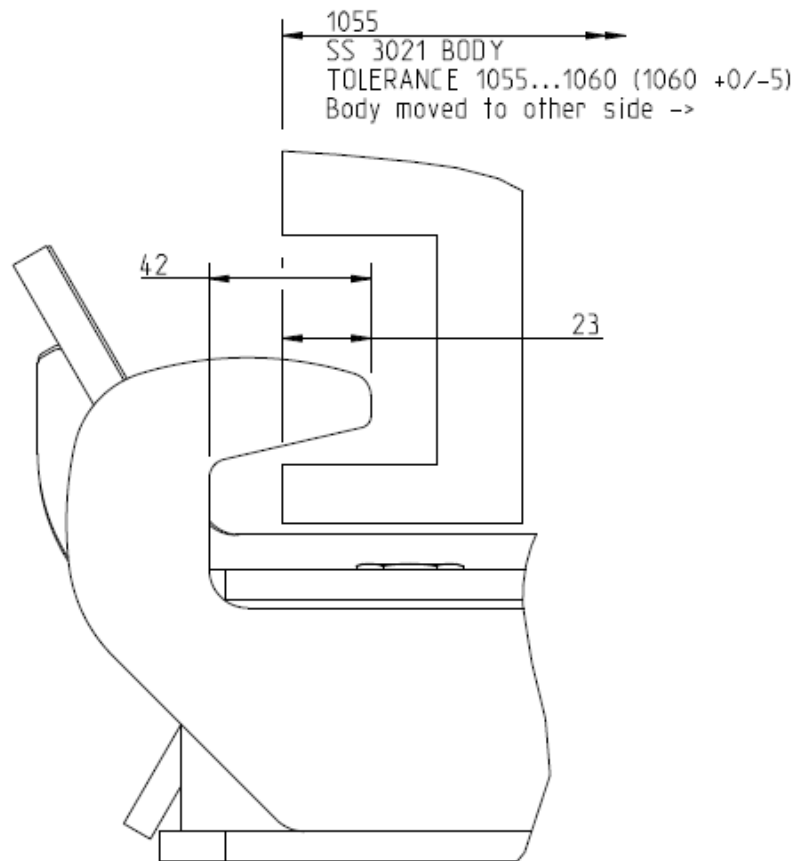
Figure 10 shows that the hydraulically operated locking clamp has an engagement length of 23 mm under the least favourable tolerances mentioned in SS3021.

Figure 10: Illustration showing the engagement length and the relationship between the locking mechanism and the container. Source: Hiab Norway AS

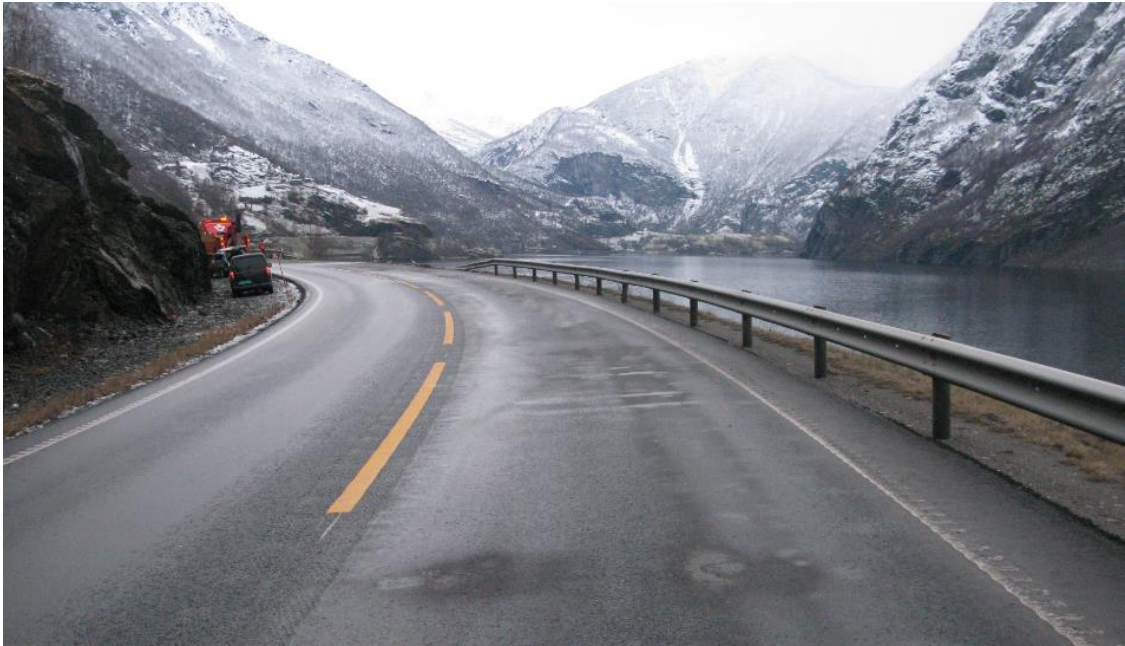
Figure 11: The scene of the accident The damage to the road barrier on the right side of the road caused by the vehicle that overturned can be seen in the middle of the photo. The photo was taken at approximately 12:00 on the day of the accident. Photo: The police

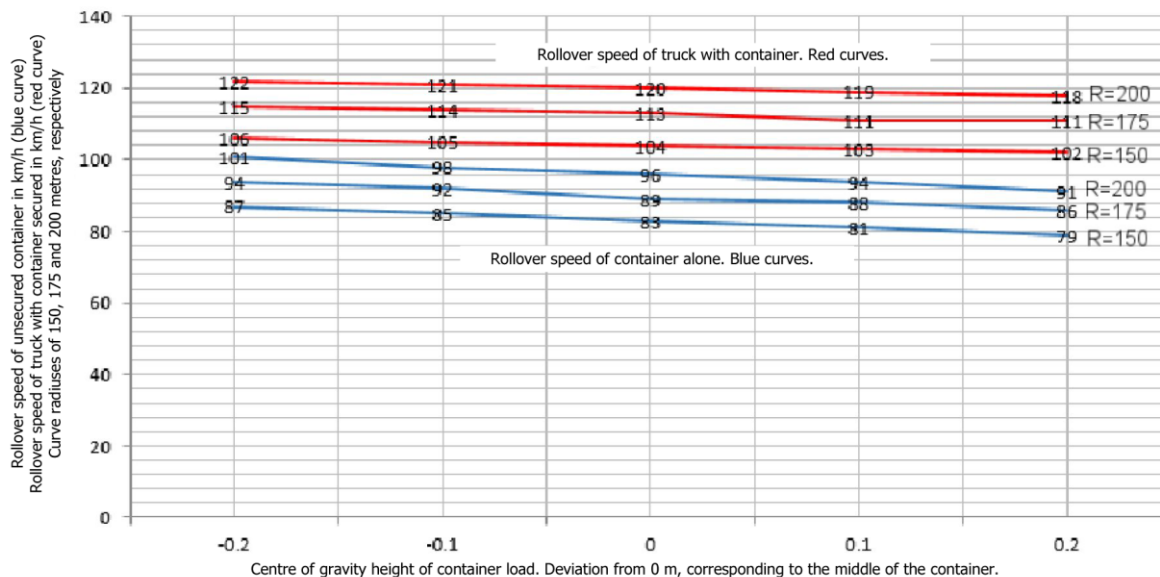
*Our calculations show that it is highly probable that the container broke loose and pulled the truck with it as it tipped.*

Figure 12: Different rollover speeds for the truck and container as one unit (red curve) and for the container (blue curve). Source: Rekon DA

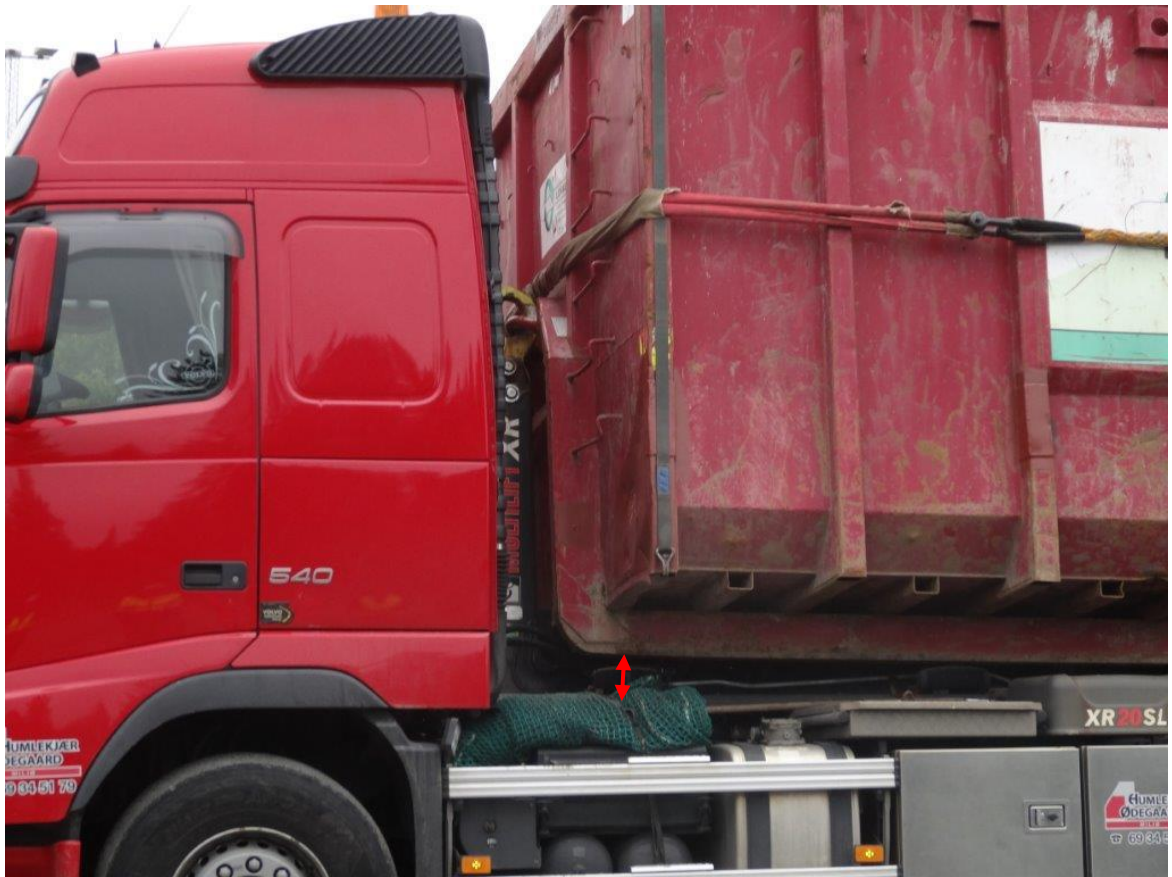
Figure 16 shows what happens to the truck when exposed to a lateral load of approximately 0.5 G. As shown in the photo, the hooklift container is lifted, leaving a gap of approximately 12 cm between the load carrier (hooklift system) and the front of the hooklift container. Figure 17 shows the hooklift arm and lift bar before the lateral load was imposed. Figure 18 shows that the hooklift arm moves in the lift bar when exposed to a lateral load of approximately 0.5 G. These are photos from one of the camera points used during the test.

Figure 16: The hooklift container on the truck is lifted approximately 12 cm (see red arrow) at the front when exposed to a lateral load of approximately 0.5 G. Photo: SP

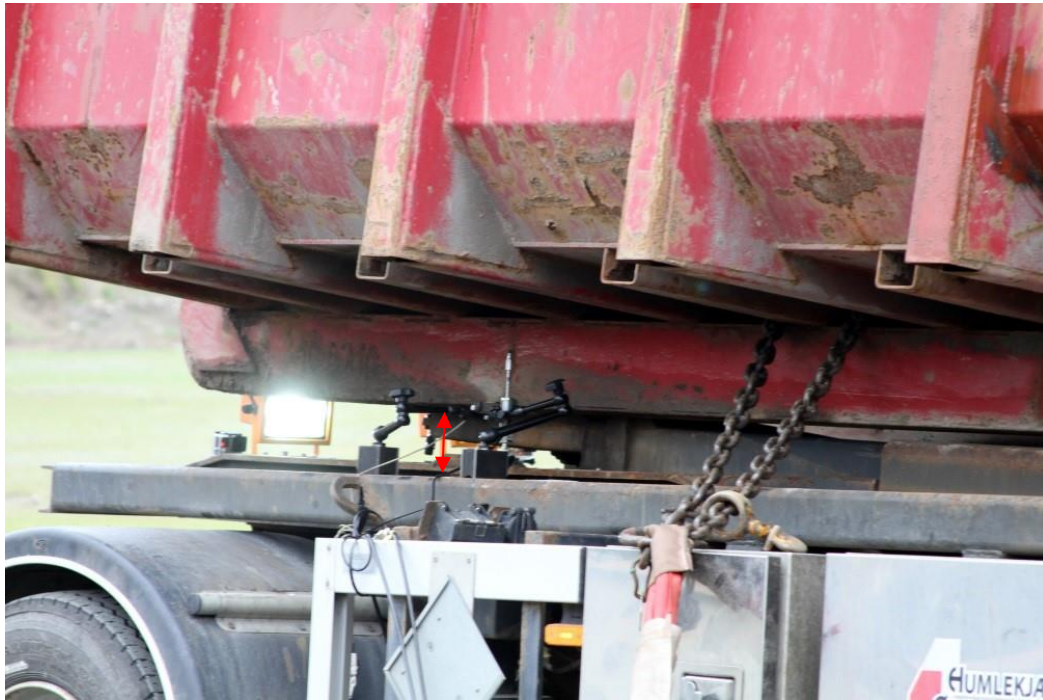
is increased from 0.30 G to 0.38 G, the gap between the load carrier and the front of the hooklift container increases from 25 mm to more than 150 mm, see figure 19. The hooklift container is held in place by the front locking studs; it is the tilt frame that is lifted from the load carrier.

Figure 19: The front of the hooklift container is lifted more than 15 cm (see red arrow) when exposed to a lateral load of 0.38 G. Photo: SP

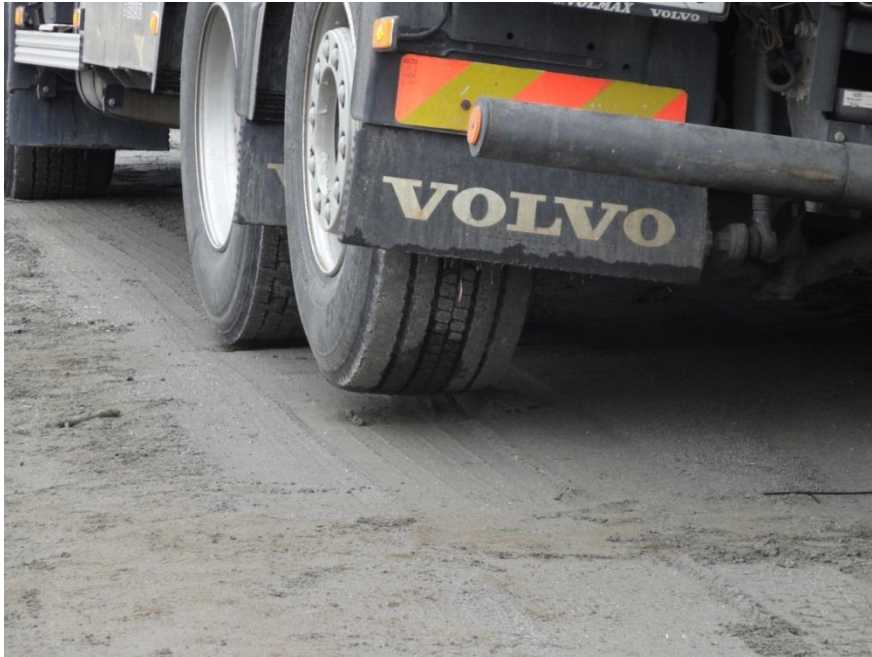
Photo 16. At a force level equivalent to 0.5 g were the aft wheels of the truck lifted from the ground.

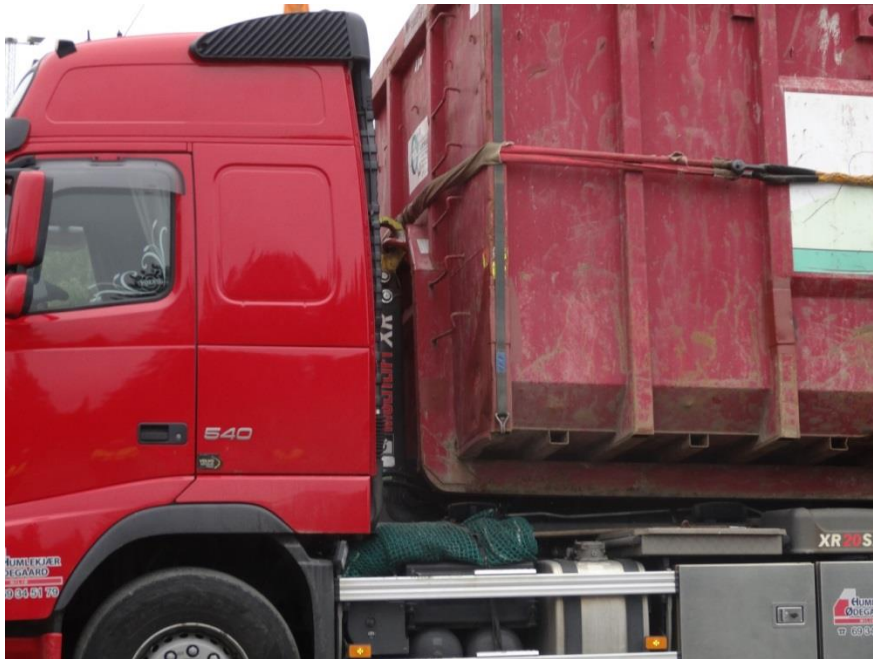
Photo 18. Force level equivalent to 0.5 g. The front part of the hooklift container has no contact with the load deck of the truck.

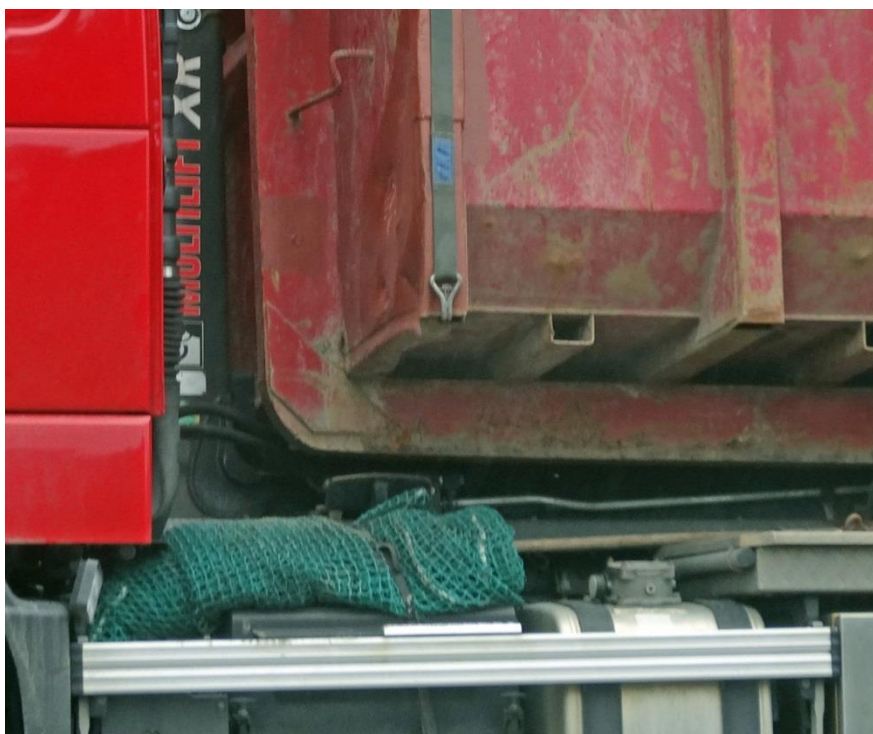
Photo 19. Detail from photo 18, the distance between container and load deck was estimated to 120 mm.

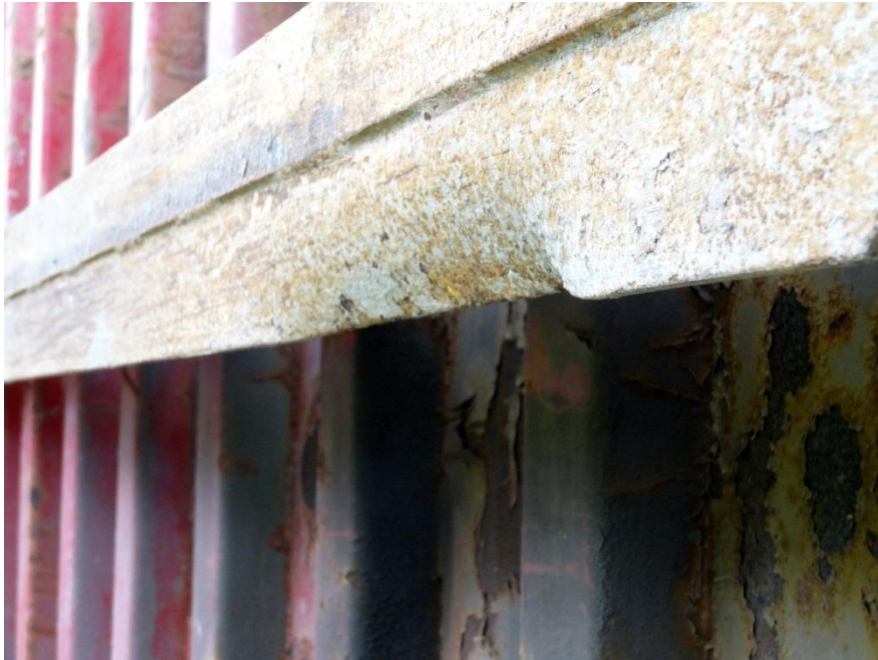
Photo 28. Damaged inner flange on the truck container.

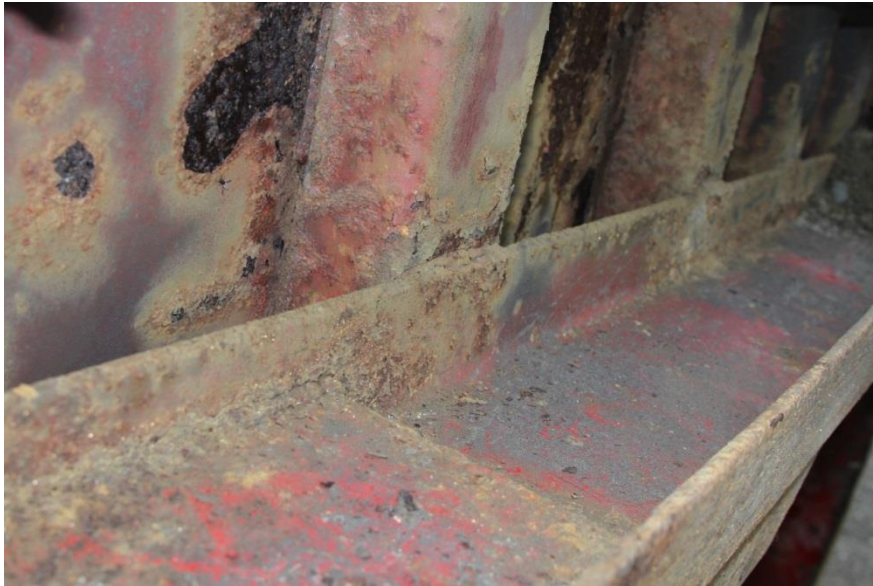
Photo 30. Cracked weld between bottom rail and container in the area where the securing devices are gripping.

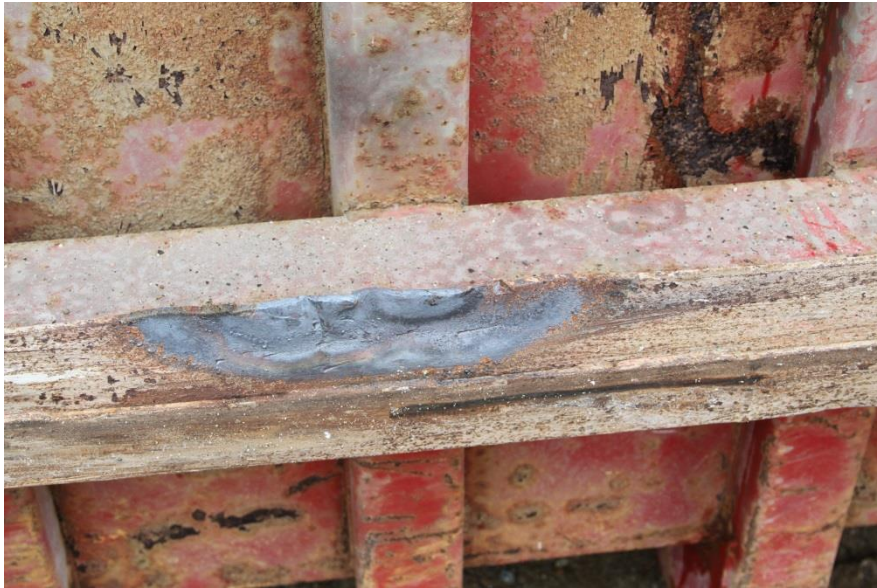
Photo 32. Traces from earlier repairs on the container used on the carrier.

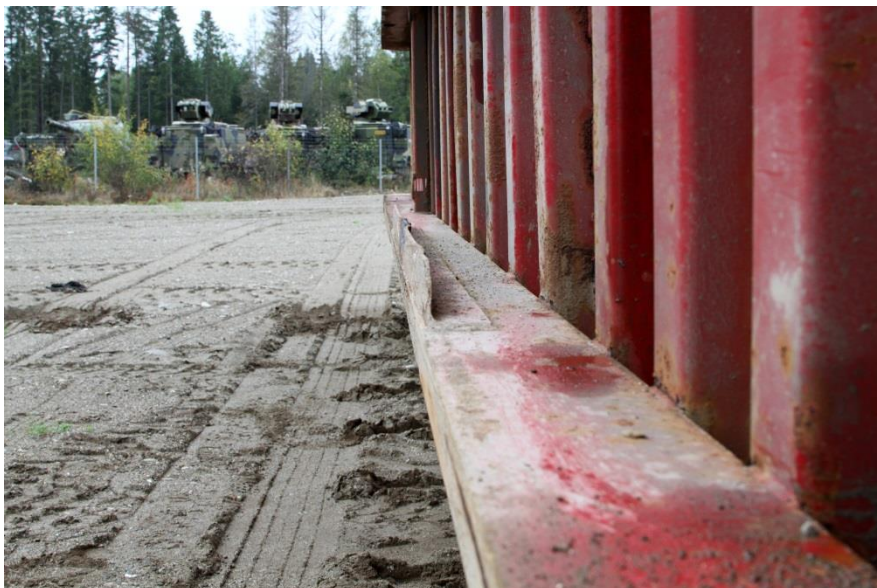
Photo 33. The container used on the trailer showed many traces from hard treatment and hasty repairs.

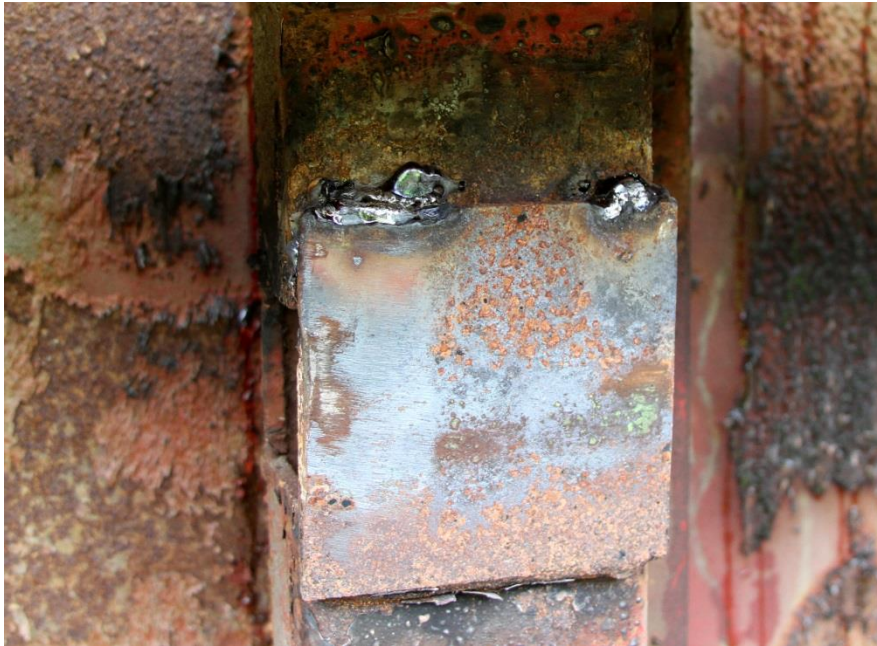
Photo 34. Weld not performed in a professional way, trailer container.
