# REPORT

Road 2017/02

## REPORT ON THE COACH ACCIDENT ON COUNTY ROAD 63 AT VALLDAL IN MØRE OG ROMSDAL COUNTY ON 30 JULY 2016

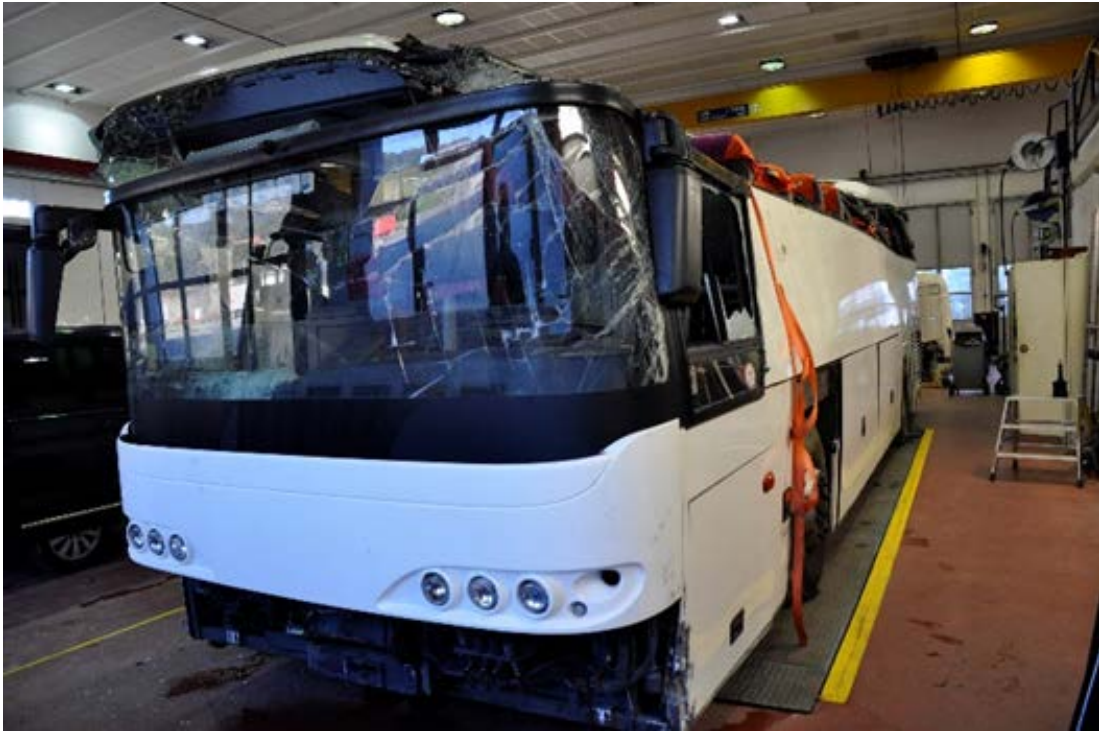
*Figure 6: Damage to the coach as a result of the collision and subsequent rolling down over, during which the roof was displaced to the right. Photo: AIBN.*

There was serious damage to the coachwork of the coach as a result of it driving off the road and turning over following the collision with the passenger car. Most of the window frames, from the B-frame and backwards, were torn from their fixture to the coachwork at the bottom edge of the windows. The roof was pushed downwards and displaced to the right. All the windows were crushed when the bus tumbled down the slope.

The left side of the coach shows marks in the paintwork resulting from the forward motion of the coach as it tumbled down the slope. There are corresponding marks on the roof which was more deformed inwards in the middle than at the front and rear. Within the coach, seats were loosened and displaced. Internal hatches in the floor had also loosened during the tumble down the slope, as they were not locked.

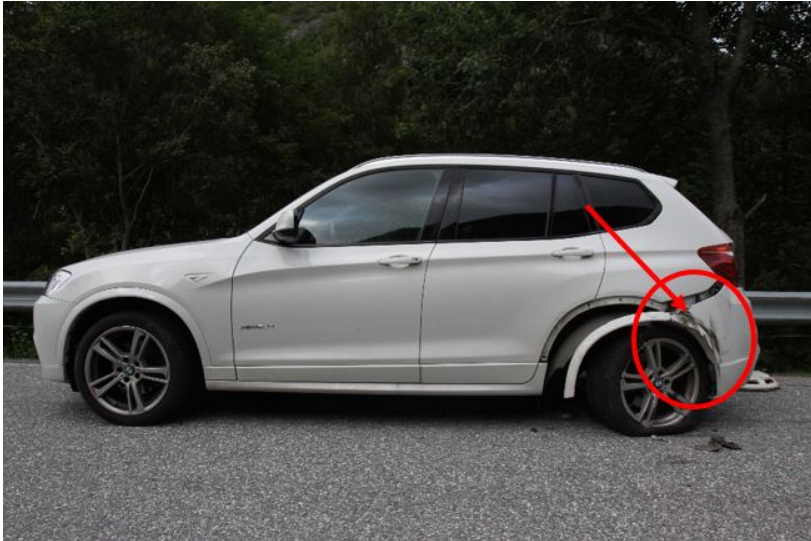
*Figure 7: The red circle marks the damage to the passenger car resulting from the collision with the bus, including the rubber track caused by the left front wheel of the coach. Photo: Police.*

The suspension of the passenger car was damaged: it was ripped loose from the bodywork of the car. The left wing, - rear wheel and rear bumper were also damaged. The left wing showed clear rubber tracks caused by the left front wheel of the coach.

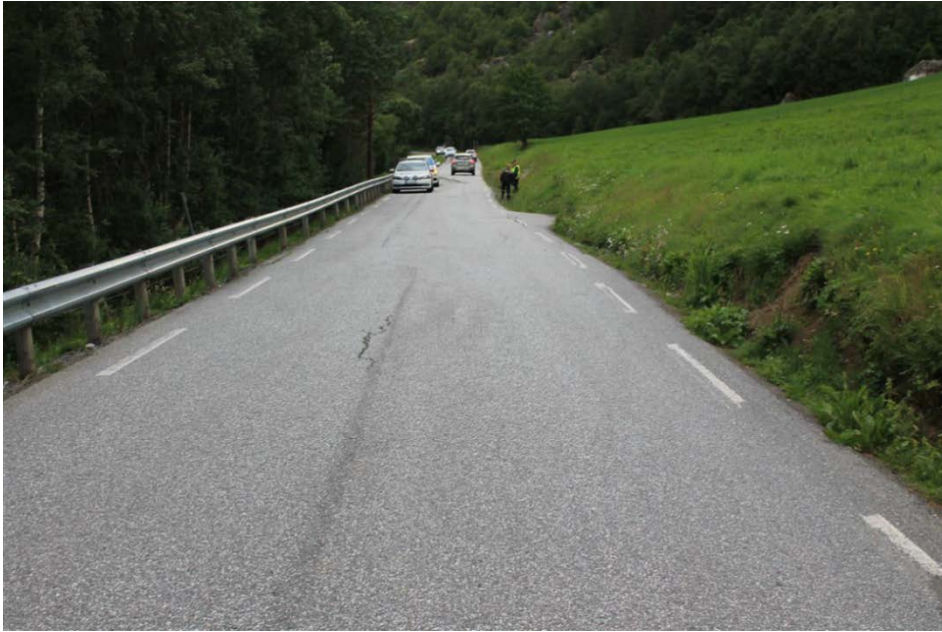
*Figure 8: South-directed driving lane seen from the position of the coach. The road is 0.7 metres narrower at this place. Photo: Norwegian Public Roads Administration*

The standard of the road shows a degree of “wear and tear”. The asphalt was partly cracked and the white edge lines were also worn so that it was difficult to see the edge of the road at a distance. There was, on the side of the coach, an access to a farmed area approx. 40 metres before the point of collision. The road, immediately after this access, was approx. 0.70 metres narrower than before the access. This narrowing of the road was not marked or warned of in advance: the width of the road on a stretch of approx. 200 metres before and after the point of collision, varied from 5.4 metres to 4.75 metres (see Figures 8 and 9).

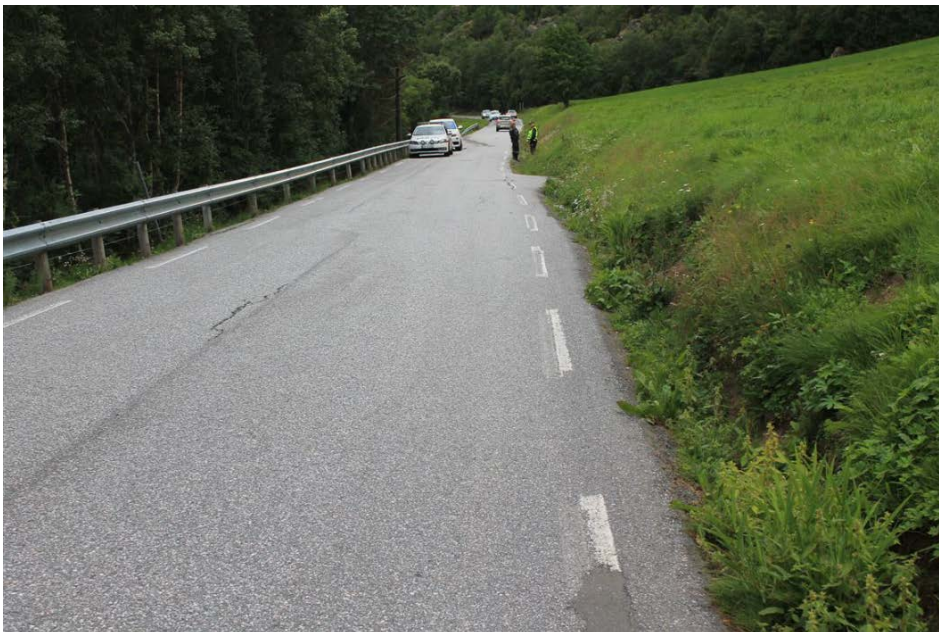
*Figure 9: The road becomes narrower after the access to the farmed area. Photo: Norwegian Public Roads Administration.*

The speed limit was reduced to 50 km/h a short time after the accident, with signs were set up, due to repair work on the crash barrier. The general speed limit was reintroduced after the repairs were completed. AIBN is critical to the removal of the reduced speed limit without any other form of adjustment. AIBN is, however, positive to the fact that a sign is now being set up to show the narrowing clearly for road users.

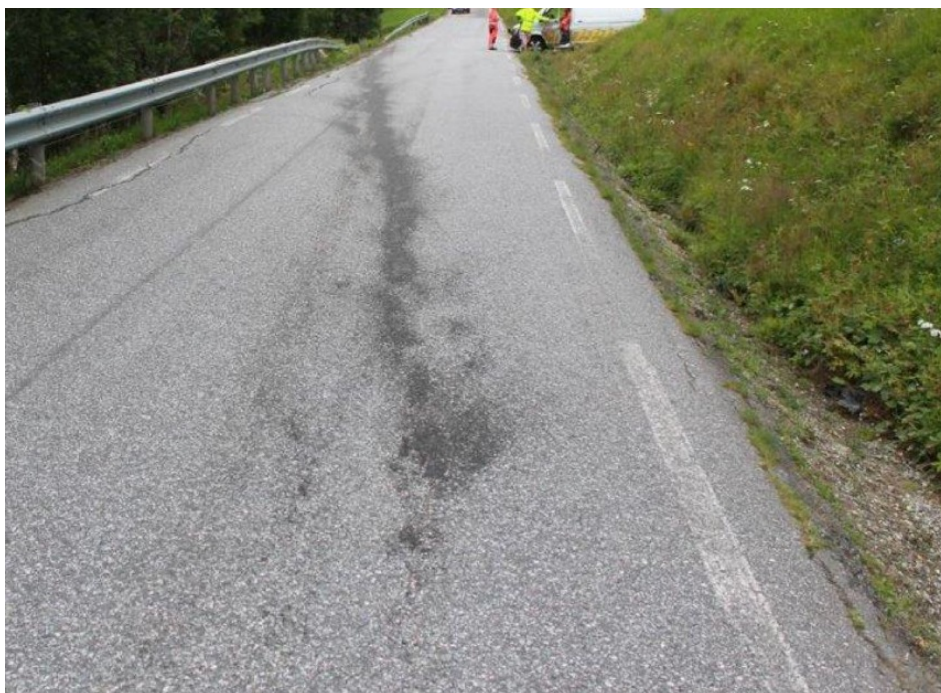
The road had no shoulder beyond the edge of the asphalt. The trench, which extended up to the edge of the asphalt on the coach's side of the road, had, as shown in Figure 12, a significant inclination and was covered in grass. There was, before the access to the farmed area, a shallow ditch beside the road in the direction in which the coach was being driven.

*Figure 12: The road viewed forwards from the point of collision in the direction in which the coach was being driven: there is a minimal road shoulder and a steeply sloping ditch. Traces of oil leaks can be clearly seen in the photograph. Source: Norwegian Public Roads Administration*

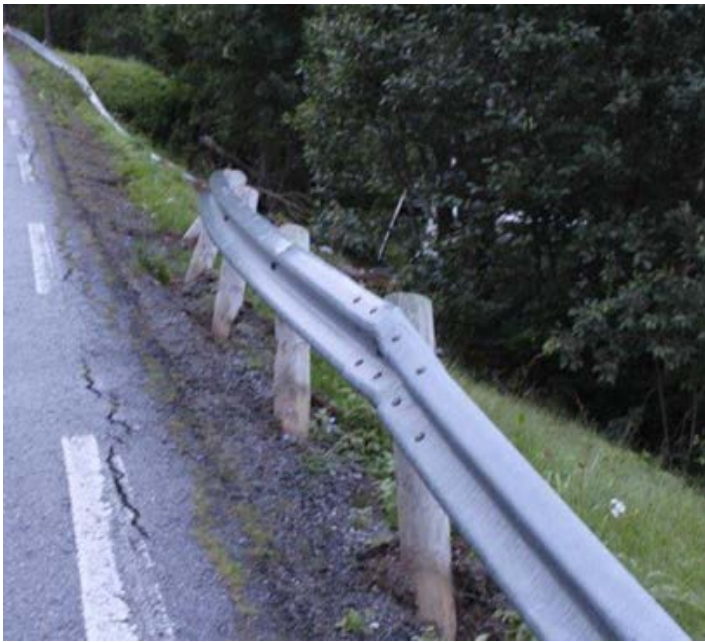
The crash barrier posts which were mounted at the top of the slope were, according to the Norwegian Public Roads Administration (NPRA), without adequate anchoring in the ground beneath. The NPRA has stated that they have, following the accident, mounted a new side crash barrier in strength class N2, which meets the requirements in Handbook N101.

*Figure 13: The crash barrier was bent down and the wooden posts loosened from their foundation when the coach rolled over. Photo: Norwegian Public Roads Administration*

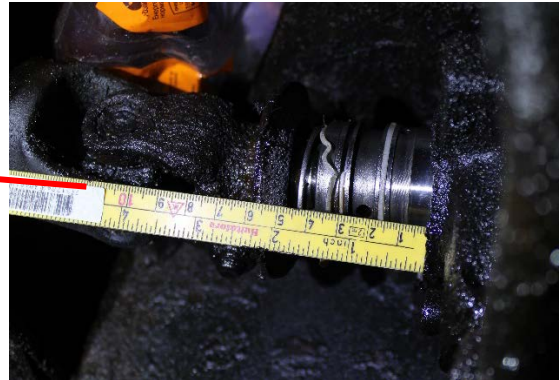
Investigation of the steering system showed that there was a fracture in the steering worm (worm housing) where the axle from the steering wheel goes into the steering worm.

Forces have, during the collision, been transmitted from the wheel rim, via the steering arms and into the steering house, see Figure 14. This load was transmitted further via the steering worm. Pressure marks were left, i.a. in the worm screw. The forces caused the support point for the inward axle in the steering house to be knocked loose, displacing it by approx. 5 cm, see Figures 15 and 16.

Figure 15: The fracture in the steering worm and the oil leak. The outward displacement of the axle in the steering worm was measurable. Photo: Norwegian Public Roads Administration

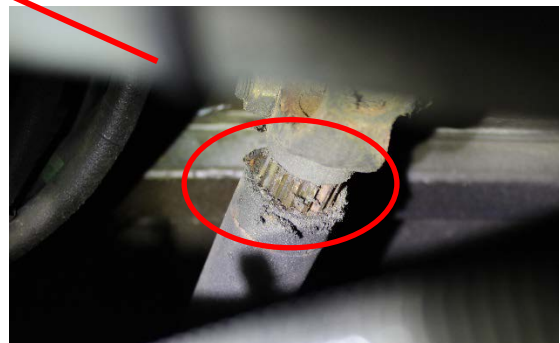
Figure 16: The axle which connects the steering worm to the steering-wheel axle has been bent and pulled a short distance in reverse. Photo: Norwegian Public Roads Administration

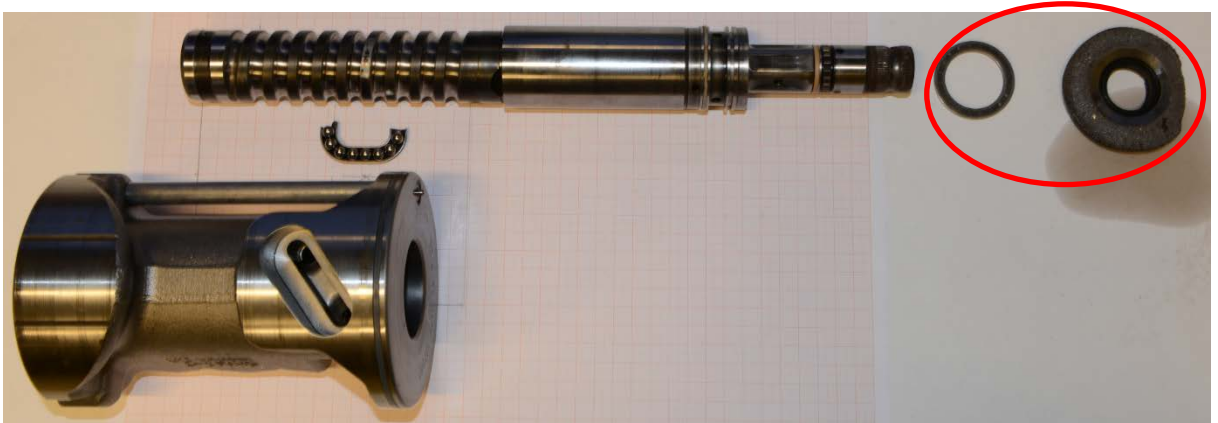
The steering worm was dismantled and the internal components checked with assistance from KGK Norge AS. The worm screw, with the recirculating ball, was locked which meant that a greater effort than normal was needed to turn it round. The worm screw and the pressure rotor had load marks which are compatible with the collision forces. There were, in addition, internal marks and a thrust bearing was destroyed as a result of the accident. The other thrust bearing, which was exposed to stresses in the collision was in the area of the break surface (red ring, Figure 17), was not found again at the accident site.

Figure 17 shows the combination of the components in the steering worm which were exposed to the forces of the collision and the components (red ring) which were studied further by FOLAT (Armed Forces Laboratory Service) at the request of the AIBN. The

conclusion of FOLAT's metallurgical investigations was that there was an overload breakage.

Figure 17: Internal components exposed to the collision forces piston, worm screw, pressure bearing and "break part". Illustration: AIBN
