REPORT

Road 2018/03

REPORT ON TUNNEL ACCIDENT IN THE RAUNEKLEIV TUNNEL ON THE FV. 7 ROAD NEAR SAMNANGER IN HORDALAND COUNTY ON 11 JULY 2017

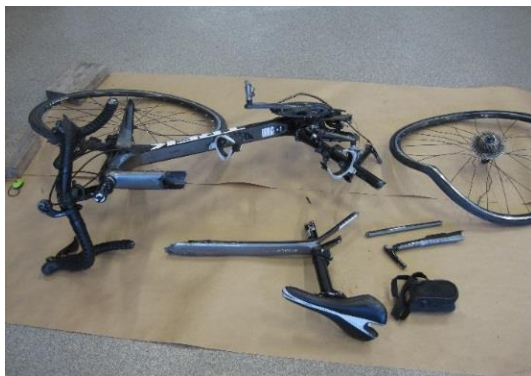
The bicycle frame broke into several parts, and the wheels were deformed. The bicycle was equipped with a front light and tail light. According to witnesses, these lights were still turned on after the accident.

Figure 2: The bicycle frame broke into several parts, and the rear wheel was deformed. Photo: AIBN

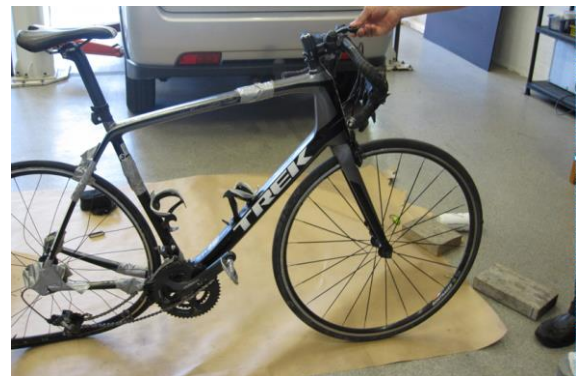
Figure 3: The reconstructed bicycle. Photo: AIBN

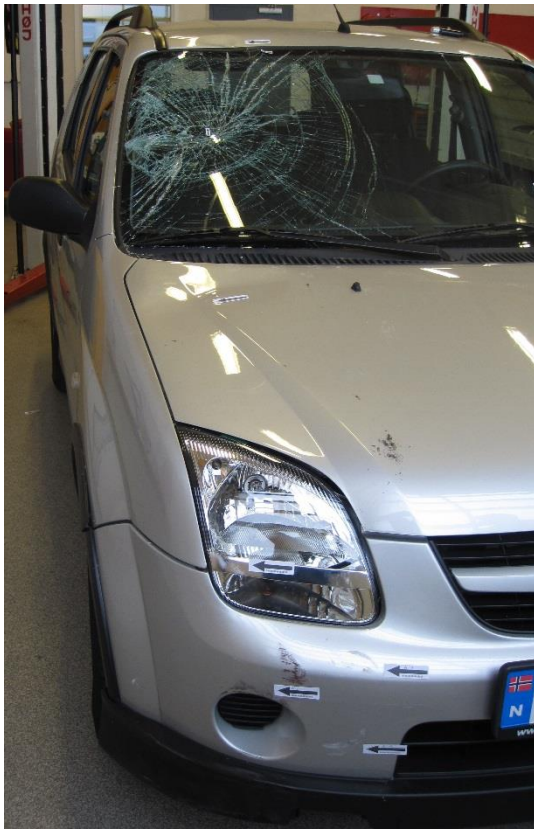
The passenger car's windscreen broke on the right-hand side as a result of the impact with the cyclist. There was one dent in the bonnet and one in the roof, in addition to various marks and scratches on the right side of the front of the car and along the right side of the car, see Figure 4. The marks found are assumed to have been caused by the accident.

Figure 4: Damage to the right-hand side of the passenger car, with arrows marking the different dents/scratches/contact marks. Photo: AIBN

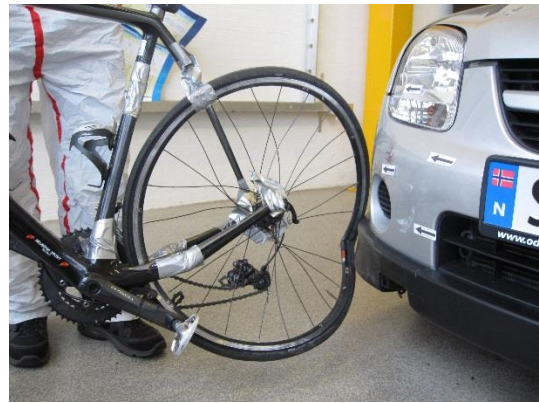
Figure 5: Assumed point of impact between the passenger car and the bicycle. Photo: AIBN

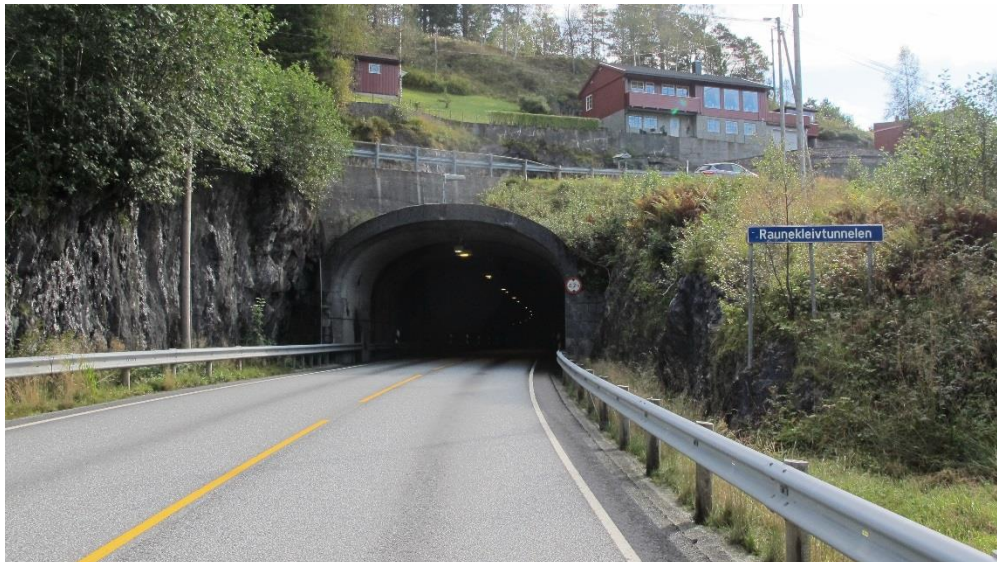
Figure 6: The photo was taken ten metres outside the tunnel opening. The light conditions when the photo was taken are very much like on the day of the accident. Photo: AIBN

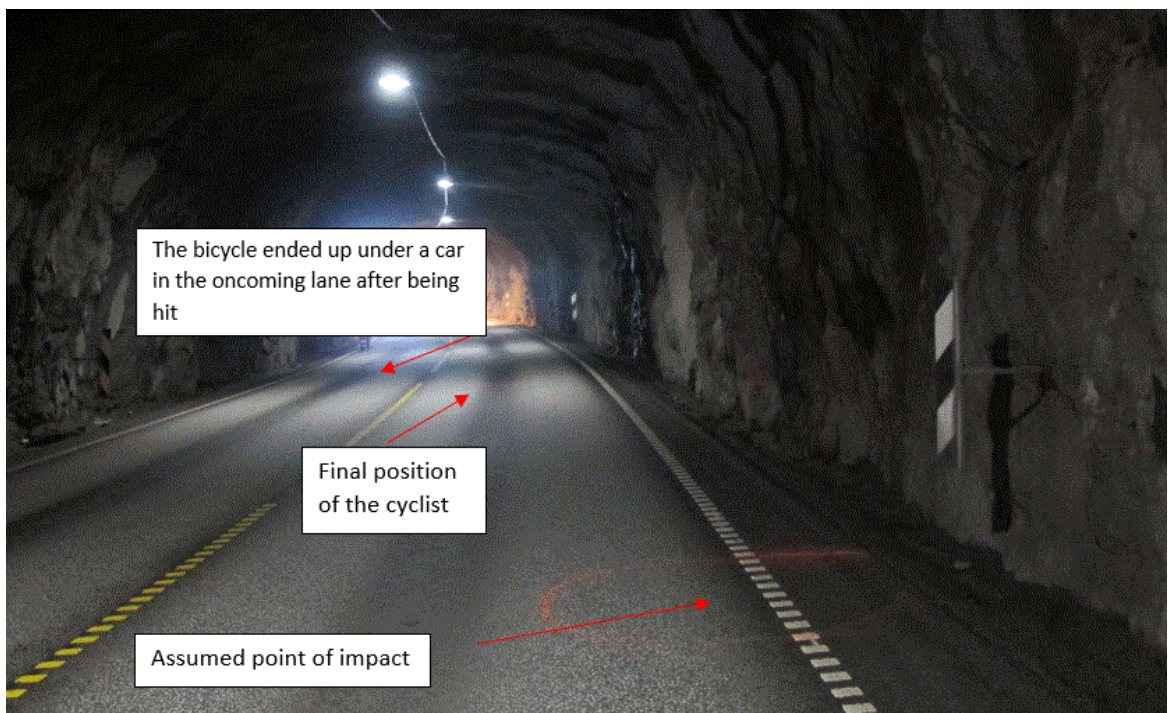
The accident took place inside the Raunekleiv tunnel. The assumed accident site is about halfway through and at the darkest point of the tunnel, approx. 138 meters from the tunnel exit on the Samnanger side. The road was tarmacked and dry.

According to the NPRA, contact marks were found on a hazard marker sign on the right-hand side of the tunnel. The distance between the assumed point of impact and the final position of the accident victim is approx. 7.9 metres.

Figure 7: Based on findings made at the scene of the accident, the point of impact is assumed to have been approx. 138 metres from the tunnel exit on the Samnanger side. The cyclist's watch was found in the ditch in the area between the assumed point of impact and the cyclist's final position. Photo: AIBN

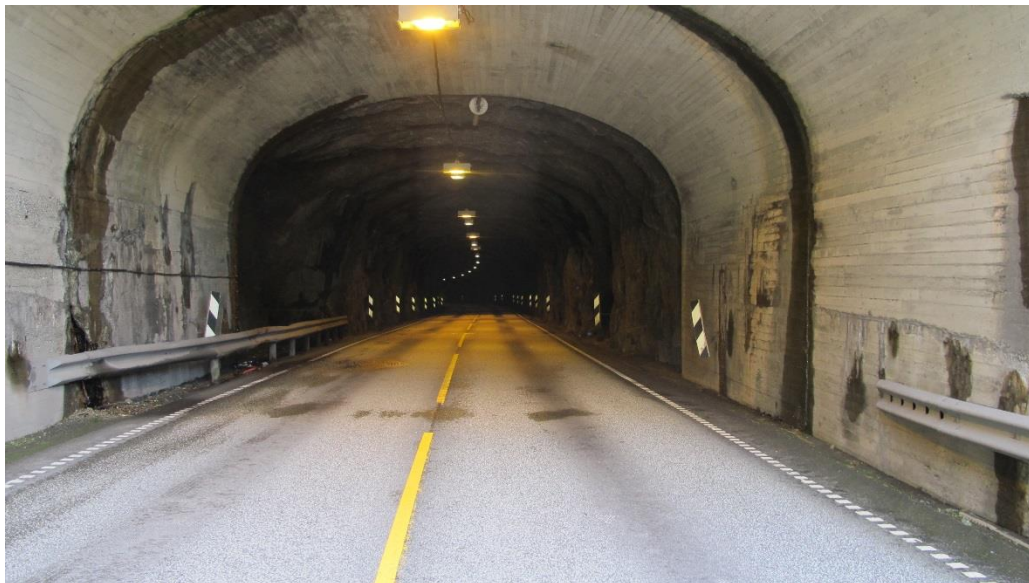
Figure 8: The photograph was taken from the tunnel opening in the direction in which the passenger car was travelling. Photo: AIBN

The NPRA measures the condition of the road network approximately once a year. The tunnel was measured in 2017, and the measurements show that the roadway from Trengereid to Samnanger consists of a relatively straight stretch for the first 100 metres or so of the tunnel. Then it continues in a gentle curve to the left, which has a horizontal curve radius of approx. 420 metres at the accident site. The curve then becomes sharper, and approx. 200 metres into the tunnel it has a horizontal curve radius of approx. 330 metres. The curve in the tunnel makes it impossible to see through the tunnel from its openings, see Figure 8.

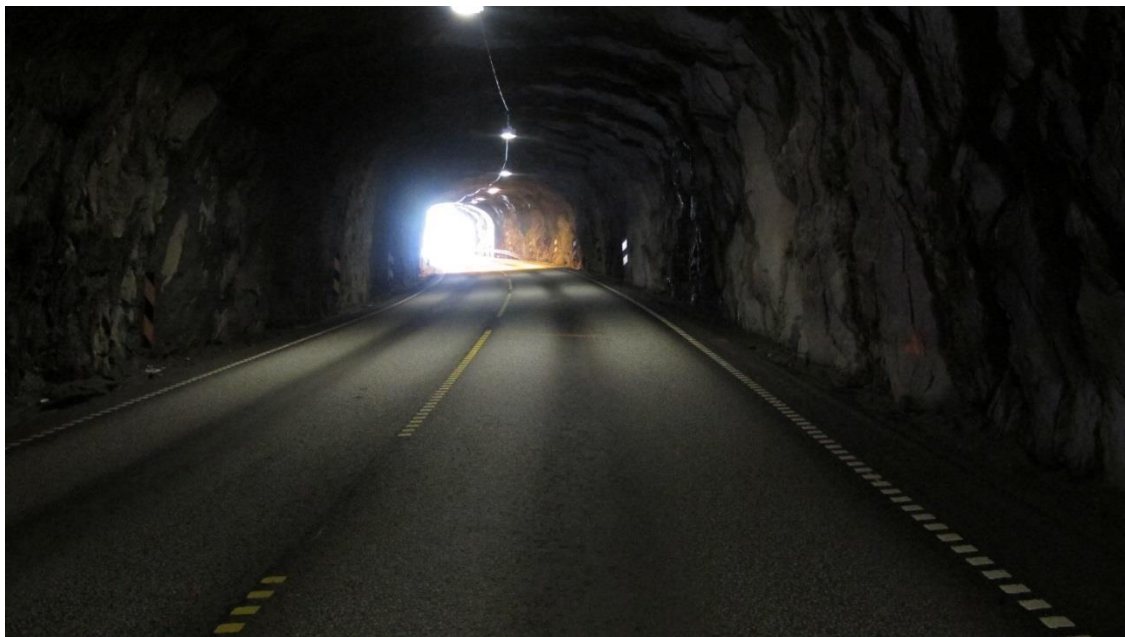
Figure 9: Road environment inside the Raunekleiv tunnel. Photo: AIBN

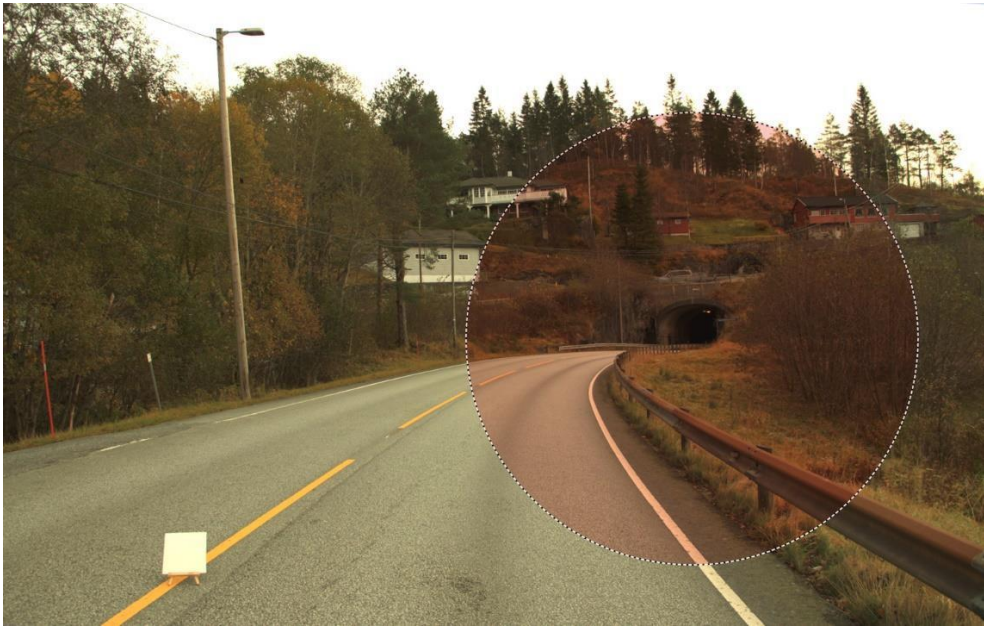
The luminance levels in the threshold zone and transition zone inside the tunnel depends on the adaptation luminance, which is measured in a visual field of 20 degrees from the driver's eye at a distance of 100 metres (in this situation) from the tunnel entrance (Figure 2).

Figure 2. Photograph taken on the day of the inspection at a distance of 100 metres from the tunnel opening with a 20-degree circle marked in red.

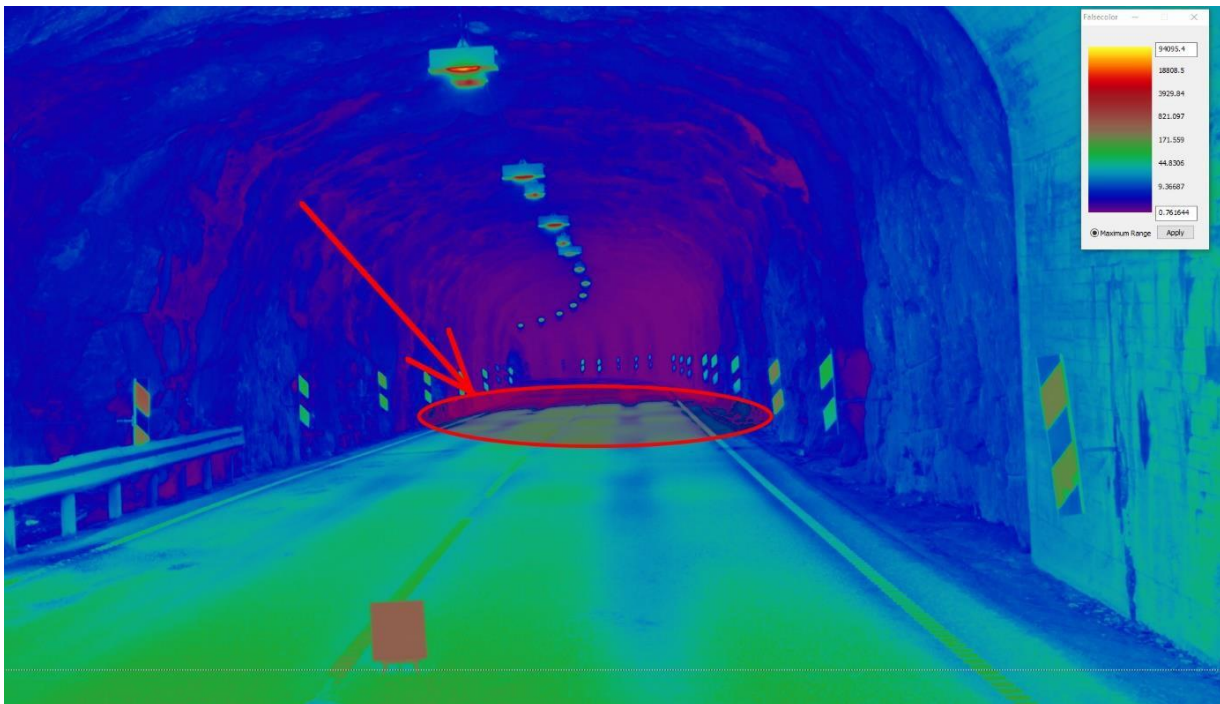
high and low luminance zones is 44.49 cd/m^2 . At the same time, the road surface's luminance after this point (in the 'dark' section) is only 2.17 cd/m^2 . First and foremost, there should be more light on the surface of the road in this zone (276.45 cd/m^2 instead of 44.49 cd/m^2). After the first 50 metres of the threshold zone, the road surface's luminance should be gradually reduced from 276.45 cd/m^2 to 110.58 cd/m^2 .

However, the luminance is dramatically reduced from 44.49 cd/m^2 to 2.17 cd/m^2 at this point, which is not in accordance with the requirements set out in Manual V124. Generally speaking, the luminance of the road surface is far below requirements. This means that light conditions are poor for all road users, and the lighting is not adapted to drivers driving a vehicle at the permitted speed limit. This increases the risk of accidents.

Figure 3. The image shows the threshold zone of the Raunekleiv tunnel in false colours. The false colours are assigned to pixels with certain levels of luminance. The luminance scale is shown in the top right-hand corner of the image. The red oval marks the point where the lighting is dramatically reduced.

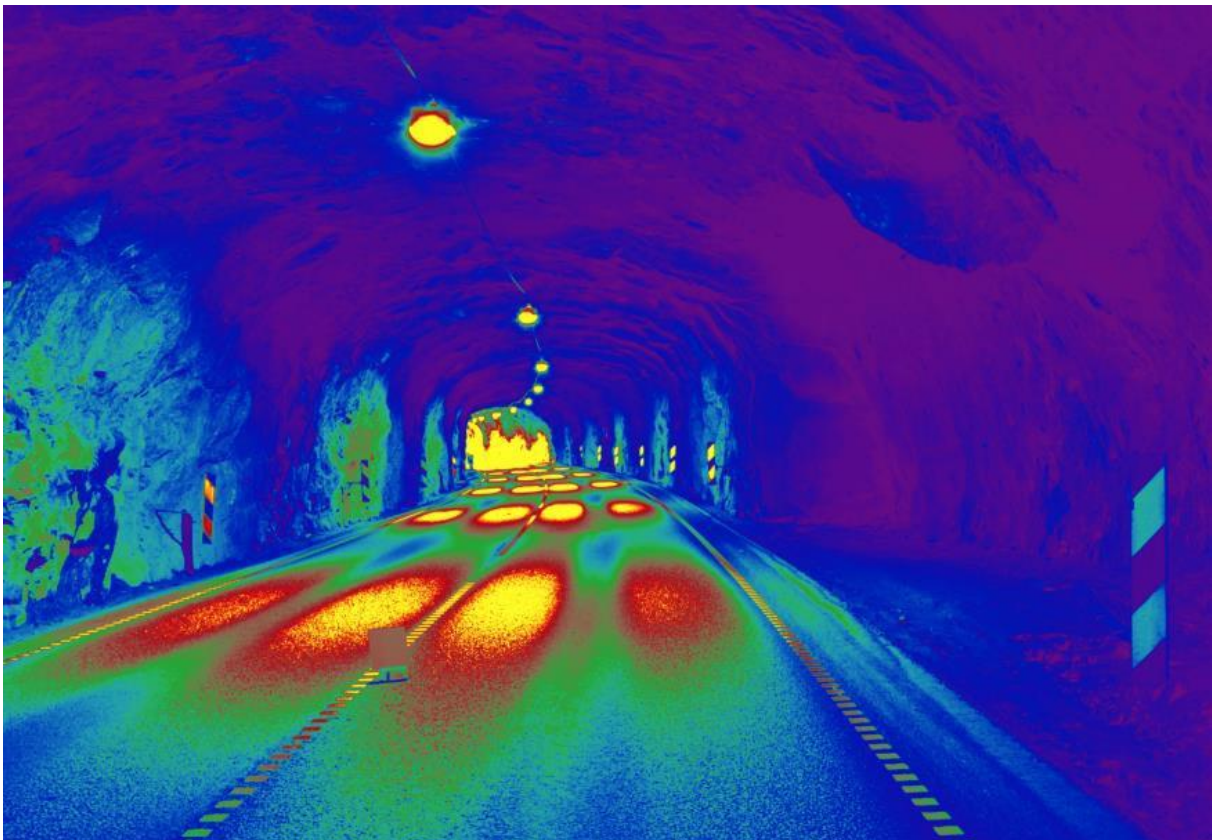
In the transition zone (where the accident took place), the luminance of the road surface must be gradually reduced from 110.58 cd/m^2 to 6 cd/m^2 . As shown in Figure 4, however, the road surface's luminance level is far too low at 0.58 cd/m^2 , while manual V124 stipulates that it should be at least 6 cd/m^2 towards the end of the transition zone. This means that the luminance of the road surface in the transition zone of this tunnel is below the manual's requirements.

the nearest tunnel wall is 2.81 cd/m^2 (while it should be at least 12.18 cd/m^2). According to measurements we made further into the tunnel, the luminance of the road surface is 2.27 cd/m^2 and that of the nearest tunnel wall is 1.17 cd/m^2 (while it should be at least 1.362 cd/m^2). Based on the above, we can conclude that the luminance of the walls in the Raunekleiv tunnel should be higher. This can be corrected by increasing the level of lighting in the tunnel, using lamps with a wider beam angle that will illuminate the walls better, or painting the walls in lighter colours. The luminance level of the tunnel walls is far too low, reducing contrast and possibly making cyclists, pedestrians and animals etc. less visible.

Figure 4. The image shows the transition zone in the Raunekleiv tunnel (approx. 100 metres from the tunnel portal) in false colours.

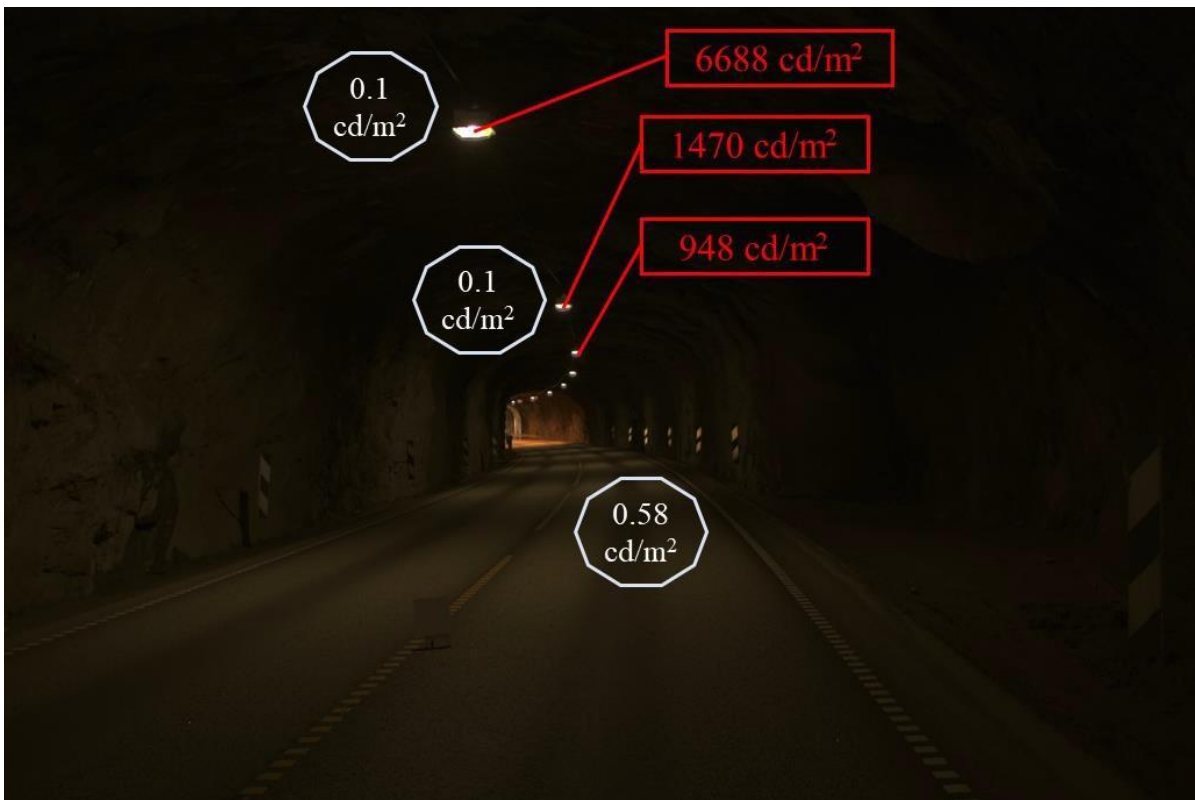
presented in Figure 5 give grounds for concluding that the difference between the luminance of the light source and the average luminance of the tunnel ceiling and the road surface is sufficient to cause glare of road users.

Figure 5. The photo shows luminance values for light fixtures in the tunnel (in red) and average luminance values for the tunnel ceiling and the road surface (in white).
