REPORT

Road 2019/04

REPORT ON HEAD-ON COLLISION BETWEEN TWO BUSES ON COUNTY ROAD FV 450, AT NAFSTAD IN ULLENSAKER ON 17 NOVEMBER 2017

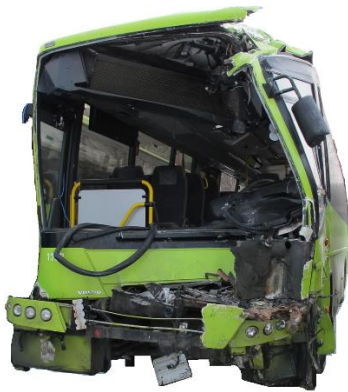
The front of the eastbound bus was pushed approximately 1–1.3 metres back into the driver's cab. The dashboard was pushed in, and the steering wheel and steering column were broken and pushed into the driver's seat. The driver's seat was torn loose from its fixings and pushed backward through the back wall to the first row of passenger seats behind the B-pillar on the left-hand side. The front of the bus was severed at the top and bottom of the left-hand side, immediately inside the side wall, and pushed back. The

Figure 3: Damage to the front of the eastbound bus. Photo: AIBN

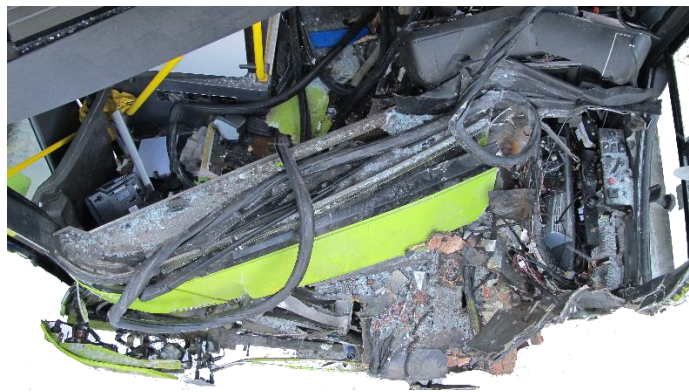
westbound bus had penetrated above floor level, in towards the raised floor in the passenger compartment, shown in Figure 4.

Figure 4: Deformations of the driver's cab in the eastbound bus, seen from above. Photo: AIBN

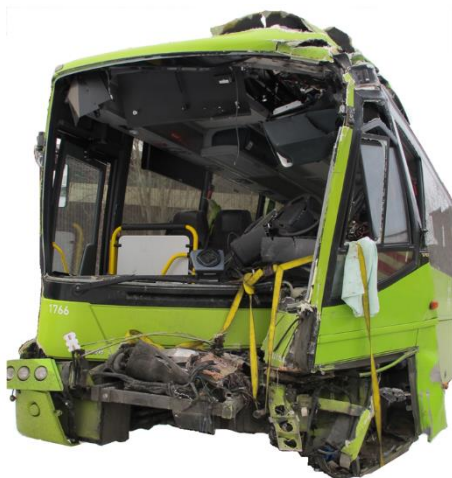
The front of the westbound bus was pushed approximately 1–1.3 metres back towards the centre of the bus in the driver's cab area. The steering wheel and steering column were broken and pushed back, and the floor plate was crushed. The driver's seat and dashboard were squeezed in towards the left-hand side wall. The front was collapsed in the centre, and the left-hand side wall on the driver's side was twisted in and back towards the aisle. The cross-beam at the far left of the chassis was severed in the collision.

Figure 5: Damage to the front of the westbound bus. Photo: AIBN

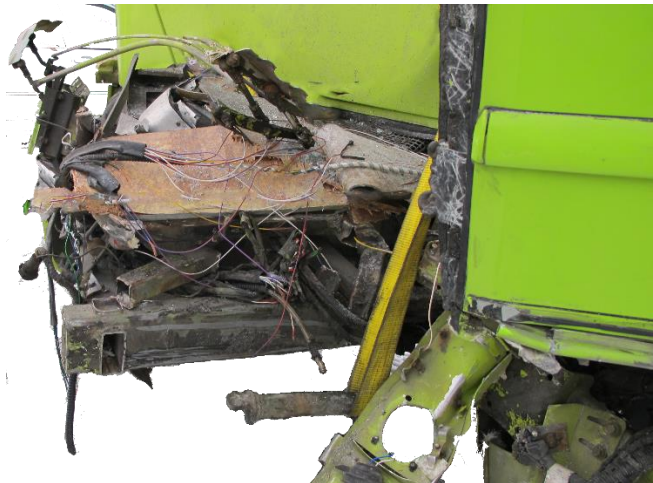
Figure 6: Cross-beam severed on the left-hand side, seen from the side. Photo: AIBN

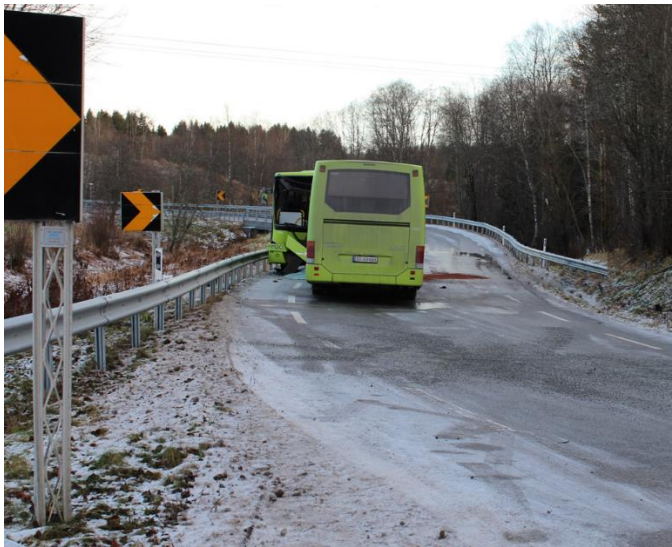
Figure 7: Final positions seen from the east. Photo: NPRA

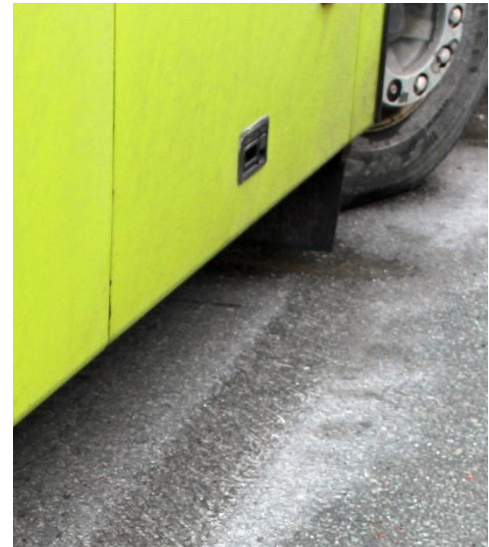
Figure 8: Tyre tracks from front wheel of eastbound bus. Photo: NPRA

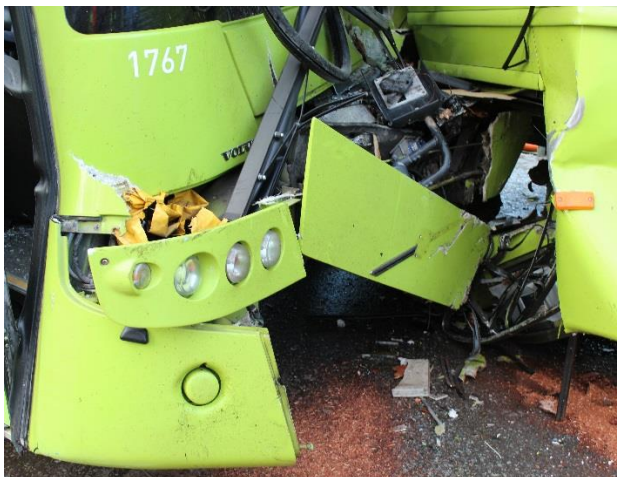
Figure 9: Overlap and penetration between the buses at the scene of the accident. Photo: NPRA

Figure 9 shows the overlap and penetration between the buses at the front, and Figure 10 shows the final position of the buses, seen facing westwards.

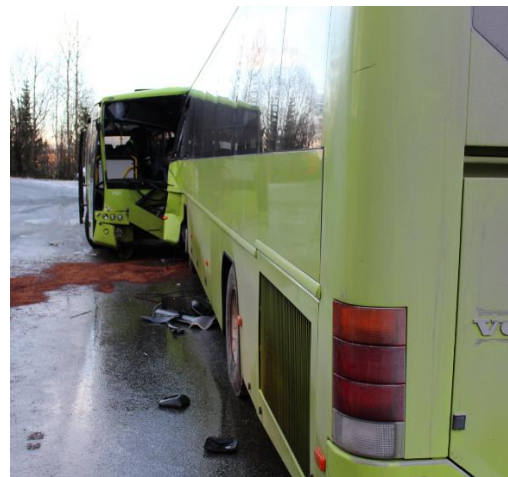
Figure 10: Final positions seen from the west. Photo: NPRA

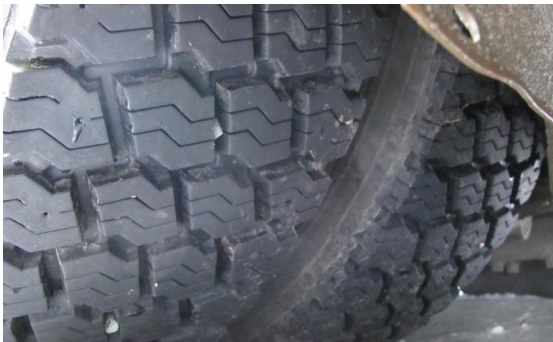
Figure 15: The tyres on the back axle of the eastbound bus. Photo: AIBN

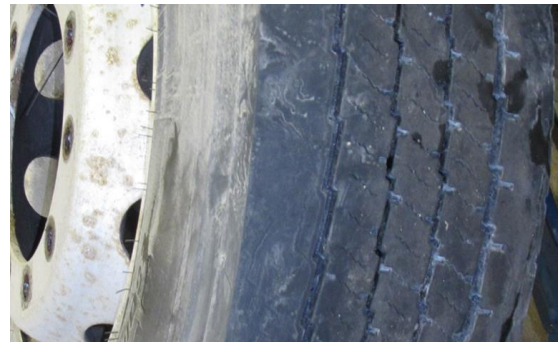
Figure 16: One of the tyres on the forward axle of the eastbound bus. Photo: AIBN

Although the tyres are legal pursuant to the regulations, the AIBN's assessment is that the tyres on the bus's front wheels did not have optimum control properties in the prevailing road conditions at the bottom of Nafstad hill, and that studs would have increased the safety margins in this case.

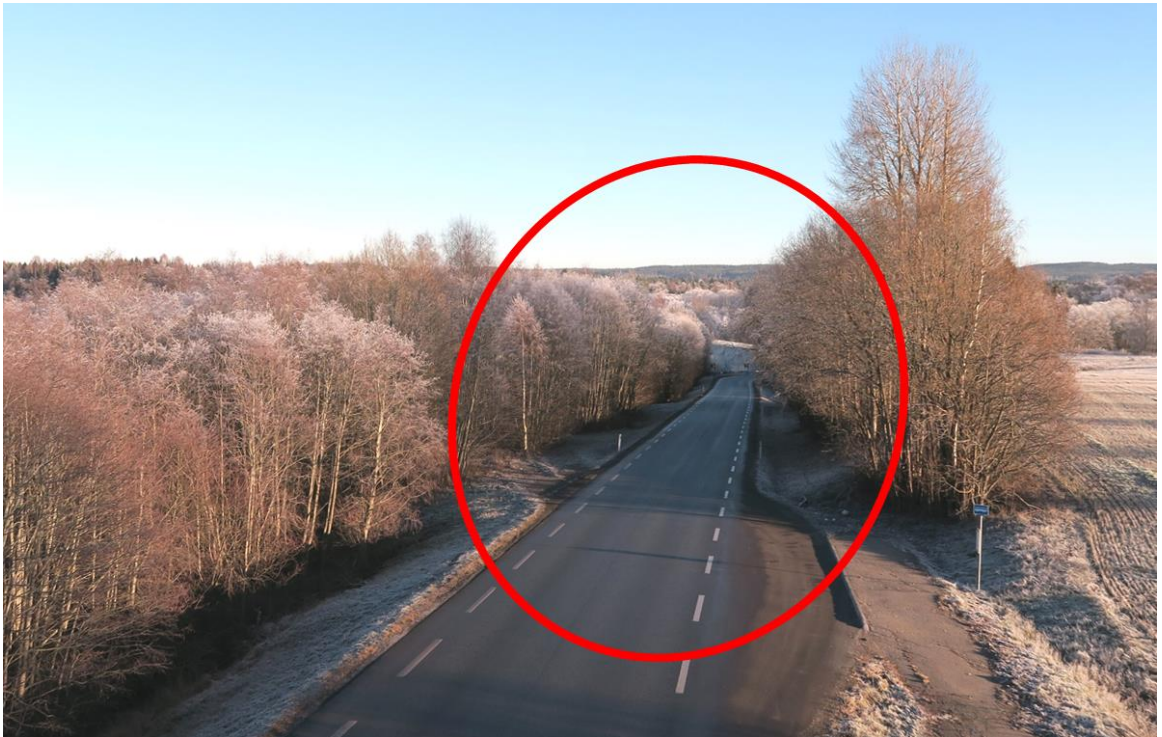
In terms of sunshine on Nafstad hill in late autumn, the roadway lies in the shadow of vegetation from around Molstad bus stop, west of the accident site, all the way down the hill and through the double bend as far as the site where the accident occurred, as shown in Figure 20.

Figure 20: Area of shade seen facing east from Molstad bus stop down Nafstad hill towards the right-hand bend. The photo was taken at 12:30 on 26 November 2018 in subzero temperatures. Photo: AIBN

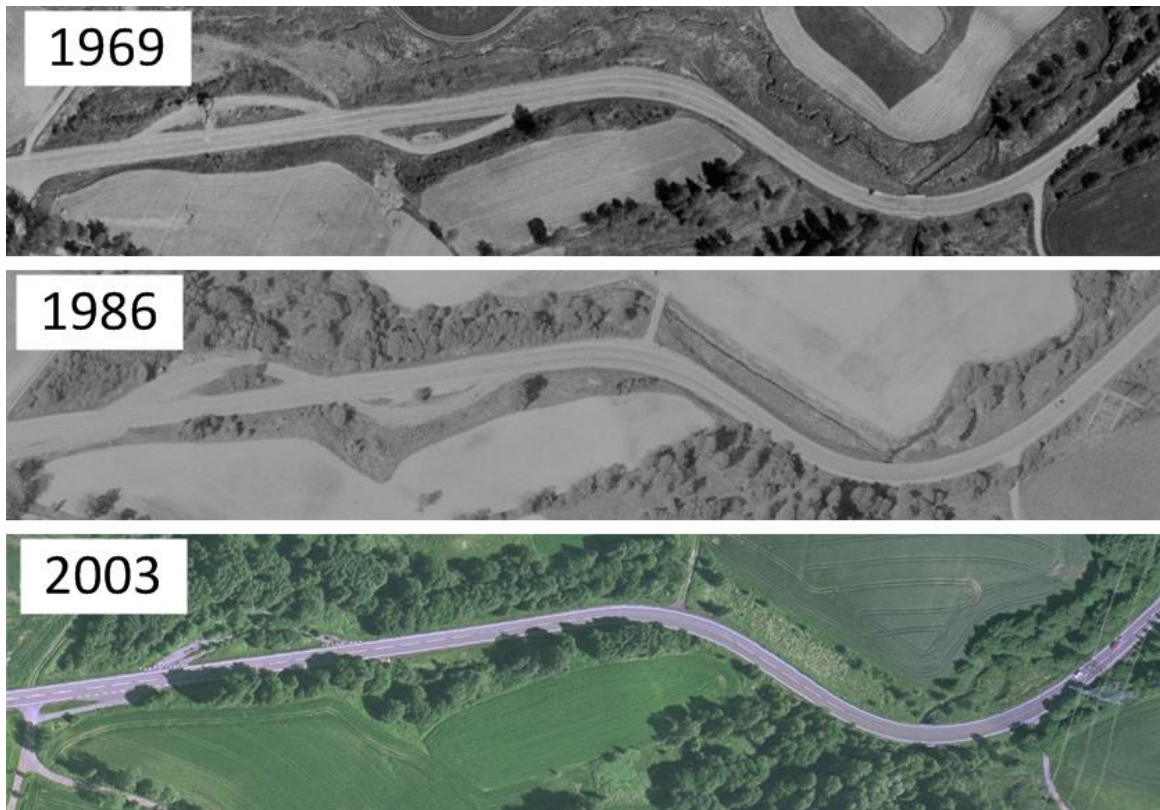
From 1969, there was no vegetation on the south side of the road, but between 1986 and 2003, a small copse of trees was established which remains there today; see the aerial photos in Figure 21.

Figure 21: Growth of vegetation on Nafstad hill, 1969 to 2003. Photo: Norge i bilder

The copse of trees on the south side of the hill has not always been there. Aerial photos show that trees have grown alongside Nafstad hill since 1986. The trees have gradually led to an increase in shade on the roadway, which has resulted in an increased risk of rime and frost formation in certain weather conditions. In the AIBN's view, this also affects safety on this section.
