Road 2019/06

## REPORT ON RUN-OFF-THE-ROAD ACCIDENT ON THE FV 651 ROAD, SVINEROIVEGEN, NEAR RJUKAN, TINN MUNICIPALITY, 2 SEPTEMBER 2018

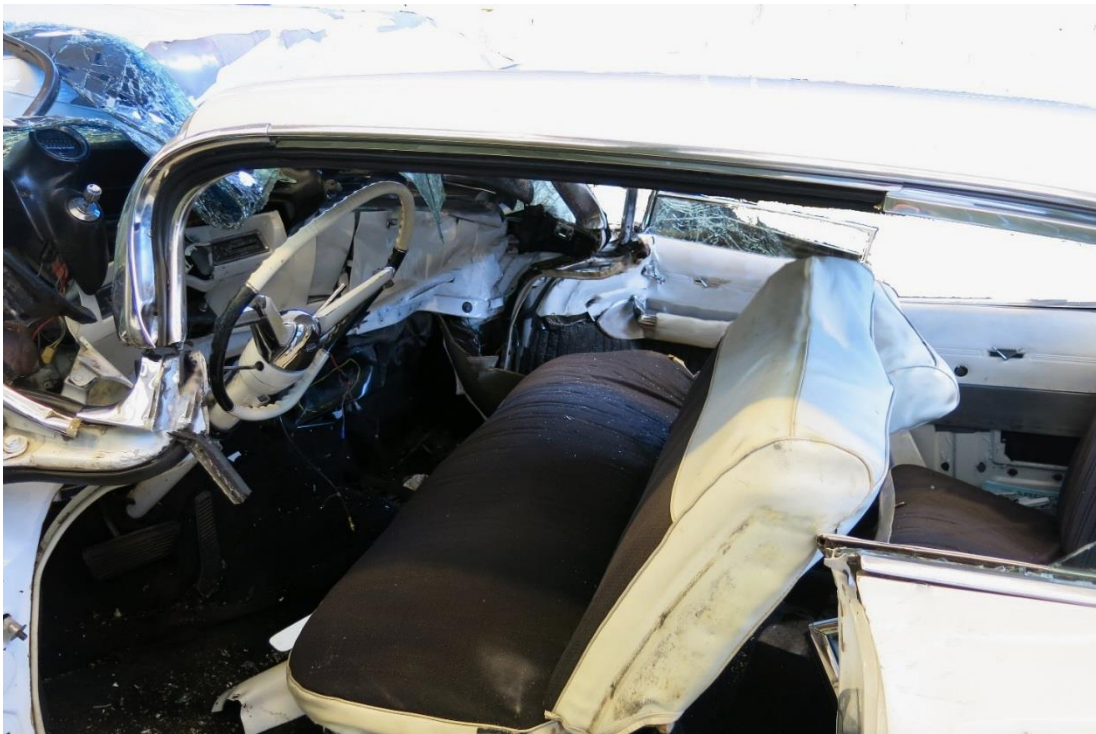
*Figure 3: There was survival space in both the front and back of the car after the crash.  
Photo: AIBN*

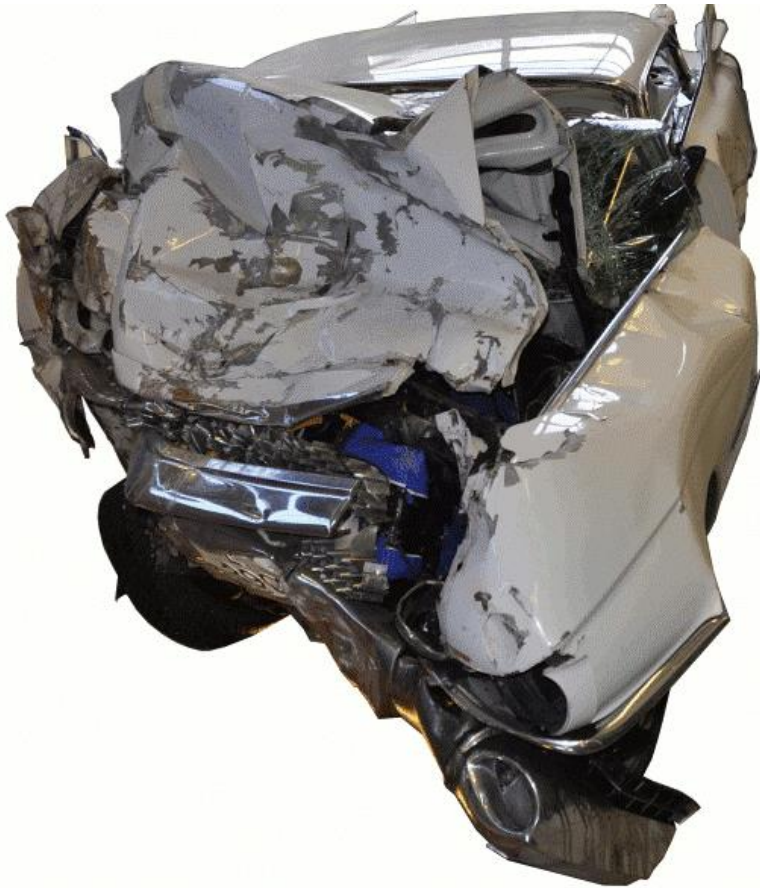
*Figure 4: Deformation of the front of the accident car. Photo: AIBN*

The bolt connections by which the gearbox and petrol tank were attached to the chassis were destroyed in the crash, and this caused the petrol tank to drop onto the roadway under the car.

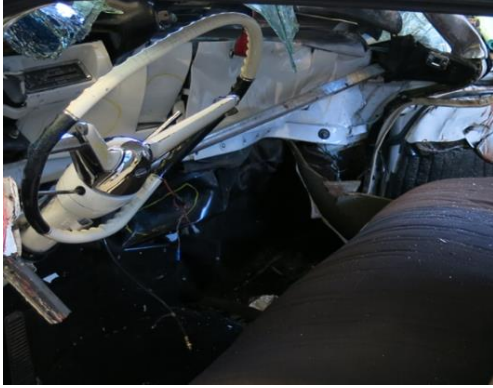
The dashboard was deformed, and the steering wheel and steering column were bent upwards and forward; see Figure 5. Both front seats, the floor fastenings for the seat cushions and the seatbacks suffered major deformations. The seatback of the back seat came loose in the crash, but the cushion remained in place.

The bulkhead<sup>4</sup> sustained extensive damage throughout, especially in the lower part.

Figure 5: Deformation around driver's position. Photo: AIBN

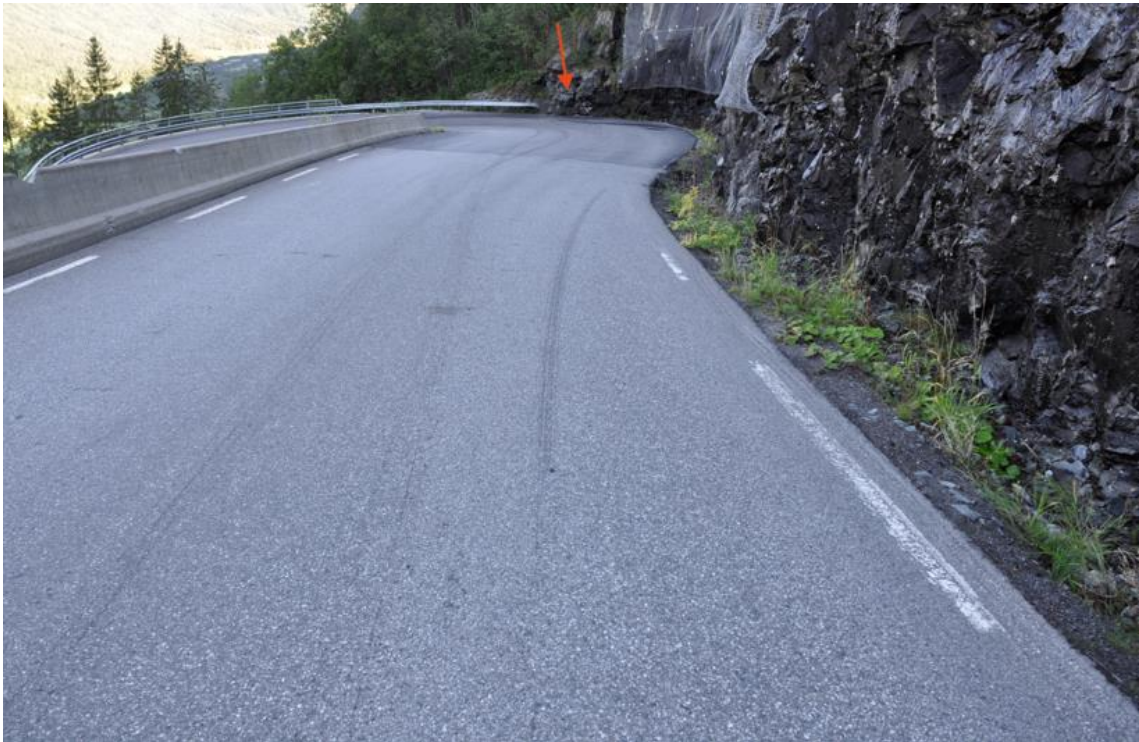
Figure 7: The hairpin bend where the accident occurred. The arrow marks the point of impact with the rockface. The tire tracks on the road are not from the accident car. Photo: AIBN

Where the accident occurred, there is a concrete crash barrier on the left-hand side of the road, when viewed in the accident car's direction of travel. In the middle of the hairpin bend, just left of the point of impact, a steel crash barrier has been erected on the right-hand side. The terrain beyond this barrier is steep and leads down to a valley.

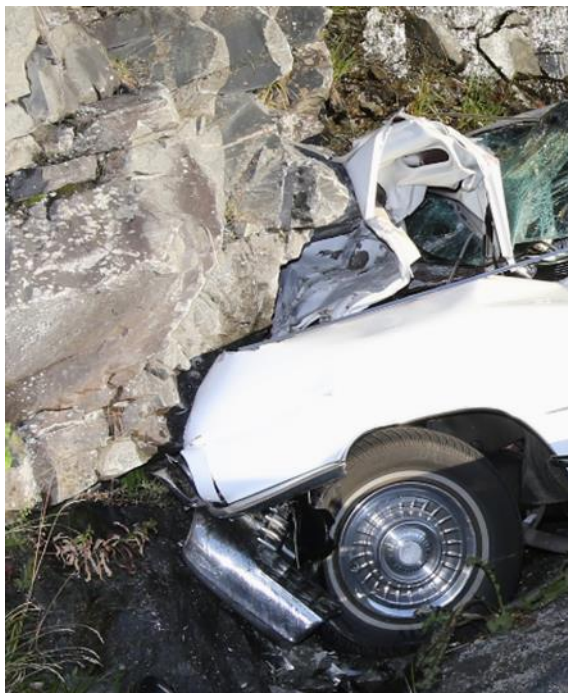
The roadside terrain on the right-hand side of the car in the direction of travel consisted of an uneven rockface with protruding rocks. The car hit a protruding rock as it crashed into the rockface; see Figure 8.

*Figure 8: There was a protruding rock where the car hit the rockface. Photo: The police*

The roadside terrain consisted of concrete crash barriers on the left-hand side and a hillside cutting with protruding rocks on the right-hand side. The roadside terrain constitutes a hazardous roadside obstacle, and the AIBN recommends that Telemark County Authority consider measures to improve road safety on this road.

According to Manual N101 (2014), to avoid the use of crash barriers, rockfaces should be blasted with an as even surface as possible out of considerations for vehicles that run off the road. Protruding sections with sharp edges on parts of the rockface that could come into contact with cars and thus cause an abrupt stop resulting in serious injuries should therefore be avoided. No section should protrude more than 0.3 metres in the relevant areas. If this is not financially feasible, the rockface shall be handled as a hazardous roadside obstacle as regards distance to the hazard and the need for crash barriers inside the safety zone.

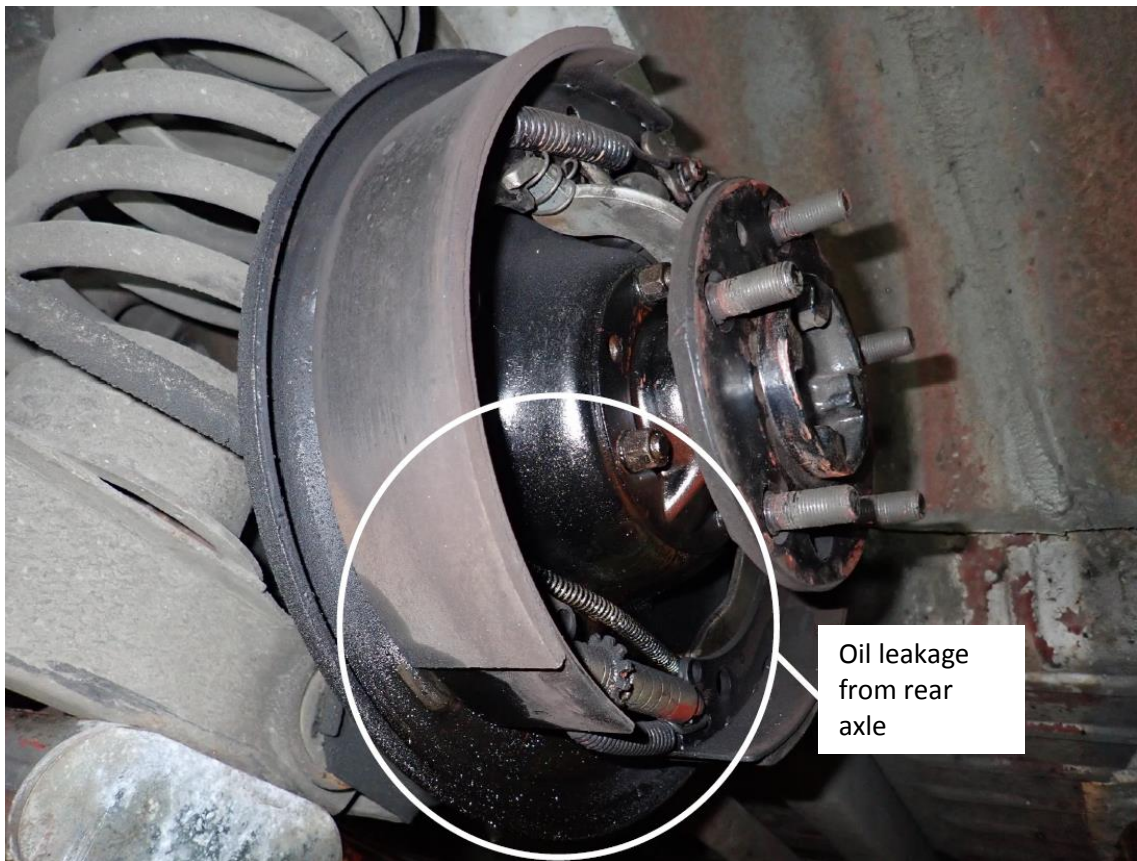
The brake drums on the back wheels were dismantled, and oil was observed to have leaked from the rear axle to the leading shoe on the left back wheel; see Figure 13.

Figure 13: Brake drum dismounted from the left back wheel, where the brake shoes show evidence of the oil leakage. Photo and illustration: AIBN

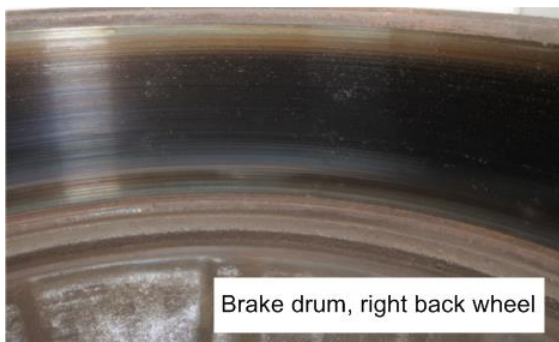
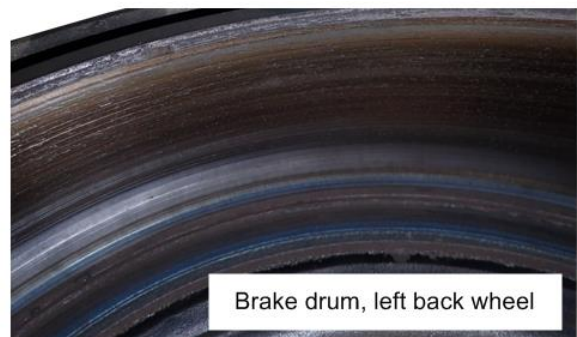
Figure 14 shows the contact surfaces for the brake bands inside the rear brake drums. The contact surface was clearly blue/brown in colour. The rear brake drums looked new, with a small wear edge. Both wheel cylinders were checked and found to be in normal working order.

Figure 14: Rear brake drum with contact surface showing a clear blue/brown colour. Photo and illustration: AIBN

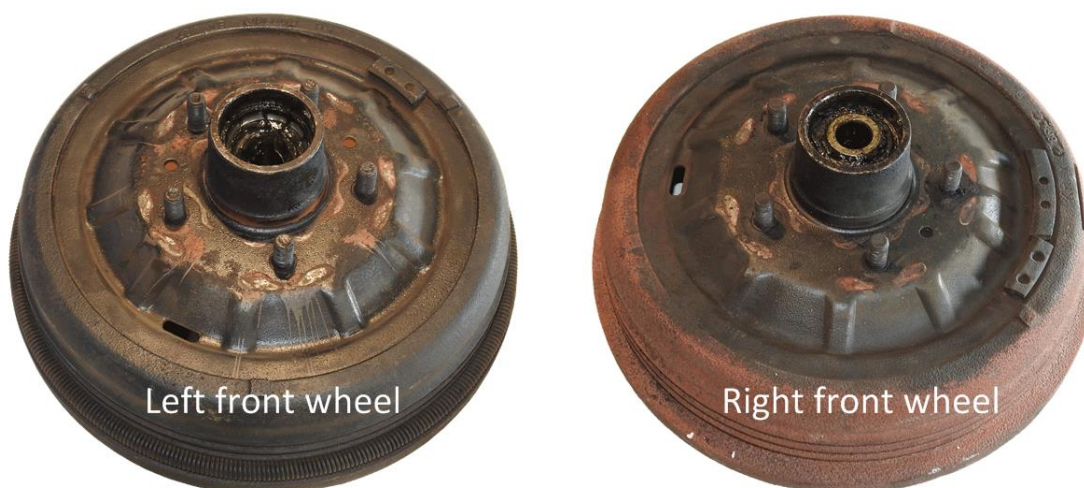
The brake drums clearly differed in colour; see Figure 15. The drum on the right front wheel was rusty red, while the drum on the left front wheel was more or less the same colour as the car's other brake drums.

*Figure 15: Front wheel brake drums. Photo: AIBN*

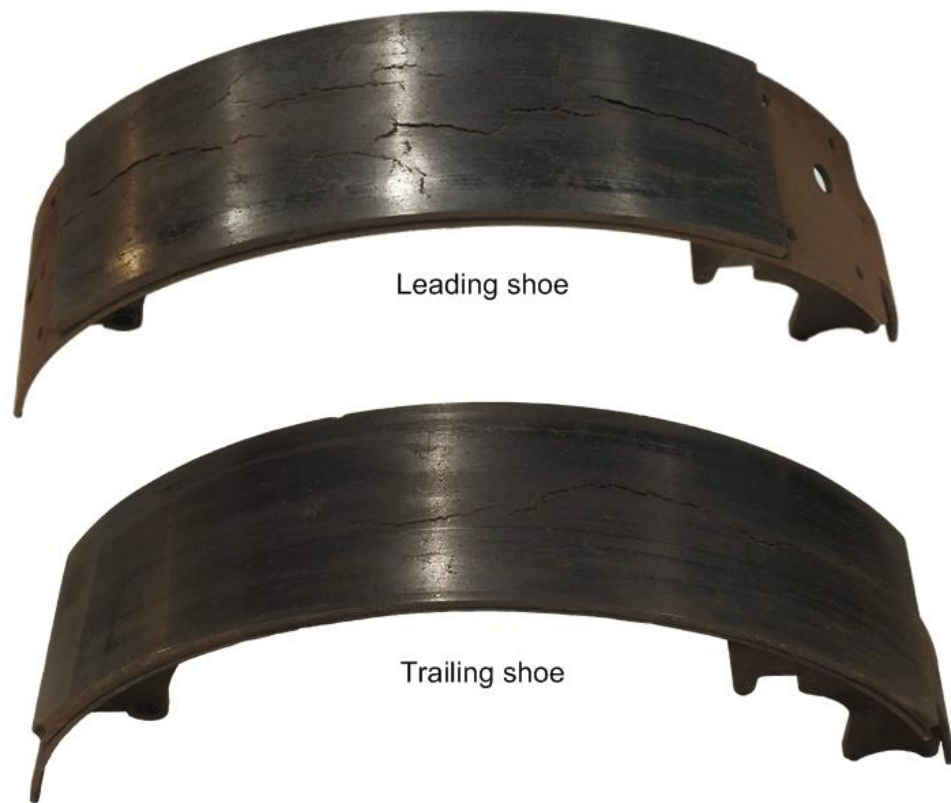
The brake bands on the left front wheel were somewhat worn, but were attached to the brake shoes. The thickness of the bands was approx. 3–3.5 mm at the edges and slightly less in the middle. The whole contact surface of the band was in contact with the drum. There were clearly visible cracks in the bands on both brake shoes; see Figure 16. The left-hand wheel cylinder was found to be in normal working order.

Figure 16: Brake shoe, left front wheel. Photo: AIBN

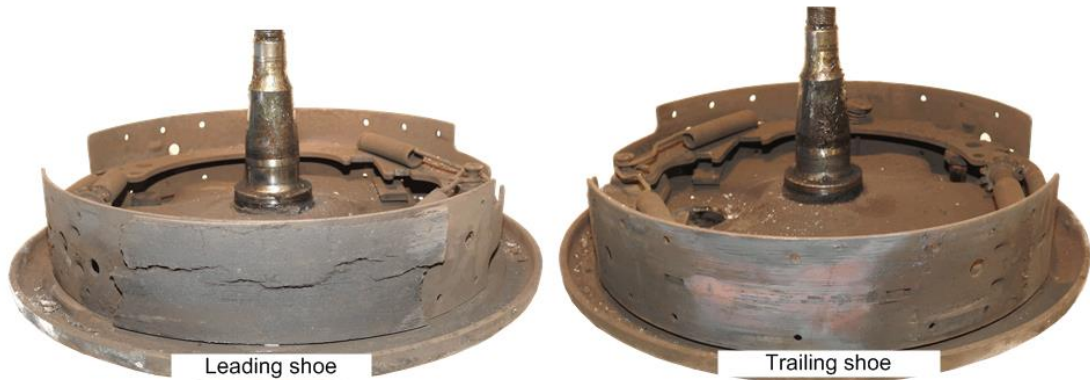
The brake bands on the right front wheel were completely worn down; see Figure 17.

Figure 17: Brake band, right front wheel. The brake band on the trailing shoe was completely worn down. The brake band on the leading shoe was also worn. Photo: AIBN

The brake band on the leading shoe had come loose at the ends, and the thickness was 2 mm at the edges and slightly less in the middle. The band on the trailing shoe had come loose from the brake shoe, and clear contact marks indicated steel-to-steel contact between the shoe and the drum; see Figure 17.

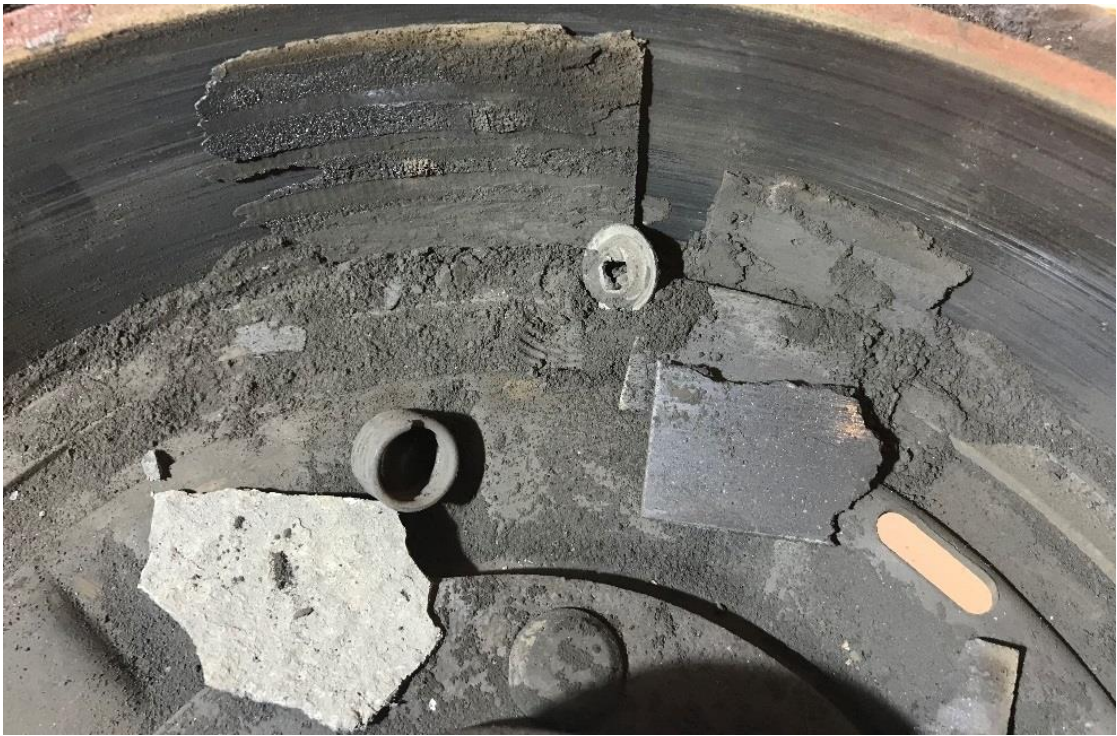
Parts of the brake bands and hold-down spring that keeps the trailing shoe up against the backing plate had come loose and were found inside the brake drum when it was dismantled; see Figure 18.

Figure 18: Parts of the brake band, brake dust and the hold-down spring inside the brake drum on the right front wheel. Photo: AIBN

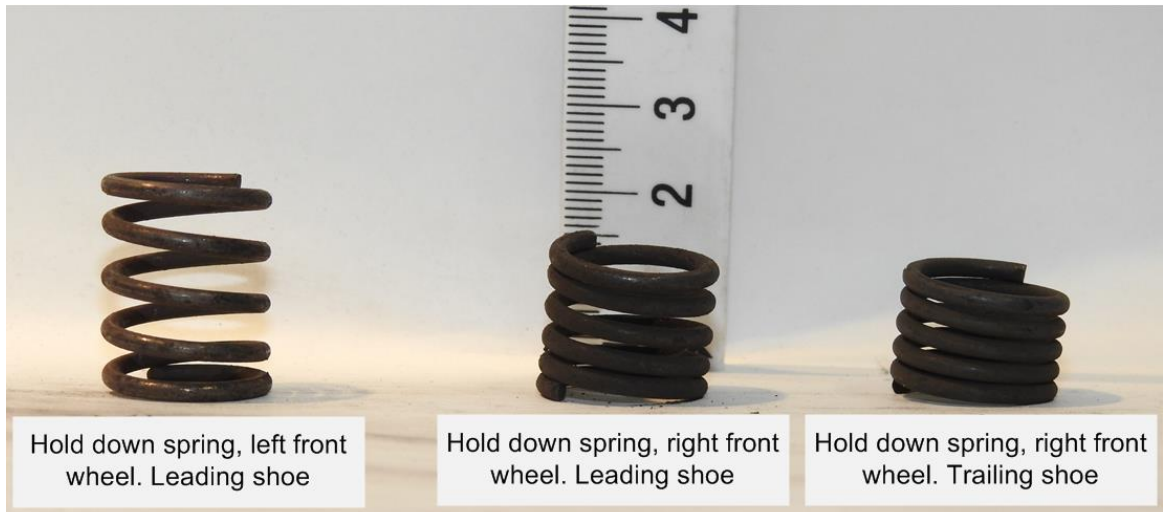
There was a clear difference in hold-down force between the springs on the right and left front wheel, particularly relating to the hold-down springs for the trailing shoe; see Figure 19.

Figure 19: Difference in hold-down force between the brake shoe hold-down springs. Photo: AIBN

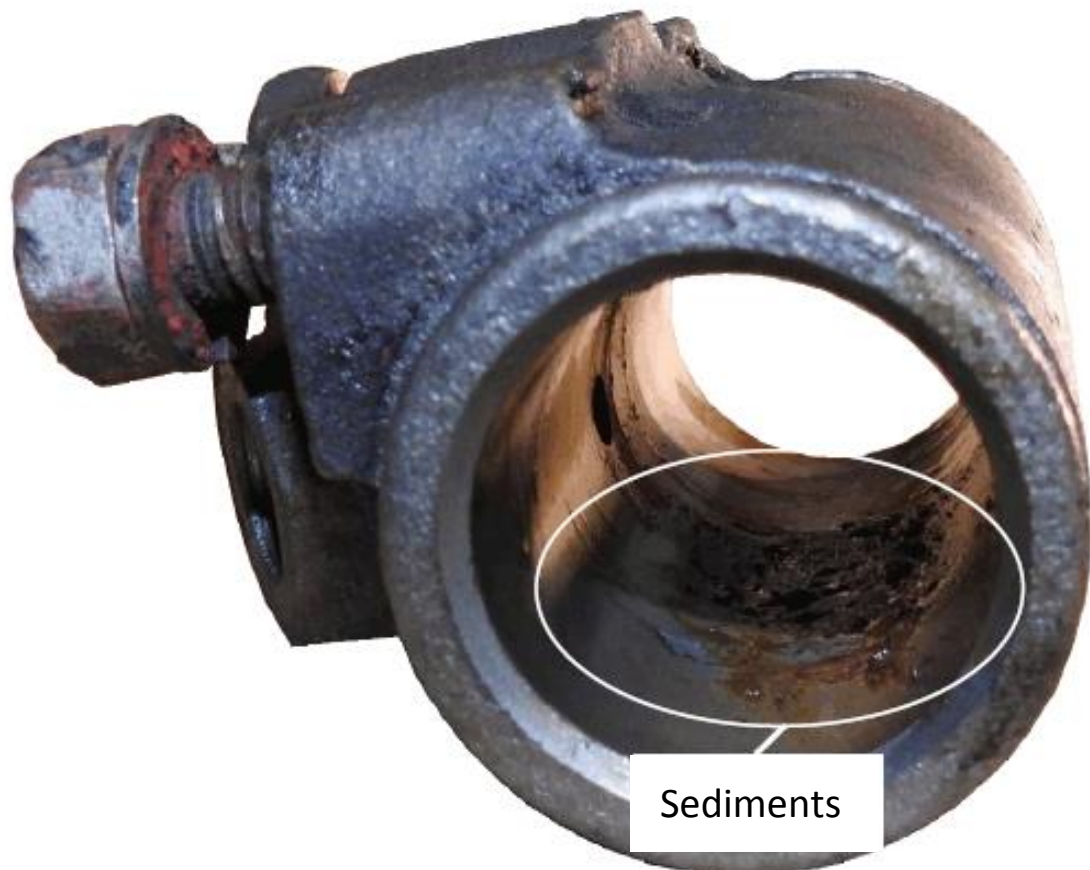
The wheel cylinder on the right front wheel was dismantled, and the piston on the trailing side was stuck, while it showed normal movement on the leading side. There were sediments inside the piston housing in the wheel cylinder; see Figure 20.

Figure 20: Piston housing, right front wheel cylinder. Photo and illustration: AIBN

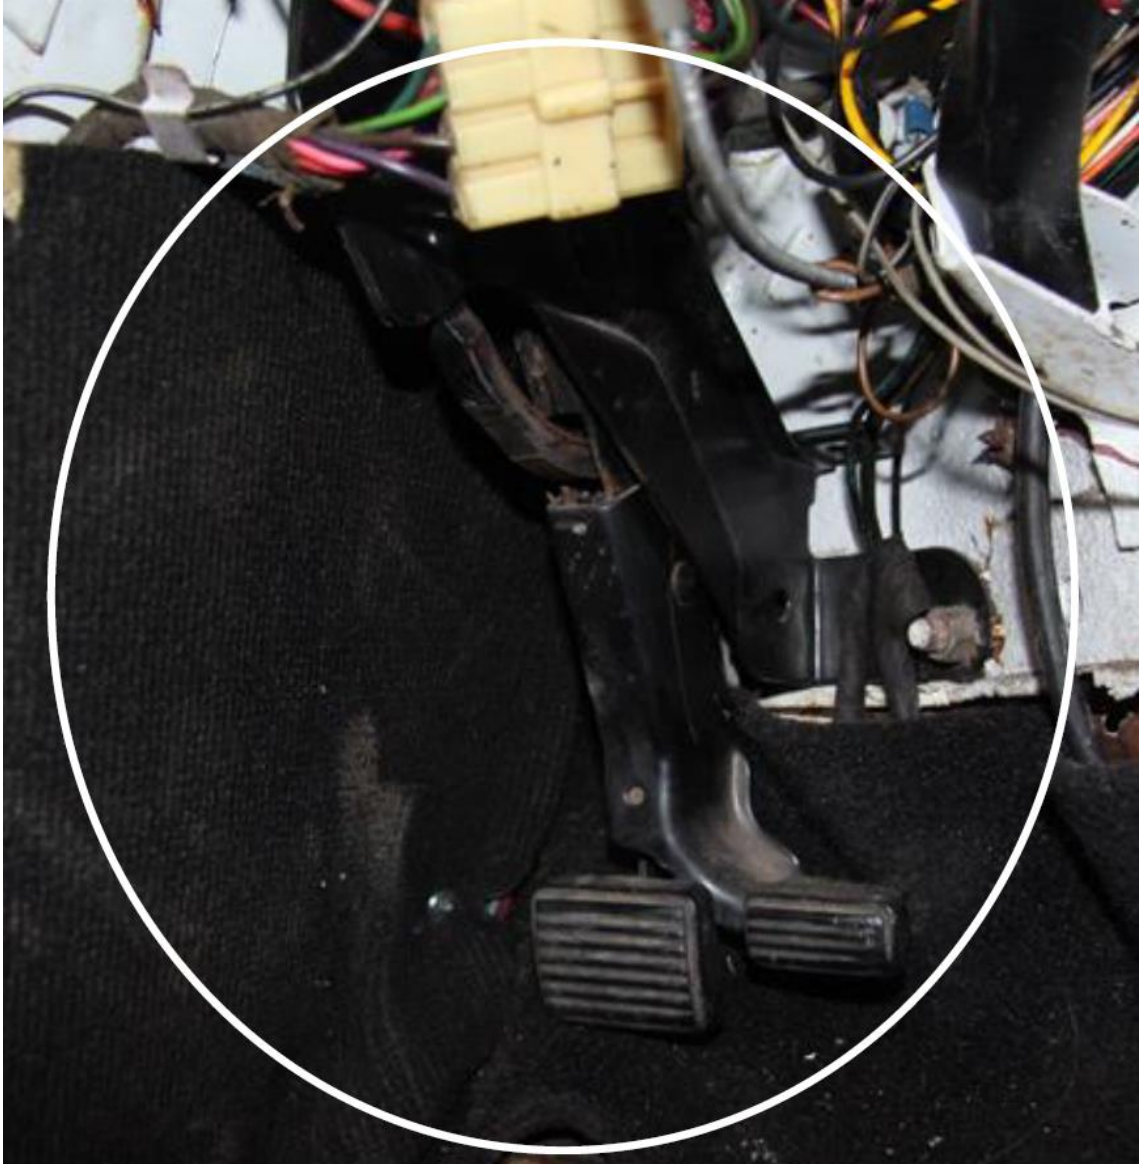
The car's parking brake was applied during the examination of the parking brake system, meaning that the foot pedal was fully depressed; see Figure 21.

*Figure 21: The parking brake pedal was fully depressed when the car was examined. Photo and illustration: NPRA*

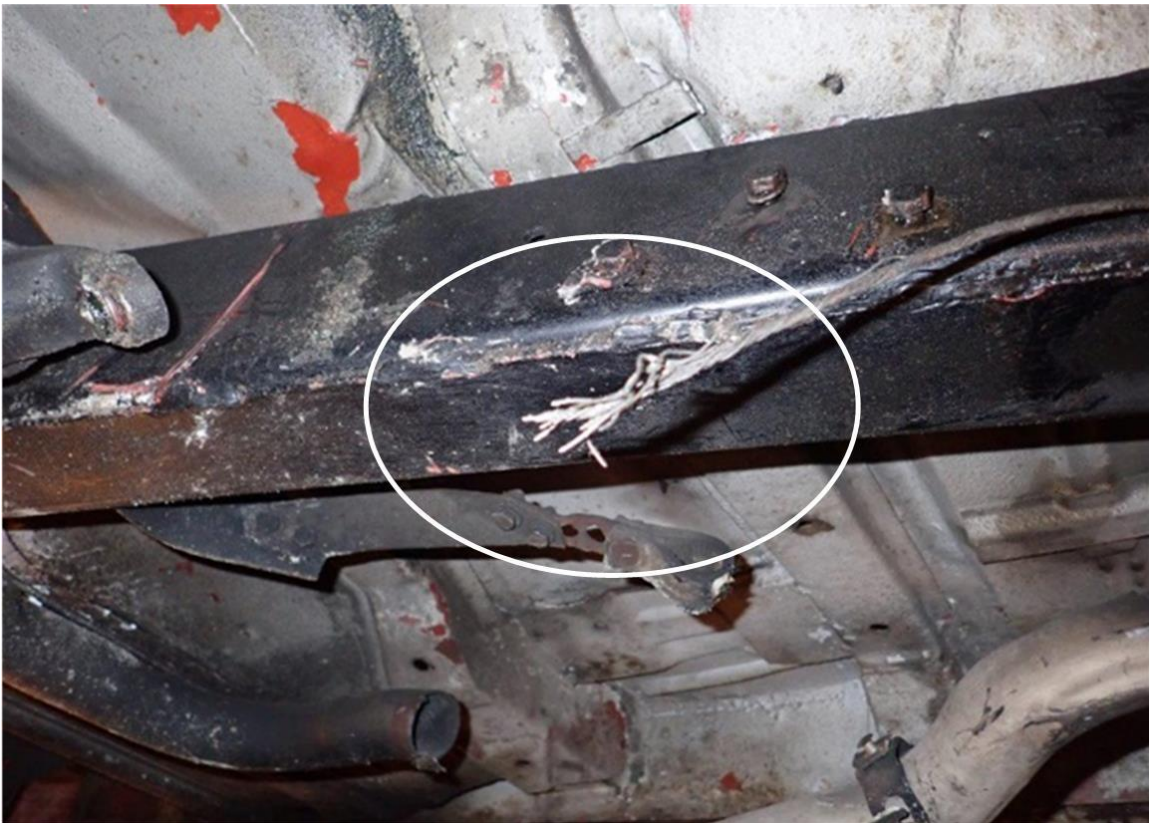
The transmission cable from the parking brake pedal to the back wheels was severed near the gear box when the car was examined. It was therefore not possible to transmit brake force from the foot pedal to the back wheels after the accident. The severed cable showed that several of the steel wires had been torn apart in more or less the same area; see Figure 22.

Figure 22: Severed cable for activating the parking brake. Photo: AIBN

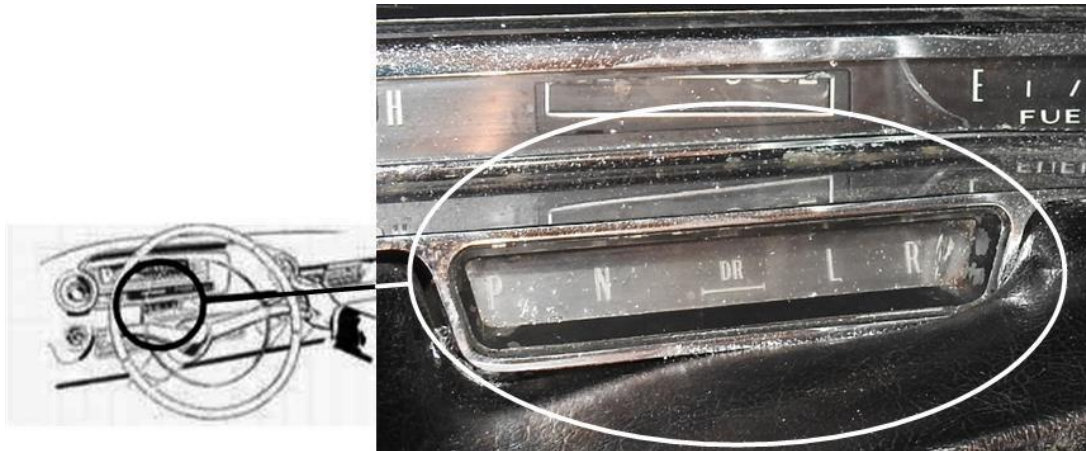
When the AIBN and the NPRA examined the car after the accident, they found that the gear lever was set to 'Dr' closest to 'N'.

Figure 23: The illustration on the left is taken from the car's instruction manual and shows the position of the gear indicator on the dashboard. The photo on the right shows the gear indicator in the car. Illustration: AIBN
