REPORT

Road 2020/07

REPORT ON A HEAD-ON COLLISION BETWEEN A PASSENGER CAR AND A VAN ON THE E39 AT AUSTEFJORDEN, VOLDA, MØRE OG ROMSDAL ON 20 OCTOBER 2019

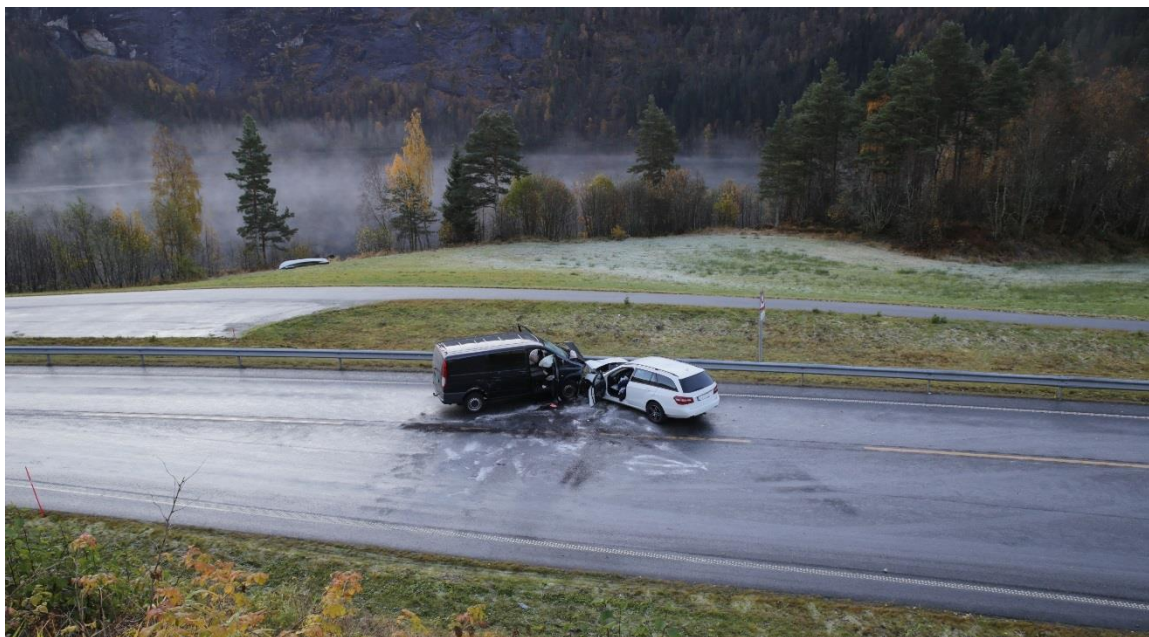
Figure 2: Final positions - northbound van and southbound passenger car photographed at 11:48. Photo: The police

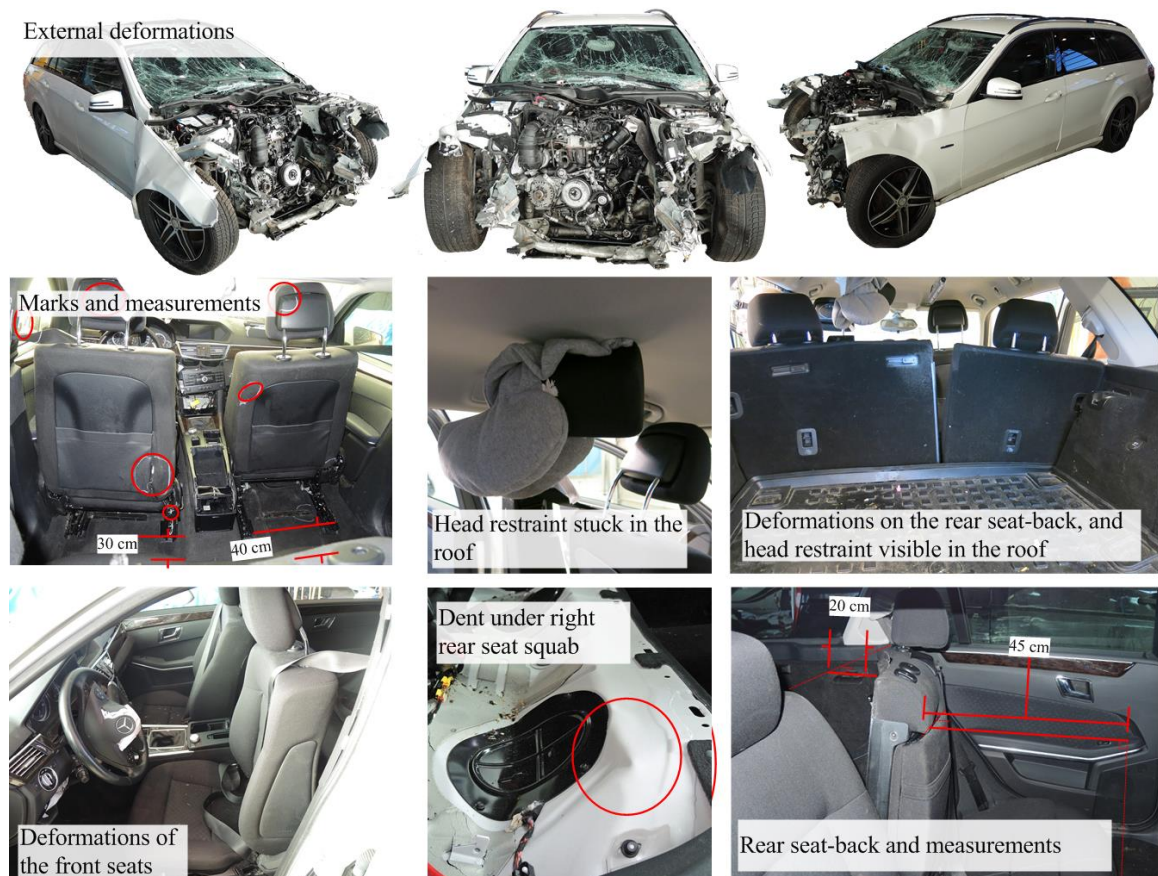
The front of the estate car had external deformations and had crumpled by approx. 73 cm on average across its whole width. The passenger compartment was intact and all doors could be opened and closed. The windscreen was the only broken window. The driver's seat was originally 30 cm away from the back seat and was displaced forward and upward, but was still firmly attached to its front anchorage. The right passenger seat was originally 40 cm away from the back seat and was loose and displaced further forward. The rear seat-back consisted of two parts, and the larger part (the 60 part) was displaced approx. 20 cm forward from the normal position at the middle rear seat. The distance between the rear seat-back, and the forward part of the rear seat squab, was approx. 45 cm. The NSIA removed the upholstery from the rear seat-back and examined it in detail, see Section 1.13.4. There were scorch marks on the right rear seat squab, and a dent under the rear seat squab, see Figure 4.

The middle head restraint was stuck in the roof, pins first, immediately behind the driver's seat, but was not ripped or damaged. At the middle of the rear side of the seat-back was what appeared to be a spot of paint, but this is not related to the accident.

Figure 4: External/internal deformations, marks and points of impact in the estate car
Illustration/photo: NSIA

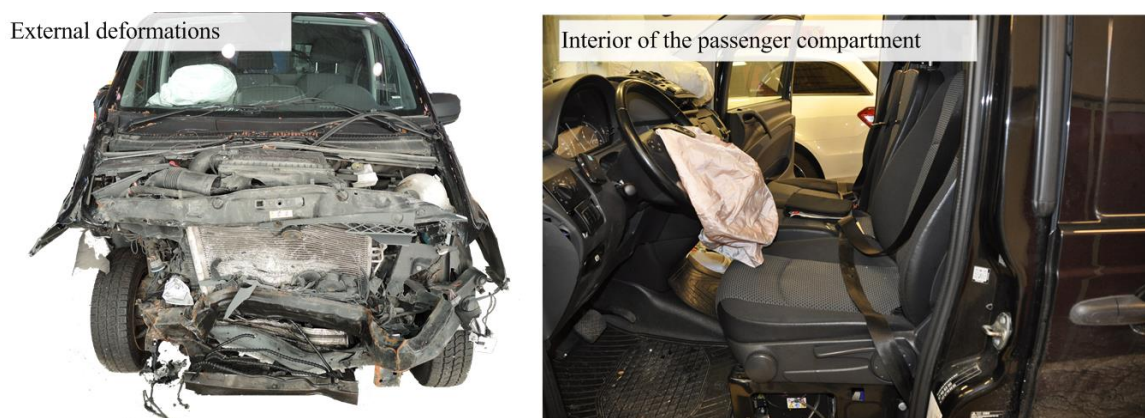
Externally, the crumple zones in the front of the van had crumpled by approx. 40 cm. The right impact cushion had completely crumpled. There was little deformation internally,

and a full partition separated the load in the cargo space from the passenger compartment. Pretensioners and force limiters were activated on both seat belts.

Figure 5: External deformations on the van and the interior of the passenger compartment.
Illustration/photo: NSIA

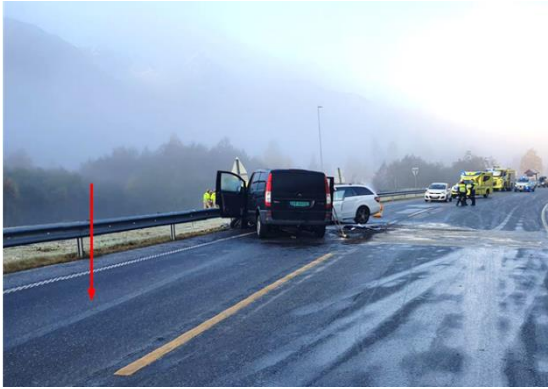
Figure 6: Temporary traces left by the van on the roadway, photographed at 10:04. Photo: The police

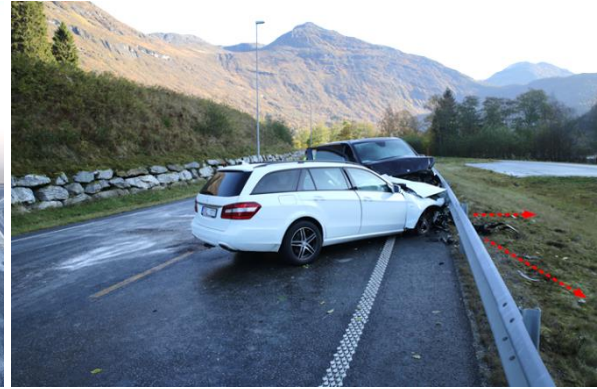
Figure 7: Spread of plastic covers and remnants from the head-on collision Photo: The police

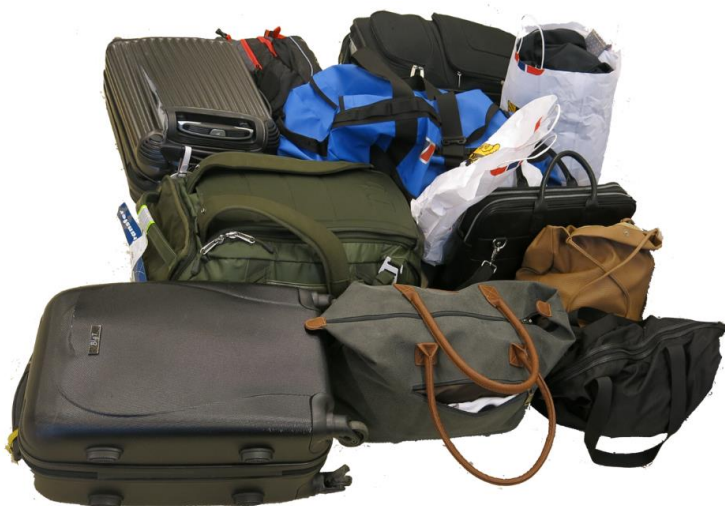
Two suitcases and one bag had external damage after the collision. All luggage, except for the 2.9 kg rucksack that was loaded last, remained in the boot following the collision. The rucksack was lying on the floor behind the right passenger seat after the collision.

The compartment cover beam, which can be fitted with a net stretching up to the roof and a fabric cover that can be drawn over the luggage, was not in place at the time of the accident. This is analysed in Section 2.5.3.3.

Figure 8: Luggage that was placed in the estate car's boot. Photo: NSIA

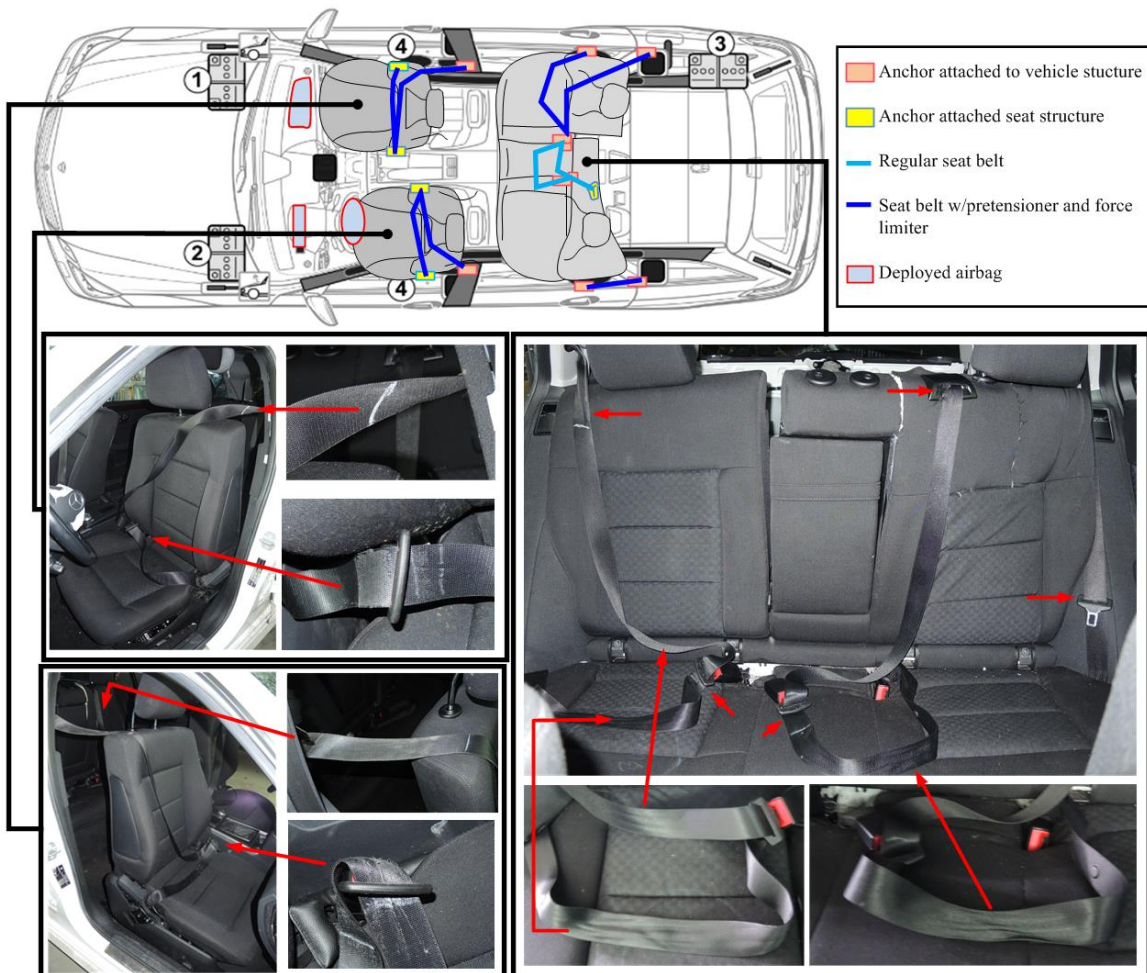
Seat	Lap belt	Shoulder belt	Pretensioner/force limiter
Driver's seat	Scorch mark by buckle	Scorch mark by B pillar	Activated / 10 cm extraction with jamming
Right front	Scorch mark by buckle	Scorch mark by B pillar	Activated / 24 cm extraction
Left rear seat	Not in use	Not in use	Activated (fastened)
Middle rear seat	Wave pattern along 20 cm, internal scorch mark	Small rip at top towards the retractor	Not available
Right rear seat	Wave pattern along 25 cm, internal scorch marks	Weak wave pattern at bottom, scorch mark by C pillar	Activated / 20 cm extraction

Figure 13: Scorch marks, extractions and wave patterns on the seat belts after collision.

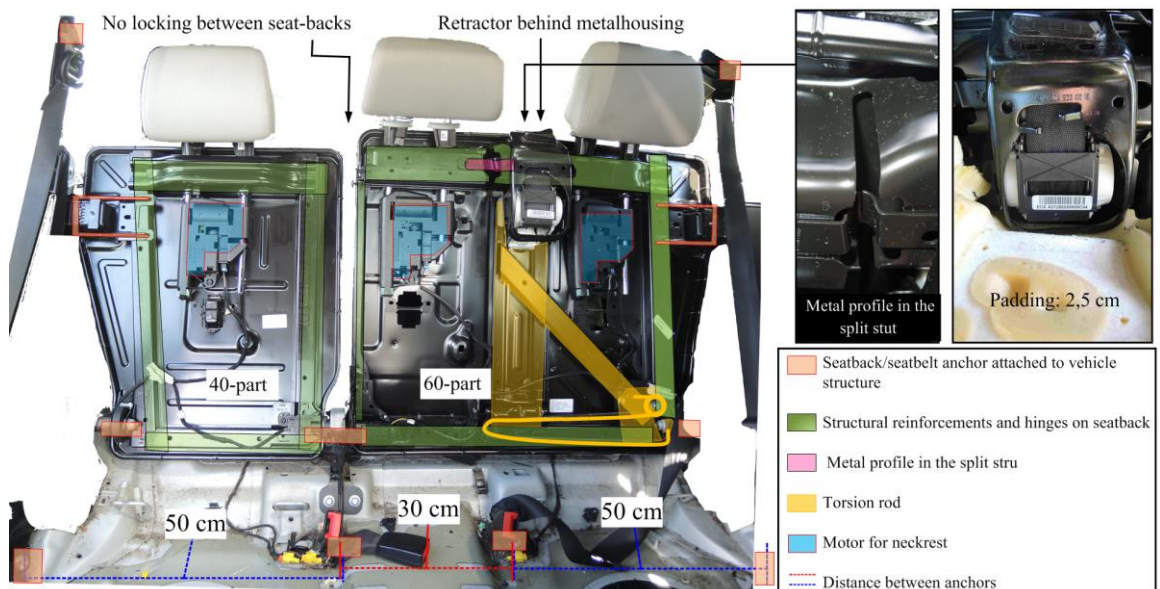
The 60-part's framework was constructed in two parts, where the framework from the outer edge towards the retractor had special reinforcement, marked yellow in Figure 14. The lateral strut at the top of the 60-part was divided in two at the retractor, with a small, profiled metal part in the gap. The reinforcement consisted of a diagonal strut, fitted at the bottom of the outer edge of the left seat, where it was linked to a torsion rod. It then led diagonally up towards the retractor for the middle seat belt.

Figure 14: The rear seat structure and distances between the seat belt anchor points. Illustration: NSIA

The retractor was installed on the front edge of the upper part of the rear seat-back. The shoulder part of the seat belt moved with the upper part of the rear seat-back when it was deformed forwards during the collision. This may also have affected the direction of travel. The NSIA considers the fractures in the upper part of the passenger's back to be related to the tightening of the shoulder belt in this situation. The NSIA also considers that the metal housing around the retractor on the front of the seat-back, beneath the thin upholstery – as shown in Figure 14 – may have contributed to her injuries.

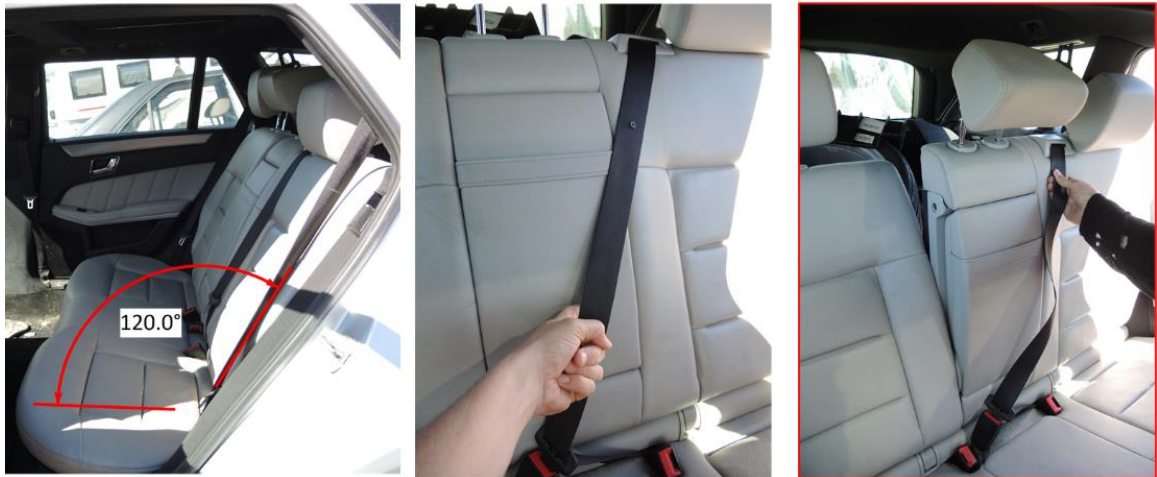
In the locked position, the rear seat-back was at an angle of approx. 120 degrees to the floor. When the middle seat was pushed forward with the belt locked, the length of the belt increased because of the difference between the seat-back rotation point and the positioning of the anchor points, as shown in Figure 15.

Figure 15: Rear seat-back angle and extension of locked seat belt's length when the seat-back is moved forwards. Illustration: NSIA

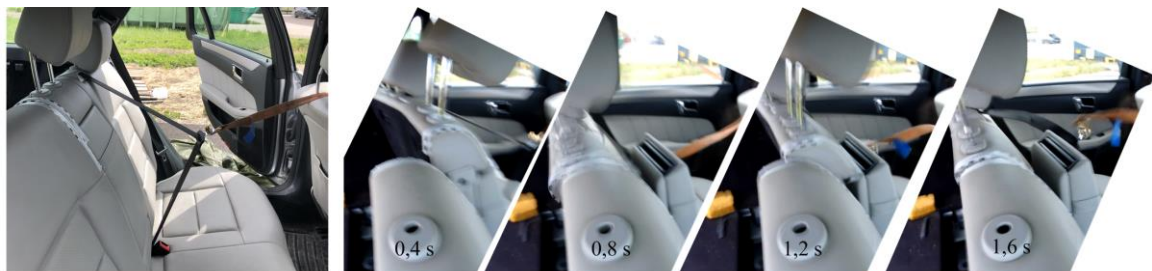
The experiment was filmed. It is very clear from the recording that the seat-back bent forward when the load was applied to the shoulder belt. When the pressure on the stop was released, the seat-back sprang back, but before it came to rest it rocked to and fro before it reverted to a roughly upright position, see Figure 16.

Figure 16: Set-up of the pulling experiment and sequence of oscillations from the video. The whole experiment lasted for around 2 seconds. Illustration: NSIA

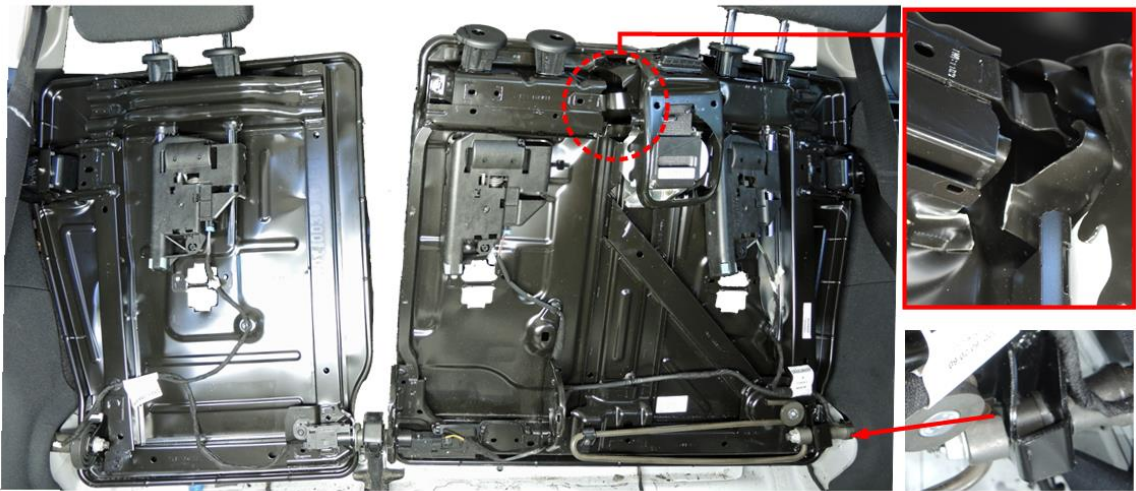
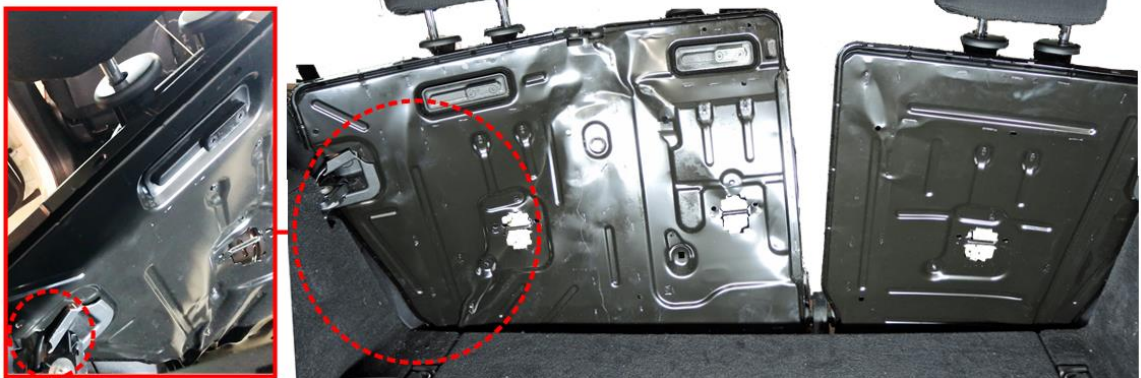
The NSIA removed the upholstery from the rear seat-back of the estate car involved in the accident in order to examine deformations, twisting and metal fractures. Both parts of the seat-back were deformed, but the 60-part was most deformed.

The 60-part was at its most deformed from the retractor in the middle and out towards the C pillar. Fractures were found in the strut at the top, by the retractor, and the small metal profile in the gap was completely stretched out, see Figure 17. Twisting and stretching was found at all three anchor points that attached the seat-back to the body of the vehicle, especially by the buckle against the C pillar.

Figure 17: Deformations, twisting and metal fractures on the seat-back's 60-part. Illustration: NSIA

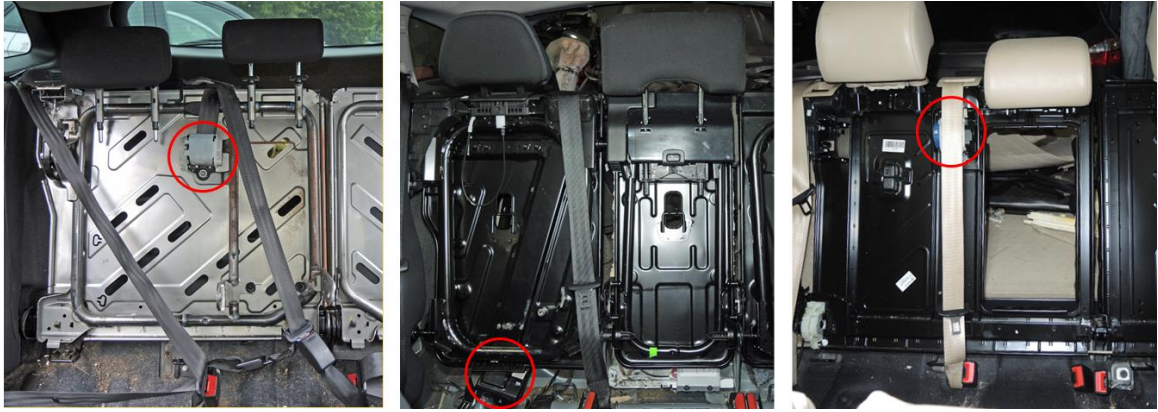
Figure 18: Design of seat belt integrated into rear seat-back for several manufacturers. The retractors are marked by red circles. Illustration: NSIA

All seat-backs that were examined consisted of welded sheet metal and a frame. The frames were either made of round tubes or u-profile struts. Reinforcement of the rear seat-back towards the retractor for the middle seat varied, and the retractors were of different types. Many retractors were fitted at the front edge, with or without a metal housing; others were floor-mounted and had a pretensioner and force limiter. The width of the seat belt across the pelvis in the rear middle seat was consistently narrower than for the other seat belts in the same vehicle.

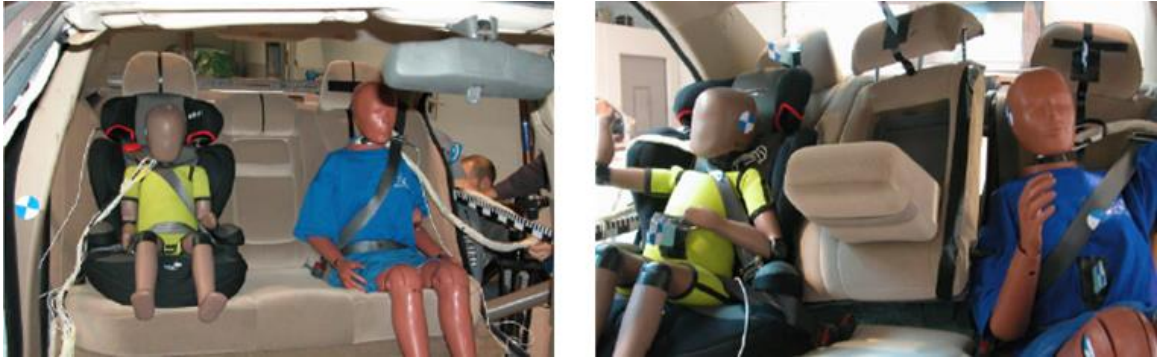
Figure 20: The back seat in one of the test cars, before and after the ANEC test. Photo: ANEC

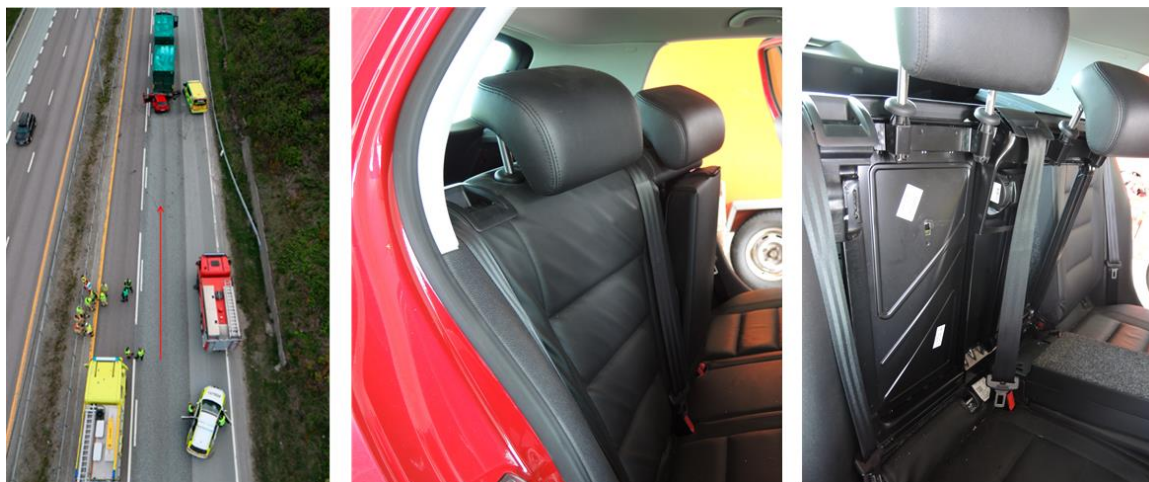
While this investigation was being conducted, observations were made concerning the rear seat of a passenger car in another ongoing investigation. The accident involved a passenger car colliding with a stationary HGV at a speed of approx. 80 km/h (SHK, 2020). There were no persons in the back seat, but the rear seat structure gave way in the collision. The only item that could have been in the boot before the accident, was a 4-litre container of washer fluid that was lying in the passenger compartment after the collision. The seat cover in the rear seat was removed and the NSIA found that the retractor integrated into the rear seat-back had been displaced approx. 15 cm forwards.

Figure 21: Deformed rear seat structure from the accident involving a collision with a stationary HGV (SHK, 2020). Source: NSIA
