REPORT

Road 2021/02

REPORT ON HEAD-ON COLLISION ON THE E6 ROAD NEAR HAMMER IN SNÅSA MUNICIPALITY ON 2 FEBRUARY 2020

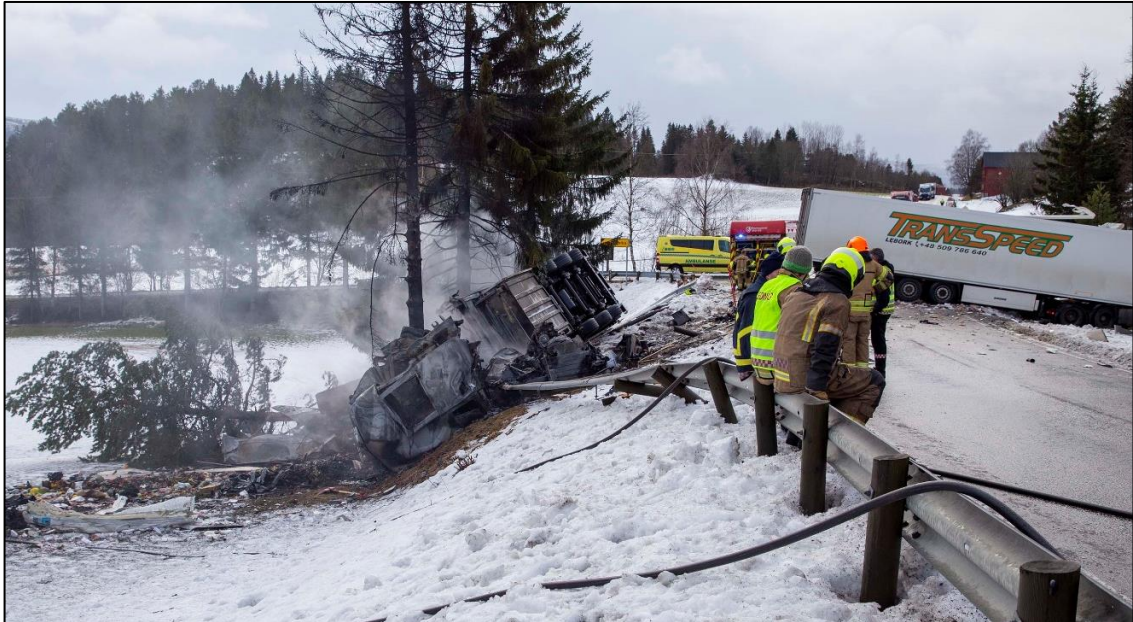
After the collision, the Polish heavy goods vehicle ran off the road from its lane. The tractor unit came to a stop with its front against some trees, and the semi-trailer ended up at an angle of approximately 90° across the road. The Norwegian heavy goods vehicle ran off the road from its lane after the collision, before it overturned and came to rest against some trees in a slope. Both tractor units sustained extensive material damage in the accident. The driver's cab of the Norwegian vehicle caught fire immediately after the collision.

Figure 5: The final positions of the two vehicles involved in the accident. Photo: The police

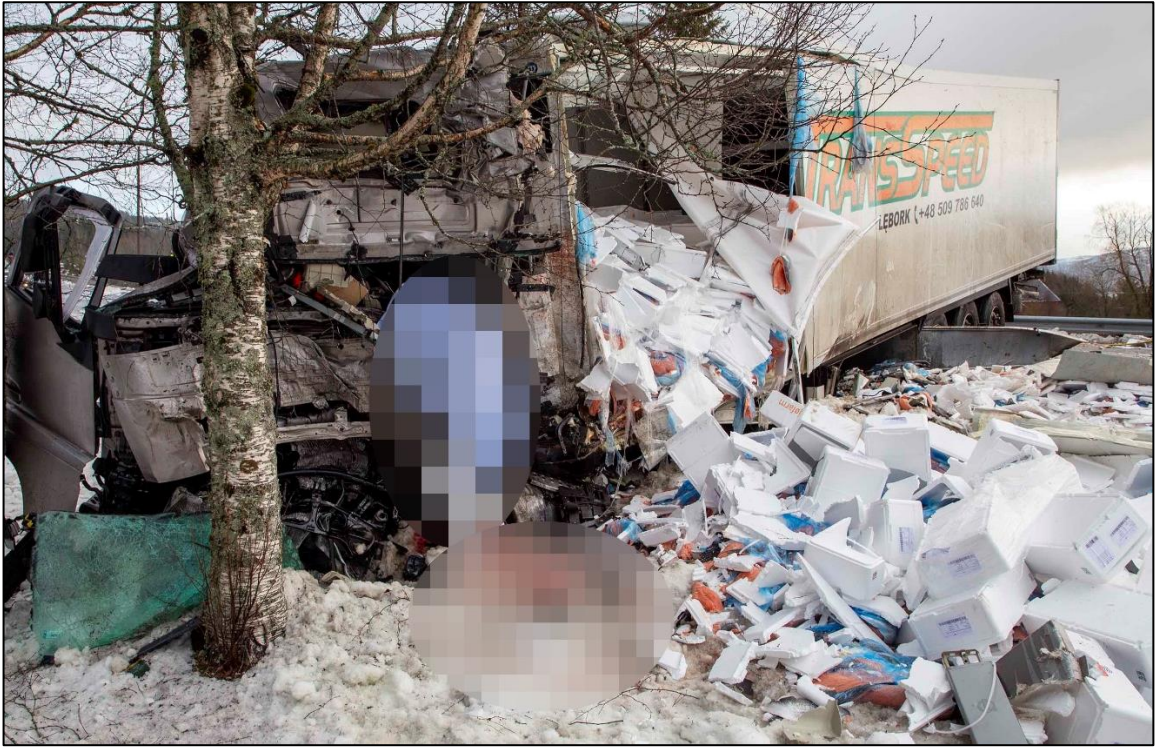
Both tractor units sustained major damage to the front as a result of the collision (see Figure 7 and Figure 8), and the tractor unit of the northbound vehicle was completely burnt out. The two semi-trailers both sustained the most serious damage to the front left-hand side.

Figure 7: Damage to the tractor unit of the southbound vehicle. Photo: The police

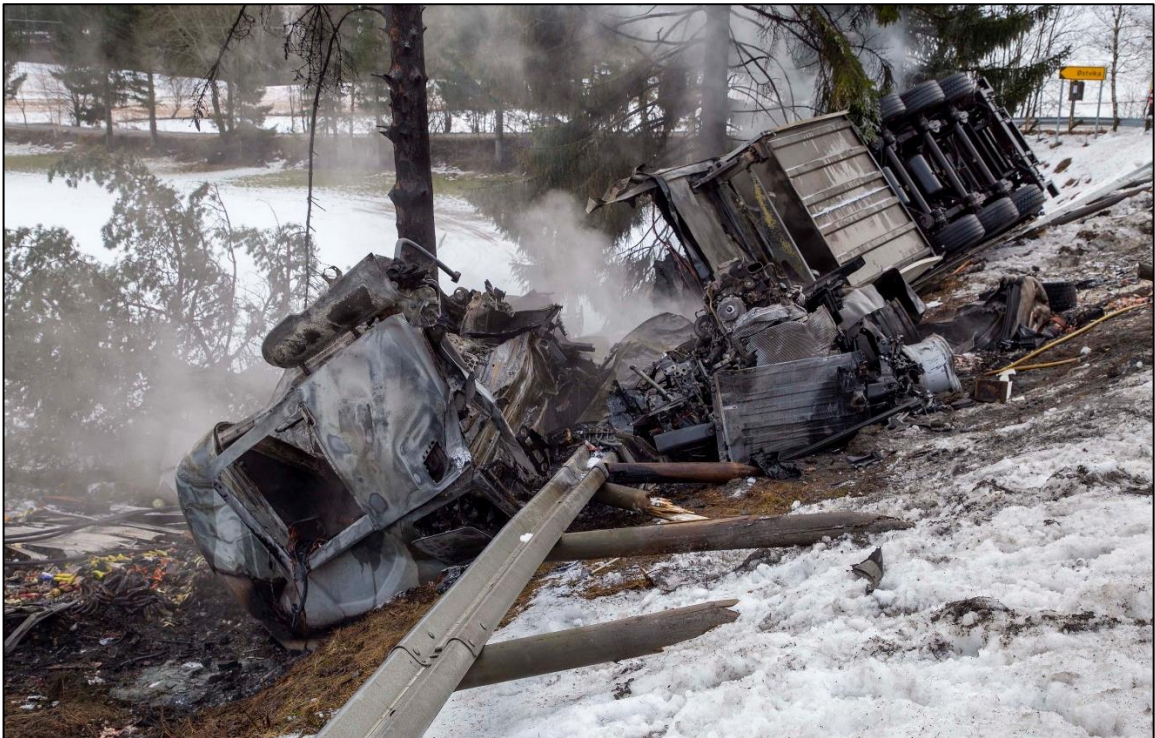
Figure 8: Damage to the tractor unit of the northbound vehicle. Photo: The police

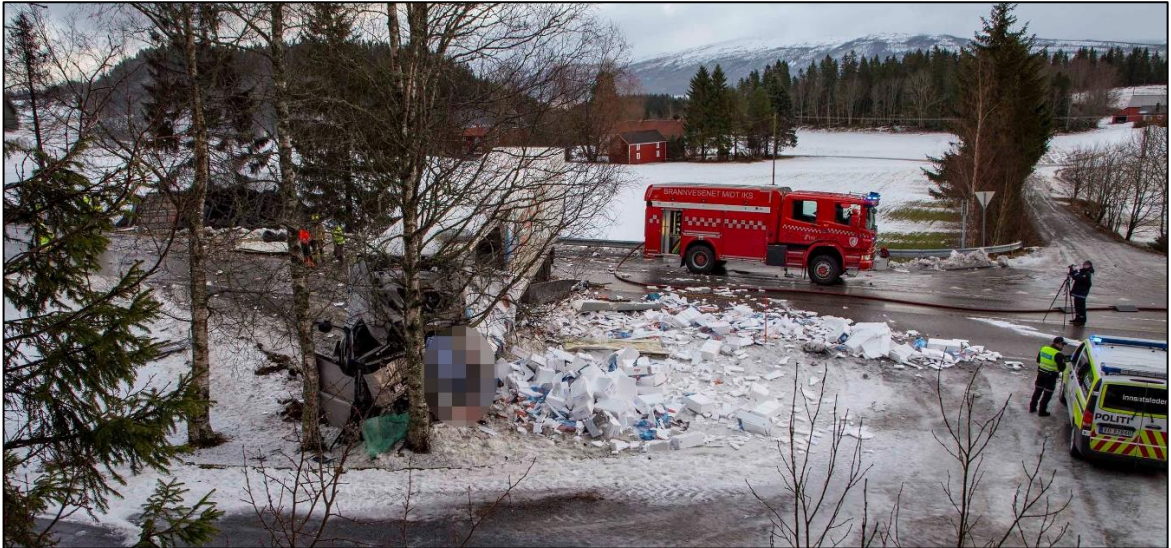
Roadside terrain and crash barriers were damaged when the heavy goods vehicles ran off the road. The southbound and northbound vehicles were carrying fish and food, respectively, and much of their cargo was scattered across the road and roadside terrain as a result of the collision.

Figure 9: The cargo carried by the two vehicles was scattered across the accident site. Photo: The police

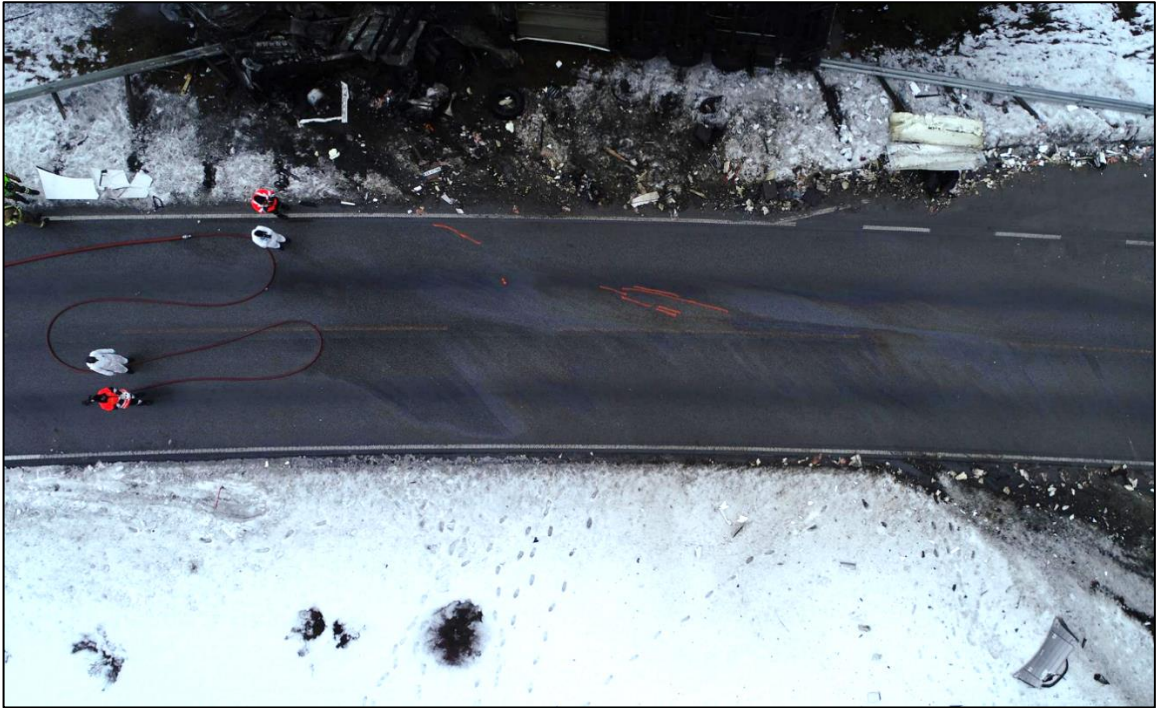
Investigations at the accident site found no marks left in the roadway before the point of the collision, but rubber and scratch marks had been left on the asphalt in the northbound lane at the accident site (see Figure 11 and Figure 12). The marks in the roadway were about one centimetre deep.

Figure 11: Marks left (indicated in orange) in the northbound lane. Photo: NPRA

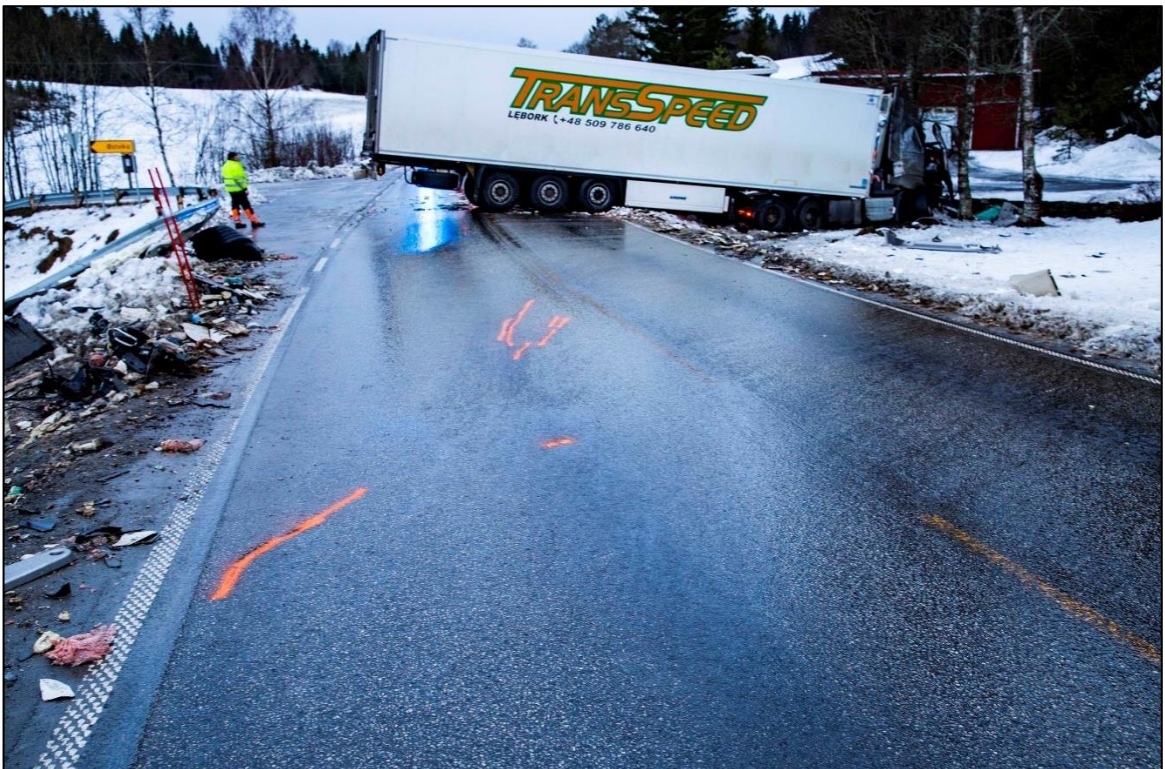
Figure 12: Marks left (indicated in orange) in the northbound lane. Photo: The police

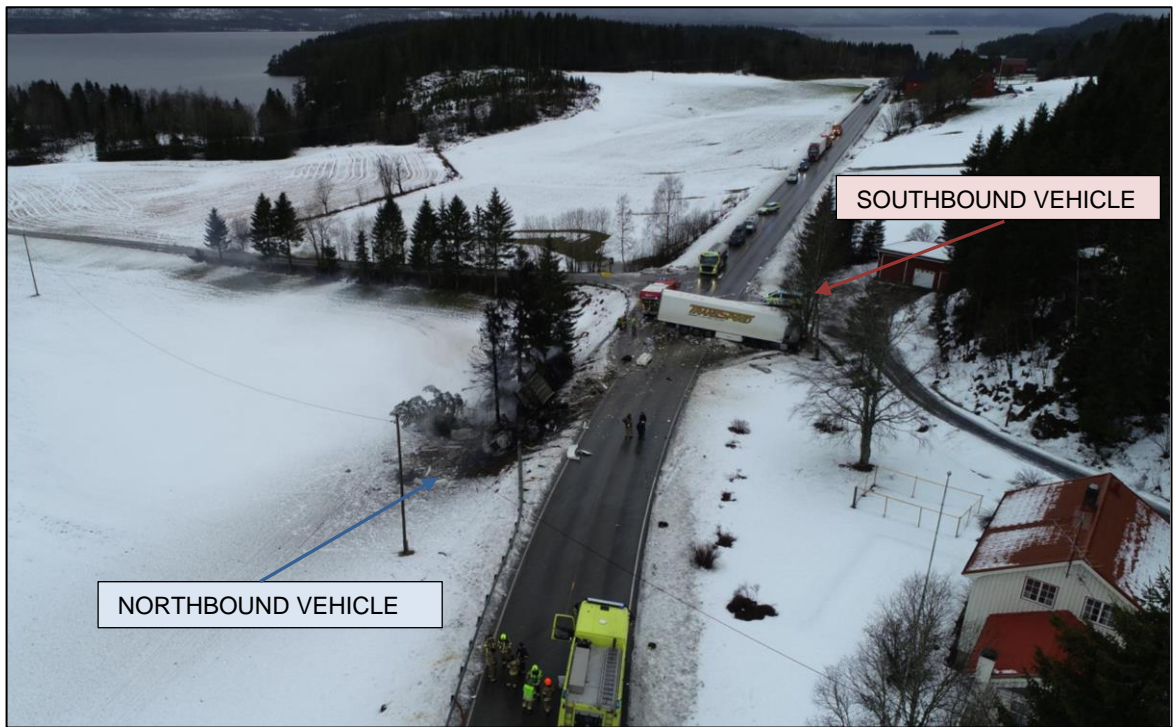
After the collision, the southbound vehicle continued out of the road on the right-hand side and ended up across the road with its front against some trees. The northbound vehicle ran off the road and overturned after the collision. The vehicle came to rest on its side against some trees in a tall slope at the side of the road.

Figure 13: The final position of the two heavy goods vehicles after the collision. Photo: NPRA

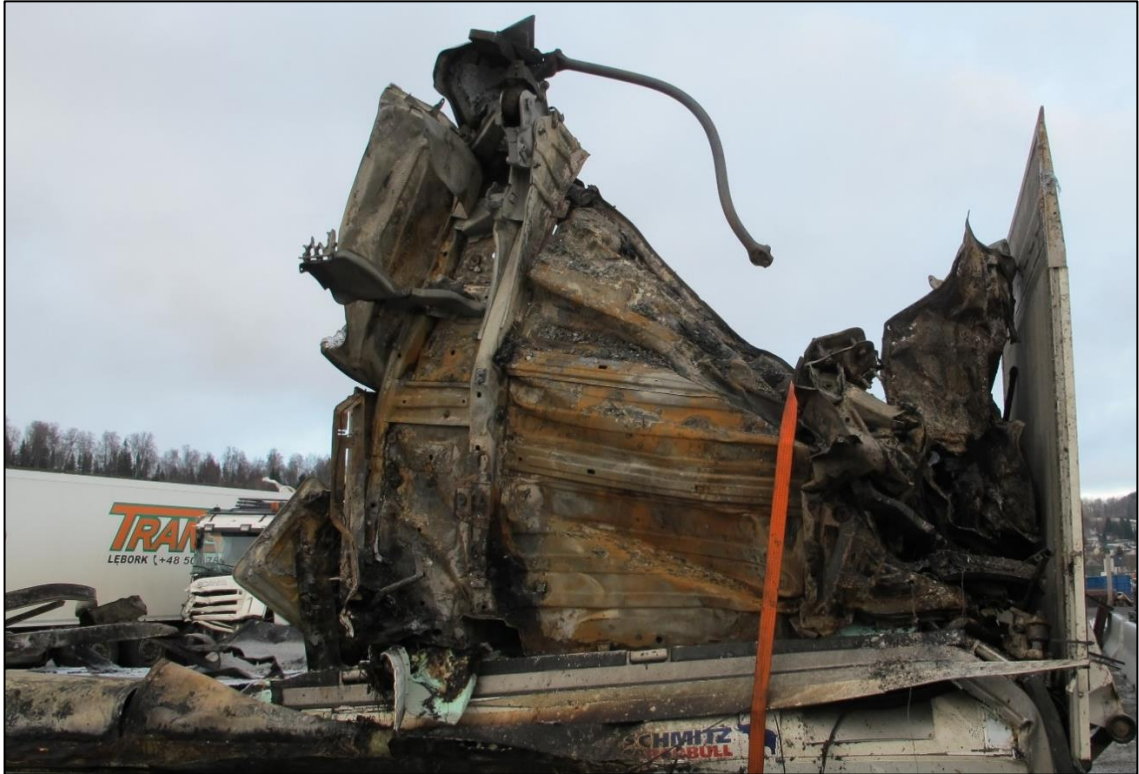
The extent of the damage meant that it was not possible to make an assessment of the tractor unit's technical condition before the accident.

Figure 16: Fire damage to the driver's cab of the Norwegian tractor unit. Photo: NSIA

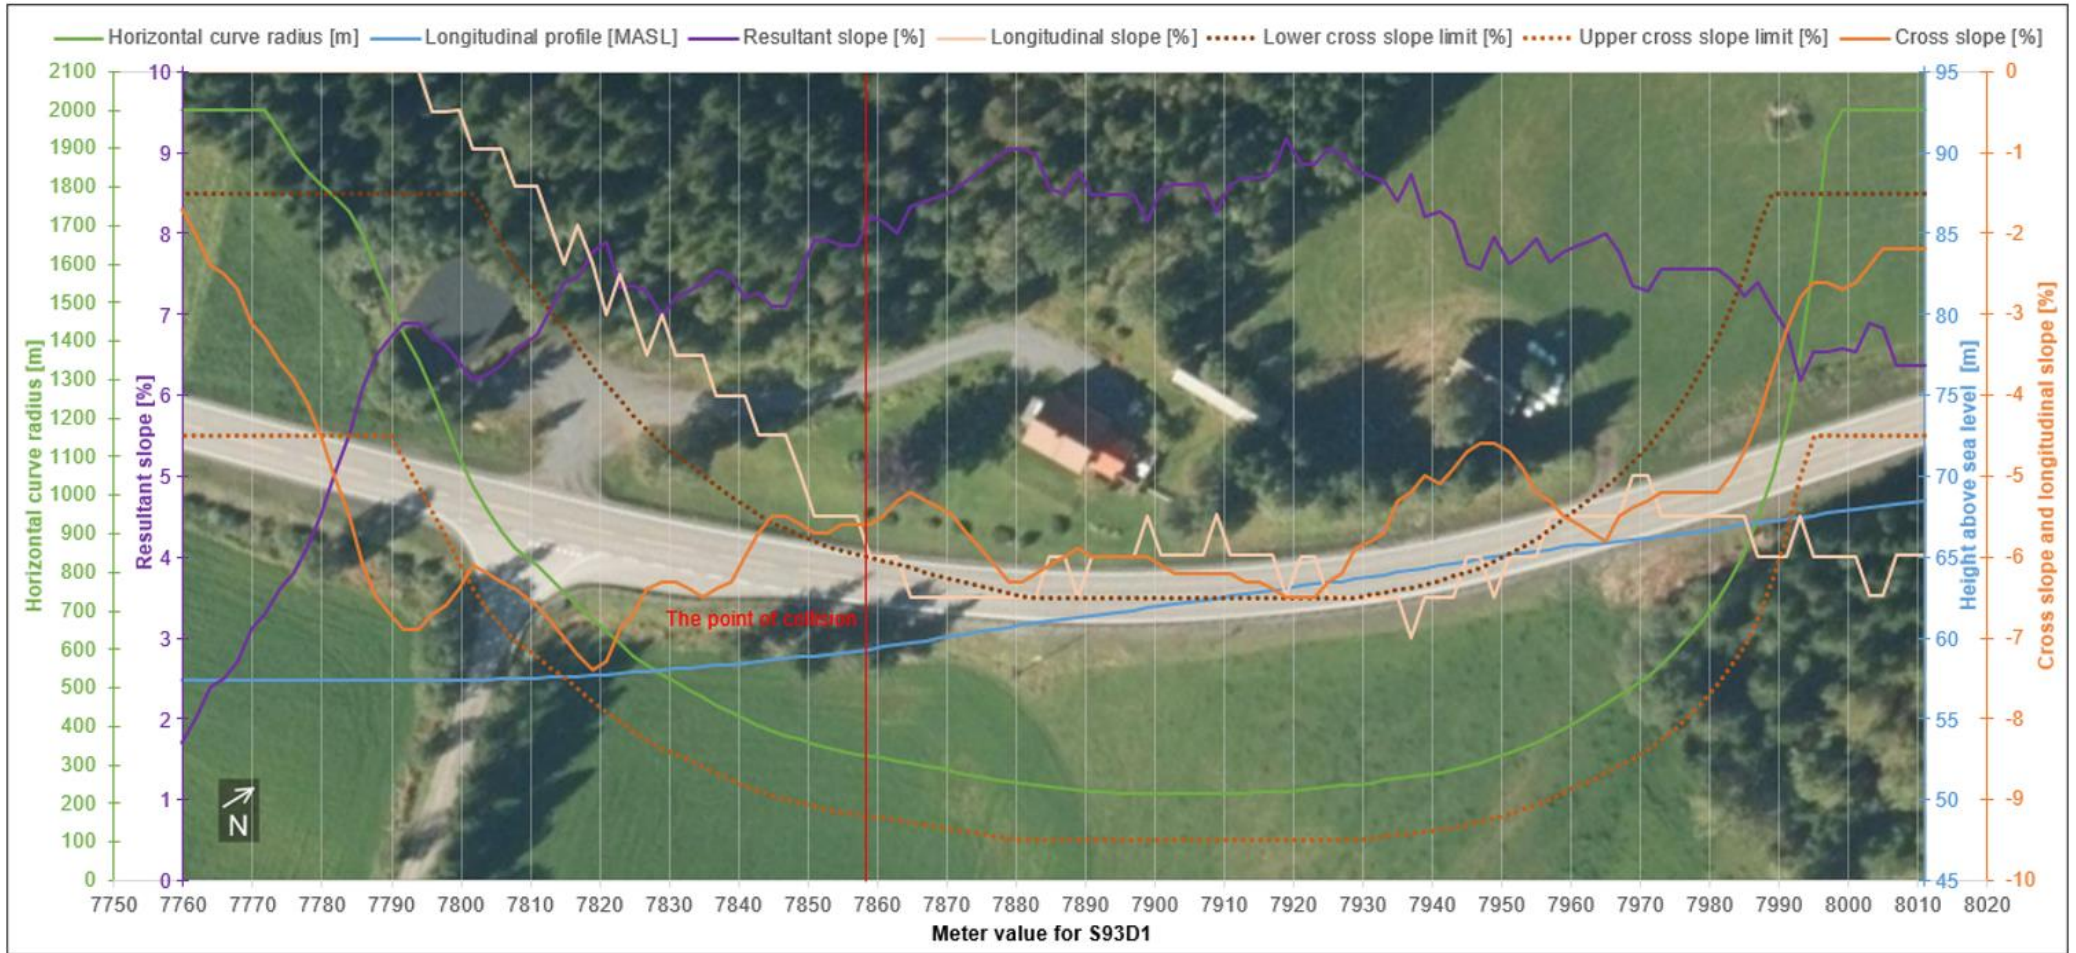
required,⁵ from approx. 40 metres into the right-hand curve for a distance of approx. 100 metres up to the point where the collision occurred (see the distance between EV6 S93D1 m7960 and S93D1 m7860 in Figure 17). The greatest non-conformity in the cross slope is found at around m7945, approx. 90 metres before the point where the collision occurred, where the difference between the measured cross slope and the calculated minimum cross slope is 1.5 percentage points.

Figure 17: Horizontal curve radius, cross slope, upper and lower cross slope limits, longitudinal slope, resultant slope and longitudinal profile of the southbound heavy goods vehicle's lane and direction of travel. Positive radius values indicate a right-hand curve, and negative cross slope values indicate sloping to the right. Source: NPRA. Overview: © Norwegian Mapping Authority. Illustration: NSIA
